Failure Analysis
of
High Strength Bolt's
Loss of Tension
on
Two Movable Bridges

William J. Doherty, P.E.
Florida Department of Transportation
Bureau of Structures Design

2nd BIENNIAL MOVABLE BRIDGE SYMPOSIUM

Based on
Report of May 15, 1987
Abridged: October 1, 1987

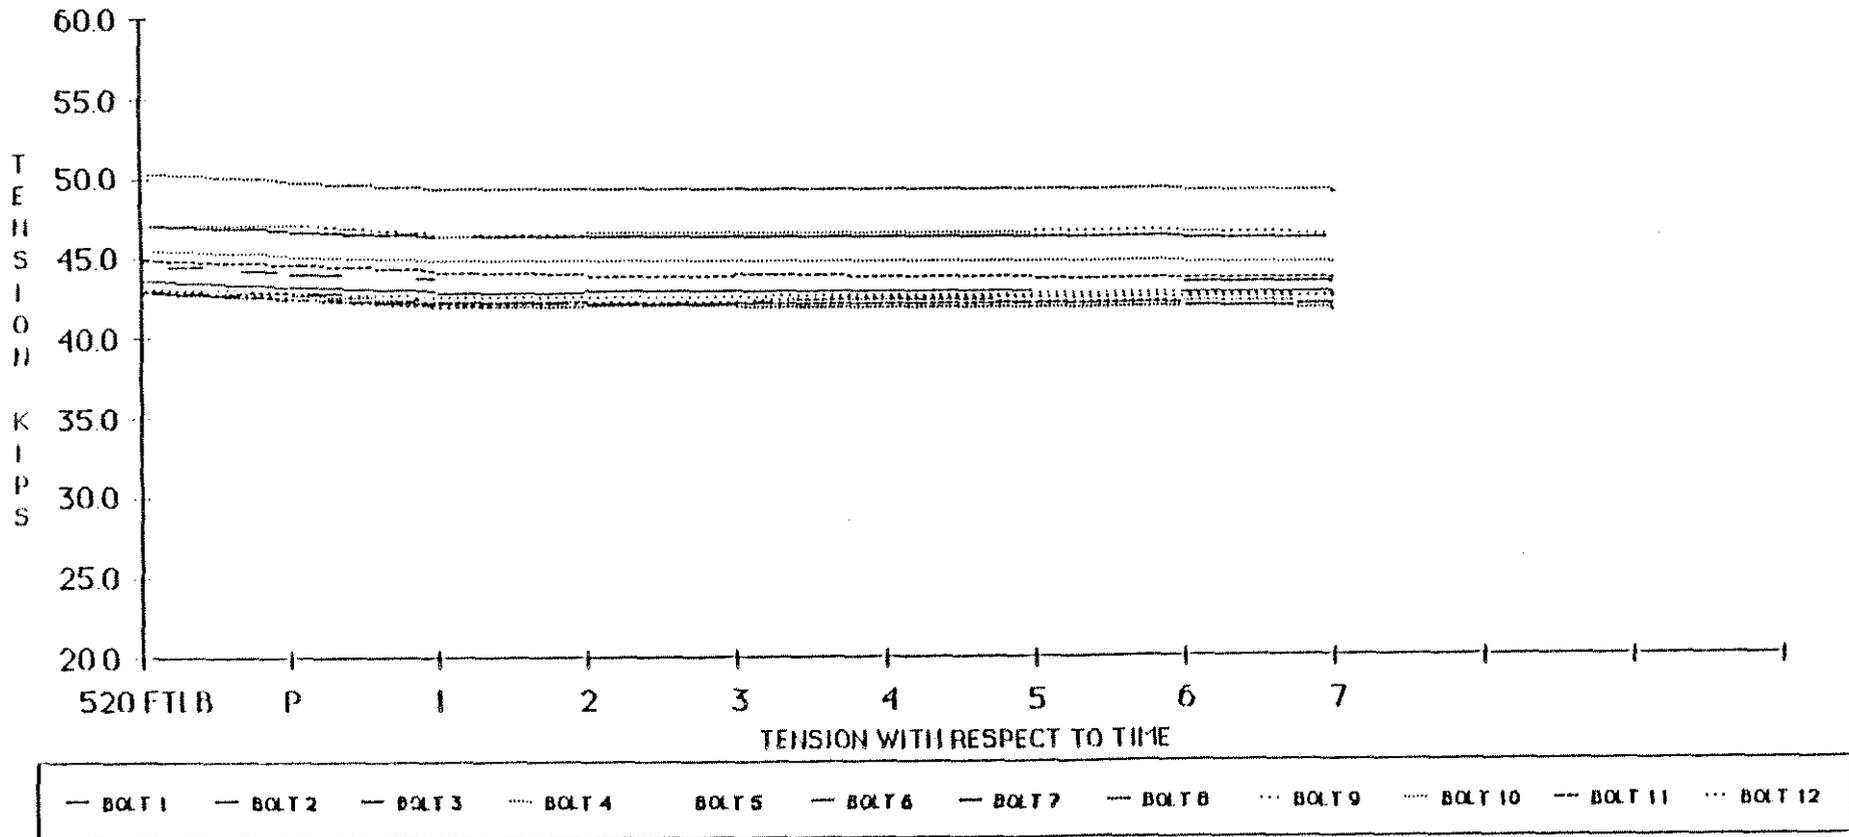
Figure 5

CONFIGURATION: 7/8" A325 Bolt, hardened washer under nut
(Reuse of Test No.4 Bolts)

TIGHTENING SEQUENCE: 12,11,8,7,4,3,1,2,5,6,9,10

TIGHTENING PROCEDURE: Hand tight, 520 ft-lb using Hytore wrench

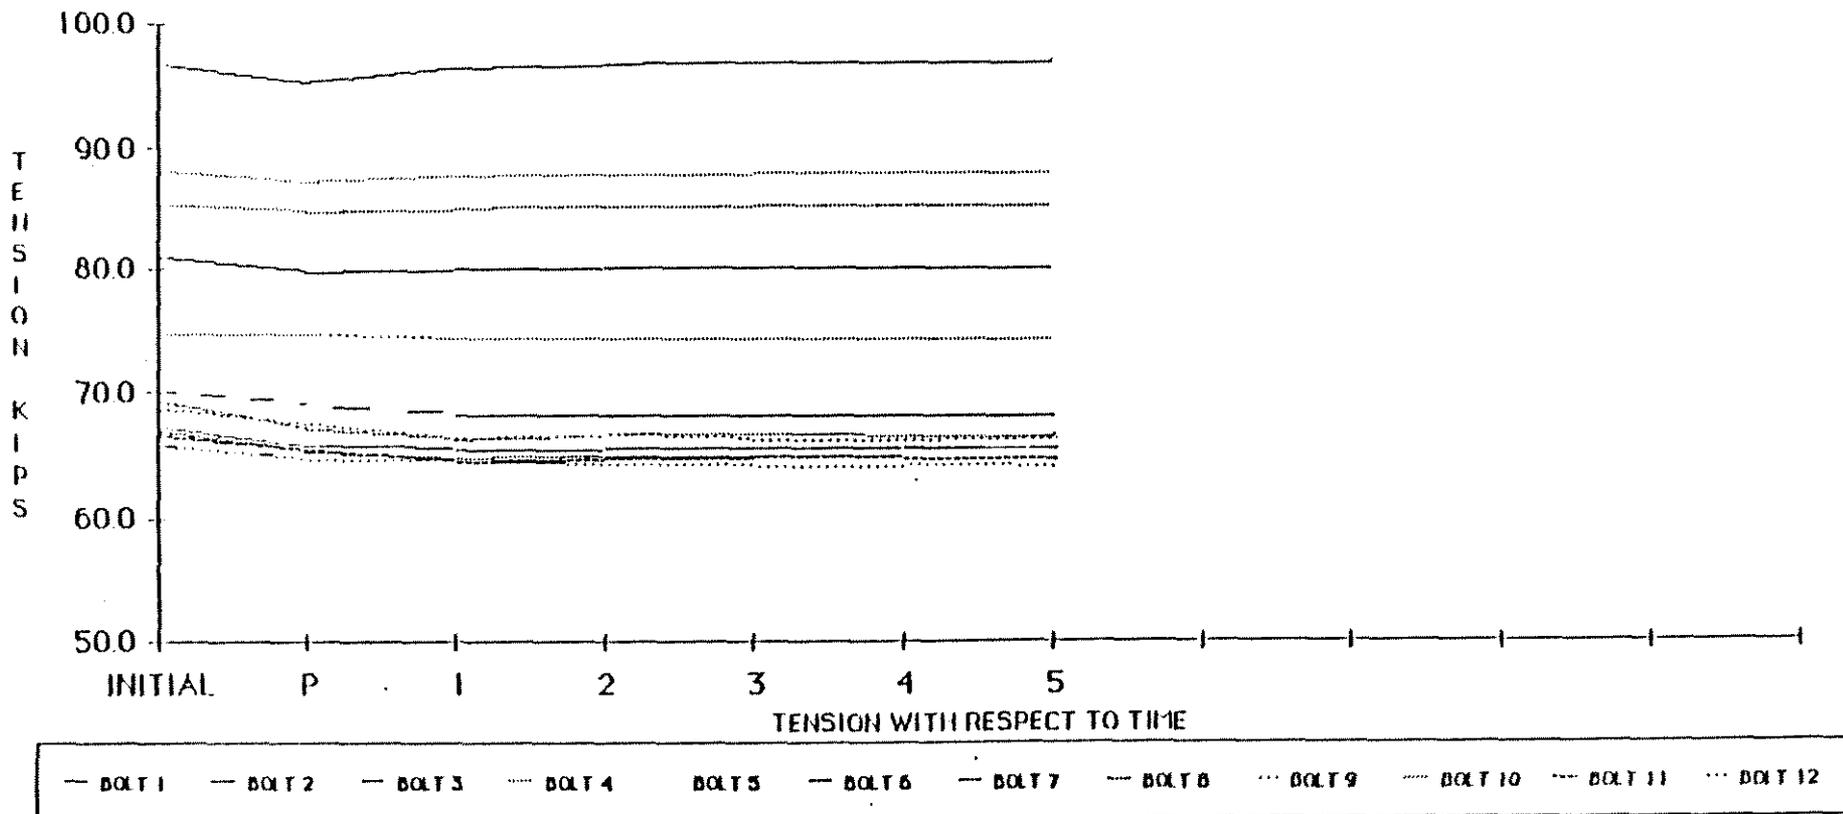
Figure 9

In summary, based upon all the test data presently available from both bridges, the opening and closing operating sequence generates a wrenching action on the structural connection NOT considered in the original design. Design assumes perfect alignment of the main girders during construction. The live load shoes are shimmed to align and maintain main girder contact. If these conditions are met, the shimming will still NOT take care of the rack/pinion teeth synchronization between the main girder racks. This will always result in some torsional, wrenching or prying action in the cantilevered structural connections (e.g., between main girder and front floor beam). The live load dynamics and an apparent amplification via total wrap-up (figure 9) are the type of unexplained loads imparted to these connections.
