2ND BIENNIAL
MOVABLE BRIDGE SYMPOSIUM

ABNORMAL MOVEMENT OF BASCULE BRIDGES

BY NORMAN J. FEUER, P.E.

PARSONS BRINCKERHOFF QUADE & DOUGLAS, INC.

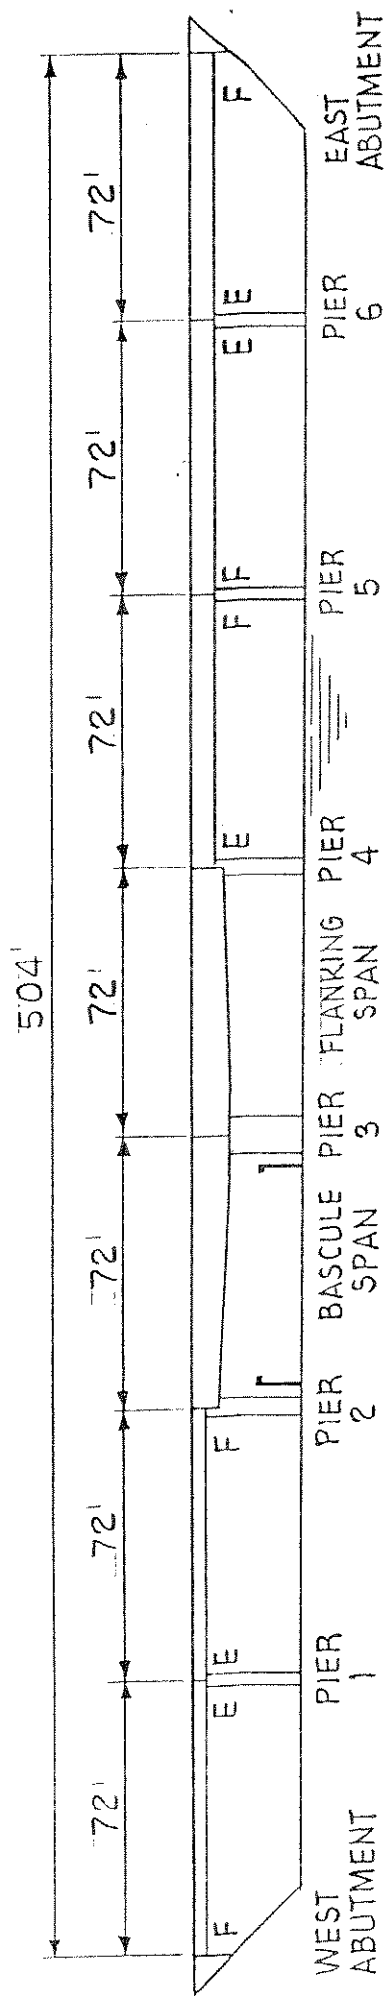
FIGURE 3 - ELEVATION OF BRIDGE NO. 2

Bridge No. 2. This highway bridge, built in 1950, is a 500-foot-long, seven span structure consisting of a 70-foot-long single leaf bascule span flanked by rolled steel stringer approach spans (see Figure 3)

Perhaps to compensate for this movement at the bearings, Piers 1 and 6 are observed to be leaning outward towards the abutments. Pier 1 leans about

4 inches horizontally over its 30 foot height while Pier 6 is leaning about $1\frac{1}{2}$ inches.

Some movement is also observed at Pier 4 where the expansion bearings of the approach span are also leaning inward towards the movable span. At the toe of the bascule span over Pier 2, the bearings for the bascule span do not seat properly, nor are the span locks tight, problems that may be a result of this movement.

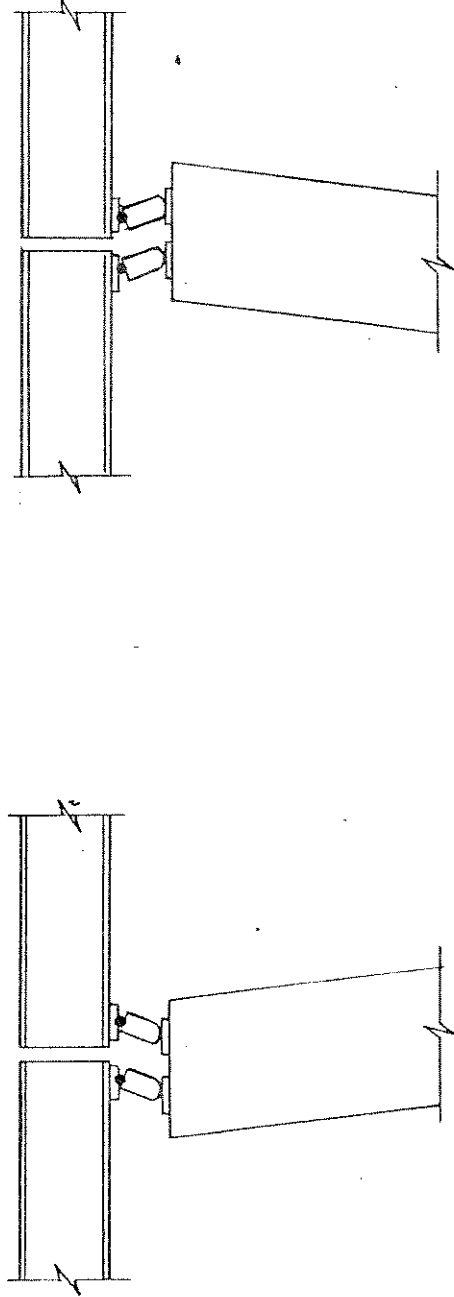
FIGURE 4 - DETAIL OF MOVEMENT AT PIERS 1 AND 6

Atop Piers 1 and 6, the first piers in from the abutments at either end of the bridge, the rocker-type bearings for adjacent approach spans are all leaning inward towards the movable span. Both sets of bearings have been rocked into their maximum position and appear to be locked in place and no longer able to function for thermal movement, the rockers of the first approach spans in full expansion and the rocker of the adjacent approach spans in full contraction. (see Figure 4)

Those existing structures on which this movement is observed should be rehabilitated to minimize or safely accommodate this movement. Bearings should be reset and base plates moved or enlarged. If possible, bearings should be replaced with types which can better accommodate this movement. Roadway joint areas should be opened up to prevent further damage. Also install tie backs at abutments to resist braking loads on the roadway approach embankment.

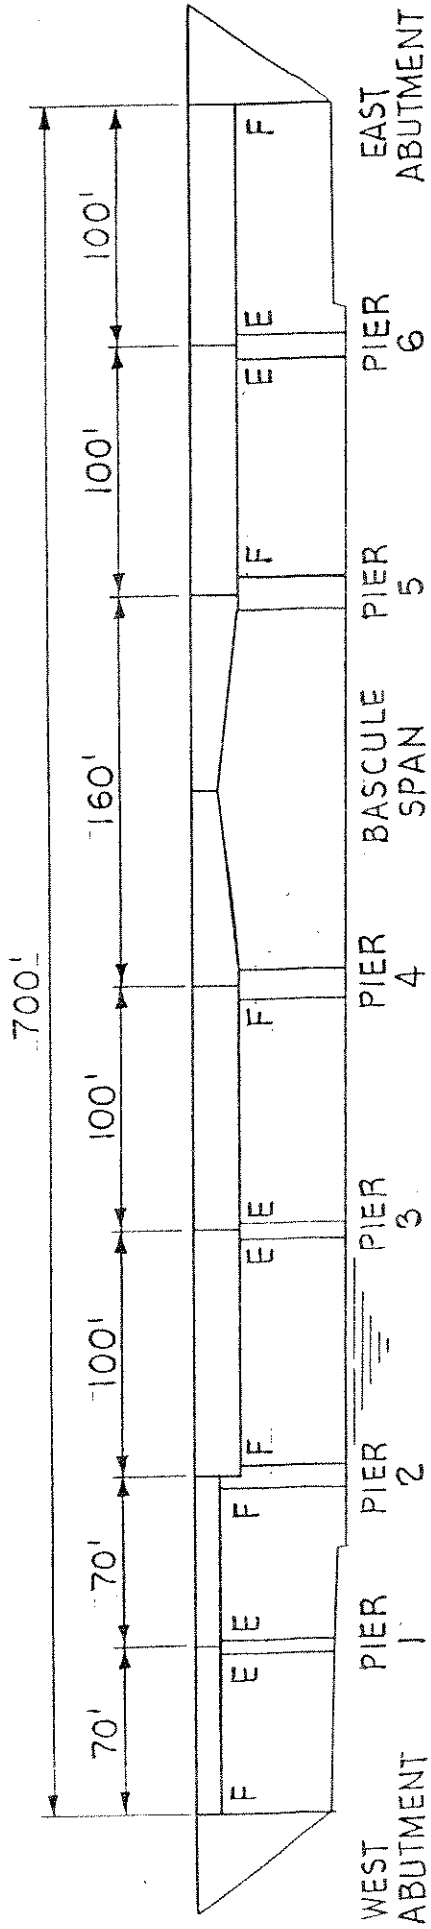
FIGURE 5 - ELEVATION OF BRIDGE NO. 3

Bridge No. 3. This last structure is a 700-foot-long, seven span highway bridge built in 1949. The bridge consists of a 160-foot-long double leaf bascule span flanked by steel plate girder approach spans (see Figure 5).

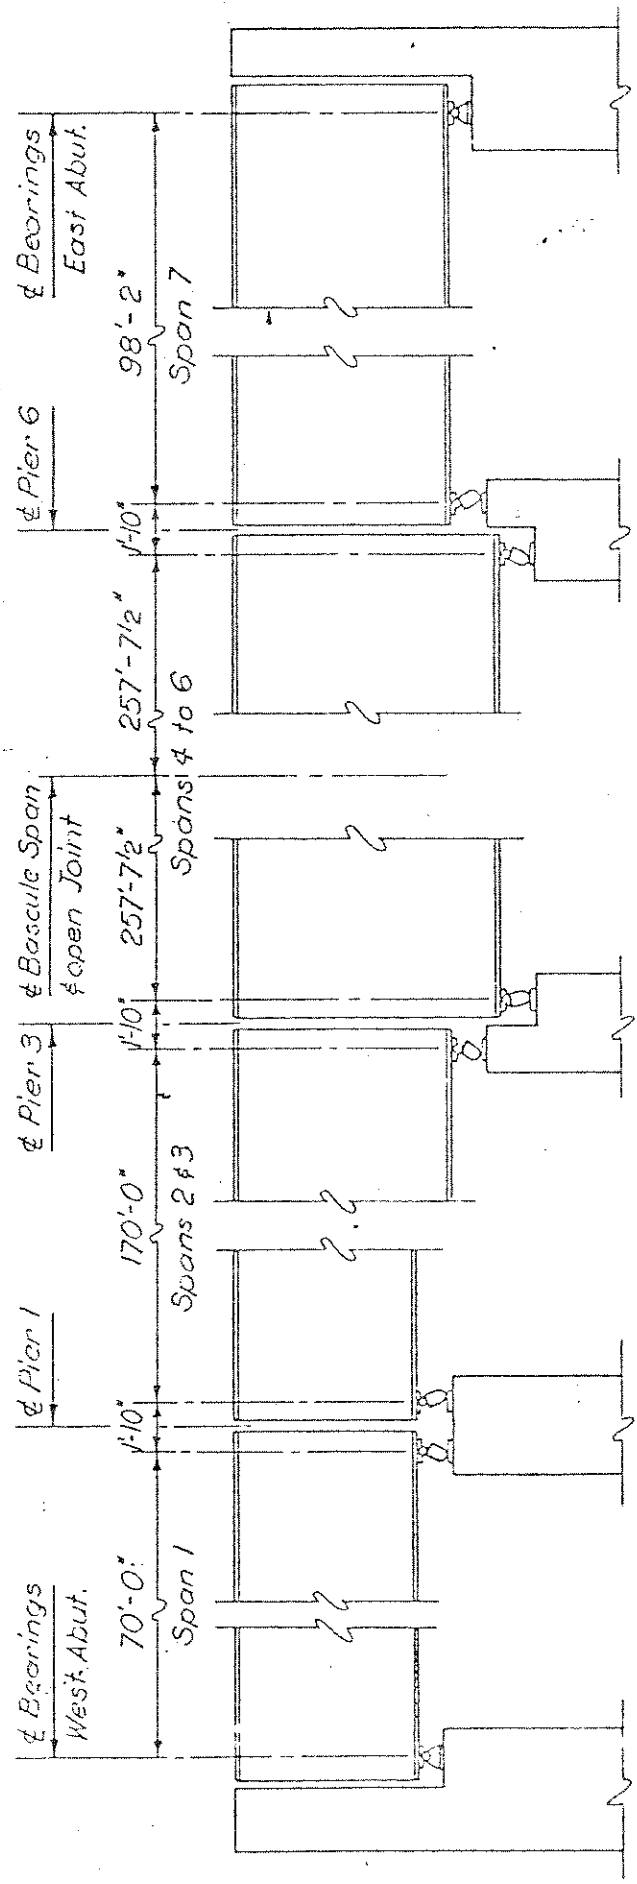
FIGURE 6 - POSITION OF EXPANSION BEARINGS

As shown in Figure 6, the rocker type bearings of adjacent approach spans at Piers 1, 3 and 6 were observed to be leaning excessively in the expansion position. Measured leans were much greater than would have been expected for normal expansion. The roadway joints above these piers, which have an original design opening of $1\frac{1}{8}$ inches, were noted to be butted tight in warm weather and only opened up $\frac{1}{2}$ inch in cold weather.
