Session (3-1)
"Major Rehab. of Jefferson and Jackson
Street Movable Bridges",
I. J. Dvorak, Teng & Assoc. Inc., Ill.

MAJOR REHABILITATION OF JEFFERSON AND JACKSON STREET MOVABLE BRIDGES

Ivan J. Dvorak, P.E., Senior Vice President
Teng & Associates, Inc., Chicago

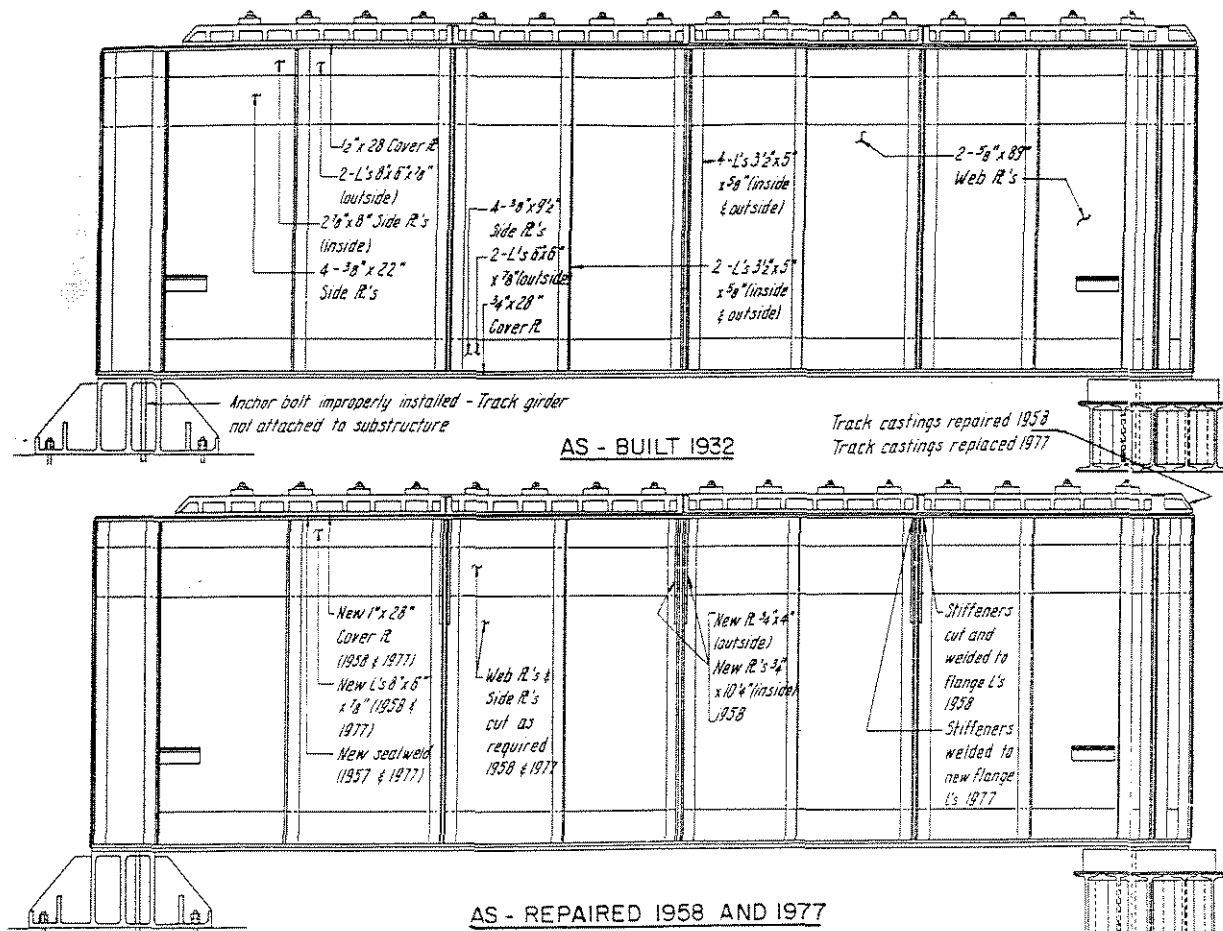
The inspection in 1956 revealed that the 1/2" top flange cover plate had been "squeezed" down in thickness at the location of track casting joints. It was also found that many rivets connecting track casting to the top flange were loose, specifically those located close to the joints. The major portion of repairs to the track girders in 1956, were as follows:

Repairs to the track girders and castings were made again in 1977. This time, all four track girder castings were replaced. Top flange angles (8x6x7/8) and 1" cover plate were replaced in kind and existing stiffeners were rewelded to new top flange angles. (See Figure 2).

Figure 2 – Track Box Girder

- 1) The 1/2" top flange cover plate was replaced with a 1" thick plate
- 2) Existing stiffeners were thickened to 2 3/4"
- 3) New stiffener plates were welded to the bottom of outstanding leg of top flange angle.
- 4) A new 1" top flange cover plate was continuously welded to the outstanding leg of top flange angle.
- 5) Rivets connecting track casting to the track girder were replaced by high strength bolts.

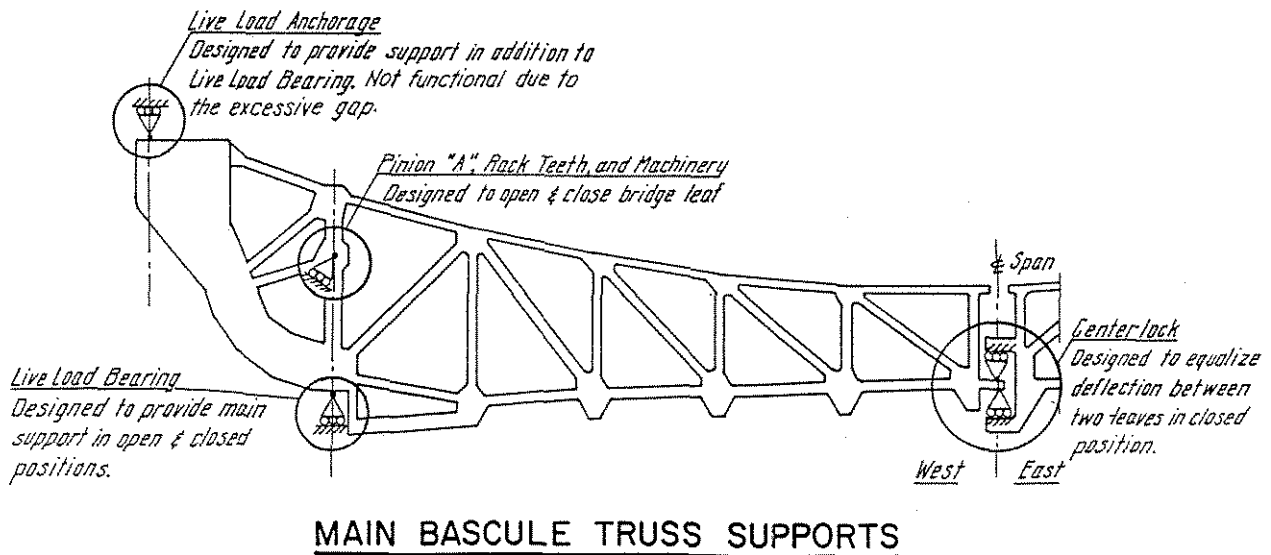
- b) **Center break and center locks.** Center break teeth were not aligned and some had to be cut to allow operation of the bridge. This was due to movable spans misalignments. Center locks had an excessive clearance between “jaws” and diaphragms, causing the leaves to bounce under live load.
- c) **Live load anchorages.** There was a gap instead of firm contact between anchor column bearing and anchor arm of the movable span. This caused the movable span to be supported by live load bearing and track teeth through the main pinion and machinery. The pinion and machinery were not designed for such loading. (See Figure 5).

Figure 5 – Boundary Conditions without Support at Anchor Column

- c) **Live load anchorages.** Live load anchorage bearing plates were shimmed to assure firm contact between the counterweight and bearing plates, when the bridge is in closed position. Fully closed limit switches were adjusted to allow such contact.
- d) **Racks and pinions.** Racks and pinions were replaced. Original track consisted of several segments. The new track design is a one piece configuration. Shims were added under the tracks, which could be removed as the tracks wear to prevent bottoming of pinions.
- e) **Counterweight and balancing.** Approximately 9" to 12" of unsound concrete counterweight was removed around its perimeter and replaced with new reinforced concrete and sealed. Electronic balancing using strain gauges attached to the pinions shaft was designed to assist in the rebalancing of the bridge.

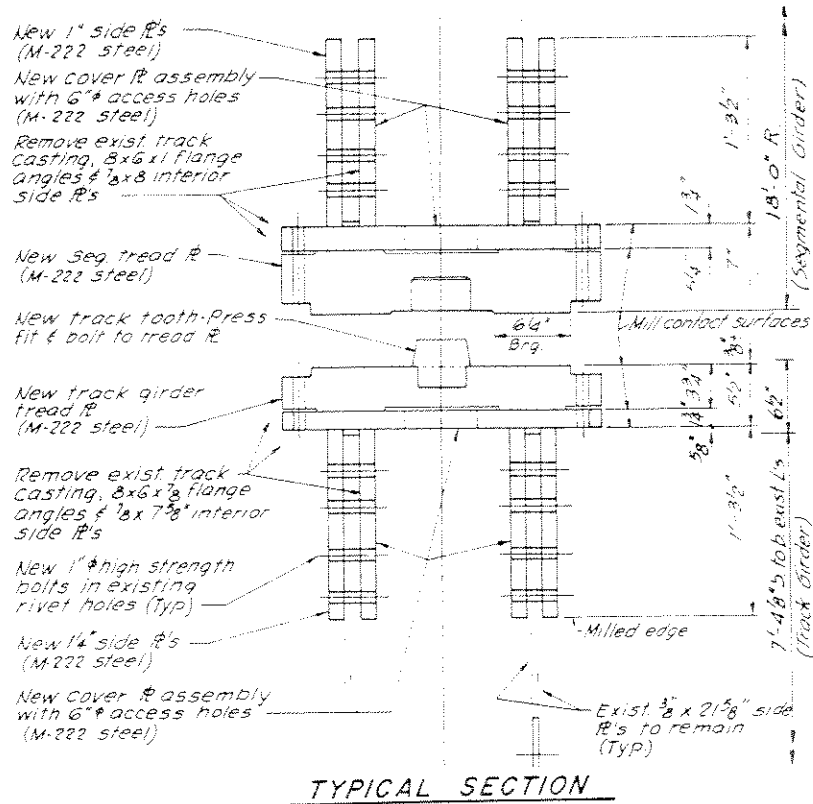
Figure 7 – New Segmental and Track Girder Stringer

It was important that the new design will keep local stresses of top flange within allowables. This was achieved in conjunction with the redesign of track and segmental plates. The new geometry facilitates a more direct transfer of the rolling concentrated load to the track box girders webs. (See Figure 7 for new detail.) By using A588 steel, the length of line bearing required was minimized. The existing top flange plates, angles and stiffener to flange connections were removed. The new flange plates were sized to keep the local tension bending stresses below the AASHTO allowable. The existing webs and side plates were cut in the field to accommodate the height of new flange and track plate. In order to attach the new top flange to the existing webs of track or segmental box girders, a weldment of a flange and two web plates was designed. (See Figure 8). This weldment was then connected by high strength bolts to the webs of existing track or segmental girder. (See Figure 9 and 10).

One of the major deficiencies in the old design was the presence of numerous joints between track castings. In the new design of track and segmental casting, a milled plate was used instead with only one joint to avoid uneven deflection and breakage of connection bolts. This joint would not be required in the case of new construction, but in this retrofit it was required due to the construction staging. Design of repairs to segmental girder was similar to those designed for the track girders.

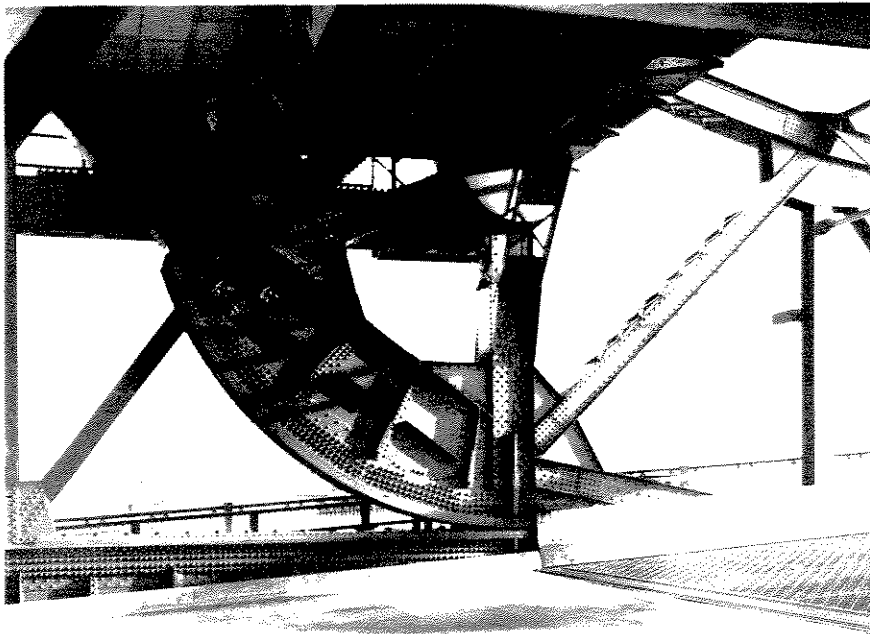
Figure 10 – Completed Installation

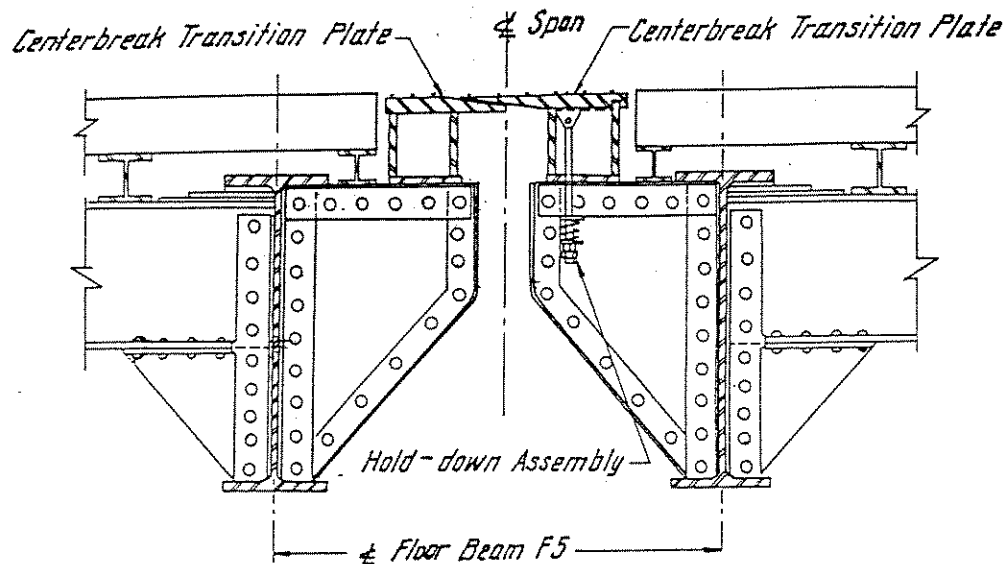
PROPOSED CENTERBREAK

Figure 11 – New Spring Loaded Center Break Plate

- b) **Center break and center locks.** To avoid lateral and longitudinal interference of the existing center break finger plates, new spring loaded center break plates were used. This center break provides a smooth transition between the bridge leaves. (See Figure 11). This detail was used in the 1960's in Germany. The author adapted this detail for design of the new Columbus Drive Bascule Bridge in Chicago where it proved to be performing satisfactorily. Worn center locks were replaced to bring clearances down to 1/16".
