HEAVY MOVABLE STRUCTURES
MOVABLE BRIDGES AFFILIATE
3RD BIENNIAL SYMPOSIUM

Session (3-11)
"Using Air Bags to Reposition A
Rolling Lift", Fred Parkinson,
Parsons Brinckerhoff Michigan Inc., Il.

USING AIRBAGS TO REPOSITION A DAMAGED ROLLING LIFT BASCULE

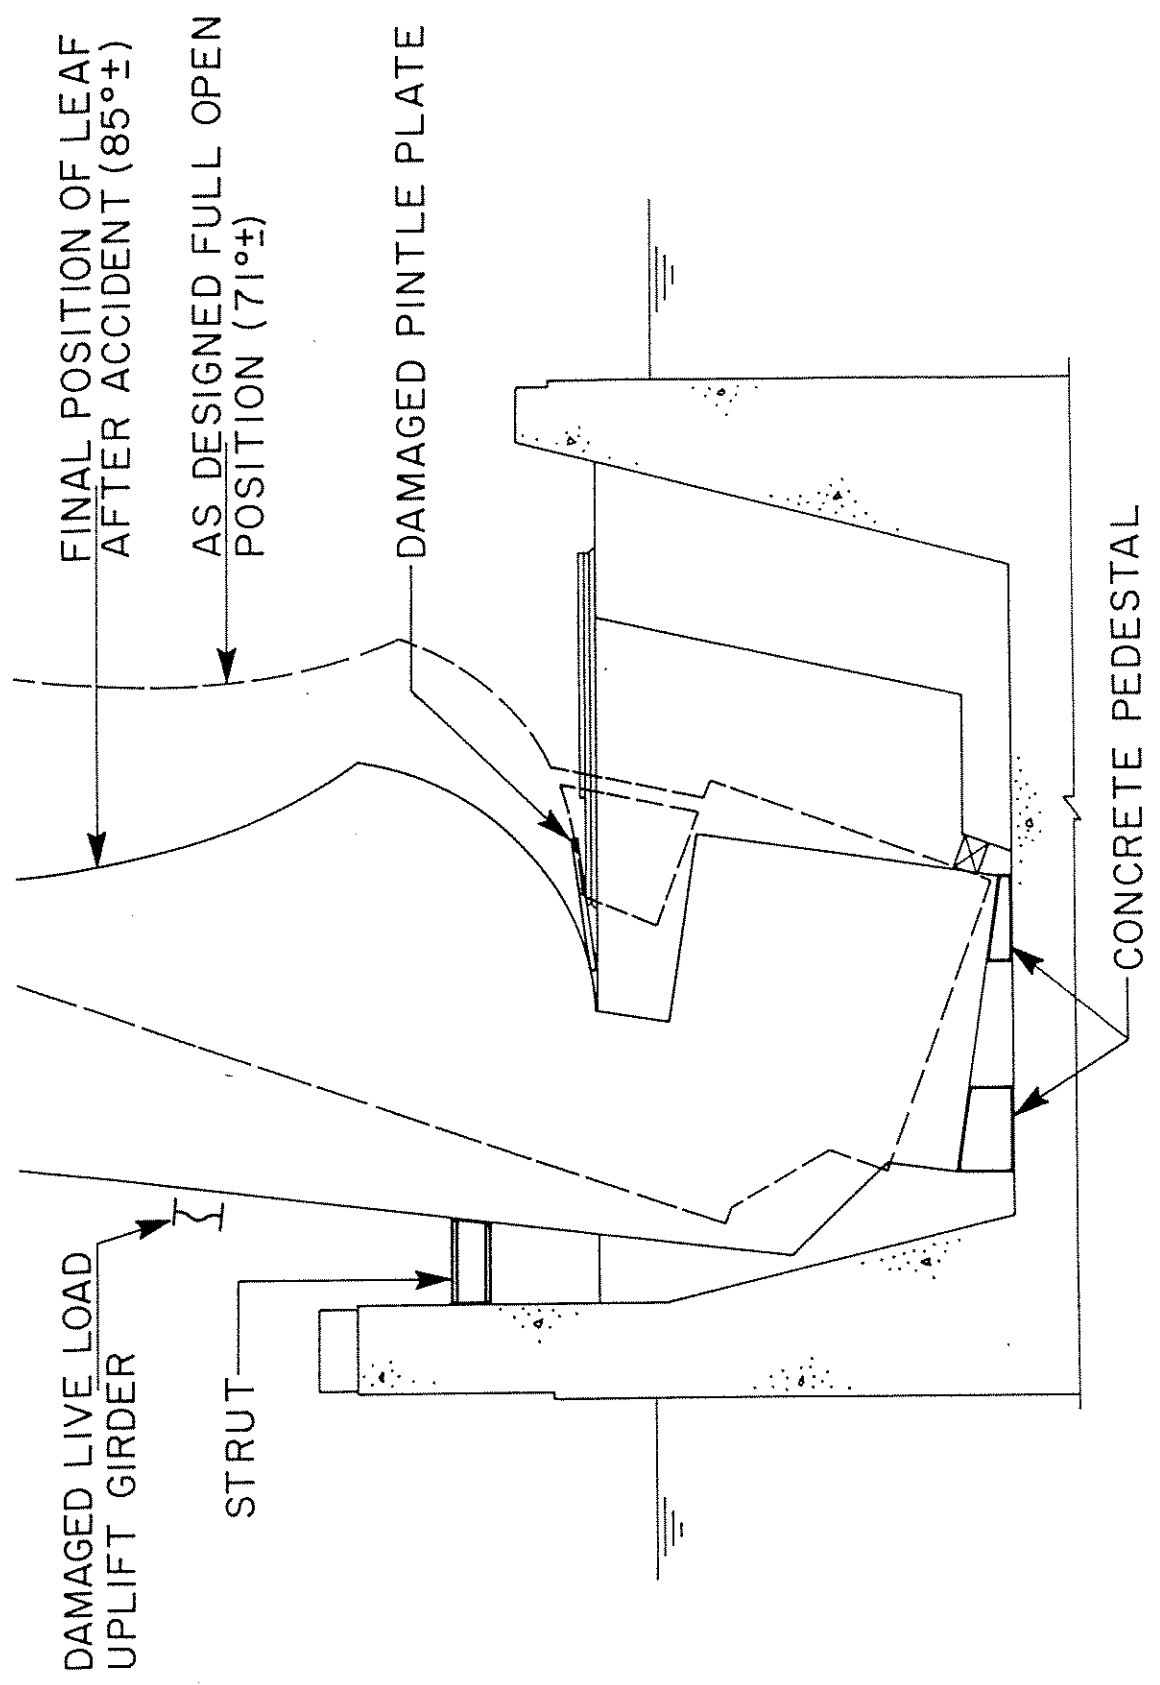
FIGURE 1

Just prior to the pin placement on March 27, the crane cable attached to the back of the counterweight parted, allowing the leaf to start rotating backwards towards the open position. The leaf developed enough inertia to go beyond the equilibrium point and continue past the normal full-open position (70°). The leaf continued to rotate open until the bottom of the counterweight struck the back of the tail stop bumper blocks, which became the fulcrum to lever the entire leaf backwards. This movement tore off the rearmost pintle plates.

The rotation about the bottom of the counterweight continued until the top flange of the main bascule girders struck the live load uplift girder. This impact tore the web connections of the live load uplift girder and caused the tops of the supporting columns to rotate. The leaf then slid downward until the sidewalk stringers struck the top of the live load girder, wedging the leaf between the liveload girder and the concrete wall supporting the rolling girder tracks, at about an 84° angle, please refer to Figure 1.
