HEAVY MOVABLE STRUCTURES
MOVABLE BRIDGES AFFILIATE
3RD BIENNIAL SYMPOSIUM

Session (5-1)
"Self Destruction of a Strauss Bascule
Bridge", John A. Schultz, Jr.,
Hazelet & Erdal, Chicago, IL.

SELF-DESTRUCTION OF A STRAUSS BASCULE BRIDGE

By John A. Schultz, Jr.
Associate
Hazelet + Erdal, Inc.

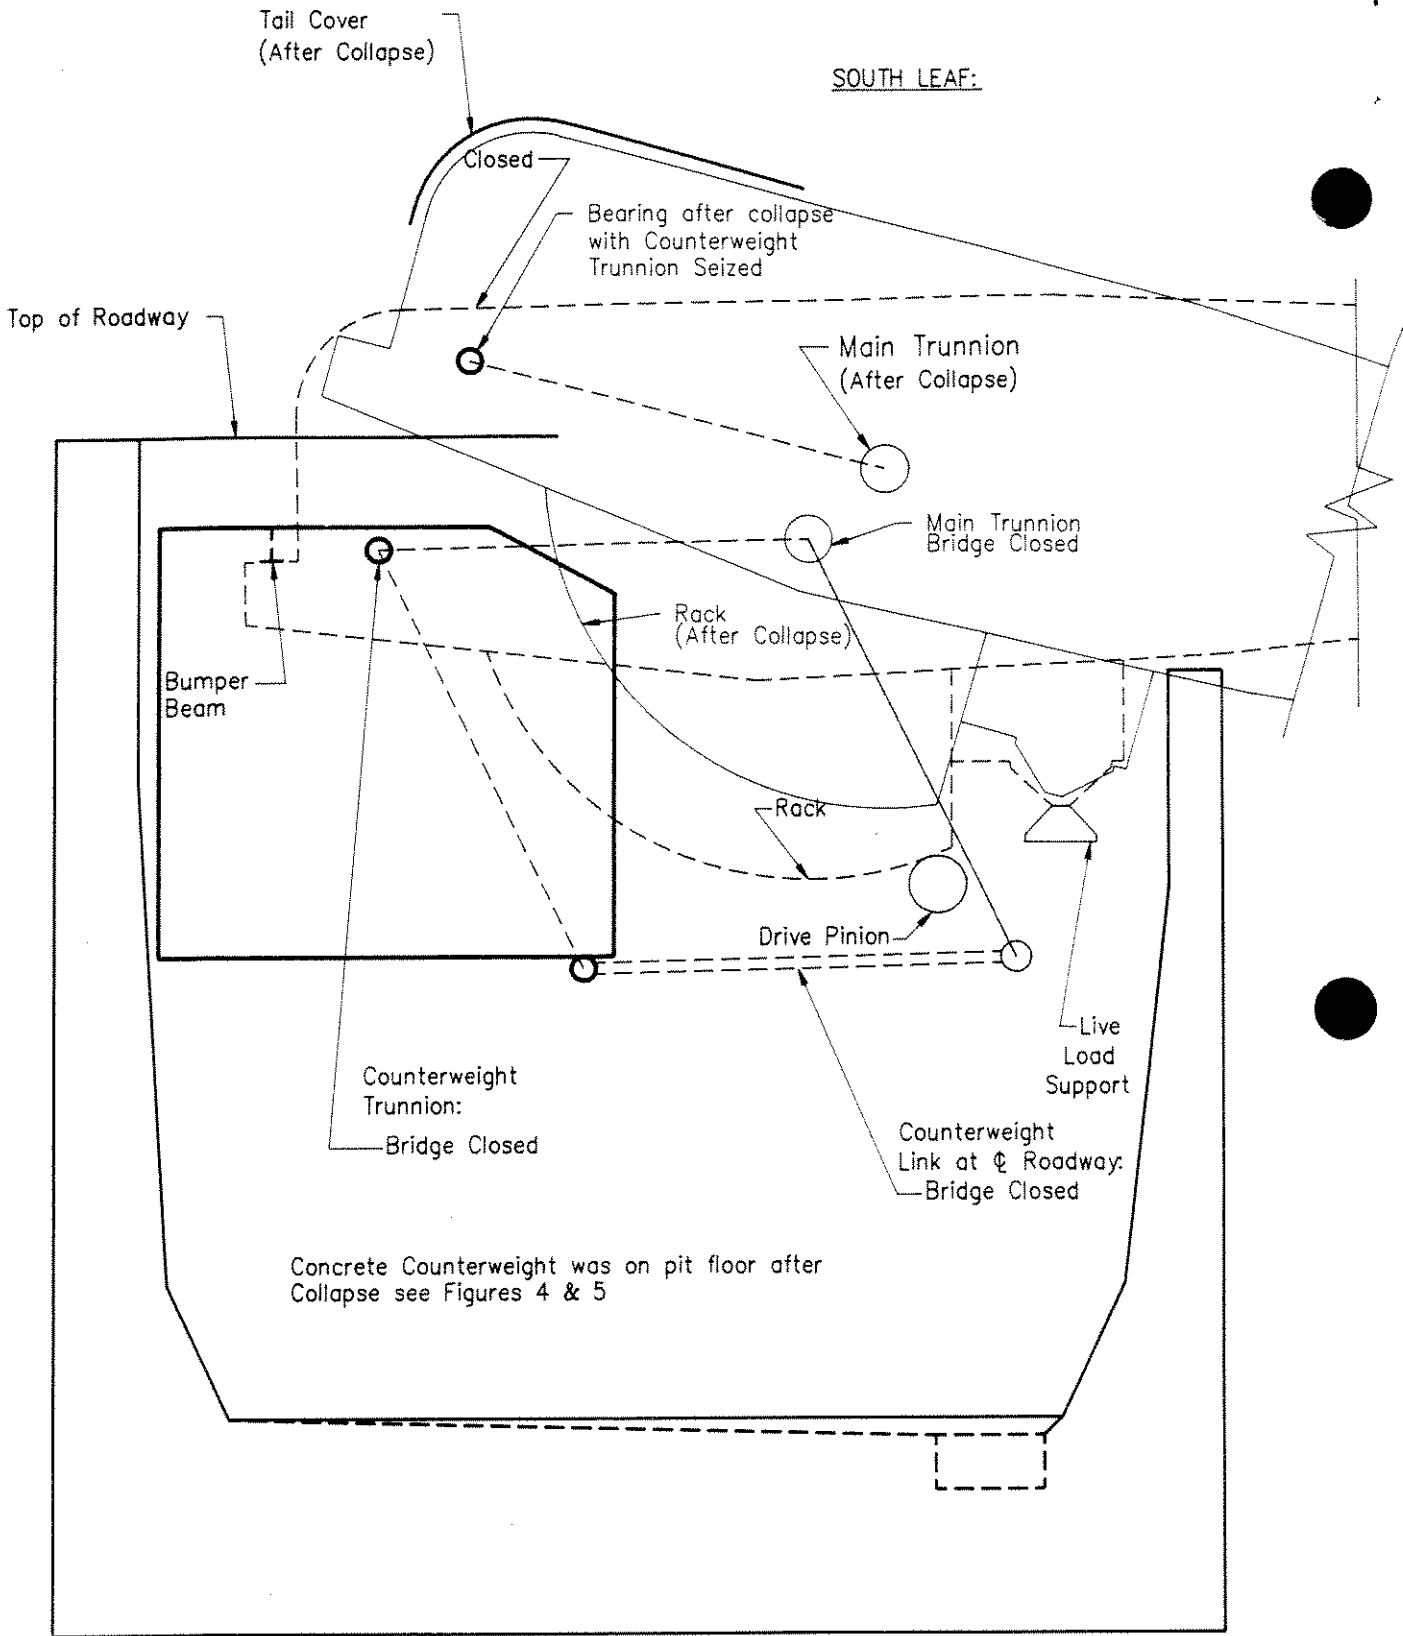
TAYCO STREET BASCULE BRIDGE
 OVER
 U.S. CANAL
 MENASHA, WISCONSIN
FIGURE 2

The channel end of the south leaf was bearing on the bottom of the canal and the front wall of the south pier. The main trunnions were torn loose from their supports on the trunnion columns. The west bearing failure took place in the attachment to the column. The bearing appeared to be perpendicular to the girder web. The east bearing was also torn loose at its attachment to the column but the inboard cap bolts were also pulled apart. The trunnion and bearing assembly was sloping down to the east with respect to the girder axis.

The west counterweight trunnion remained in its bearing, oriented approximately 10° from its normal "bridge closed" position. The portion of the trunnion protruding 3 inches from the west end of the bearing exhibited no indication of distress in the bearing area or keyway. The key, recovered from the pit, was intact. Rust patterns on the trunnion surface indicated that only the inside $3/4$ " plate of the counterweight hanger was in bearing. The east end of the trunnion protruding $3-3/8$ inches from the bearing exhibited significant distress with a portion of the shaft torn off at the north face of the keyway and at the edge of the bearing area. Parallel abrasions on the east face, most probably caused by the hanger plate as it fell off the trunnion, were at about a 45° angle to the girder axis. The screws connecting the bronze bearing insert to the housing were all distorted in a clockwise direction indicating some minor rotation between the bushing and the housing. The key, recovered from the pit, was sheared so that the top portion was moved $2-1/2$ " at the rear face and somewhat less at the front face. The girder web at the bearing was distorted and the trunnion was sloping downward to the east.

The east counterweight trunnion bearing was almost completely torn loose from the distorted girder web. It too was sloping downward to the east. The trunnion was found in the counterweight pit adjacent to the main trunnion support column.

The west girder tail cover was torn loose from its supports and was resting at the top of the girder. The east girder tail cover was torn loose and thrown completely free onto the sidewalk, left and forward of the operators house.

SECTION THROUGH COUNTERWEIGHT PIT
 SHOWING BASCULE LEAF AFTER COLLAPSE

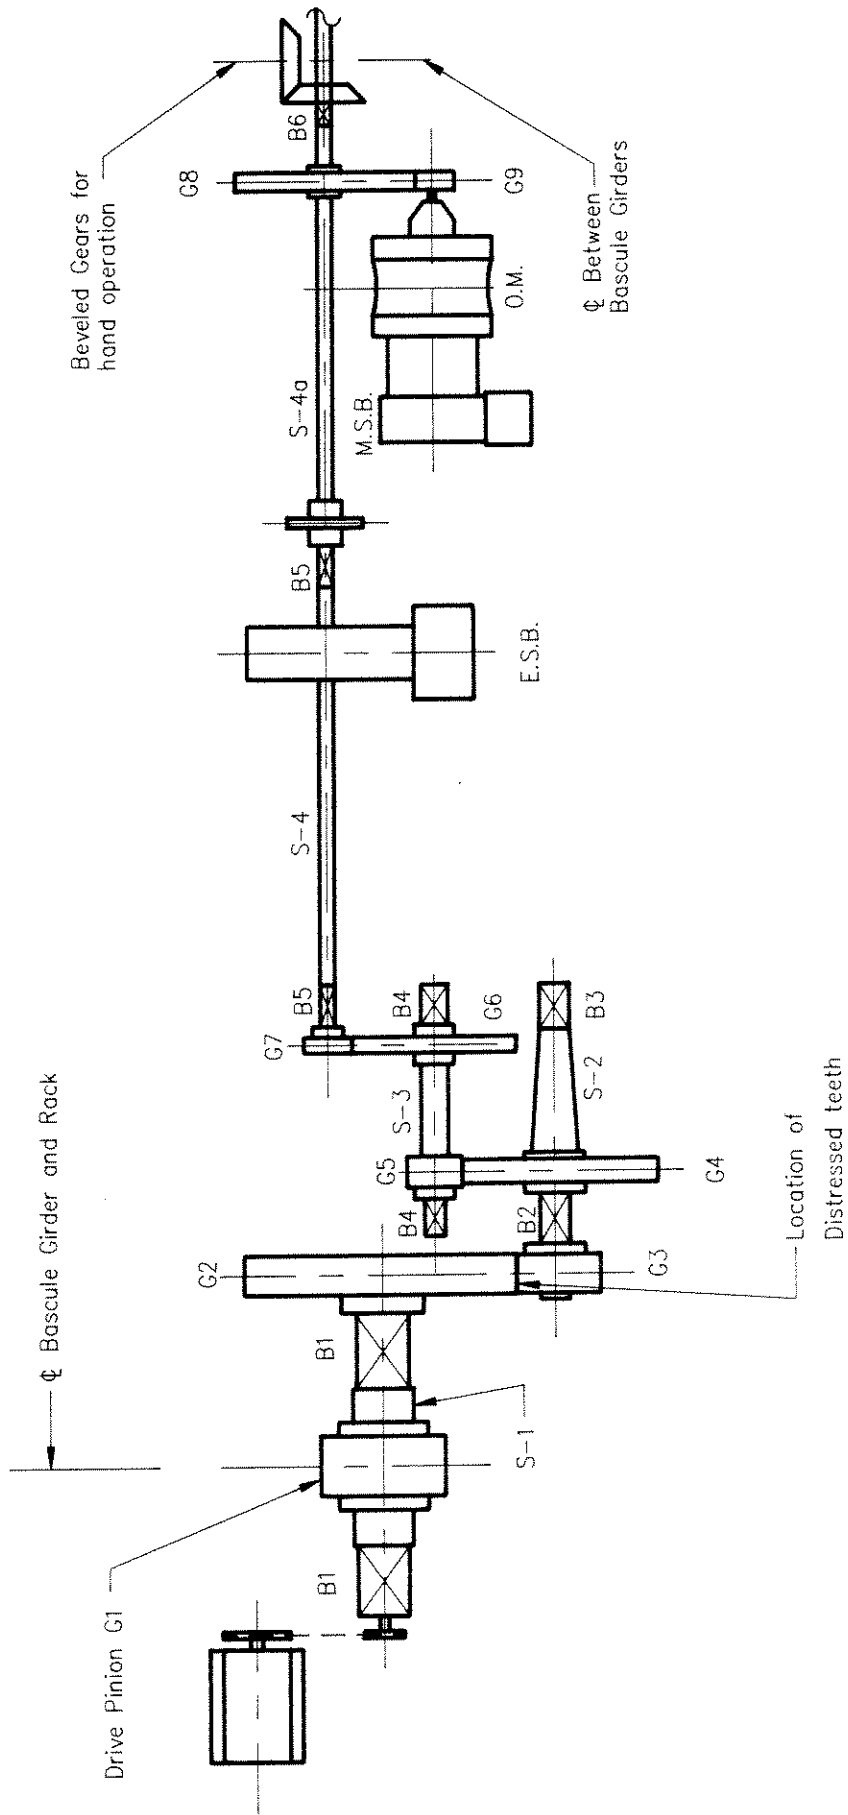
FIGURE 3

Referring to Figure 3, the racks and pinions showed no significant evidence of damage. Shafts S1 also appear to be undamaged. Gears G2 and their companion pinions Gear G3 were severely damaged with deformations in the teeth of both sets of gears. The beams supporting bearings B2 and B4 were severely deformed with the web torn completely loose from the flange on the west beam.

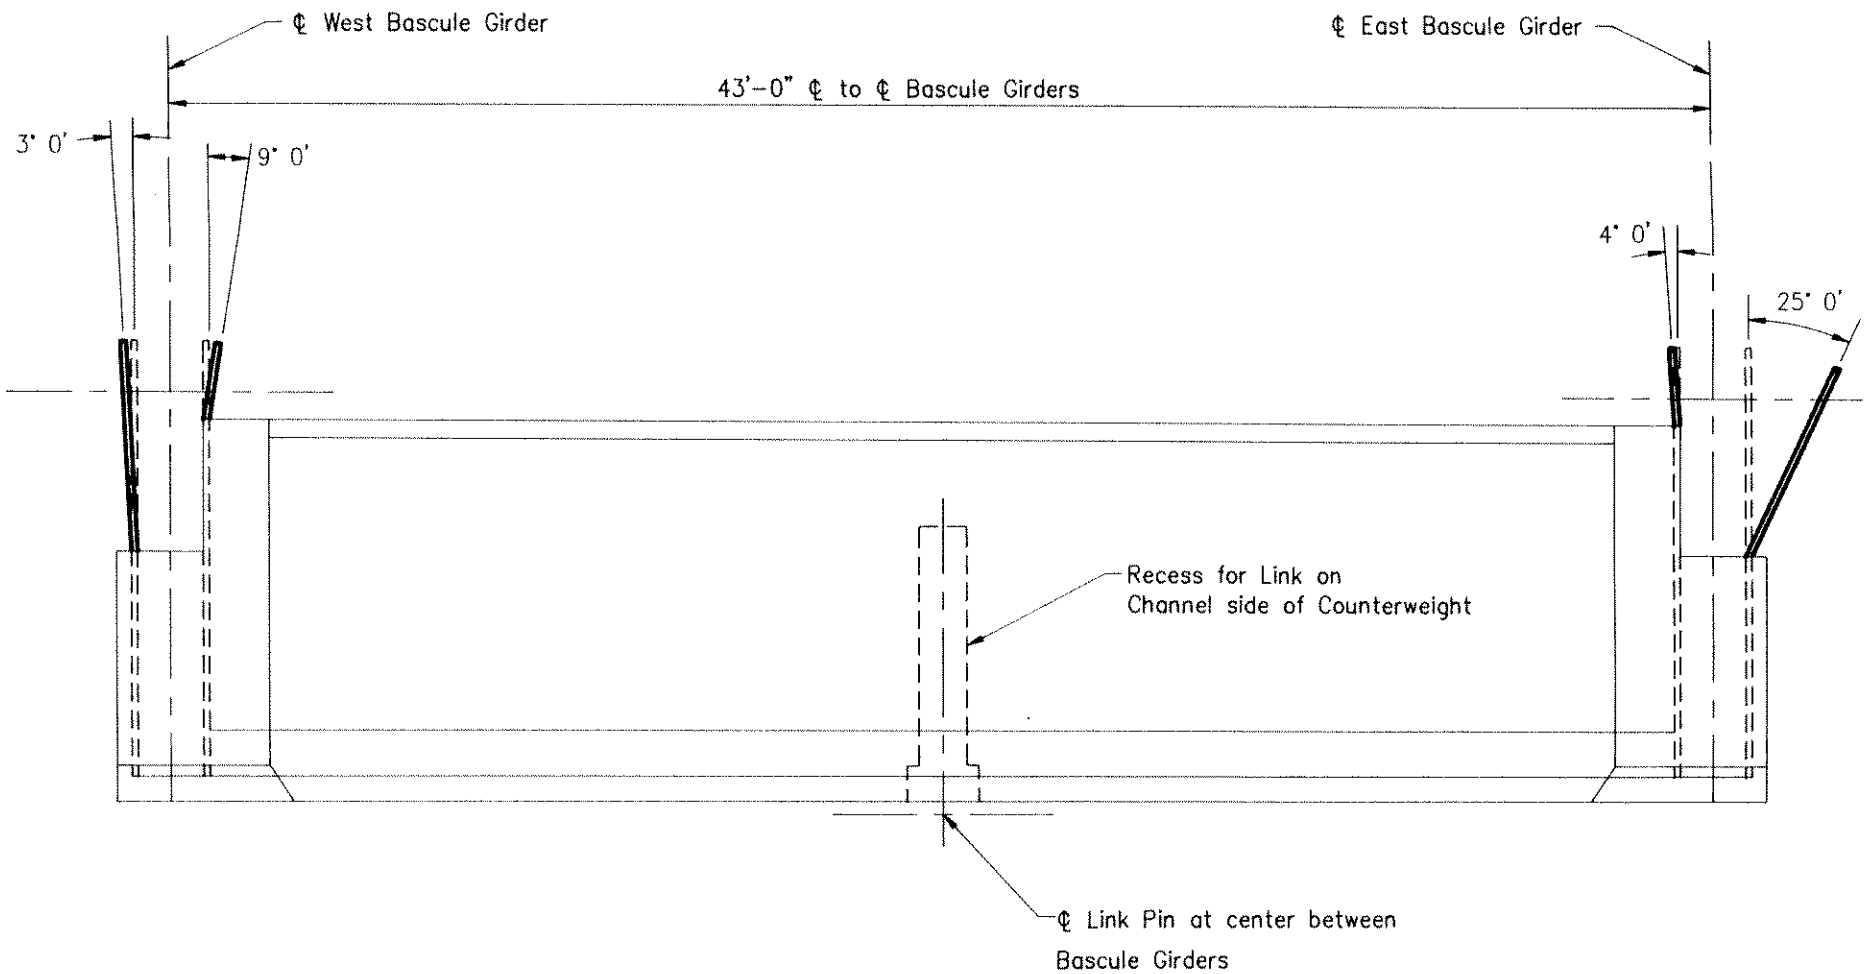
The counterweight hangers were bent and showed other evidence of distress. (See Figure 4). The outside hanger for the west girder was bent out about 3° and had evidence of bearing failure at the upper portion of the trunnion bore on the inside plate. Close inspection of the bore also indicated that only the inside 3/4 inch plate of the three plate (3/4", 3/4", 1/2") assembly had been bearing for a significant period of time. Grease build up of up to 1-1/4" on the inside of the plate corroborated this finding. There was no evidence of distress in the keyway in this plate. The inside hanger was bent inward about 9° and exhibited considerable distress in the upper area of the trunnion bore and at the key way. The plates were distorted and separated as they partially sheared the key during their clockwise rotation around the trunnion. The bearing area showed evidence of the hanger sliding off as it rotated. There was no evidence of fresh lubricant on the east hanger plate.

The inside hanger for the east girder was bent about 4° to the west while the outside hanger was bent to the east about 25°. No distress was noted in either of these plates in the trunnion bores or keyways.

LOOKING NORTH FROM APPROACH SIDE
SHOWING BENT HANGER PLATE ASSEMBLIES

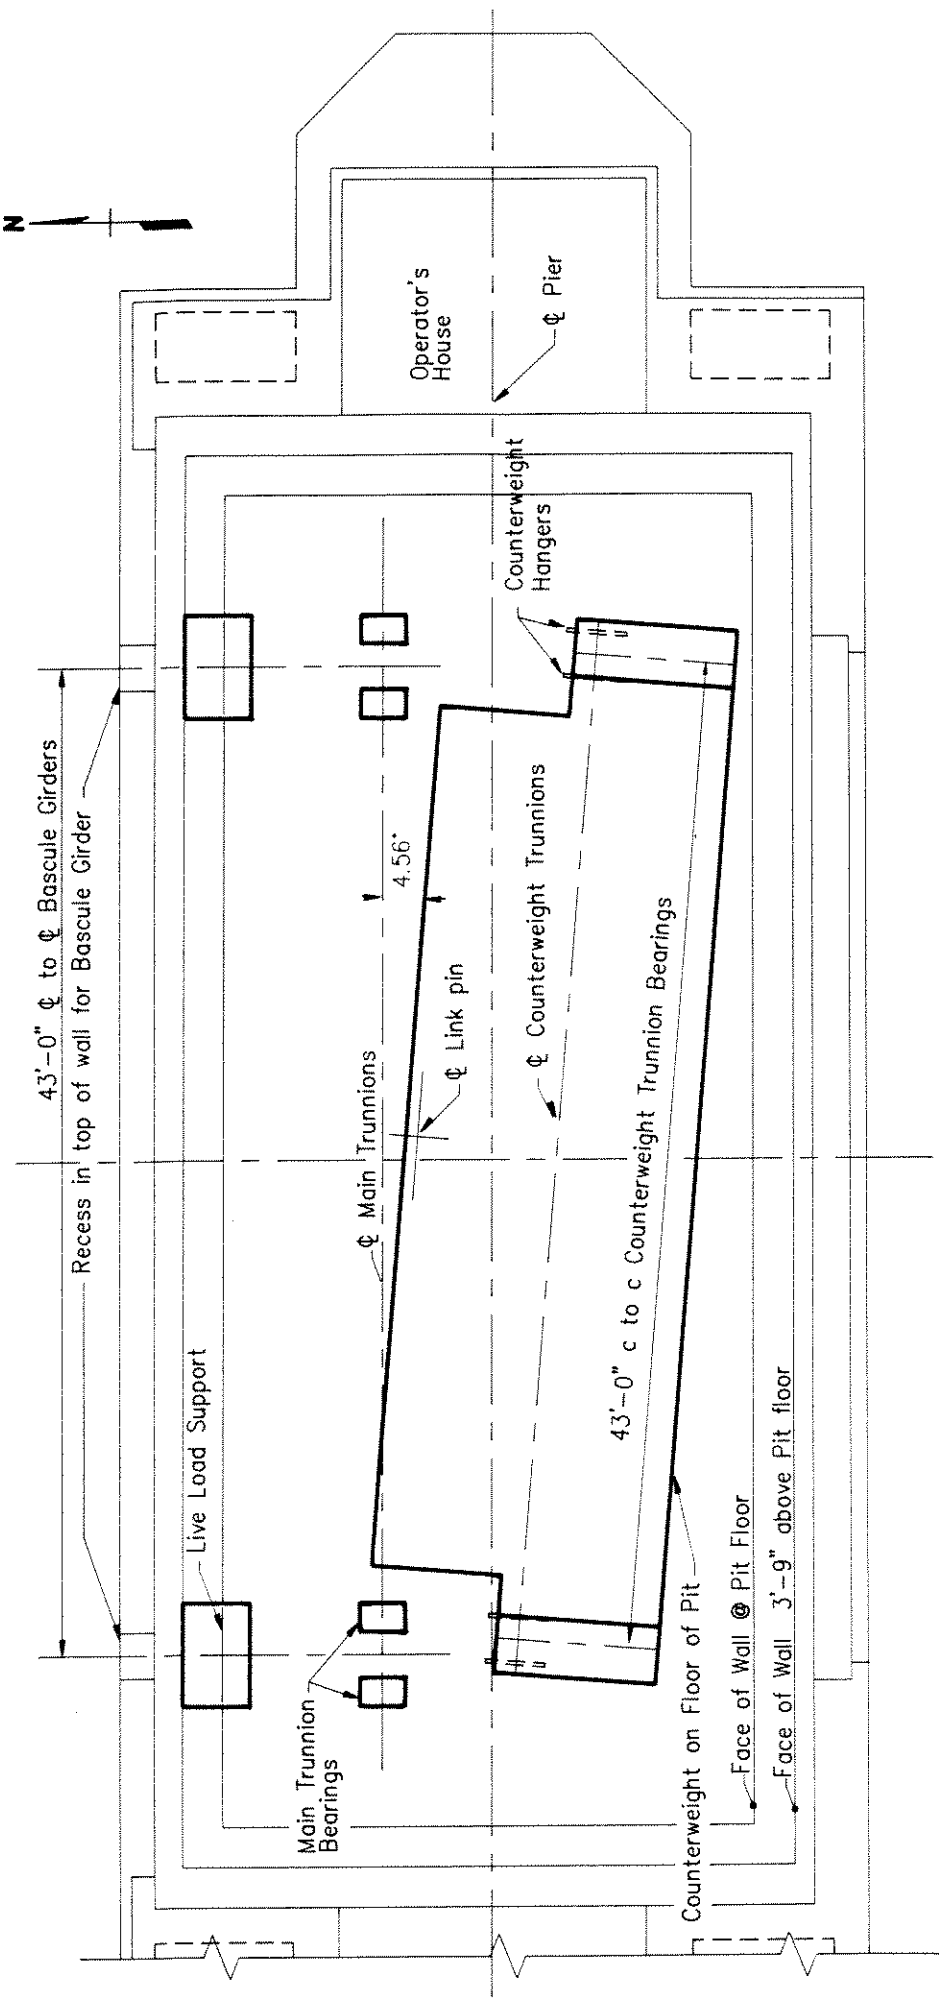
The counterweight was resting on the pit floor at a skew of about 4.5° and about 12 inches east of its normally projected position. (See Figure 5). The southwest corner was in a position consistent with an opening of 59°. This does not agree with other evidence which indicates the girder was open to approximately 45° when the inboard hanger

came off the trunnion. Considering the friction between the hanger plates and the trunnion, and shear value of the key, it is probable that the counterweight was hanging out of vertical. However this can account for only about 5° of opening if one assumes a friction coefficient of 0.8 and ultimate strength of the key at 50,000 psi. The counterweight concrete was cracked at the top in the area surrounding both outside hangers and sustained considerable damage at the west end and the northeast corner. The damage at the west end indicates initial impact occurred on the southwest corner, consistent with the feeling that the west end of the counterweight was out of vertical at the time of failure. A bounce forward after impact could well account for the apparent inconsistency in counterweight location. A section of the east trunnion column pier was spalled as a result of impact from the northeast corner of the counterweight.

PLAN SOUTH BASCULE PIER
 SHOWING LOCATION OF COUNTERWEIGHT IN PIT

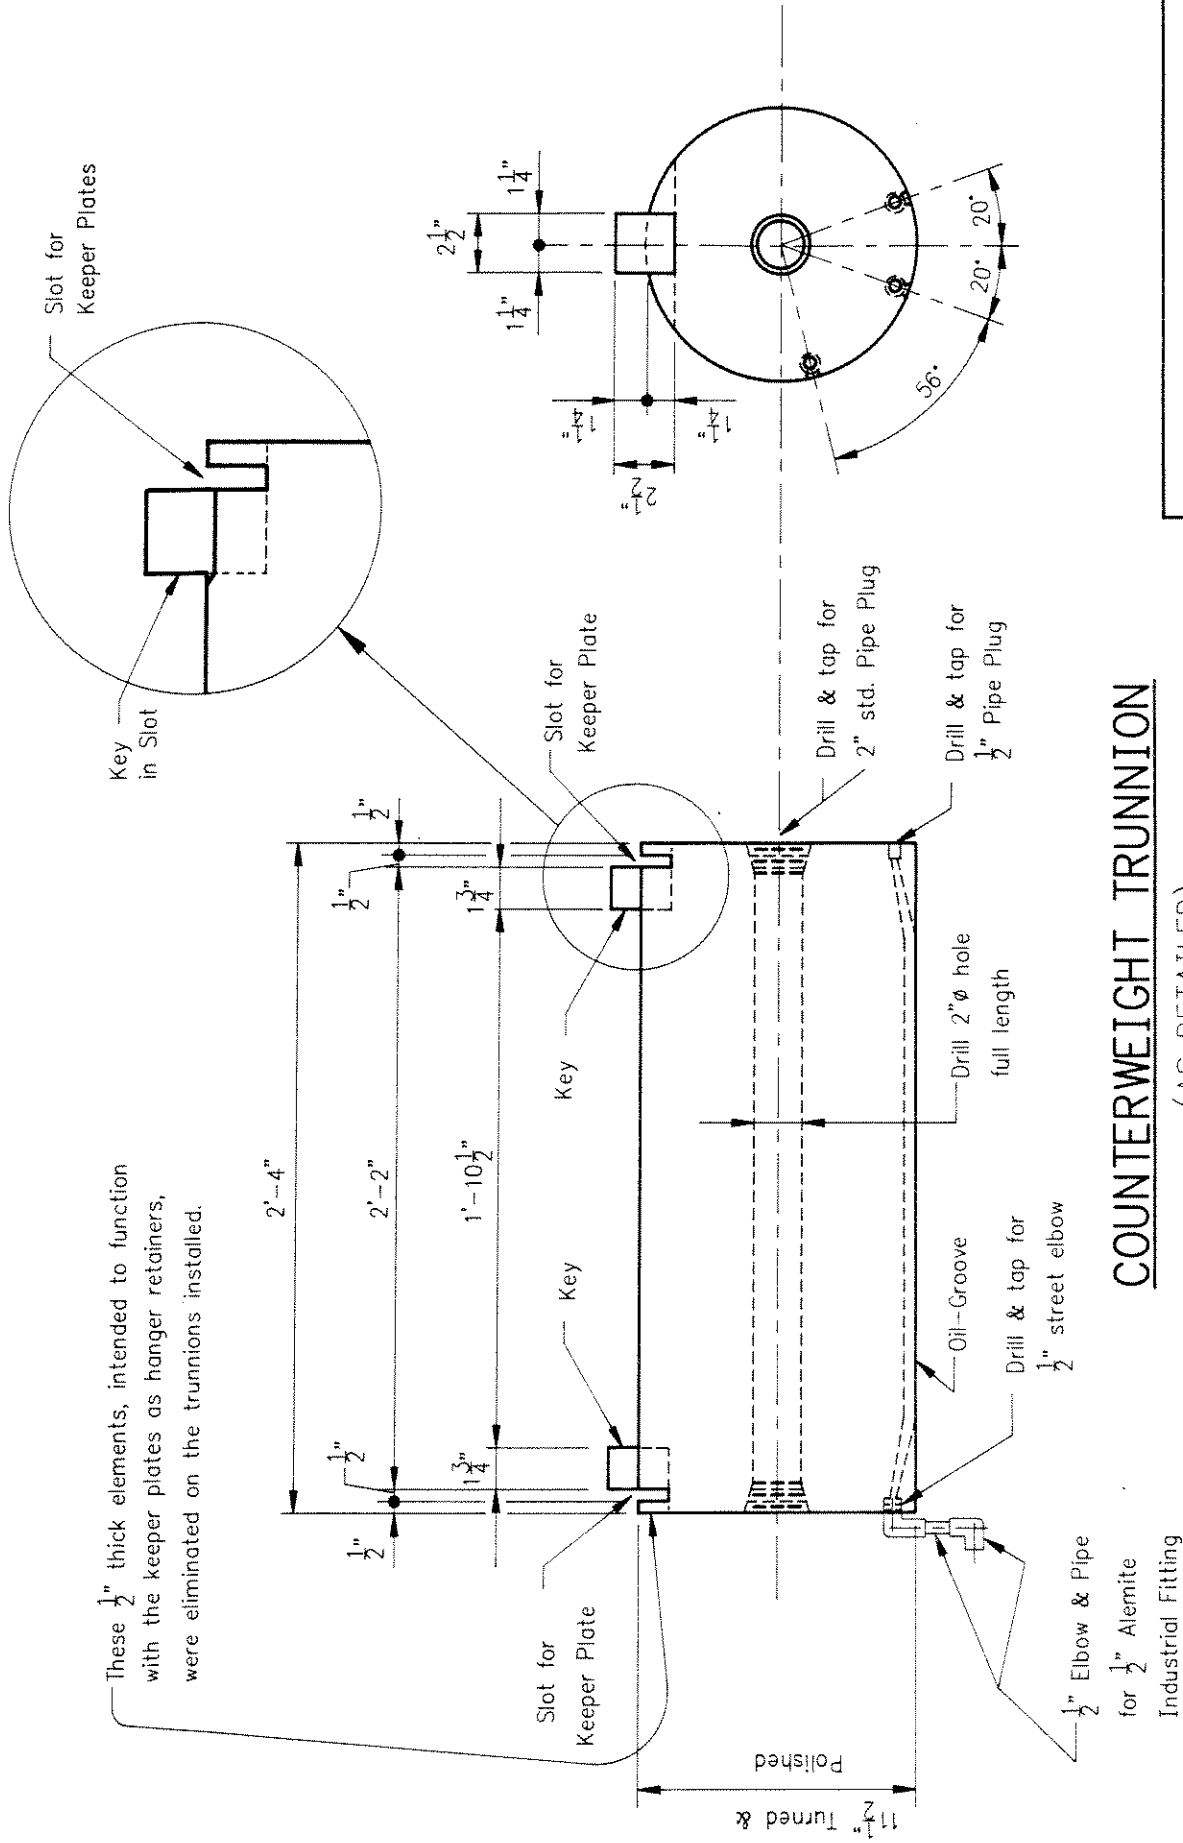
The evidence indicates that the outboard hanger on the west trunnion had been bearing on a single 3/4" plate for a significant period of time. See Figures 6 & 7. When the final lift was made, the west counterweight trunnion seized in its bearing after approximately a 10° rotation. As the girder continued to rotate about the main trunnion, the counterweight hanger was being forced out of its vertical orientation exerting a very high torque load on the interface between the counterweight trunnion and the hanger plate assemblies. Concurrently, the hanger at the east girder maintained its vertical orientation and the counterweight link at the center of the bridge was exerting a force to maintain the vertical orientation. This combination of forces was sufficient to cause the single plate in bearing on the outboard side of the girder to move outward until it failed in edge bearing and slipped completely off the trunnion. This happened very soon after the bearing seized since there was no evidence of distress in the keyways or the key at this location. With the full component of the west counterweight support on the inboard side of the girder, the span continued to rise. The eccentric load on the trunnion caused a distortion in the web and a twisting of the girder so that the trunnion was sloping significantly downward to the inside. As the span continued to open, the inboard hanger rotated about the trunnion. As it sheared the key, the hanger plates separated and started sliding off the trunnion. The shearing action on the key indicates a rotation of about 2-1/2 inches which corresponds to approximately 25° of opening prior to the key being pulled or forced out of the keyway. The hanger stayed on the trunnion for an additional 10° of rotation

1. The design drawings for the counterweight trunnion called for a slot 1/2" from each end to permit a single keeper plate for both the key and the hanger assembly. In lieu of slotting, the trunnion was machined flat to the bottom of the keyway. This eliminated the restraint of possible hanger movement off the trunnion. Had the restraints been

2. The trunnion details called for three oil grooves with drilled holes from both trunnion ends to the grooves. The outboard ends were to be fitted with alemite fittings for lubricant while the inboard ends called for pipe plugs. The plugs, which were installed, were intended to hold the lubricating oil in the grooves. No record is available with regard to the lubricants used in the years past, but at some point in time, grease was substituted for oil lubrication and this practice was continued. The lubricant in use at the time of the failure was MobilGrease HP, a multi-purpose extreme pressure automotive grease. When the lubricant was changed to grease, the plugs should have been removed. This would have allowed free movement of the lubricant through the grooves which would not only insure full coverage of the bearing surfaces, but would also purge contaminants that might enter the grooves. Their presence had to contribute greatly to the improper circulation of lubricant which permitted the complete clogging of the oil grooves. See Figure 6.

These $\frac{1}{2}$ " thick elements, intended to function with the keeper plates as hanger retainers, were eliminated on the trunnions installed.

A critical factor contributing to this failure was the lack of any positive provision for preventing the hangers from coming off the trunnion. All bascule bridges with suspended counterweights should be provided with positive restraints to preclude the possibility of the hanger plates slipping off the trunnions or sensors that will alert the operator of any movement of the plates relative to the trunnions.

Most critical was the use of grease without removing the plugs for the lubrication of the trunnion bearings. Periodic checks should be made in such a modified application to insure proper flow of lubricant through their full length. Had the lubrication been satisfactory at all times, the hangers would never have moved on the trunnions and the failure would not have occurred.

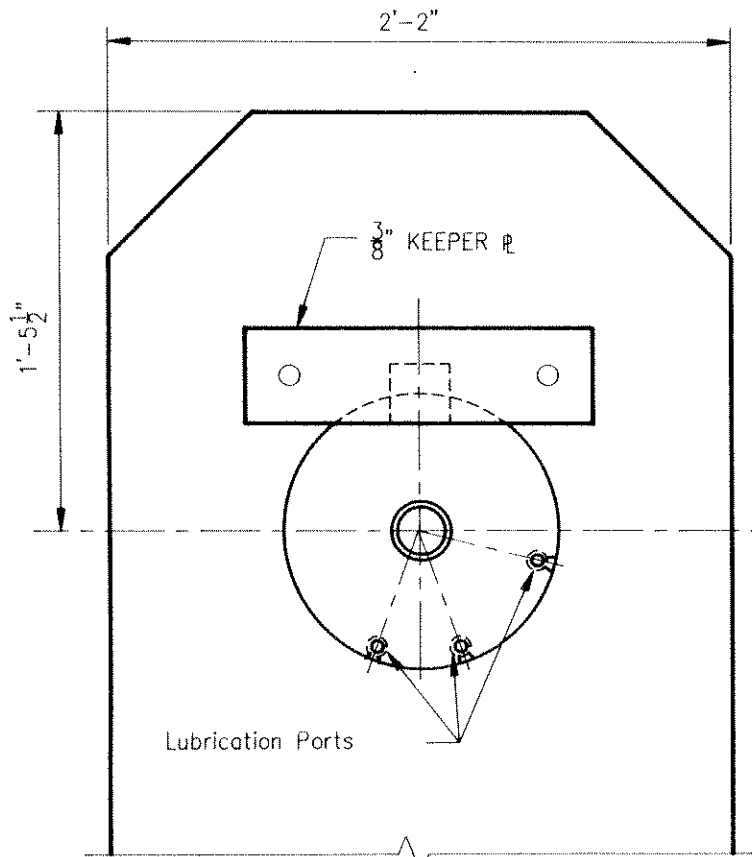
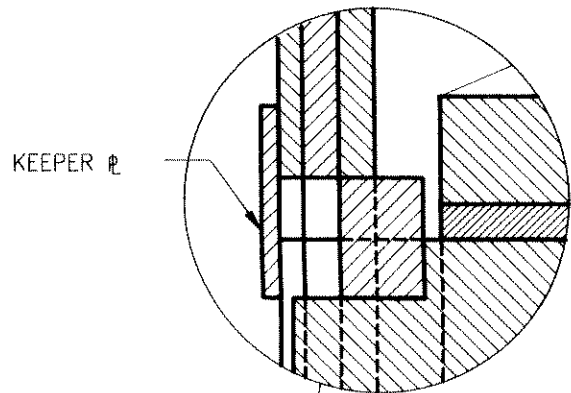
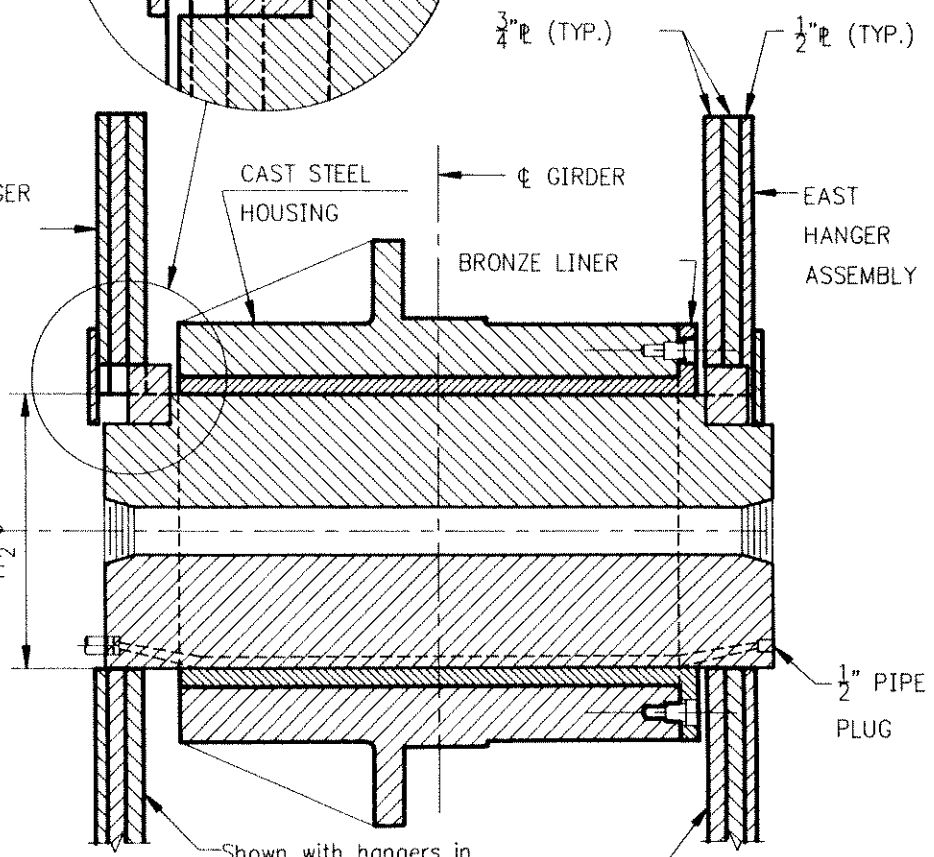
TAYCO STREET BASCULE BRIDGE
OVER
U.S. CANAL
MENASHA, WISCONSIN
FIGURE 7

in place, the bearing seizure would probably have stalled the motor before the counterweight hanger could slip off the trunnion (Figures 6 & 7).

COUNTERWEIGHT TRUNNION
(AS BUILT)
