3RD BIENNIAL SYMPOSIUM

Session (5-2)
"Gritty Grease Can Cause Big Problems",
William E. Nickoley,
Hazelet & Erdal, Chicago, IL.

**GRITTY GREASE CAN CAUSE BIG PROBLEMS
(or, What Can You Afford to Take For Granted
On Your Movable Bridge?)**

**by William E. Nickoley, P.E.
Mechanical Engineer
Hazelet + Erdal, Inc.**

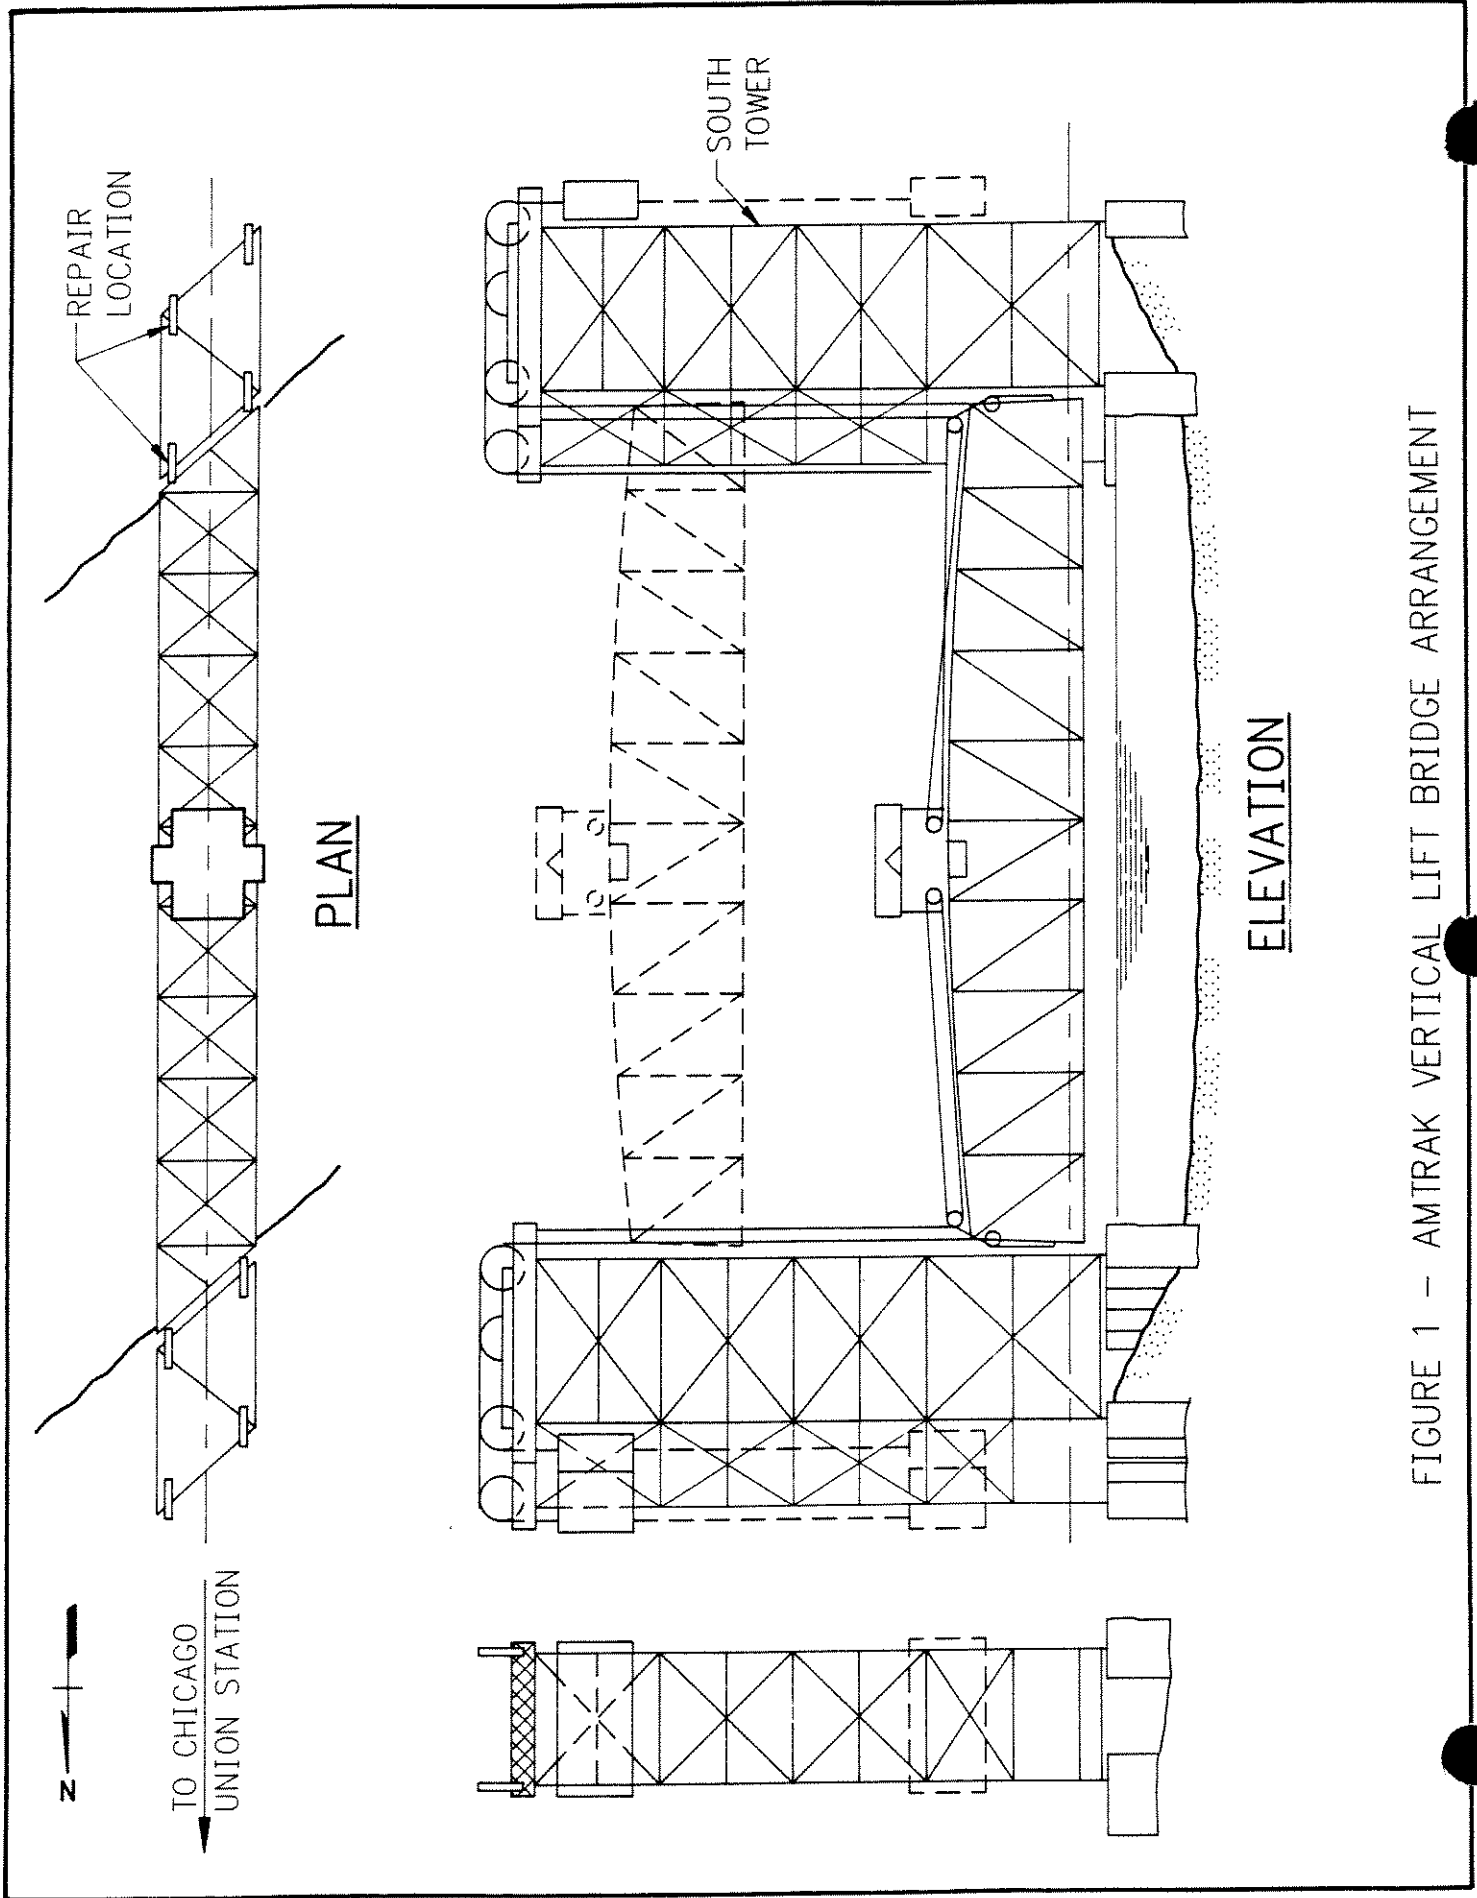
FIGURE 1 - AMTRAK VERTICAL LIFT BRIDGE ARRANGEMENT

The movable span, which supports the machinery house on the Amtrak vertical lift bridge, is a Pratt through-truss with double tracks, 273 ft. long. The span is raised and lowered using a system of up-haul and down-haul ropes attached to the channel side of the two 220 ft. high towers. Counterweights, suspended by ropes over sheaves at the top of each tower, balance the span on either end. Because the span is built on a skew across the river, and the counterweight ropes from each corner of the span require two sheaves each set (the ropes bending 90° at each location), vertical back legs are required for each tower (see Figure 1). This description and an early photographic print of this bridge are contained on pages 734 and 736 of Mr. Waddell's book, Bridge Engineering, which was published in 1925.

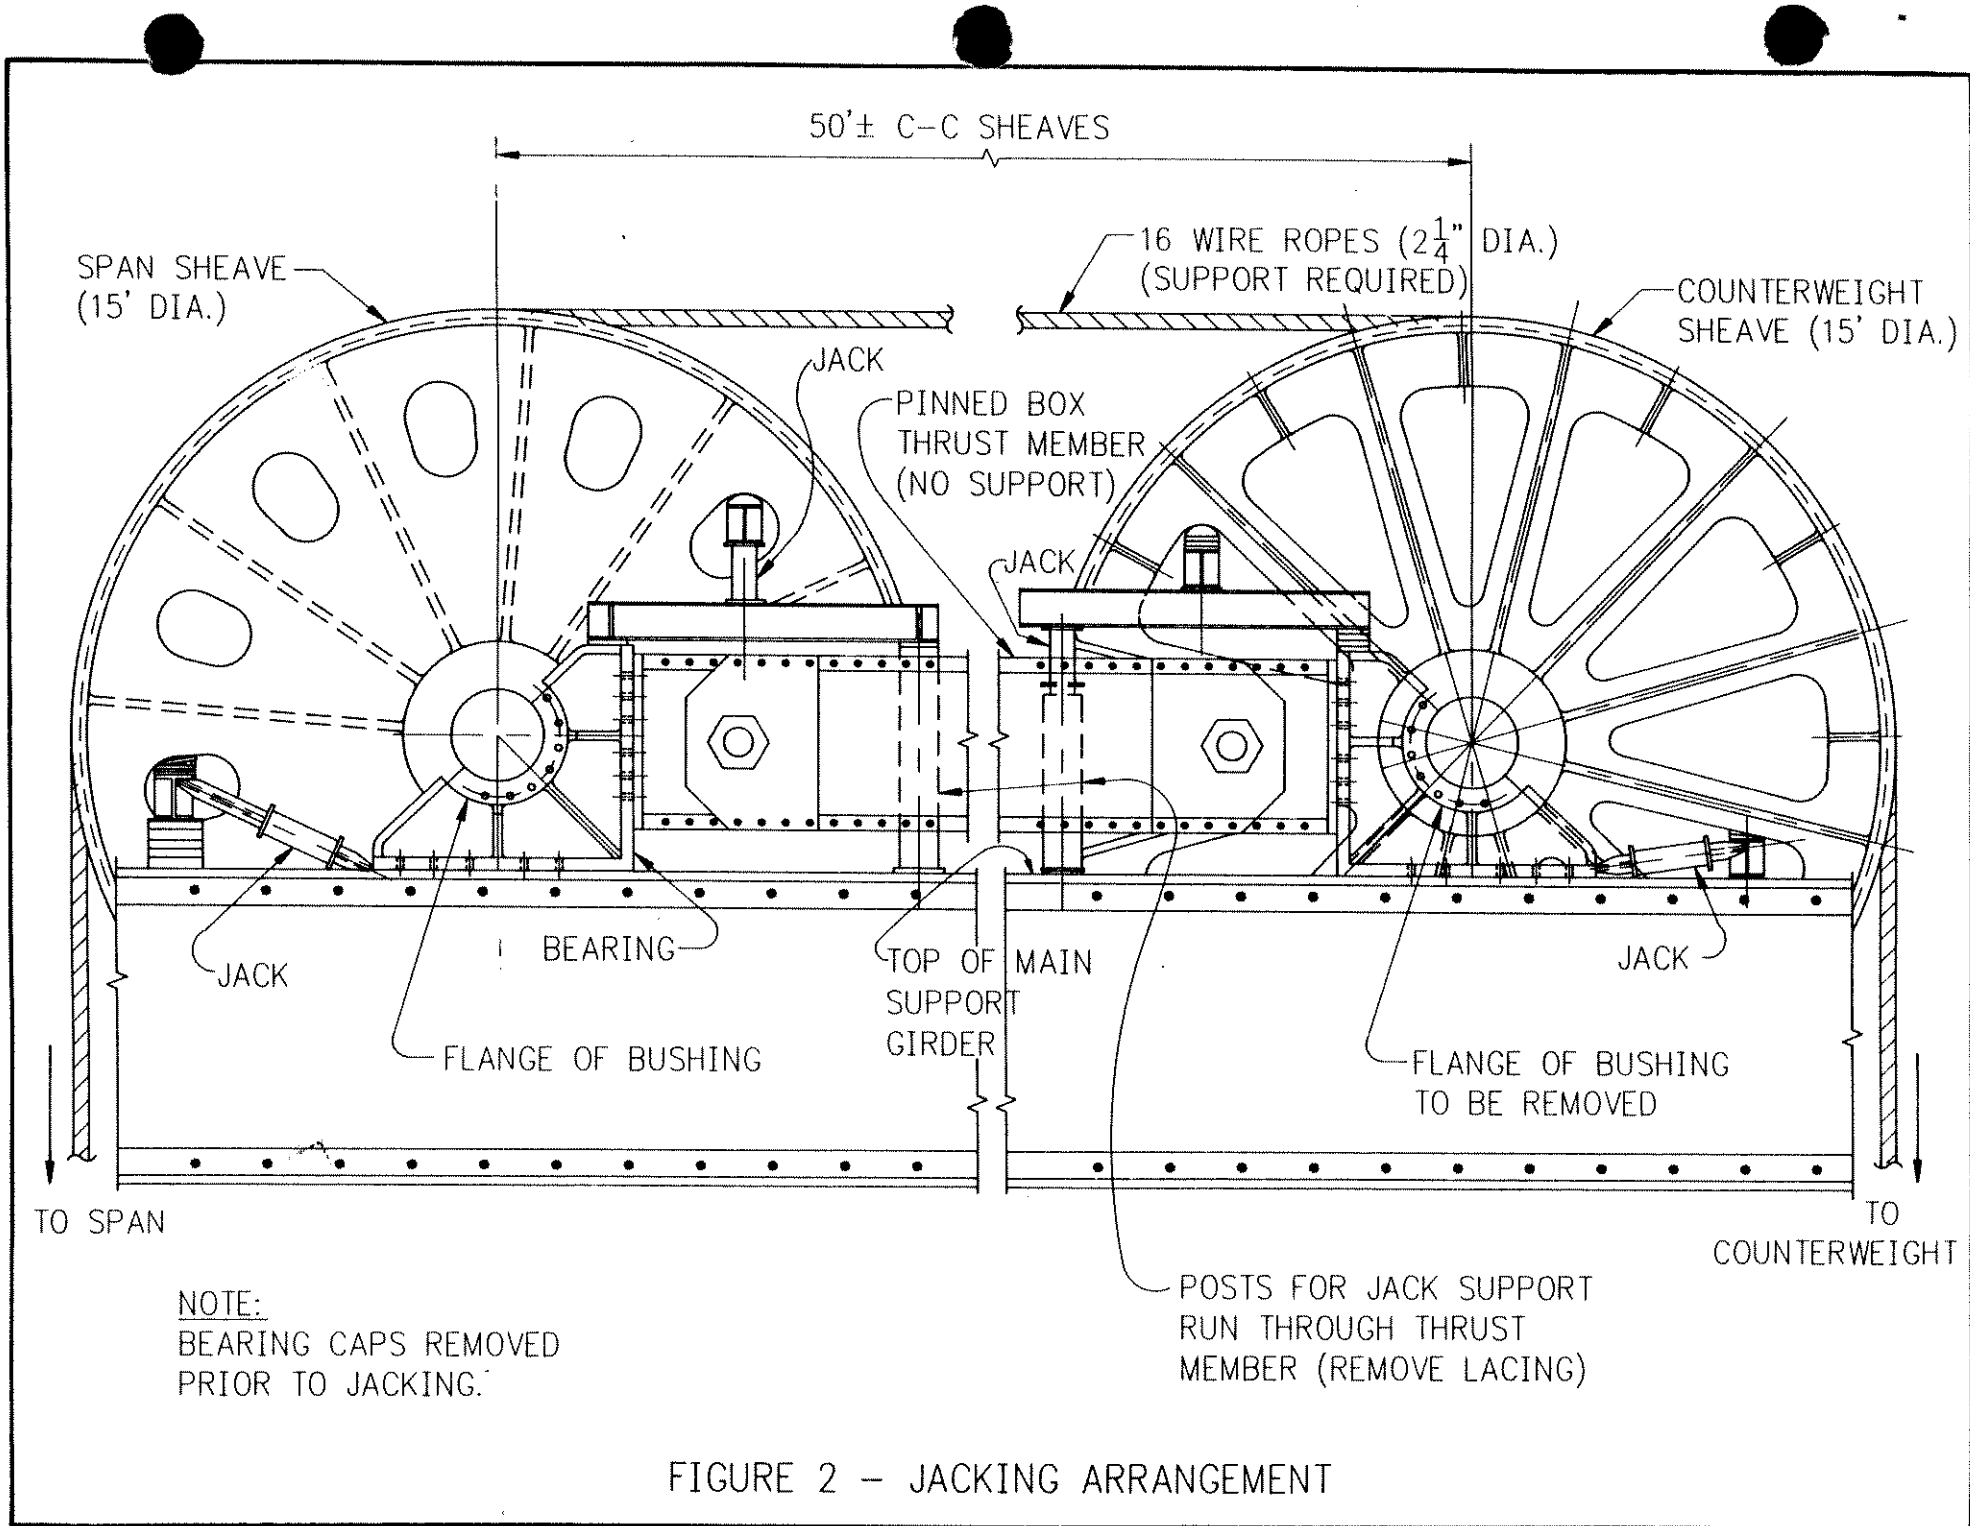
FIGURE 2 - JACKING ARRANGEMENT

Replacement of the bushings would be complicated (see Figure 2). The external static load on each sheave is delivered by horizontal and vertical rope tension. The vertical components of these loads are equal to the hanging weight of the portion of either the span or the counterweight supported by the ropes. A horizontal component is produced as rope tension is transmitted between the sheaves. The resultant, at approximately 45°, was incorporated into the original design for supporting the trunnions by splitting the bronze bushed pillow block bearings at 45°, perpendicular to this line of force. In order to lift the sheaves at the bearings, so that the bushings could be replaced, it would be best to remove this tension as much as possible so that only the weight of the ropes themselves, plus the weight of each sheave assembly, would be involved. It would also be necessary to use a special jacking arrangement so that the sheaves would move out at the 45° angle. To further complicate the situation, two different types of sheaves, one cast and one fabricated, were to be lifted, and the only support for the jacks was located *below* the thrust members between the bearings.

To remove the tension from the counterweight ropes, the counterweight was to be lifted and supported. Since these sixteen 2-1/4" diameter ropes would then sag between the sheaves, special supports would have to be built there for them. It was necessary to maintain operation of the bridge until the actual day of bushing

Work on the top of the tower and on the ground below continued all week. Several days were required to lower the counterweight support eye assemblies, which are threaded into large nuts for positioning and support. The screw threads on each eye lacked protective lubricant and had corroded over many years. Even after cleaning, heat had to be applied to the nuts, and hydraulic actuators had to be used to turn them a few degrees at a time. While this was being done, the rope supports between the sheaves were being put into place. Support frames were designed to stand on either side of the ropes without horizontal cross members upon which the ropes would bear until they were required. The cross members could then be installed in a short time. On the ground, beams and posts were fabricated for use in lifting the sheaves. The Engineers decided that the best method of jacking would be to support each sheave with a beam placed through the sheave between spokes ahead of the shaft and to jack against a second beam placed behind the shaft. In so doing the fixed support would become a pivot point and, with a little simultaneous movement of that pivot point, the shaft would move out at the required 45° angle. Support posts were to be set on the girder below by removing some of the lacing in the thrust member through which the post must pass. Careful measurements and calculation of loads were used in the design of these field fabricated members. W8x40# members were utilized to meet the requirements of strength, availability, and maximum envelope dimensions. Jacks of 100 ton capacity were to be used to lift the 15 ft. diameter sheaves.

Support of the counterweight and the ropes between the sheaves was not accomplished until late Saturday. As jacking was attempted on the first sheave Sunday, some unexpected deflection was experienced in the forward (span side) support through-beam. It was concluded that one aspect of the forces involved had been incompletely assessed, for as the weight of the counterweight was removed, the ropes shortened the amount they had originally stretched under load, causing sheave rotation toward the span. The deflection was determined to be of minor consequence in this case since no further loading in the direction of deflection would occur during jacking

Once the preliminary work was accomplished, the actual replacement of the bushings took a short time, and was done successfully. The second sheave was lifted and its bushing replaced on Monday, June 27, using the same procedure. Bearings were rotated out of the bases using small hydraulic rams to push one end and "come-alongs" to pull the other end. The new bushings were more easily installed in the same manner.
