HEAVY MOVABLE STRUCTURES  
MOVABLE BRIDGES AFFILIATE  
3RD BIENNIAL SYMPOSIUM

Session (5-10)  
"Bolted Connections For Machinery;  
A Case Study", R. Mayeaux,  
Mayeaux Engr'g, Inc. Baton Rouge, La.

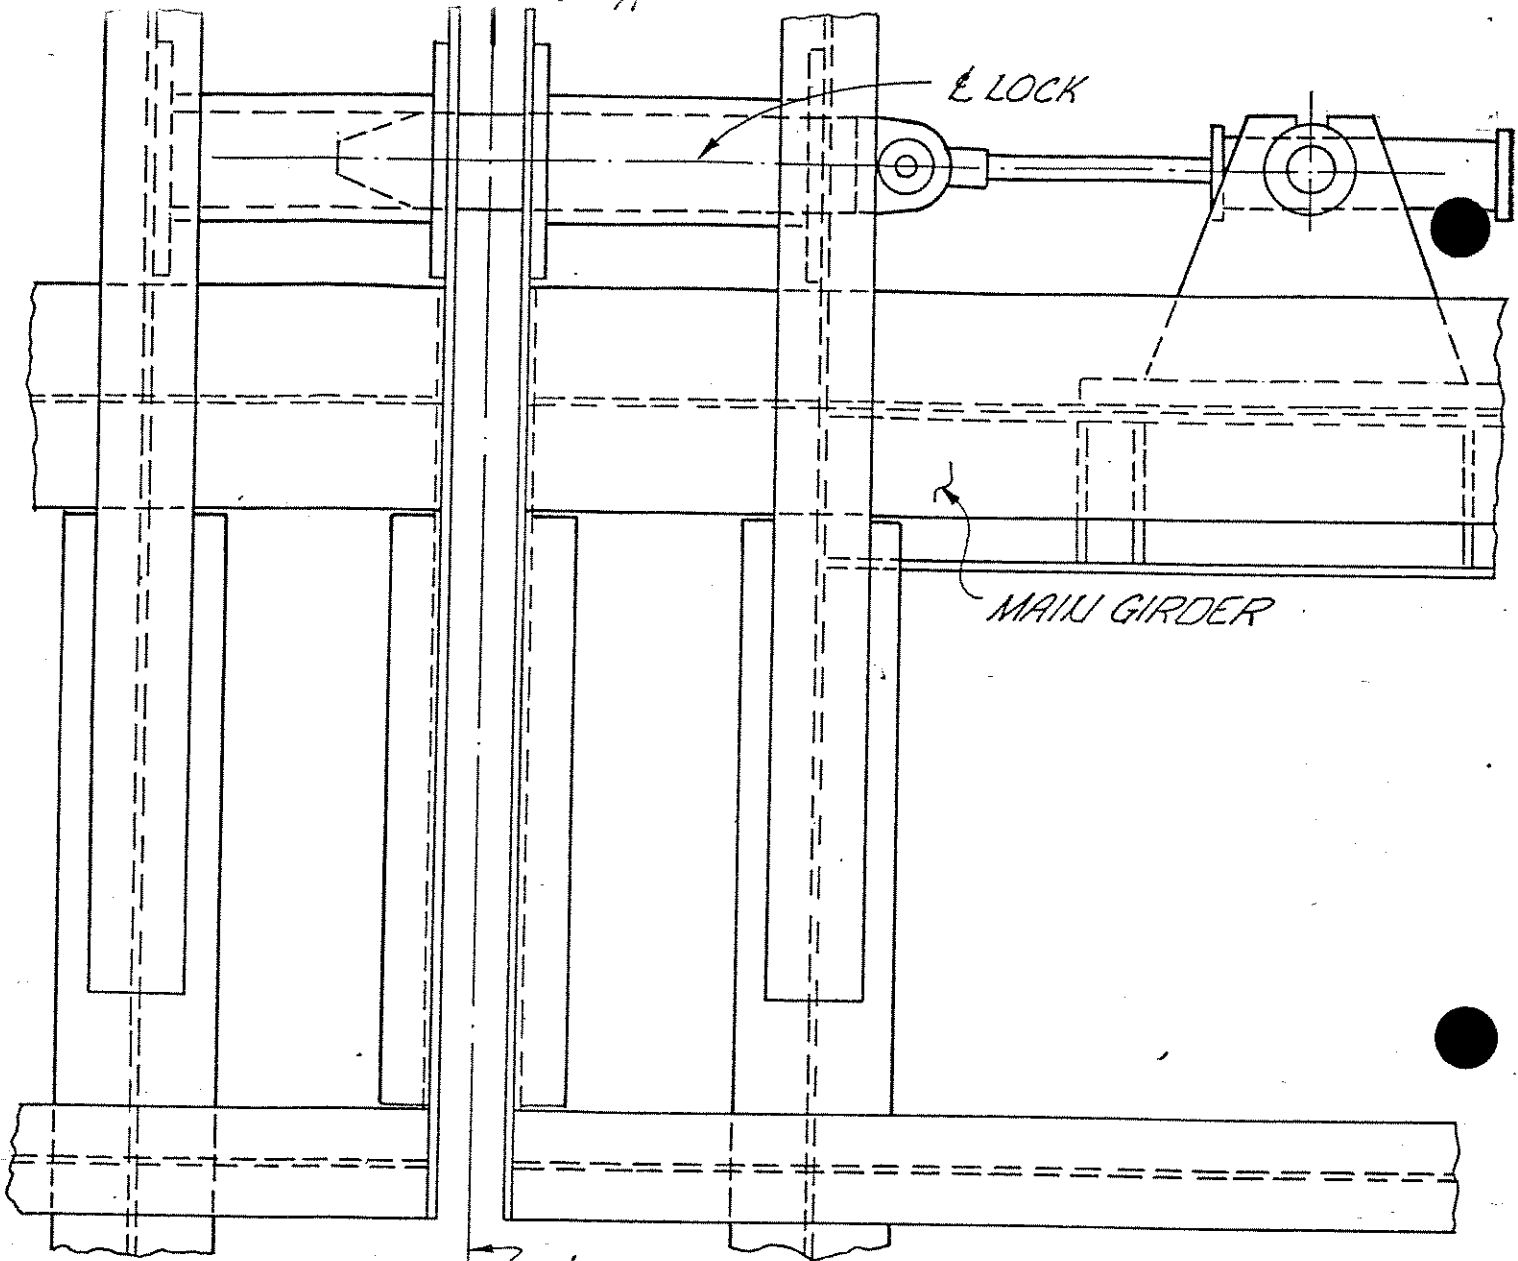
PLAN ~ CENTER LOCK

The effects on the structure about the center locks were bent structural plates, loosened structural bolt assemblies, elongated bolt holes, broken welds on the grid flooring, skewed lock alignment and increased operating pressures to drive and withdraw the locks. See Plate 1A. The plates supporting the locks over the middle of the waterway were bent. This bending, resembling the "oil canning" of sheet metal, required heat straightening and shimming to put the center locks into alignment. Plating was added to reinforce the existing members as well as distributing the forces over a larger area. Elongated bolt holes were filled by plug welding, inspected for cracks,

ground flush and redrilled at the proper location. The bolt assemblies were of adequate strength in regards to size. This conclusion was deduced by reviewing the original design and reinforced because of no shear failures of the original bolts. The new structural bolts installed were equipped with prevailing torque nuts of sufficient strength in accordance with ASTM A 325.

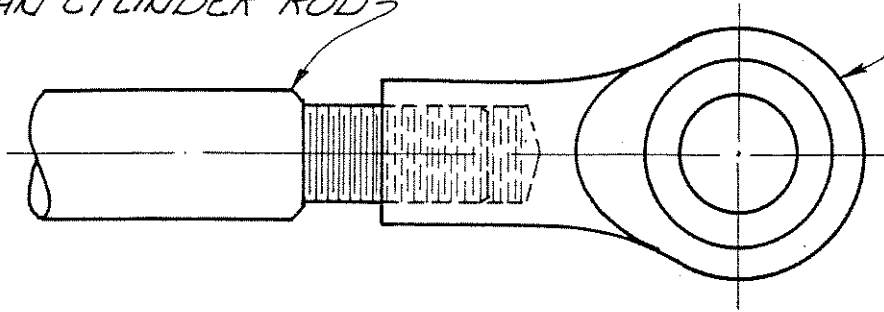
ORIGINAL  
DESIGNED  
ROD END

A fastener failure is the subject of this next case study. The failure occurred on the span drive of the bridge in the previous case study. Horizontally mounted hydraulic cylinders provide the motive power to move the rolling bascule leaves. On one occasion, the rod end separated from the cylinder rod. The components were inspected to determine the failure mode. The threads in the rod end and on the cylinder rod were undamaged except for the first five of the 4"-12UN external threads on the rod. These had been stripped but, were repairable. Damage to the rod end threads was negligible and held the remains of the stripped threads from the rod. Further examination resulted in no other features on the rod or the rod end; no set screws, locknuts or any adhesive on the threads. The rod simply unscrewed itself.

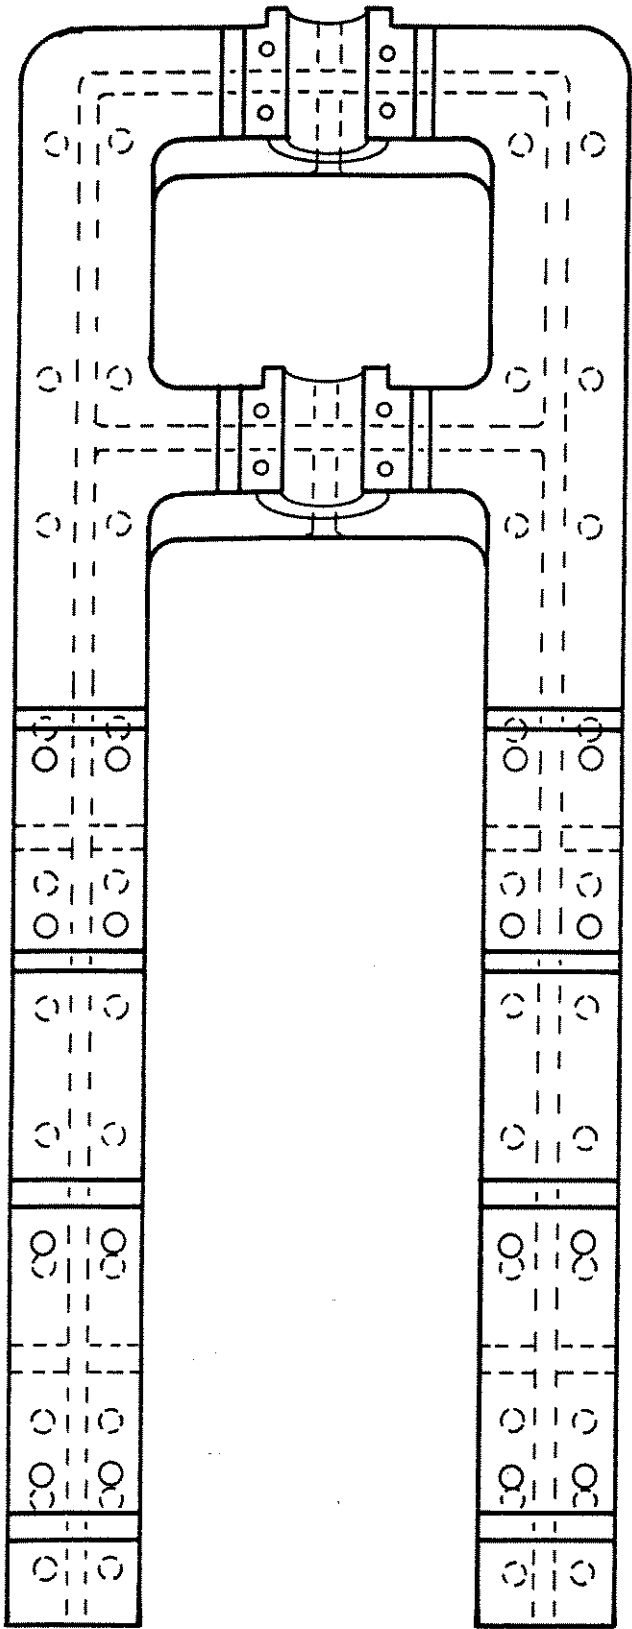
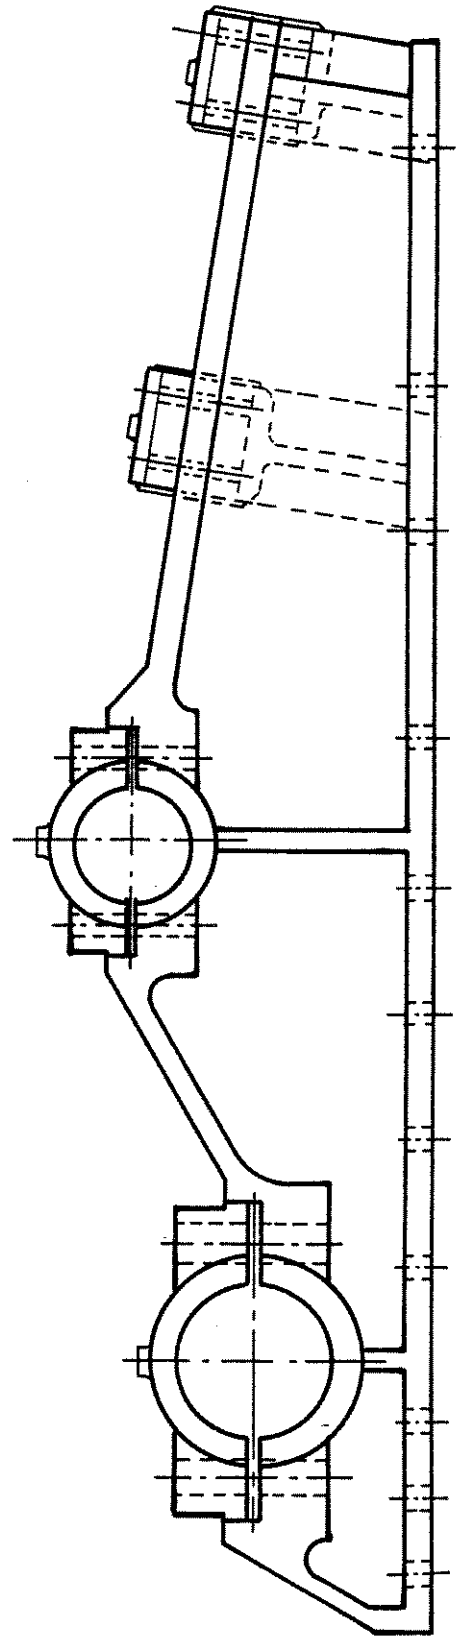
One notices immediately that the gear drive appears as a monolith. See Plate 3A. This is because of the density of the gear sets and the fact they rest in a single frame. This substantial cast iron frame provides for a precise and rigid mounting for the gears. Though this is 1920's technology, a frame of equal moment and torsional rigidity may be accomplished with welded members for current gear drives. The single frame allows the machining of the frame to be accomplished with a minimal amount of fixturing thus, reducing misalignment of bearing and gear surfaces. Note the number and location of the

anchor bolt connections. The  $1\frac{9}{16}$ " diameter drilled holes were fitted for  $1\frac{35}{64}$ " (  $1\frac{9}{16}$ " -  $\frac{1}{64}$ " ) turned bolts. The tight fitting bolts fixes the frame location to less than 0.050" between ideal and actual orientation. Also noticeable are the numerous anchor bolts at the more heavily loaded bearings. This results in a most equitable distribution of forces into the substructure. The monoframe concept reduces working loads and increases accuracy when it is bedded into place. Leveling relative points on the frame is easier which, reduces construction cost.

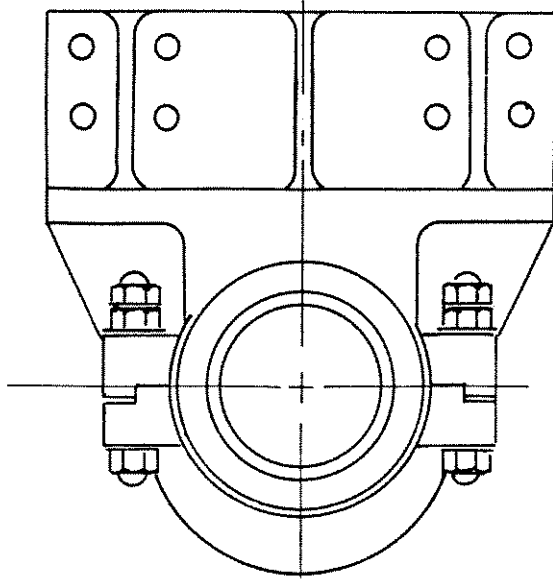
BEARING CAP STUD

The existing bearing cap studs were breaking at the rate of twice weekly. These studs were made from ASTM A 193, Grade B7 alloy steel bars. This is a ductile chrome-moly steel. The alloy has a minimum ultimate tensile strength of 125 kpsi, a minimum yield strength of 105 kpsi, and a 2 inch gage elongation of 16 per cent. The steel was turned to the required body dimensions with cut threads and a 125 finish. Nuts used with the studs were either ASTM A 194, Grade 2H or A 563, Grade DH. All fractures of these studs were tensile failures occurring at the reentrant corner of the chamfer.

The fracture plane exhibited 80 per cent to 85 per cent brittle fracture with the remaining fracture area exhibiting ductile shear lips on the periphery. This brittle fracture was the result of the stud geometry. The sharp angles of the necked transition and rough finish produced a high stress concentration factor. When a large load is applied to the stud, an area near the surface would be stressed well beyond the yield strength even though the core of the stud is lightly stressed. Increasing this

load stresses this peripheral area to the ultimate strength and the beginning of fracture. This start of fracture is exhibited by the shear lips. Rapid propagation of the break results in the brittle type of fracture in the core of the stud.

Indications from this fracture are that three characteristics of the stud can be changed to prevent failure. They are material, geometry and finish. See Plate 4B. The material selected was ASTM F 593, Group 7 heat treated in accordance to ASTM A 564, Type 630, in the H1025 heat treated condition. Otherwise known as 17-4PH stainless steel, this alloy is readily available, equivalent in cost as ASTM A 193, Grade B7, exhibits slightly better impact and machining properties, superior strength and longitudinal toughness and has corrosion properties similar to austenitic, type 18-8, stainless steel. The second change was to use generous fillets at any section changes thus, reducing the stress concentration factor and stress gradient. Low stress concentration was assured by a 32 finish on the stressed areas on the stud by the prevention of tool marks of significant size.

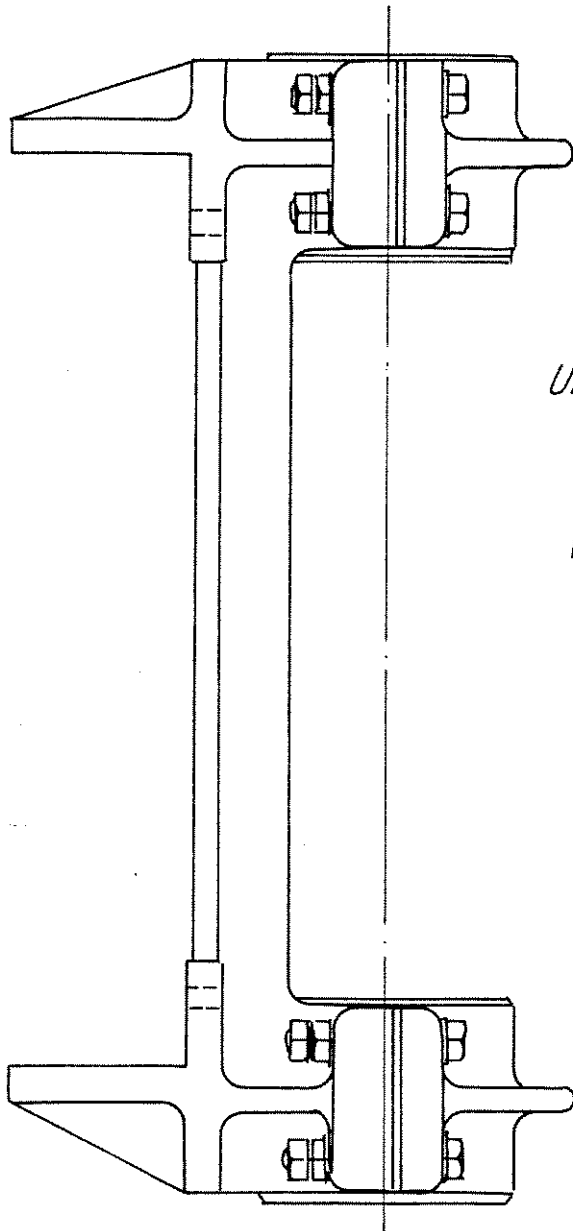
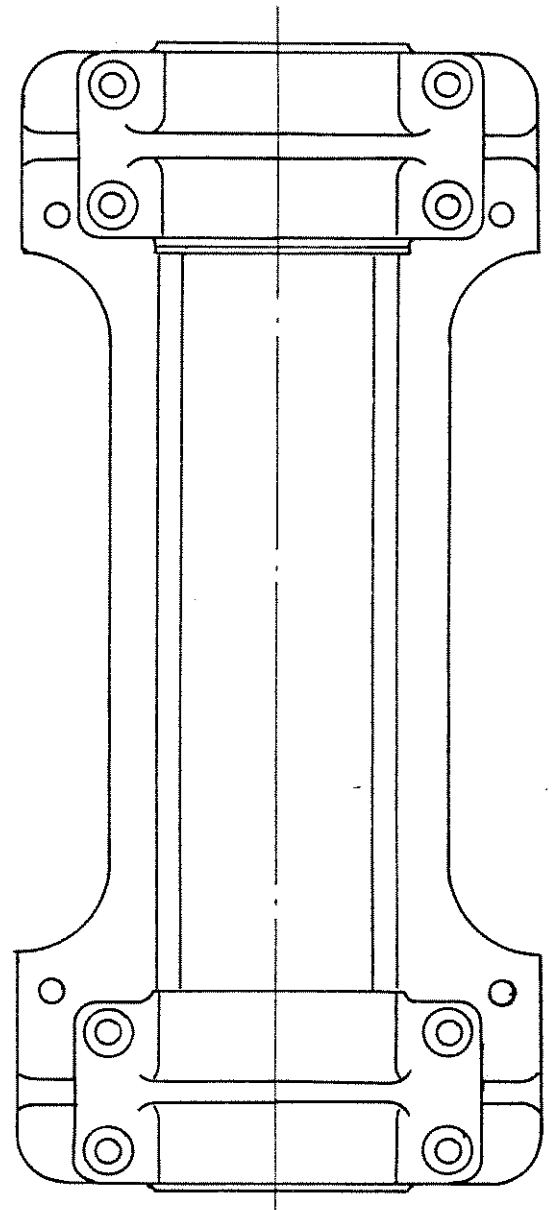
PLATE: 4A

The pinion is the last open gear reduction set of the bridge span drive. One of the vertical gear sets consist of a bull gear on top driving a 6 inch diameter forged steel shaft to the rack pinion on the bottom. Supported by bronze bushings, this shaft assembly turns in a cast iron bearing assembly. The bearing assembly consists of the housing, bronze bushings and bearing caps. See Plate 4A. This gearset-bearing assembly was shimmed and bolted to a built up machinery beam to transfer the rotating forces into the movable span thus, moving the bridge. Problems in this pinion drive assembly had been developing in the form of broken bearing cap studs and loose structural bolts connecting the bearing assembly to the bridge structure. Noticeable movement between the bearing assembly and machinery beam brought these problems to the attention of maintenance personnel.

Rigidity in the bearing assembly to machinery beam connection was achieved by two fronts. First, the bolted connection loads were distributed over a larger area. Second, gussets were added to key areas of the assembly along primary load paths.

The new bearing assembly provided a larger bolting area. A 3'-9" wide connection was used in lieu of the original 1'-9". This added 80 per cent to the original bolting strength capacity and over 176 per cent to connection stiffness. Additional bolt spacing allows the use of larger bolts should repairs be required at a later time. Gussets were added near the bronze bushings along primary load paths to increase rigidity and reduce internal bending stresses. The combination of a larger bolting area and stiffening gussets restricts relative displacements between the bearings while they are being machined and while they are under working loads.

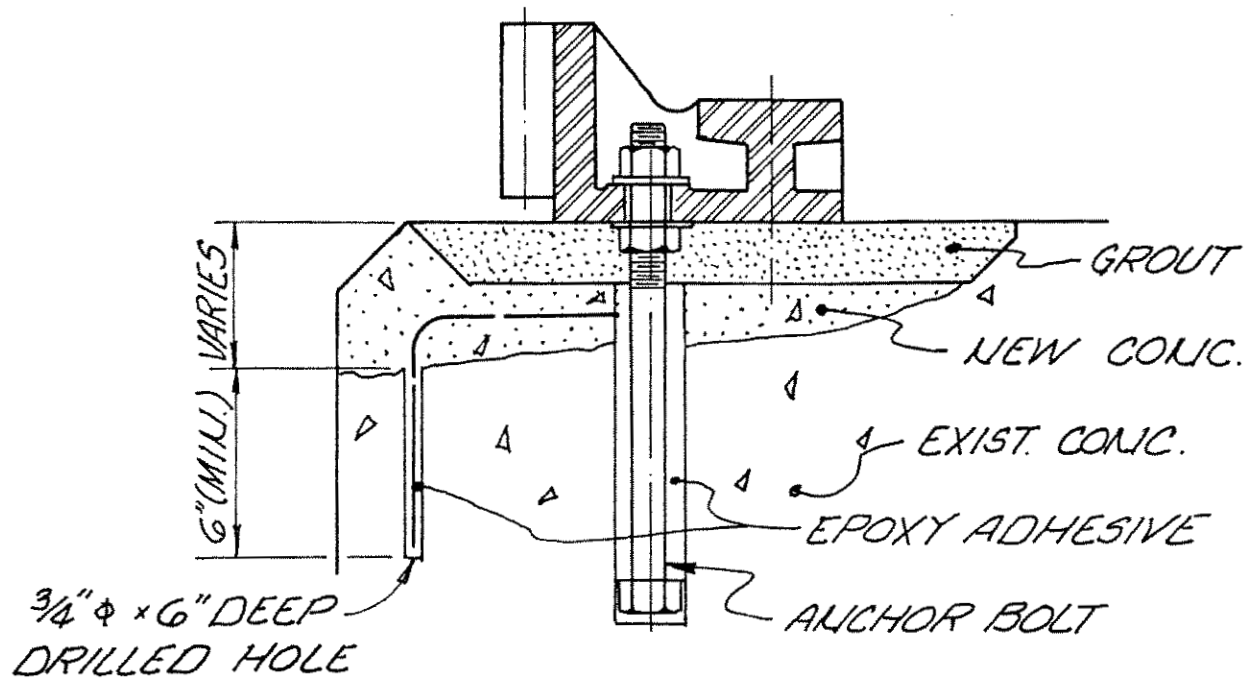
TYP. REPAIR

On the previously discussed bridge, anchor bolts and structural bolts fasten the sectional rack to the pivot pier of this swing span bridge. Sixty years of service in an exposed marine environment had taken its toll on the steel fasteners. Rust over  $\frac{1}{4}$ " thick on bolts, nuts and rebars gradually loosened these bonds. Before long, rack sections began to move. Concrete spalling started as tiny flecks then, almost overnight, grew to slabs the size of shoe boxes. Exposed by this spalling, anchor bolts and rebar corrosion accelerated, further aggravating the problem. Bolted connections between the cast iron rack sections stretched, elongating bolt holes and loosening nuts under the increased impact and strain. Examination of the existing condition and design drawings determined that the concrete pier should be rehabilitated to provide a solid foundation for the rack and new anchor bolts set for a rigid, solid load path into the pier. Prevailing torque locknuts were required to prevent loss of preload on the anchor and structural bolts.

Executing concrete repairs required the removal of all loose, cracked and broken concrete. Reinforcing steel was cleaned for reuse, spliced or new holes drilled for insertion of new rebars into epoxy. Existing anchor bolts were cut flush with the concrete and new anchor bolt holes drilled midway between

them. Accuracy for the new anchor bolt holes were tight in order to maintain a AGMA Gear Quality 6. After the epoxy had set on the new anchor bolts and the leveling nut installed, the rack sections were roughed in. Finally, the rebars were installed, the pier formed up and the rack leveled and set in its final position. The epoxy cement was mixed, pours made and allowed to set. A typical repair section is illustrated in Plate 5A.

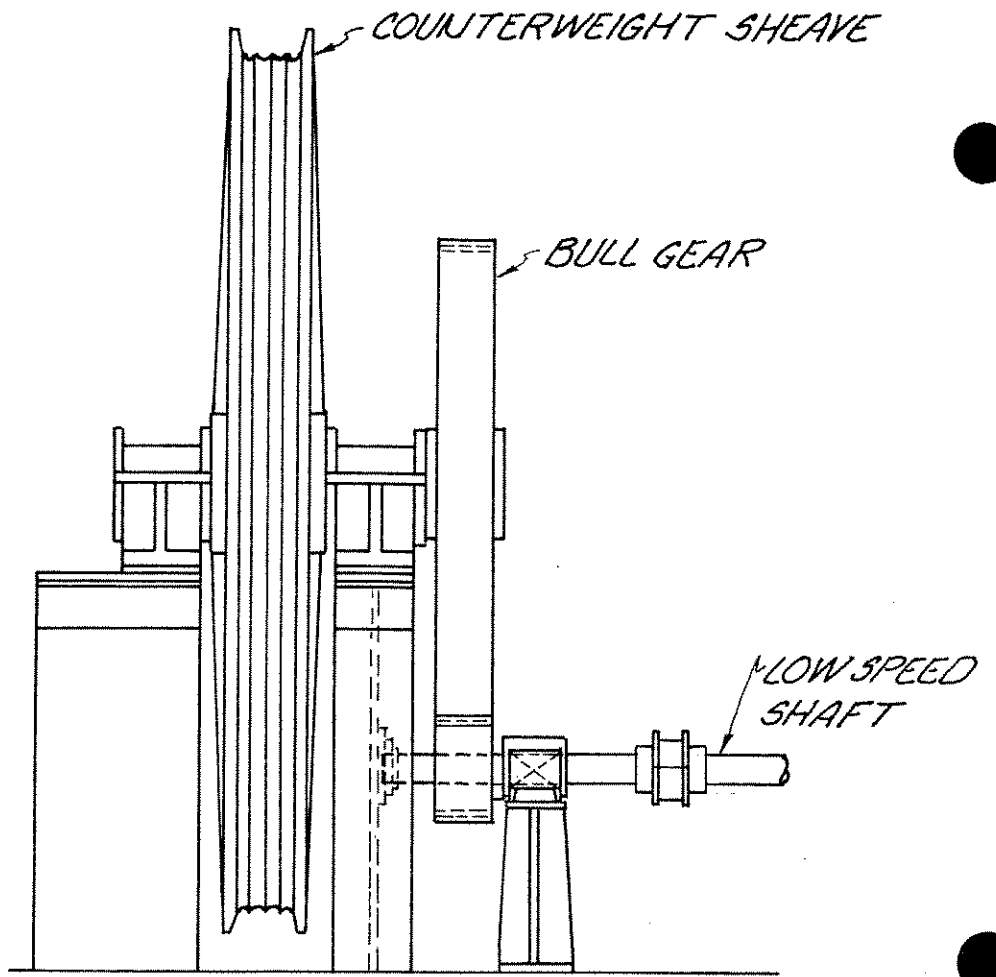
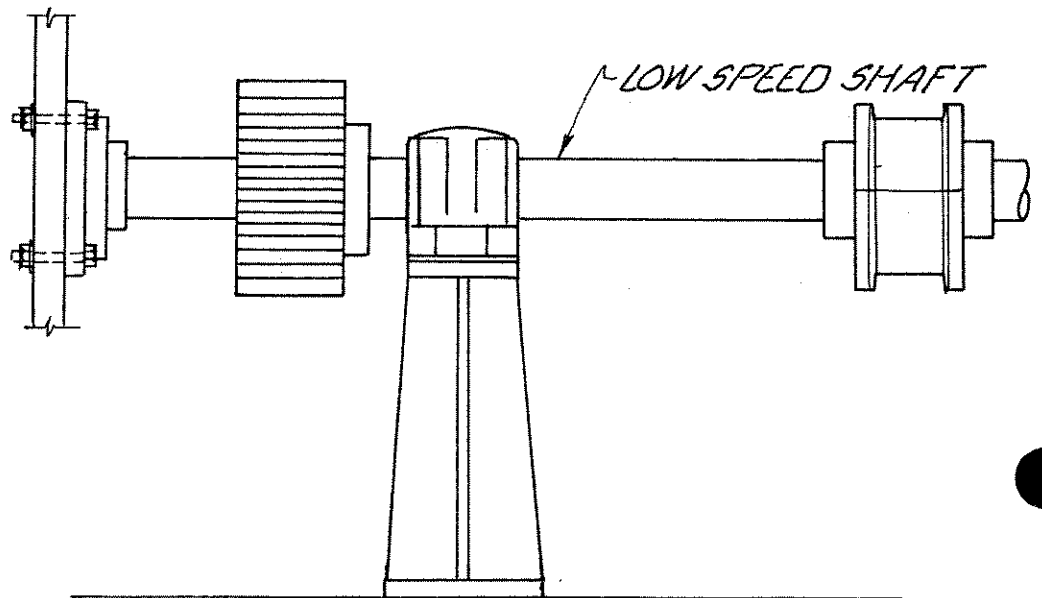
The maintenance crews began disassembly of the shafts to replace the coupling. A pinion gear drives a bull gear on a common shaft with the counterweight rope sheave. The rotating sheave moves the lift span up and down. Maintenance workers had noticed the gear lubricant extruded from the gear teeth, leaving the top outer quarter of the teeth clean of lube. This pattern was mirrored on the other side of all the gear teeth, indicating one or both of the gears were moving relative to each other under load. Plate 6A illustrates the machinery layout.

Misalignment and length of time over which this occurred sharpened the tooth profile in this area. One end of this pinion shaft is supported by a flange pillow block. The four A 325 bolts on this pillow block were found to be loose. Upon removal of the pinion shaft and pillow block, it was apparent that bridge operation had elongated the holes. The original pinion shaft and bearings were put back into position and the bolts installed to approximately their original tightness. Loading the shaft at the flanged pillow block end deflected that end of the shaft a total of  $1/2$ " roughly  $\pm 1/4$ " from the design centerline. This movement was 450 per cent above the maximum operating deflection angle recommended by the manufacturer. What began as loose bolts deteriorated to a shaft slamming to and fro against its supports. The impact must have been tremendous to elongate the holes in the  $3/4$ " web.

This excessive movement explained both phenomenon, the rupture of the cast cover and sharpened gear teeth. The cast coupling cover was ruptured when the excessive deflection caused the shaft to bind inside the coupling thus, inducing a moment into the coupling cover. It was this moment that eventually ruptured the coupling cover. The sharpened pinion gear teeth were not only a result of this deflection but, also indicated the long period of time of this occurrence.

Identifying the source of these problems determined the solution. Recommendations were made to seal the elongated bolt holes by plug welding, align the pinion shaft, drill and ream new bolt holes, tighten bolts to specifications and install a new coupling. Two of the new bolts recommended were to be turned bolts installed at opposite corners of the new flanged pillow block. Turned bolt holes in the structure and pillow blocks were to be drilled and reamed together at assembly and after shaft alignment. The remaining two bolts were to be high strength bolts conforming to ASTM A 325. Nuts for the new turned and structural bolts on the pillow block were recommended to be prevailing torque nuts. The use of round bolt holes and tightened bolts increase rigidity, reduce wear and decrease maintenance cost.
