Session (6-12)
"In-house Reconstruction of the One
Hundred Year Old Carroll Street Bridge",
M.S.Hershey, New York City, Bridge Div.

CARROLL STREET BRIDGE REHABILITATION

NEW YORK CITY DEPT. OF TRANSPORTATION
BUREAU OF BRIDGES

MICHAEL S. HERSHEY, P.E.
CHIEF ENGINEER BRIDGE MAINT.
OCTOBER 1990

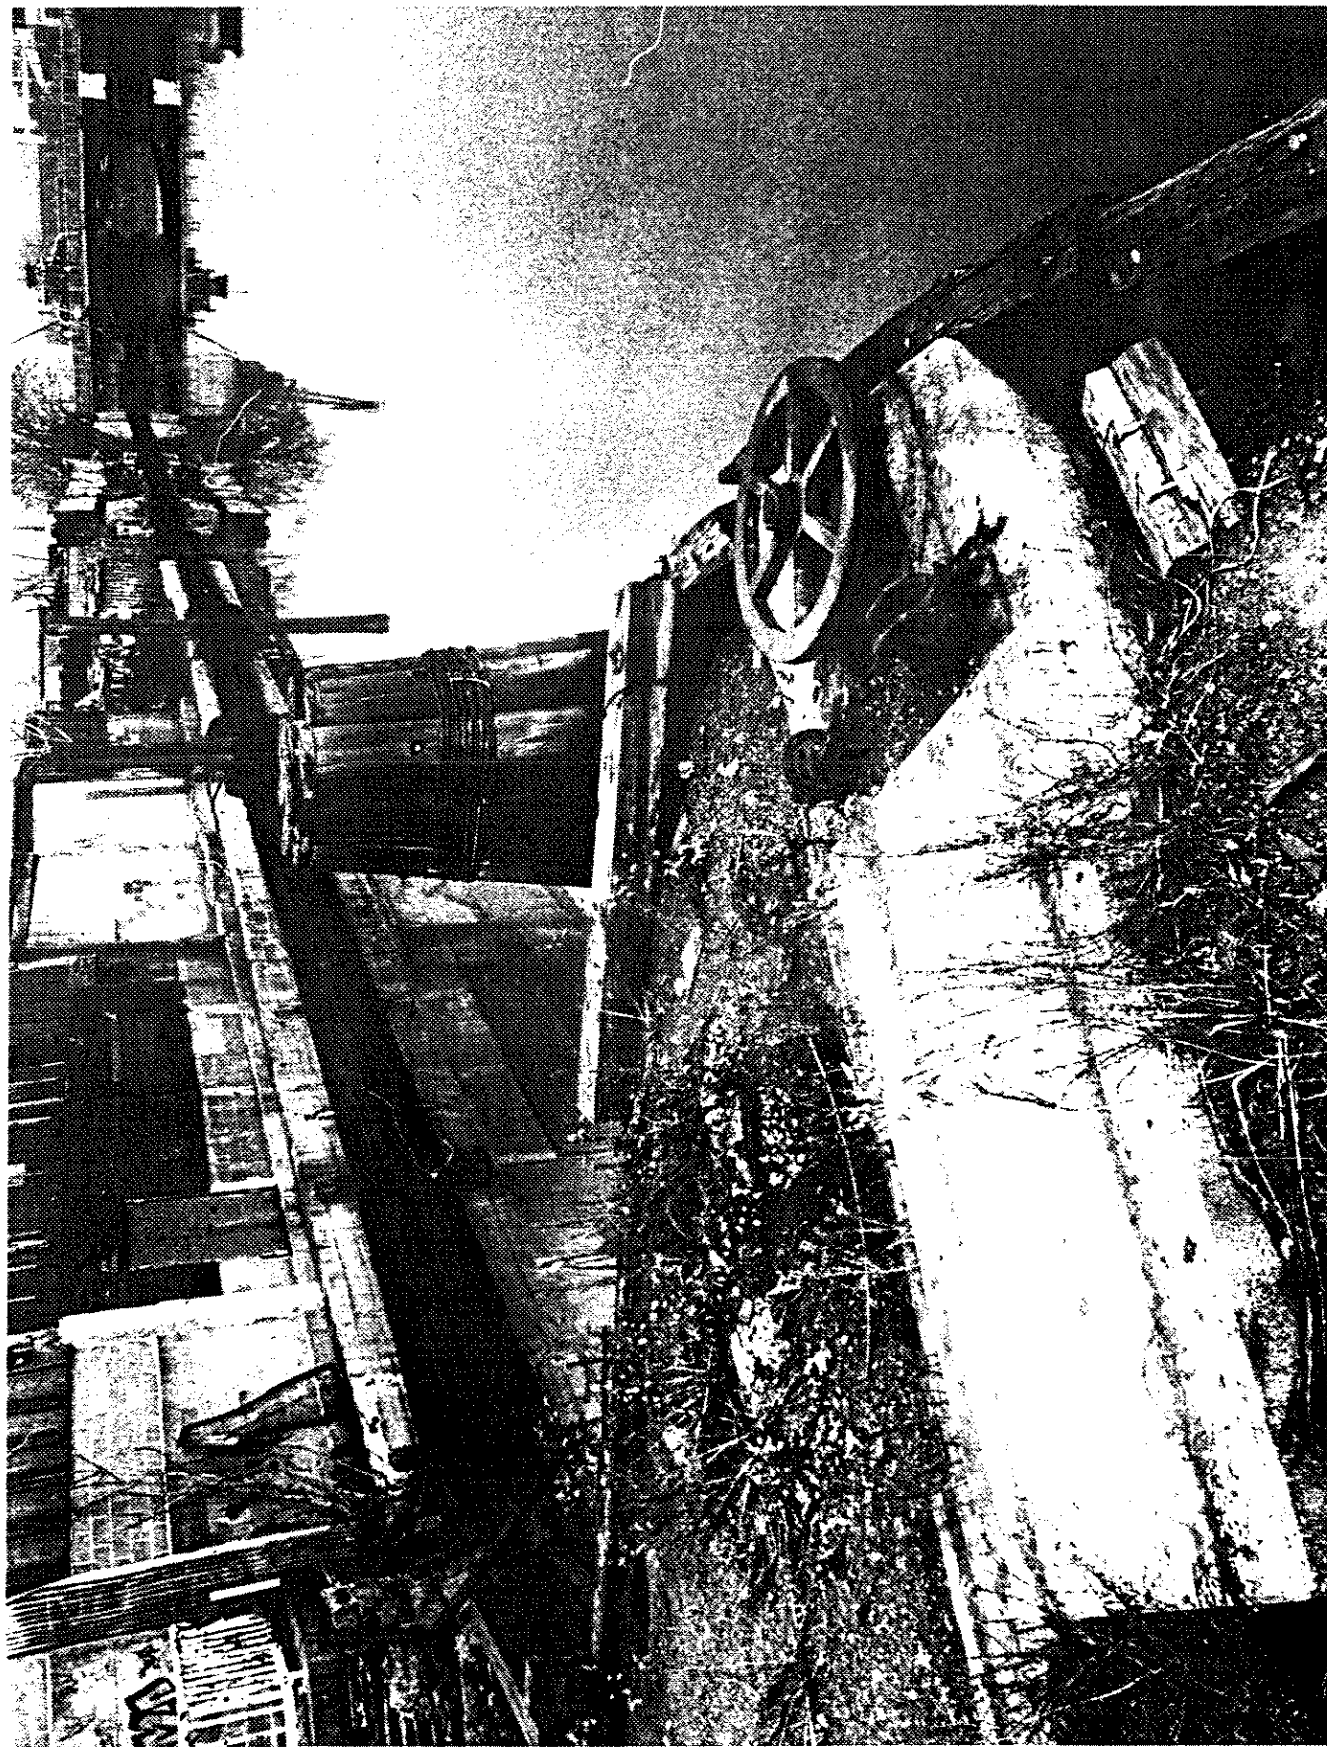
Photo No. 2

- o The substructure of the bridge, in general, is in very poor condition with deteriorated timber abutments and wing walls.
- o At the west bank (the side to which the bridge retracts), the timber retaining wall around the embankment is decayed and damaged and the top section is missing in one area (refer to Photo No. 2). The low height of this wall makes it susceptible to periodic floodings which submerge the rails. There is settlement of the rails especially in the area of the tracks supported on timber cribbing rather than on pile supports. The bottom of the girders graze the top of the pulley guides because of this settlement. The end of the rail at the east face of the embankment is broken due to boat collisions, causing some of the wheels to be left only partially supported.

- o Abutment Joint with Deck -- This is an open joint, which allows transverse movement for the opening/closing of the bridge. The joint also allows water and dirt to accumulate on the floor beam. This causes extensive corrosion to the ends of the stringers and the west face of the floor beam.
- o Bridge Seat -- The rails on which the carriages are seated show signs of settlement and become submerged at high tide. This condition makes the bridge inoperable when the water freezes.
- o Wing Wall -- The wing wall at the abutment is of stone masonry and there is some loss of mortar. There is evidence of movement in the north wing wall.

Damaged West Bulkhead And Sheave

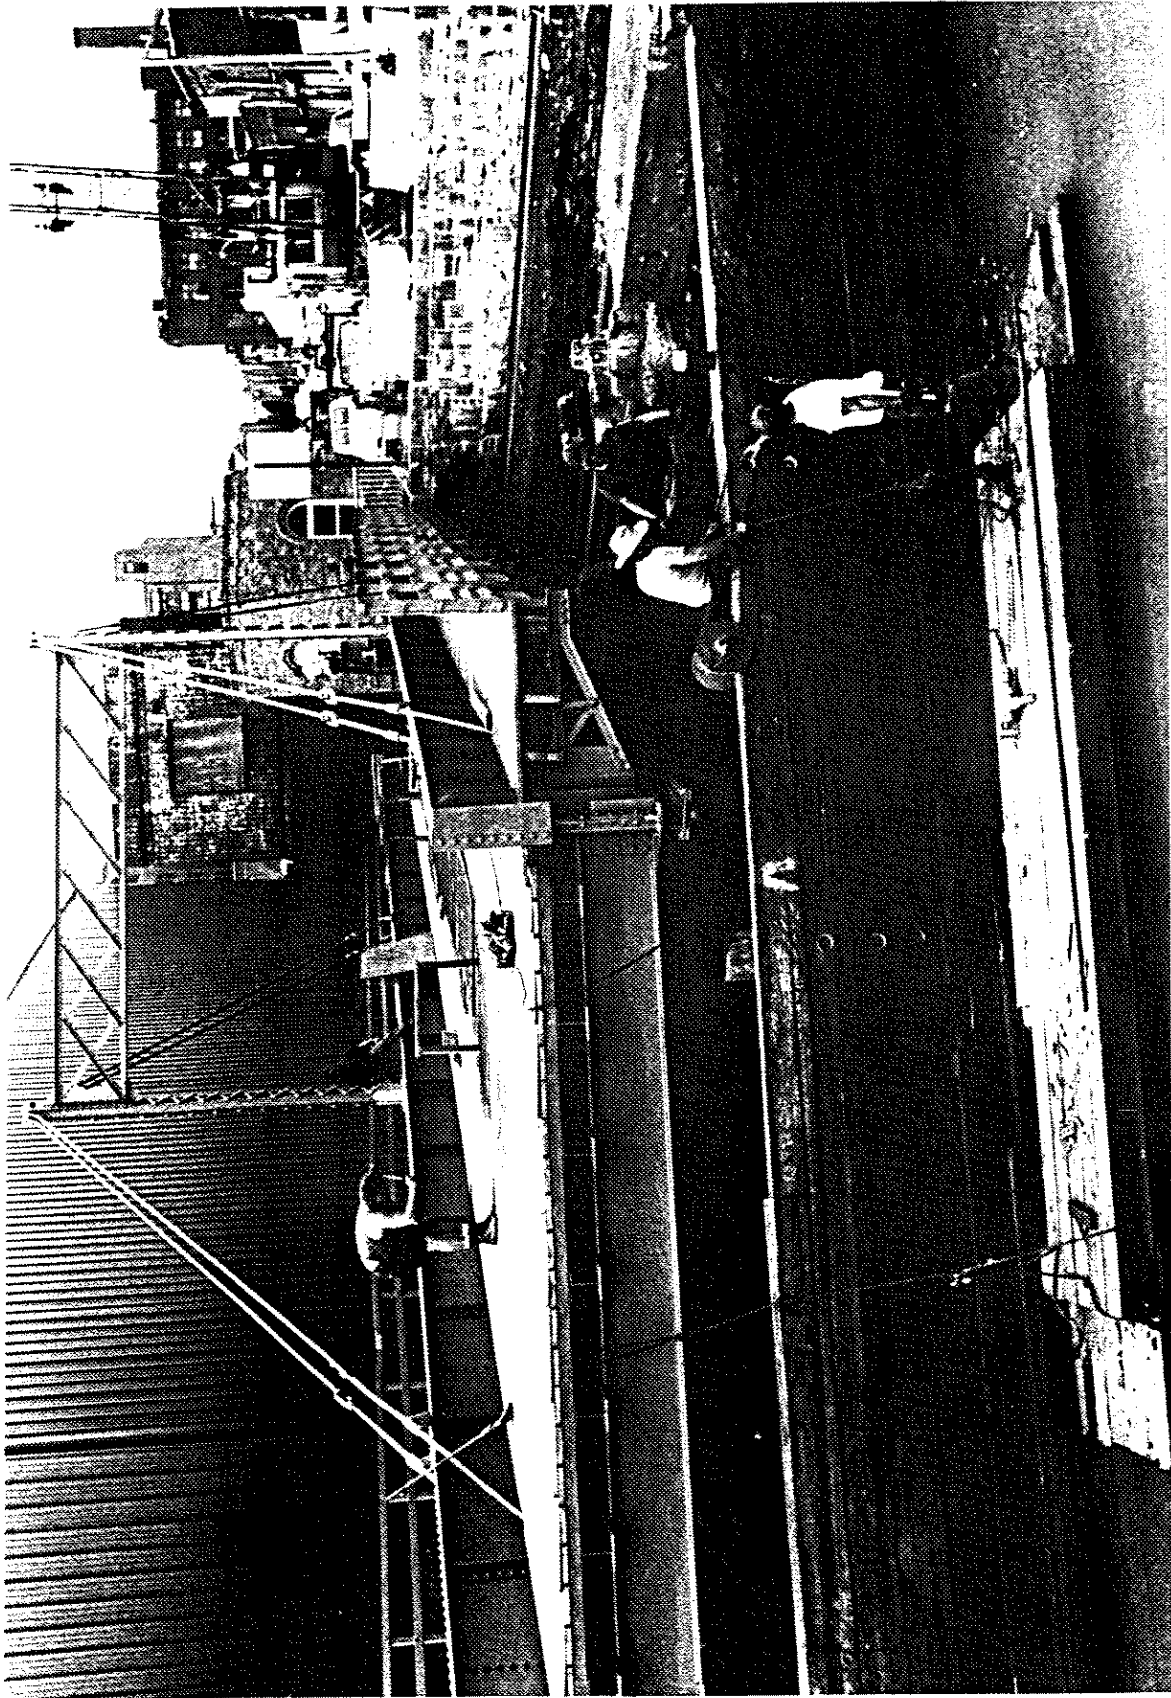
Photo No. 6

West Bulkhead And Deck Installation

The bridge maintenance division employs approximately 18 carpenters but it had been many years since any substantial timber fender or bulkhead work had been attempted. Rehabilitation of the bulkheads included approximately 125 linear feet on the west abutment and 110 linear feet on the east abutment. Depth of repair was down to low water level and was done with 12" x 12" timber. On the east abutment which was constructed as a cribbing, it was necessary to excavate inboard to sound timber and splice to these members. (See photo No. 6 in the Appendix.)

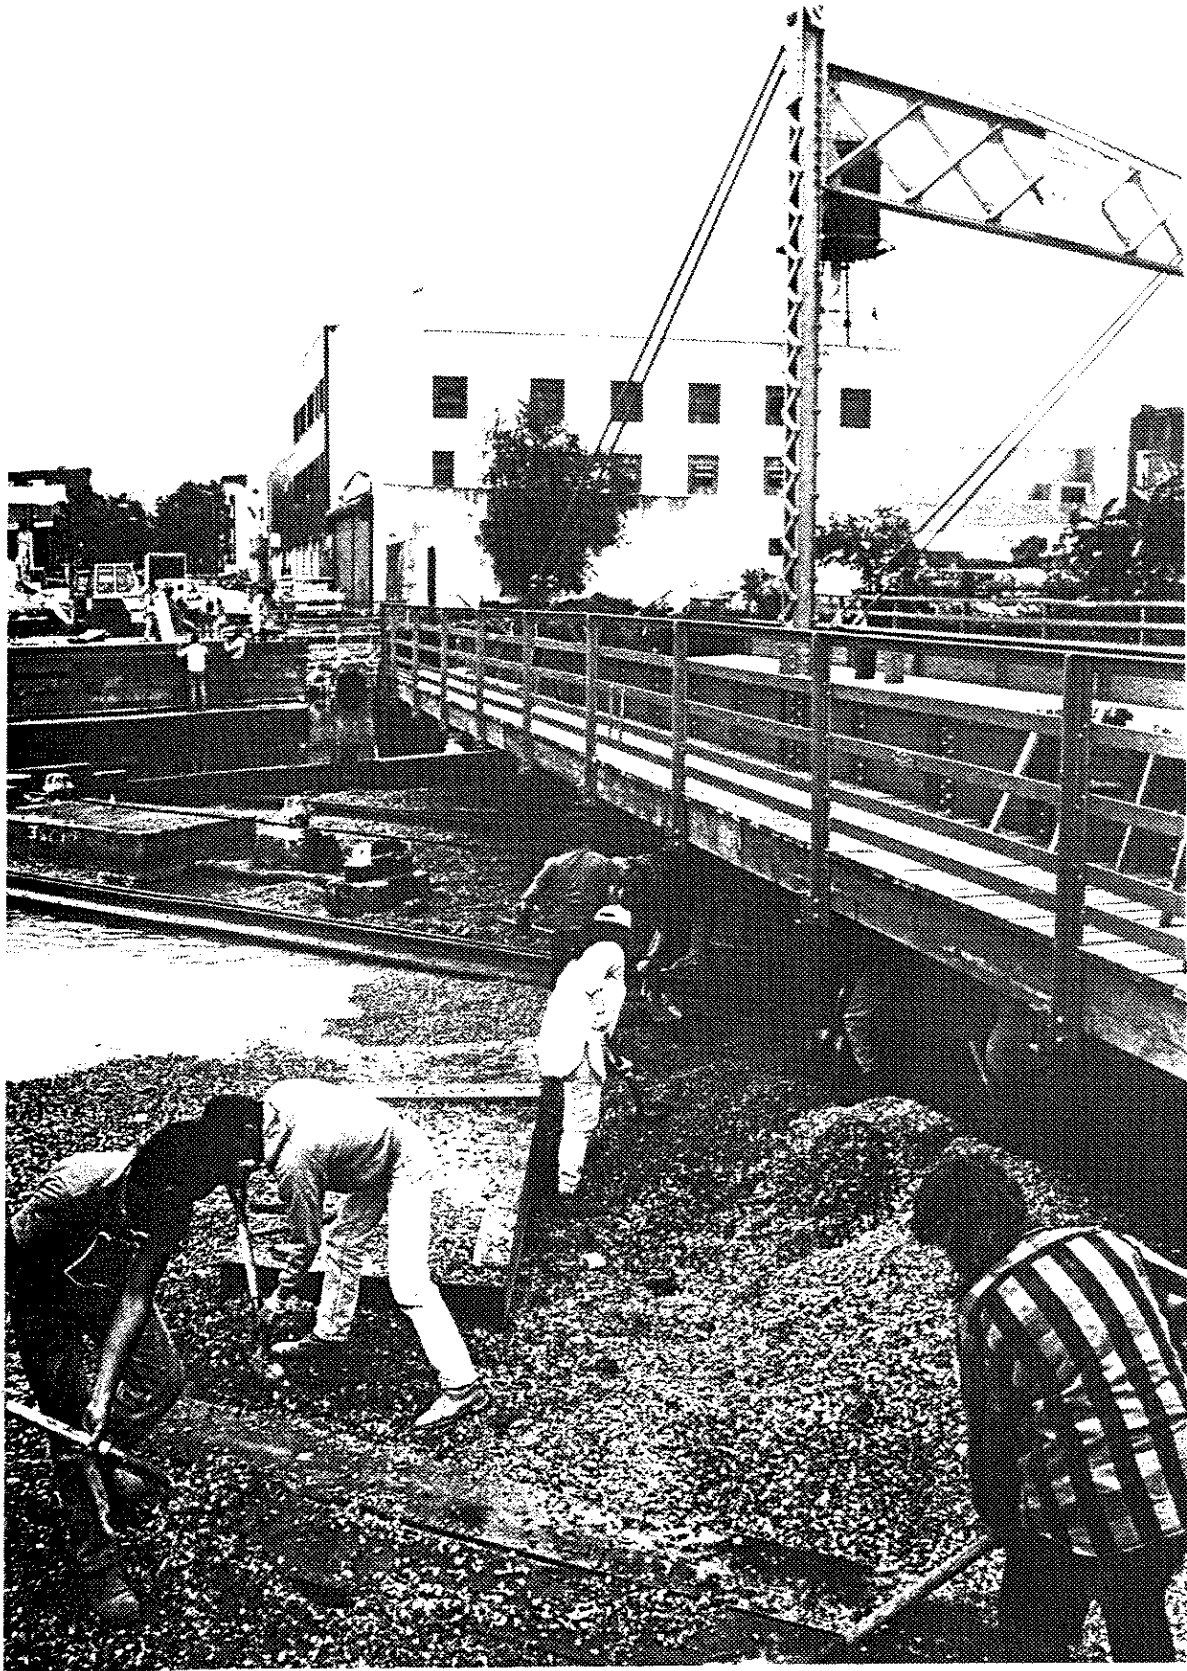
Photo No. 7

Placing Gravel Bed

It was decided to design a reinforced concrete pile cap that would serve as rail supports and span the abandoned bulkhead without allowing rail settlement. The existing timber pile cap was removed and a 3' x 3" deep reinforced concrete cap was placed over each group of rails. A two to four inch layer of greenheart timber was installed over the concrete pile cap and covered by a 1/2" steel bed plate on which the rails sit. The area between rails was graded and covered by a bed of gravel to prevent growth of weeds (Photo No. 7).

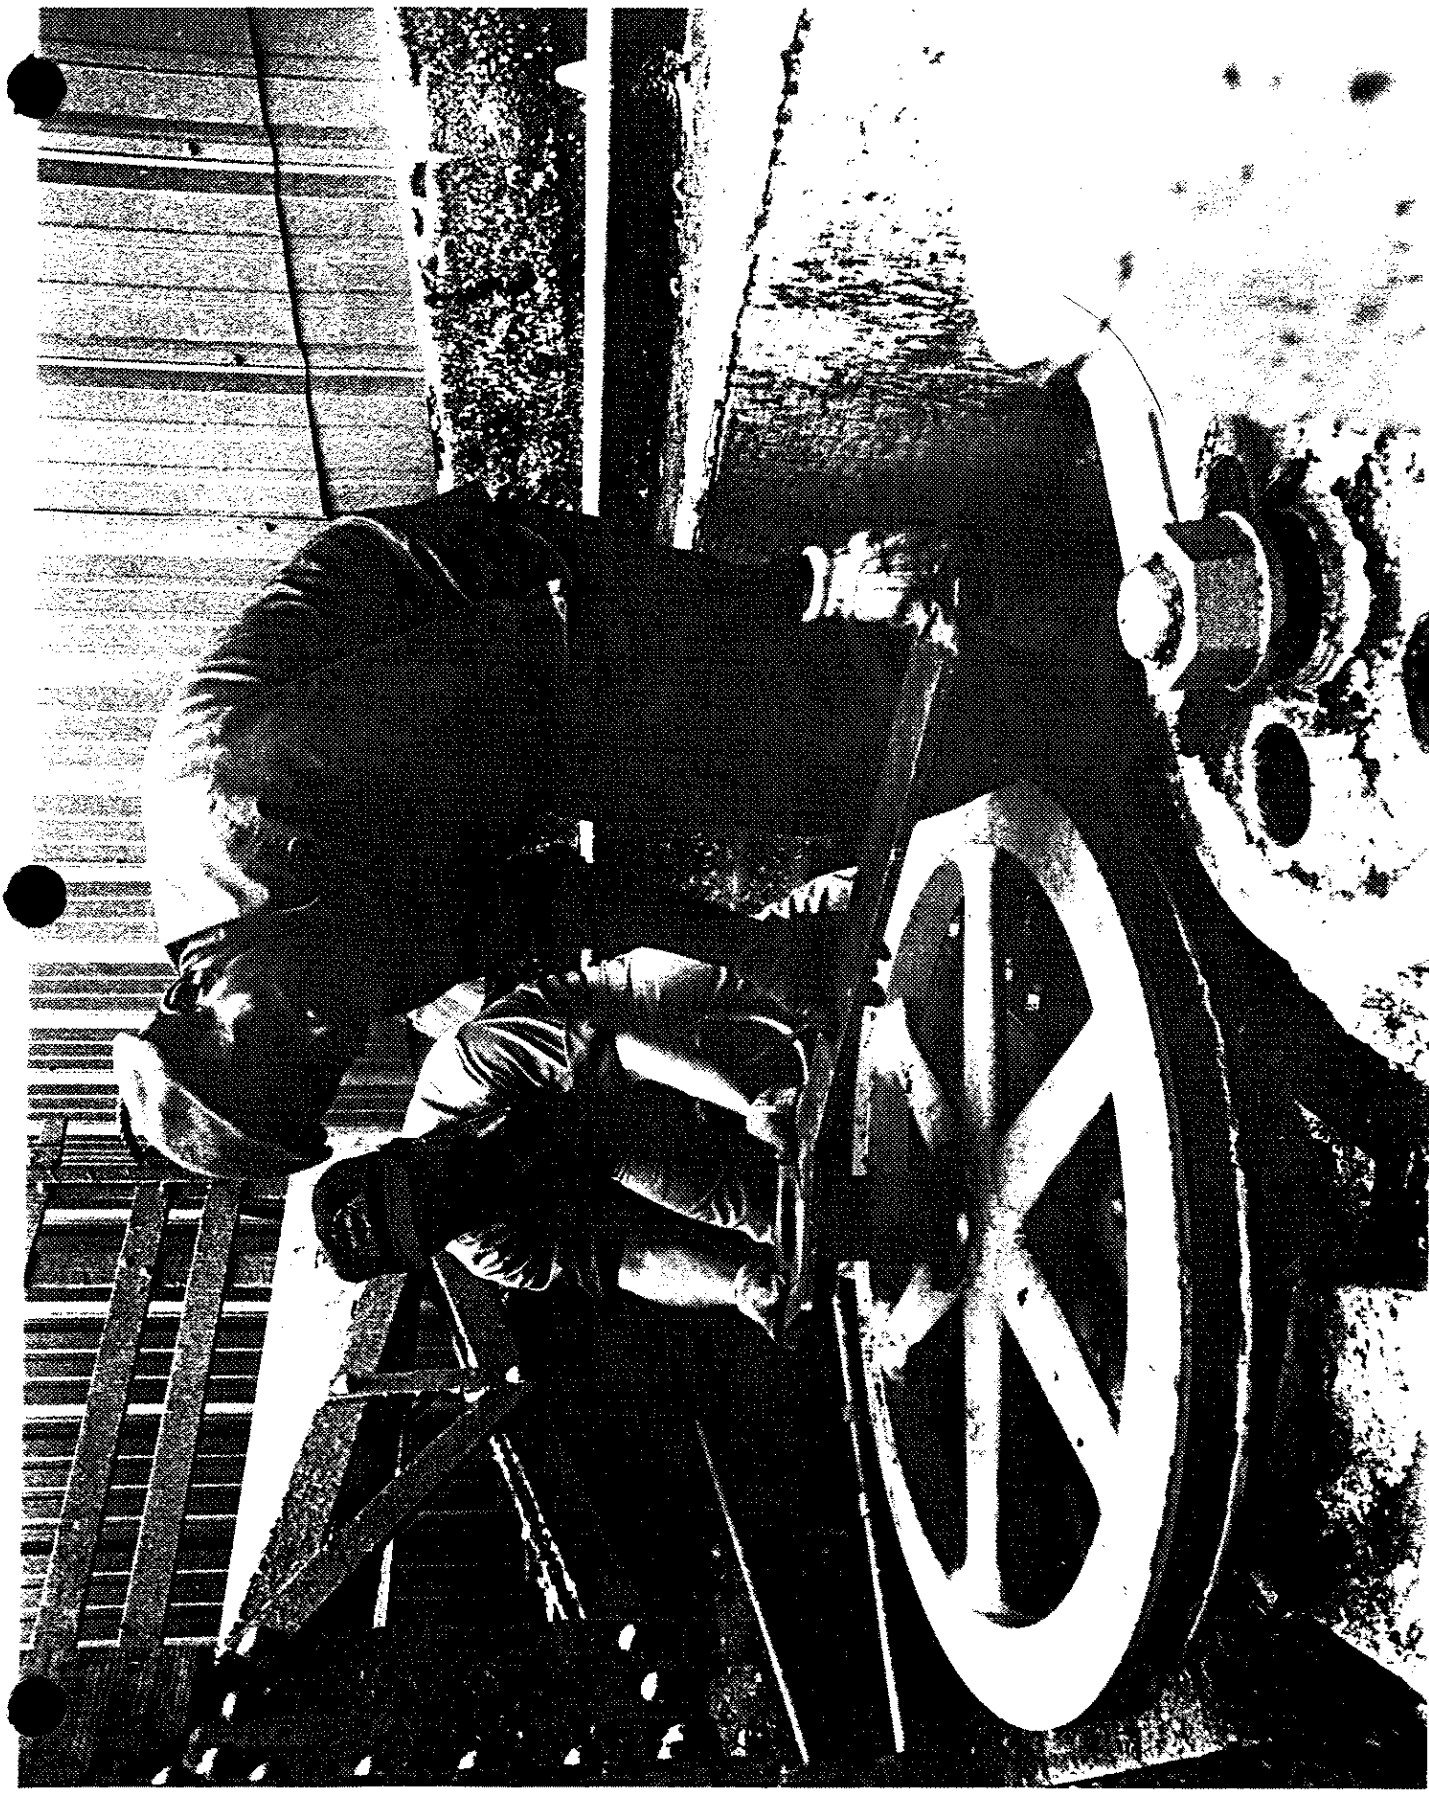
Photo No. 8

Four of the six sheaves are original equipment in operation for over 75 years. Their grooves are well worn, corrugated and have become oversized.

Installation Of Sheave
