#03 Author: Hassan Eldessoky
NYC Dept. of Transportation
*"Failure of Automatic Skew
Correction System"*

BROADWAY BRIDGE
FAILURE OF AUTOMATIC SKEW CORRECTION SYSTEM

HASSAN ELDESSOKY, P.E.
ADMIN. ENGINEER/H.R.B
SEPT. 1992

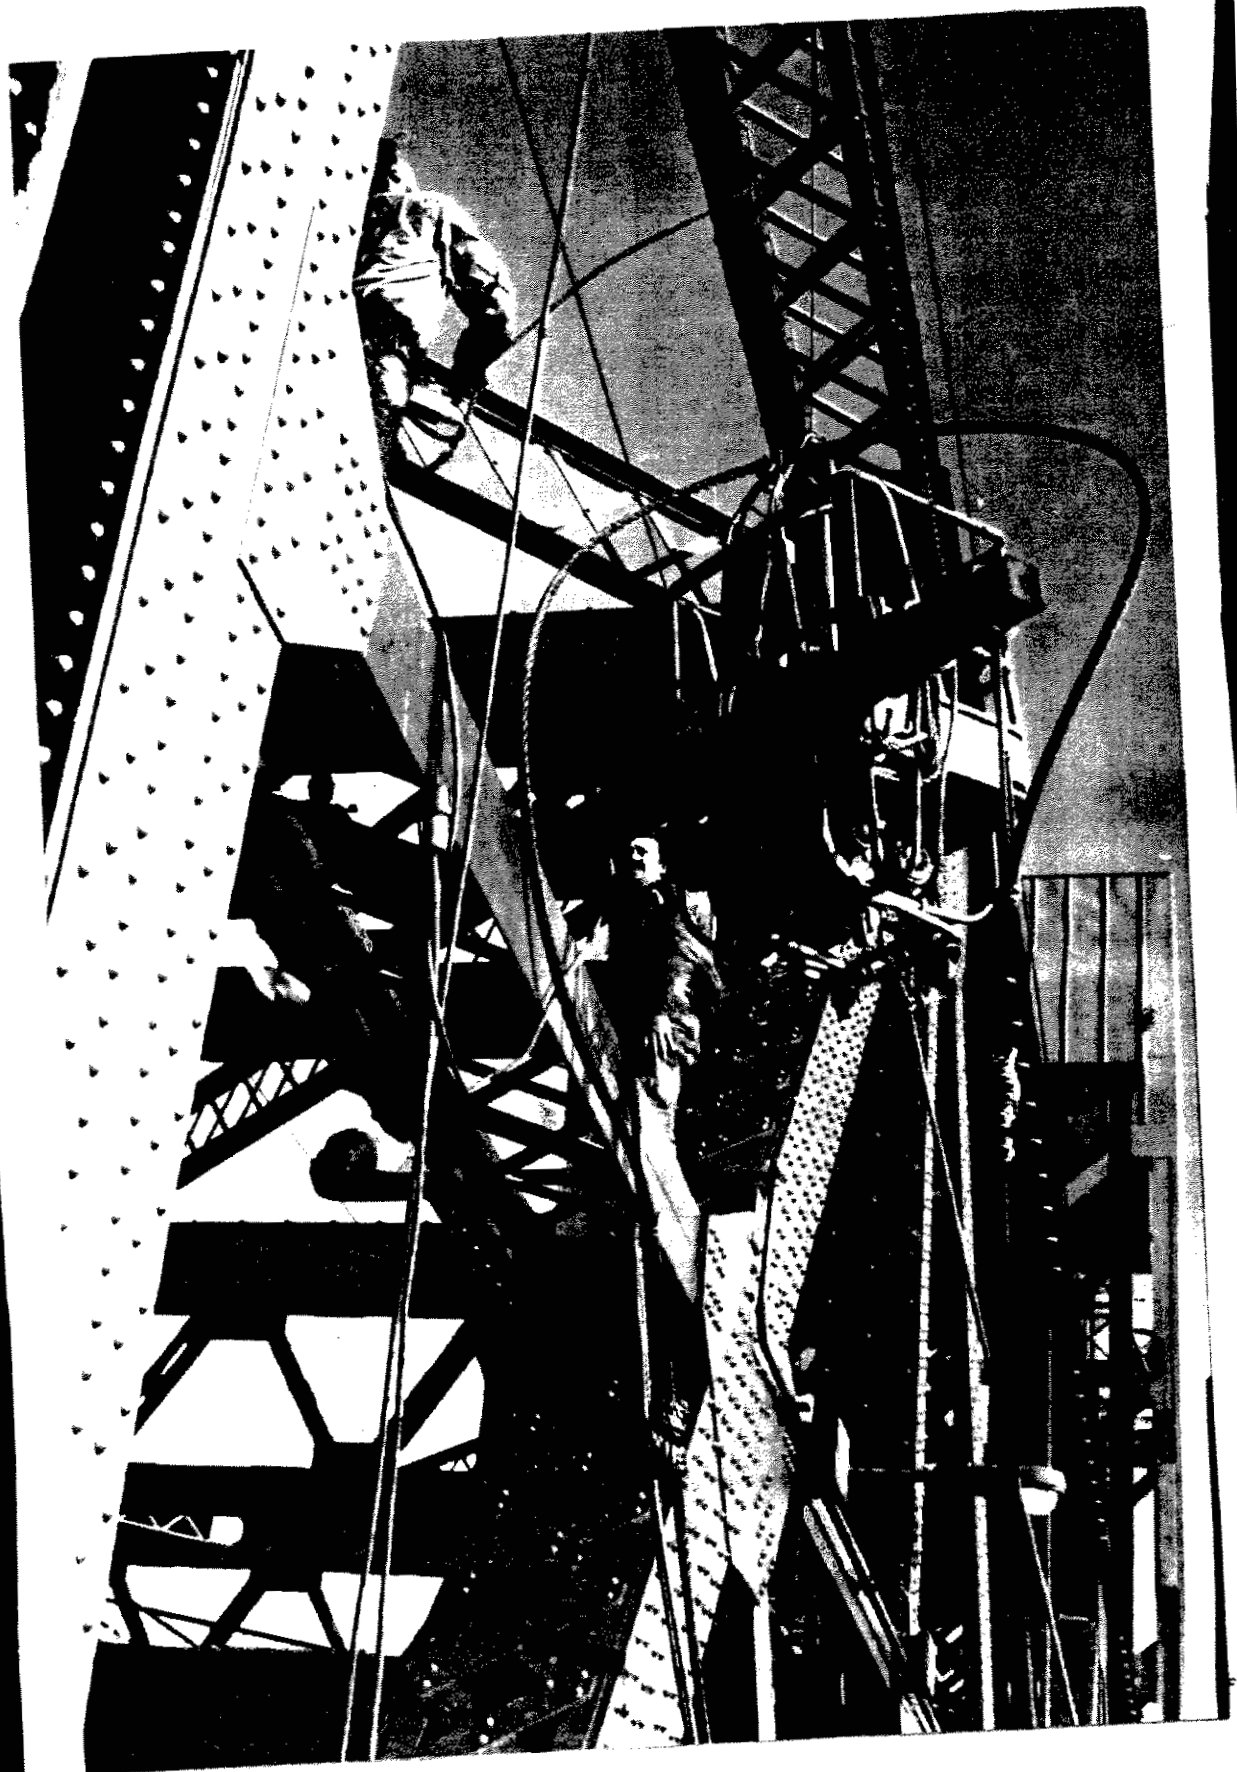
By 8:30 PM Tuesday (6/6) all steel repair and checking was complete and we were ready to lower the span. The manual skew correction was not working properly due to a defective selsyn receiver which activates limit switch 107 (Fig 4). This switch controls the selection of the drive motor. We had to trace the control circuits for each drive motor and bypass various limit switches and relays on the control board to drive the ends alternately and level the span. This meant that the lowering would proceed tediously and would involve trial and error.

Device 106 in normal system and 506 in emergency system is the selsyn receiver that is supposed to receive both signal from N & S. towers and differentiate it to develop an error signal to activate the Amplidyne to slow down the faster motor. During operation testing on the emergency system device 506 failed to operate at all and all micro L.S. on the device were set improperly causing relay 118, 121, 122, to stay engaged all times which by passed the ultimate skew L.S. for both S & N tower and never dropped out relay 117 (Undervoltage relay) to shut down power and stop the span.

It was suggested to incorporate an audio alarm signal to the skew correction circuit to alert the operator when the skew reaches 18" in case the automatic skew correction system fails to function properly. A buzzer circuit could be added to micro switch 106 (see Fig. 4) of the selsyn receiver motor for the skew indicator between wires 1102, 1106 and C1 to accomplish this.

Micro switch #2 or #4 will activate the buzzer circuit when either end of the bridge leads the other 18" and will stay on until the skew is corrected. Using a buzzer system in the circuit will add one more safety feature to the system since visual determination of the amount of skew is difficult if the skew indicator fails to function for any reason while the automatic skew correction is defective. All modification on the control circuit will be done in-house by our electricians. A wiring diagram for the new control circuit will be prepared to show the modification.

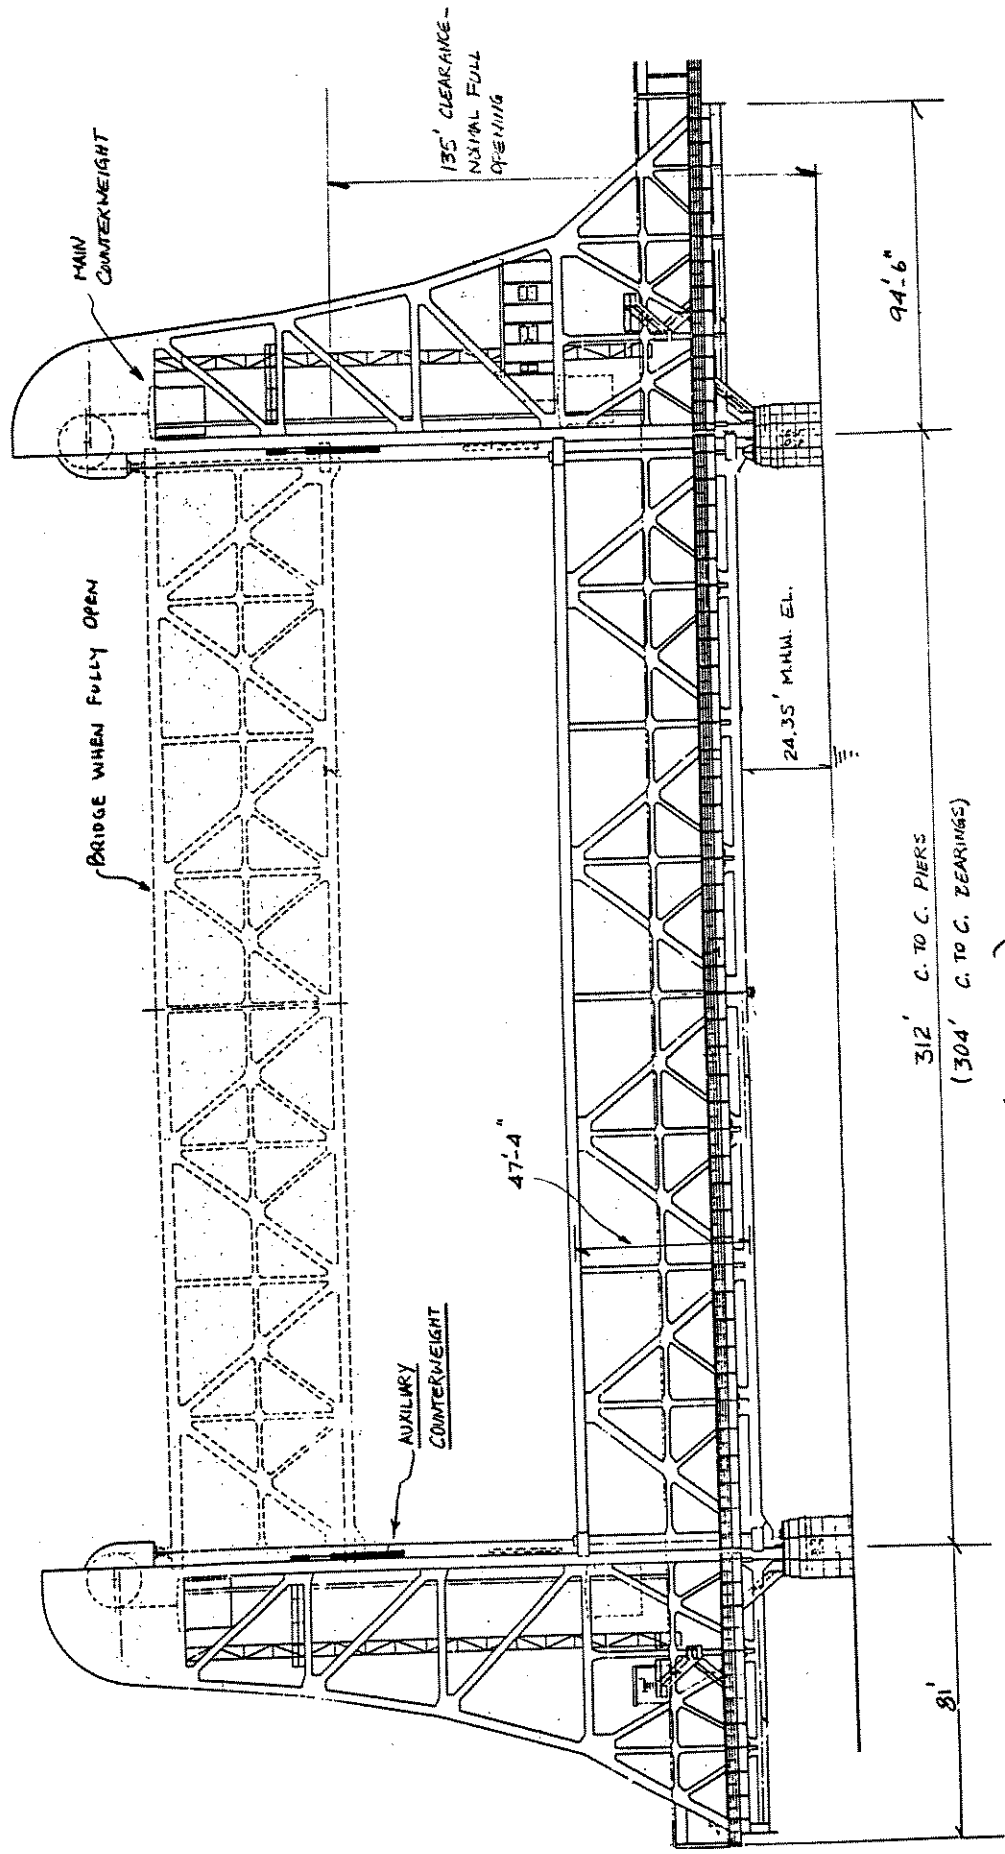
ELEVATION

Broadway Bridge was constructed in 1962 as a Tower Drive lift bridge that stands 24 ft. above mean high water. The 304ft lift span comprises two decks, the lower deck supports two 34ft wide roadways (one between each of the two outer trusses and central truss) for vehicular traffic and two 8ft wide sidewalks outside of the exterior trusses. The upper deck supports three railroad tracks which are used by the IRT Rapid Transit line. The span weighs 5,000,000.00 lbs. and is carried by 96 main cables, each 2-3/8" in diameter and 177 ft. long. There are 8 sheaves altogether, 2 at each corner and each carries 12 cables. Refer to figure 1 for an elevation view of the bridge.

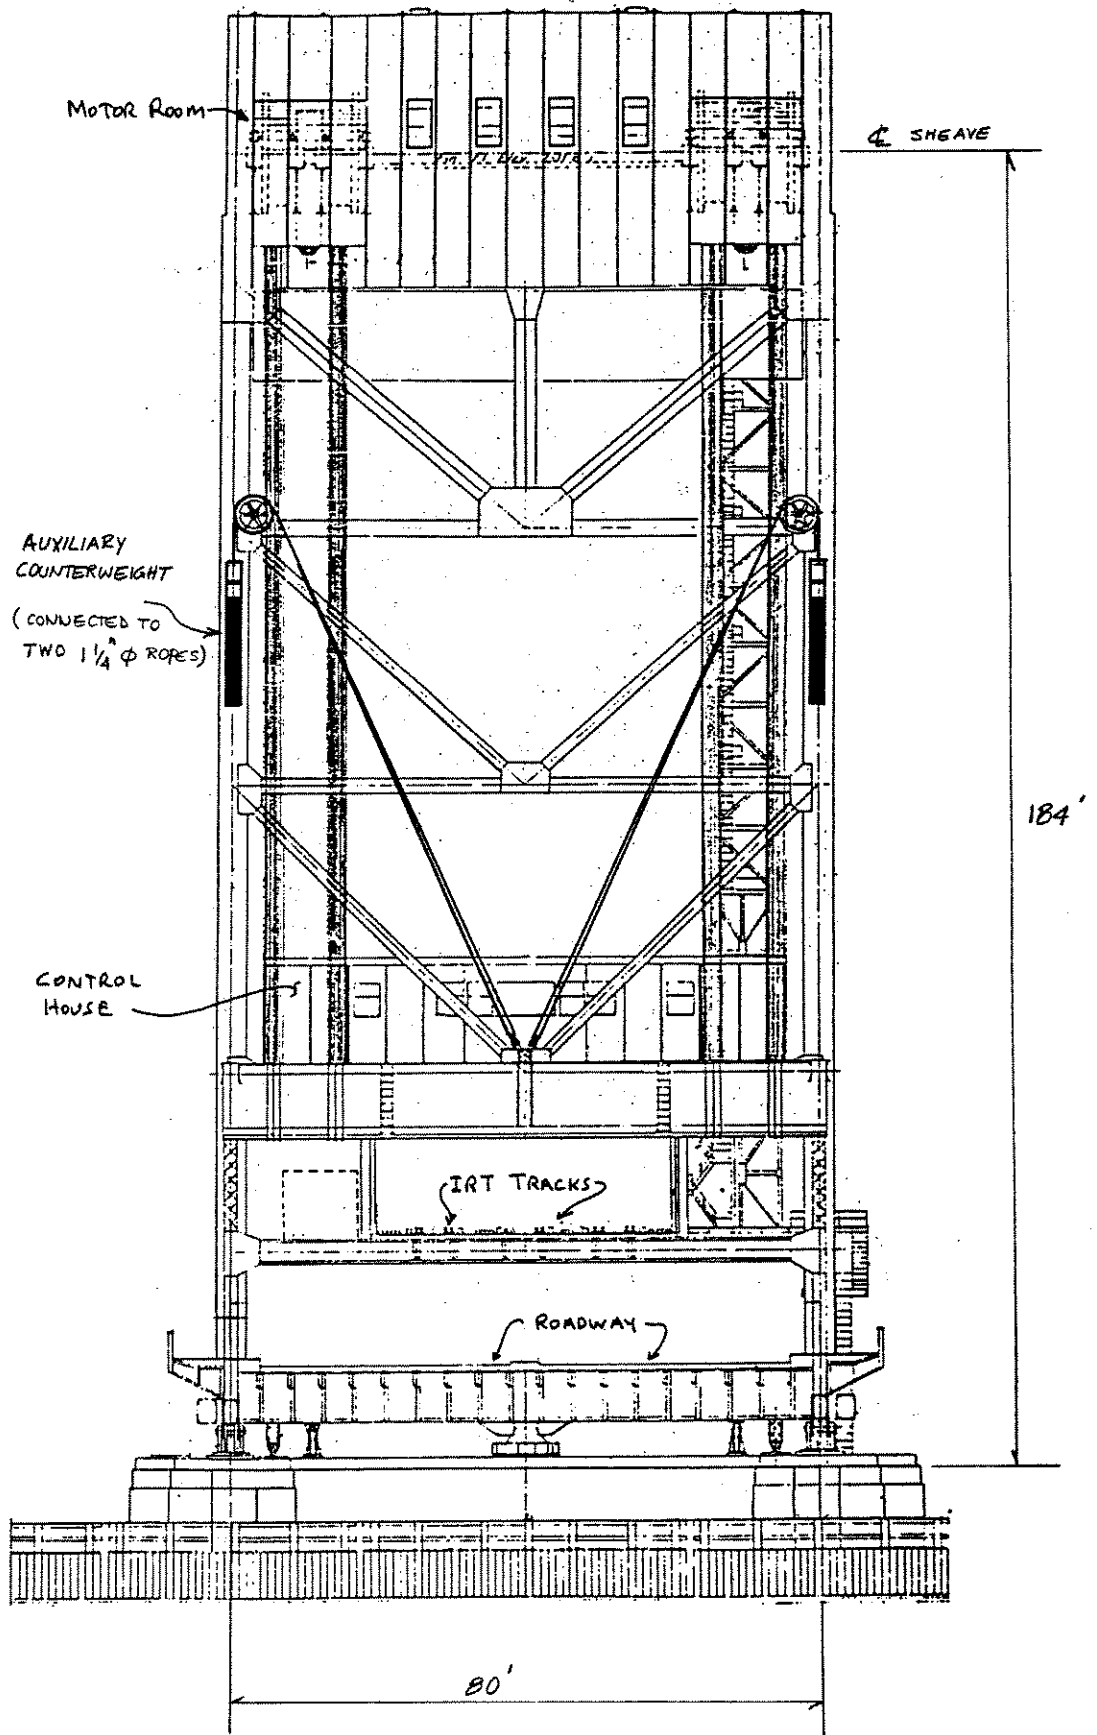
(FIGURE 2)

The span is balanced by two main counterweights, one on each end, tied to the other end of the main cables. Four auxiliary counterweights, one at each corner, are used to compensate for the weight of the main cables when they travel over the main sheaves to the main counterweight side. Each auxiliary counterweight weighs 30,000.00 lbs. and is carried by two 1-1/4" cables (Figure 2).

The top truss of the South end of the span was jammed against the auxiliary counterweight. Two 1 1/4" cables carrying the Southwest auxiliary counterweight snapped off at the socket ends (Fig. 2) The Southeast cables were also highly stressed, but did not snap. Without the support of its cables, the Southwest auxiliary counterweight had to be secured in place to prevent it from falling down to the roadway before any attempt could be made to move the span.
