IMPORTANCE OF LUBRICATING/FLUSHING . . . BASCULE TRUNNIONS

NEW YORK CITY DEPARTMENT OF TRANSPORTATION

BUREAU OF BRIDGES

NICOLAE DINI, P.E.
E.I.C. MECHANICAL SECTION
MAINTENANCE

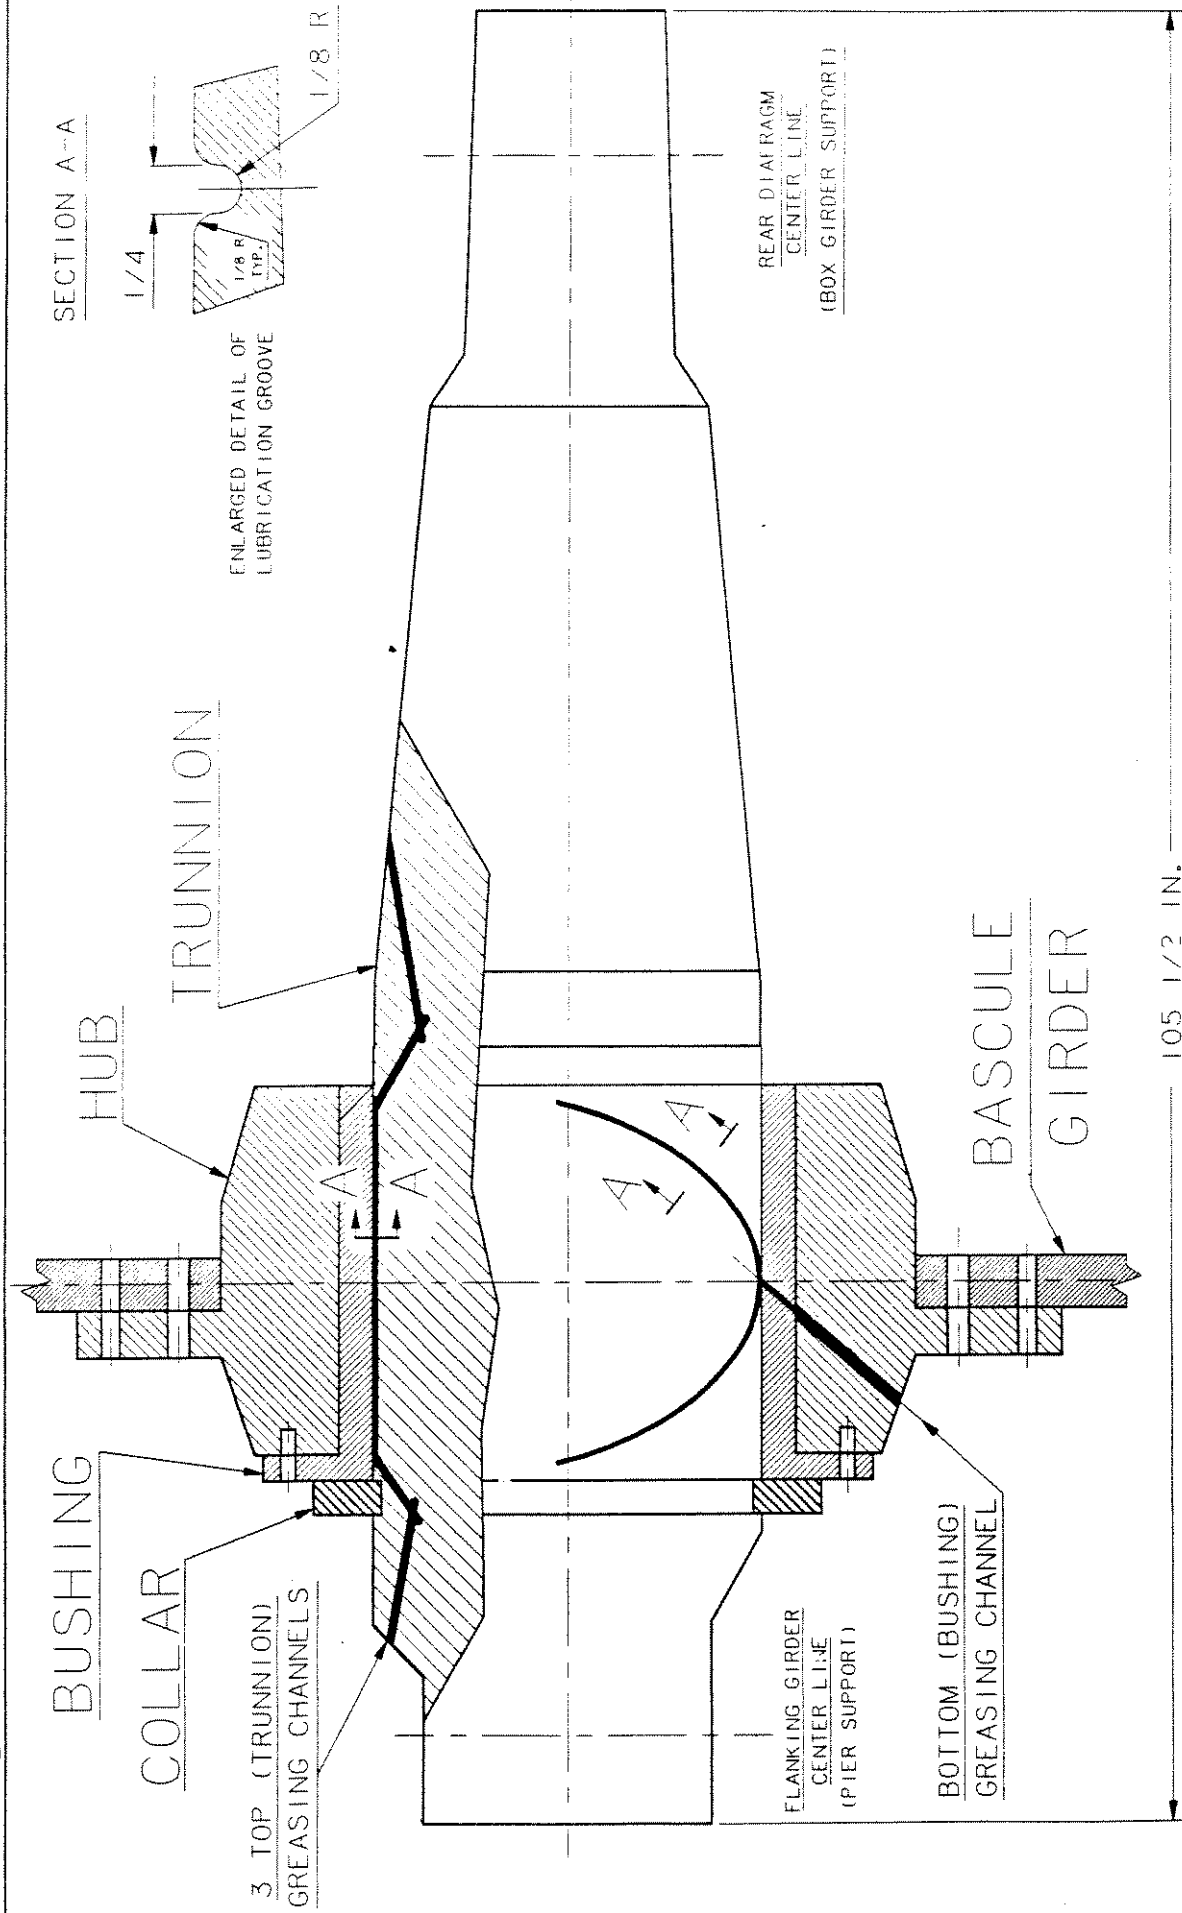
FIG. 2

Inspecting the lubrication channels in the northeast trunnion shaft and bushing, that permit flow of lubricant to the trunnion bearing, it was found that all these channels were clogged.

The logical conclusion was that because of total lack of lubrication for most likely a long period of time the friction in the northeast bearing was very high. As a result the electrical motors of this particular leaf (east) were overloaded during opening or closing the leaf. The unclogging of the channels was the first logical step to be undertaken.

To lubricate the surfaces subjected to friction there are four lubrication channels. Three channels are machined on the top of the trunnion, 25 degrees apart, which of course are stationary and one in the lower half part of the bushing that moves with the bridge at every opening-closing.

As stated earlier, for one reason or another, none of the northeast trunnion lubricating channels received any lubricant (grease or oil) in even minute quantities.

Because the trunnion severely needed to be lubricated we abandoned trying to lubricate it from the top and instead focused our efforts in introducing oil into the bushing's grooves, through the trunnion's bottom port.

After about 8 bridge opening-closing cycles, the oil pumped at a pressure of 10,000 psi, burst through the clogged passage of the bushing and the amperes drawn by the electrical motor suddenly dropped down. We kept pumping oil while the bridge was opened and closed another 4 - 5 times. The next step that we undertook was to flush out the helical grooves cut in the bushing as much as possible.

Step 1, when we managed to unclog flush and pump grease through the lower (bushing's) lubrication channel. The result was obvious and sudden; the ampers drawn by the East leaf motor during the openings dropped from 120 amps to 85 amps, only 5 amps more than the number of amperes drawn by the other leaf west during its opening (80 amps).

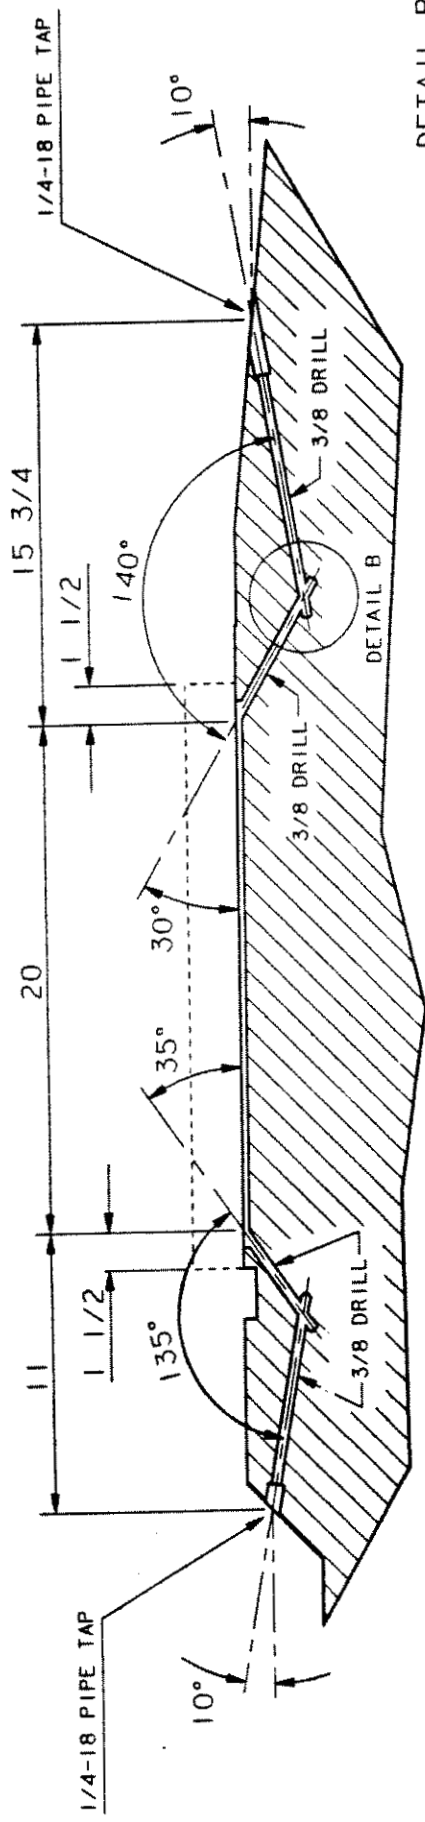
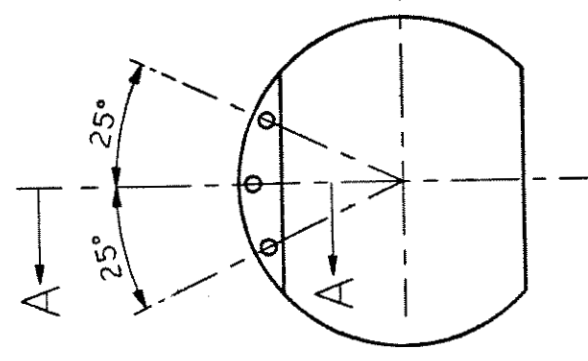
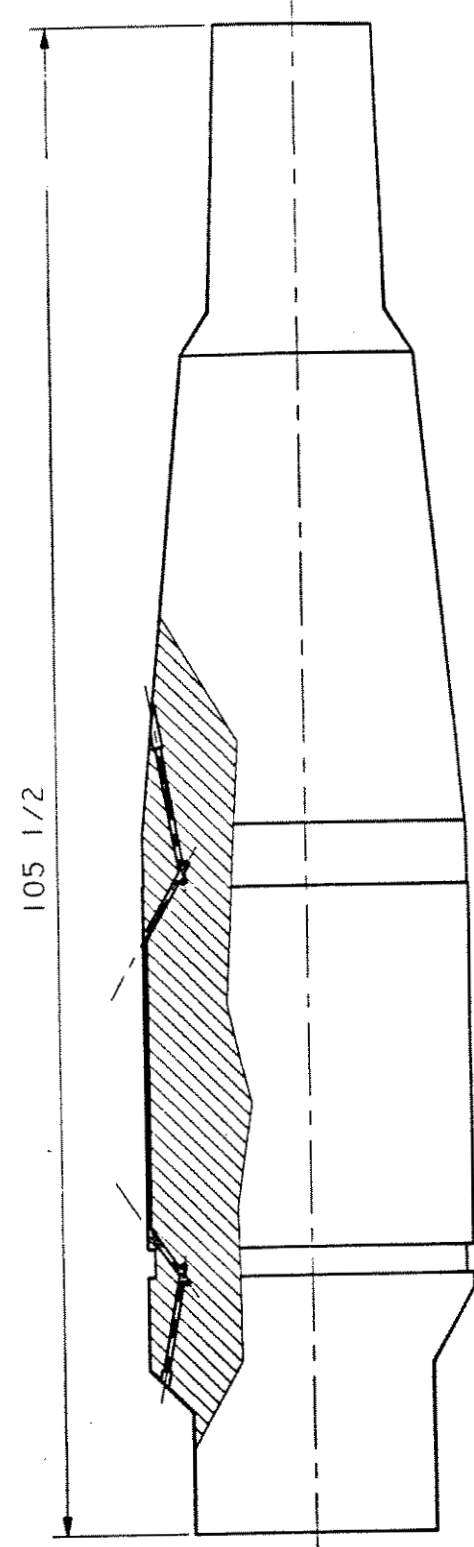
FIG 3

The channels in the shaft sometimes called clean-out channels have the location shape and size shown in figure 2 & 3.

The detailed drawing of the grease channels of the trunnion, (see figure 3 section AA and detail B) does not show how the lubrication channels are machined in the shaft. Based on standard machine shop procedure we must assume that the "bends" are not a smoothly blended surface but are actually an intersection of two bored cylinders with each of them overshooting the intersection. In addition, they might not be in the same plane. Because of these conditions, a straight probe cannot pass the bend, but bottoms out in the dead end hole.

Once the bottom channel was unclogged, we refocused our efforts to open top (shaft) channels. Realizing that none of the methods already tried would work, we decided to try a "make-shift snake" power rotated by a variable RPM cordless drilling machine.

As a "snake", we used a strand taken from a wire rope. To ensure that the thin wires of the snake (strand) would not be broken (cut) by the sharp edges of the bend, we inserted in the channel a semirigid plastic tube. Through this tube we inserted the "snake" while it was turning at low RPM. Once it encountered hardened grease, the RPM of the "snake" was increased to maximum.

After the snake reached the end of the "dug out" passage, the RPM was increased and pressure (by pushing) was applied to the snake. By repeating this operation with several various length snakes and using about 6 cans of 16oz. solvent (carburetor choke cleaner) the entire length of the groove under the bushing was cleaned. Then we repeated the same procedure from the other side of the trunnion.

Finally we managed to unclog the entire channel by this method. To completely unclog the channel took about 10 hours of effective work. Our next step was the flushing of the hardened grease that was not dislodged by the snake. To flush the remaining grease, we made a T connection using regular plumbing supplies and proceeded to blow compressed air in one leg and kerosene into the other leg of the T. The mixture went through the third leg of the T into the lubrication channel and then collected on the other side, in a container.

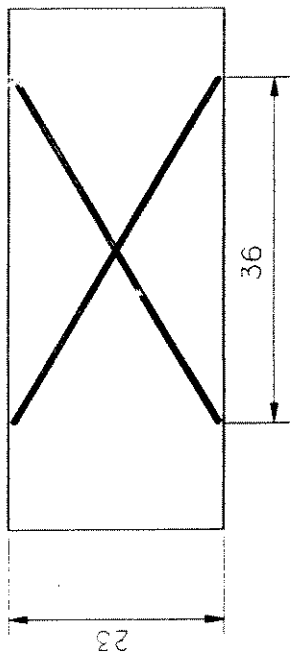
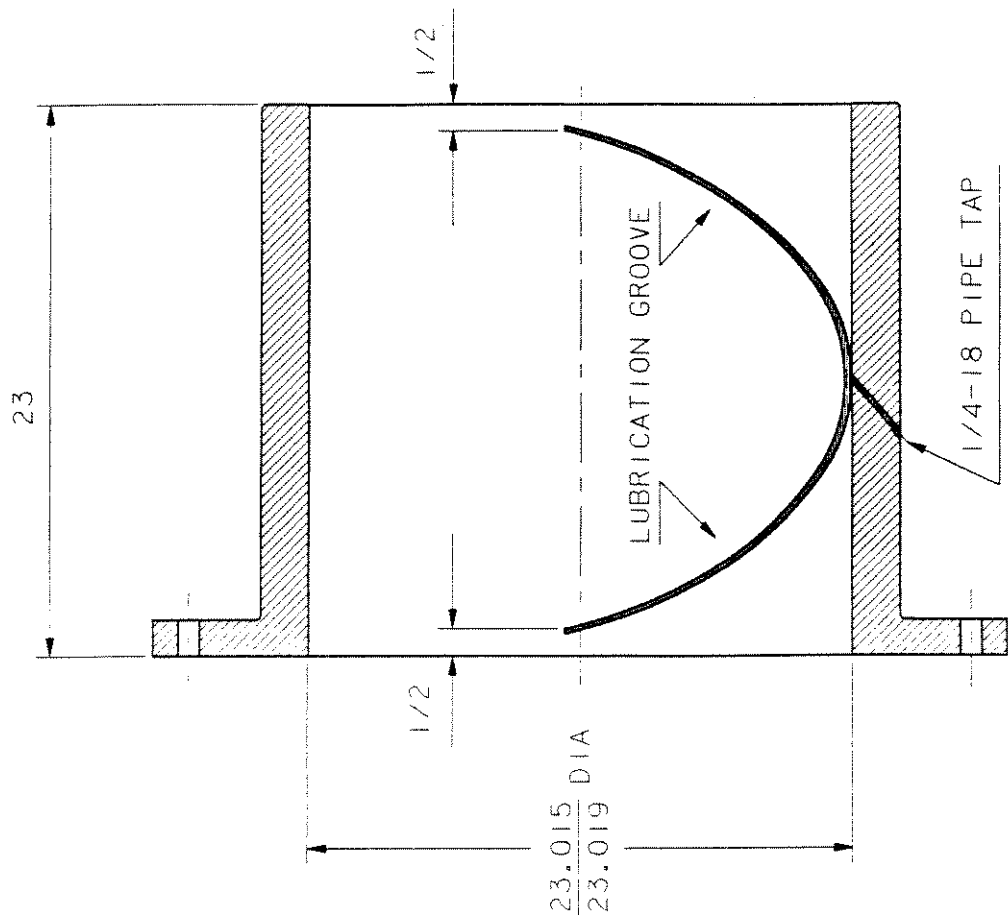
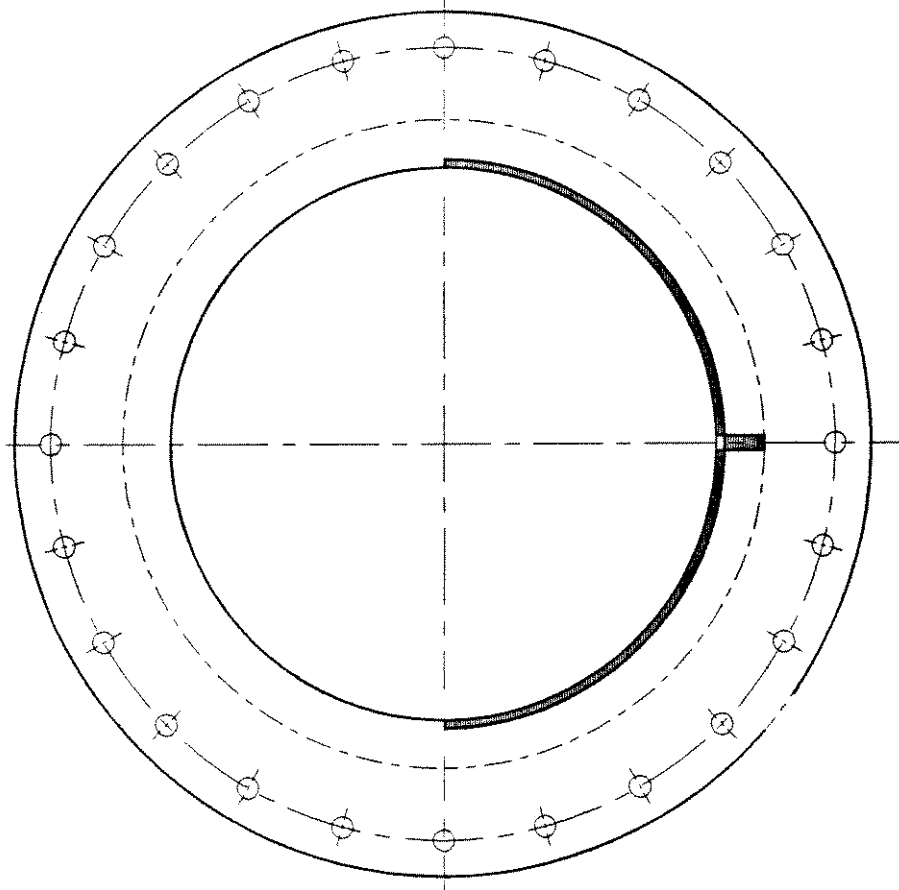
FIG 4

The lubrication channel in the bushing has the location, shape and size shown in figure 2 & 4.

When the bridge is fully opened (71 degrees) the very ends of the spiral grooves in the bushing pass over one of the shaft grooves by 6 degrees.

To accomplish this, for several hours we pumped a mixture of compressed air and oil while we opened and closed the bridge many times. Then we pumped grease until it came out clean and free of oil.
