#24 Author: Paul Bandlow
Stafford Bandlow Engr'g., Inc.
*"Repair of Counterweight
Trunnion Bearing"*

THAMES RIVER BRIDGE
COUNTERWEIGHT TRUNNION REPAIR

Paul M. Bandlow, P.E.

Stafford Bandlow Engineering, Incorporated

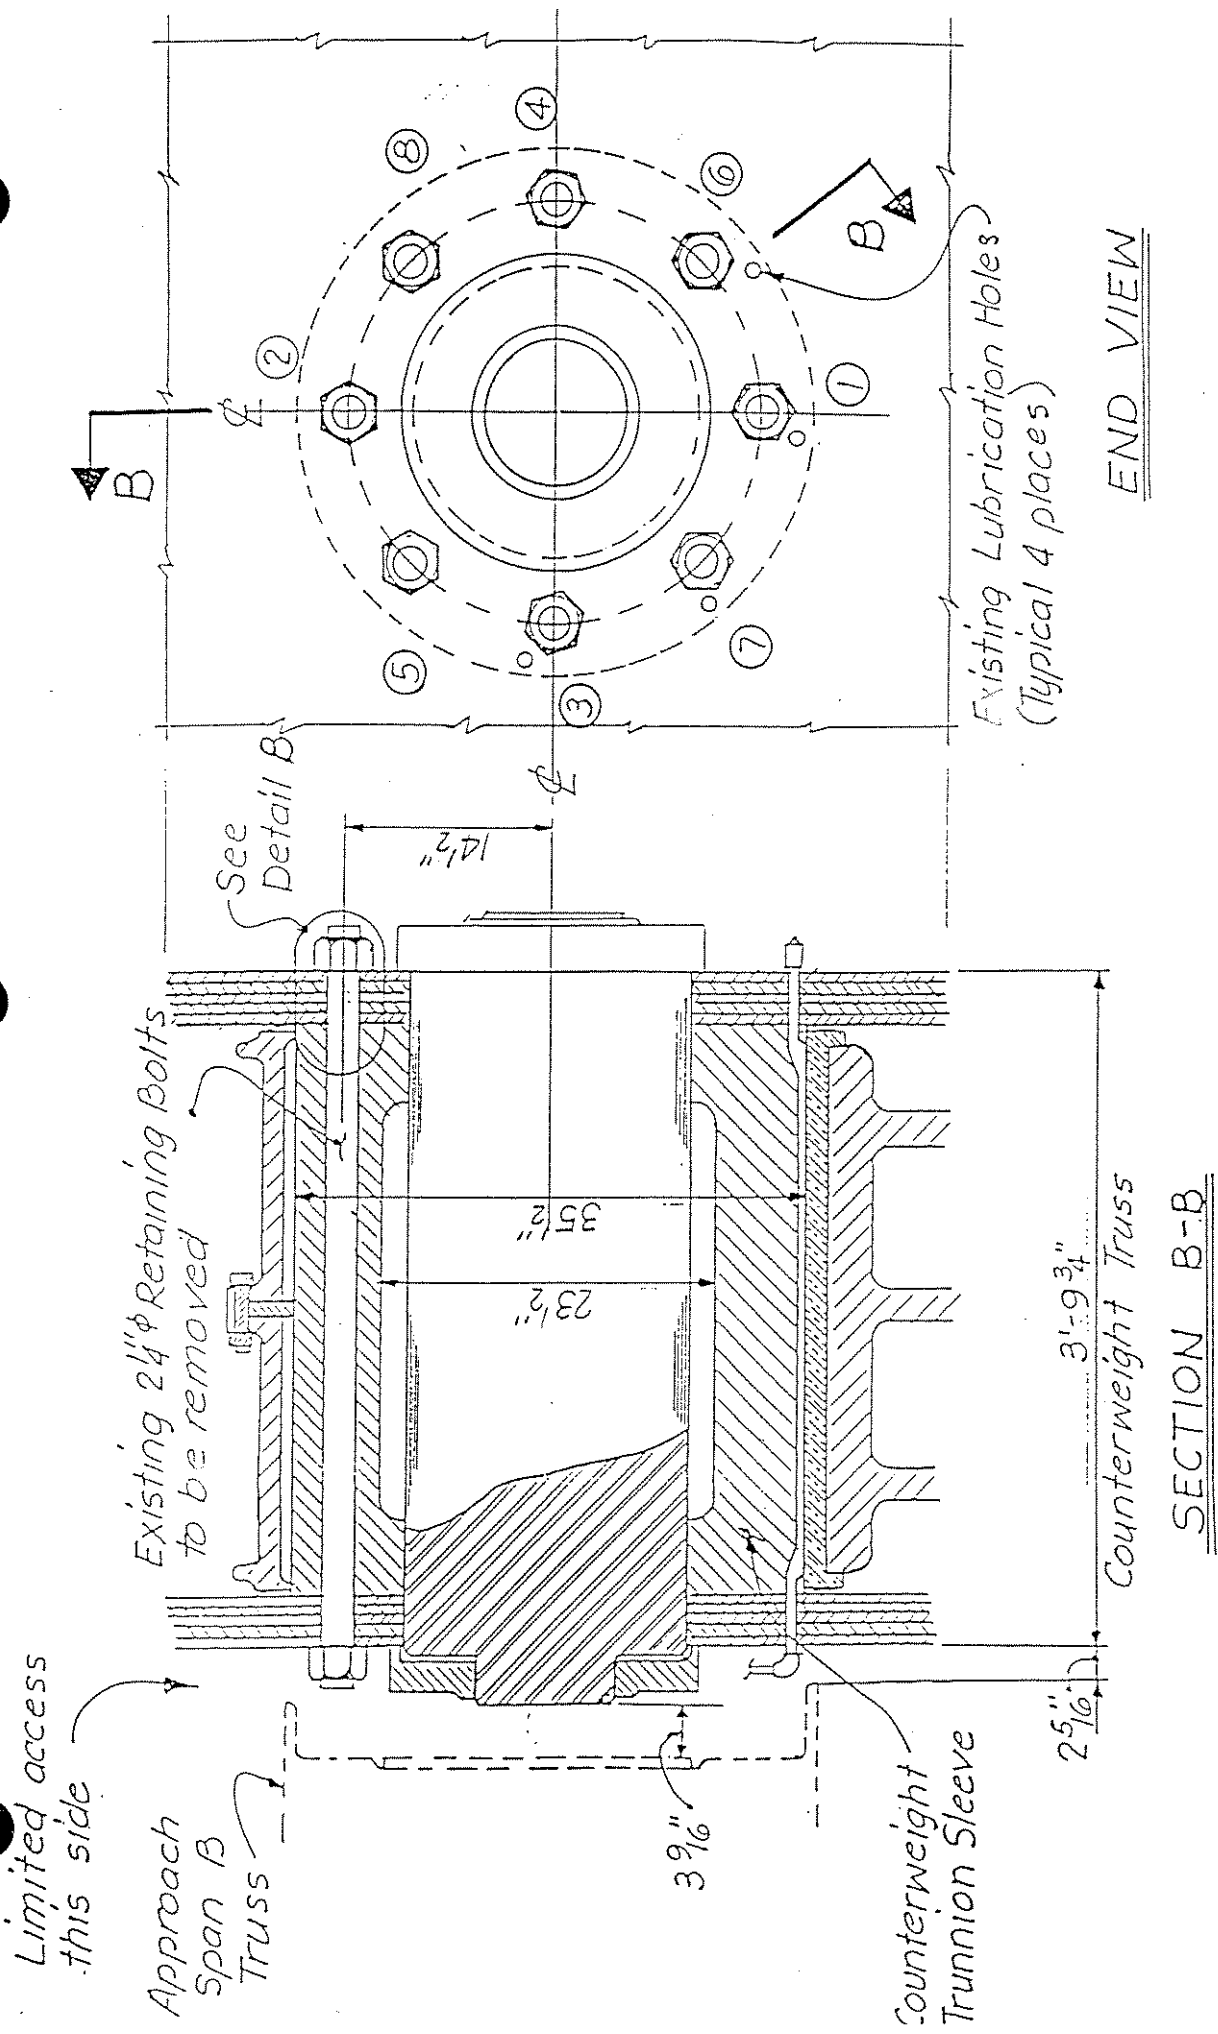
FIGURE 3

diameter cylinder with a bore through the center which accommodates the 20" diameter counterweight trunnion shaft. This assembly is bolted between the two sets of laminated plates which make up a portion of the counterweight truss on each side of the movable span. When the span rotates the counterweight truss, trunnion shaft and journal were designed to rotate as a unit in the bronze bushing in the bearing base. The bearing cap is babbitt lined. The counterweight trunnion can be seen in Figure 3.

EXISTING COUNTERWEIGHT TRUNNION

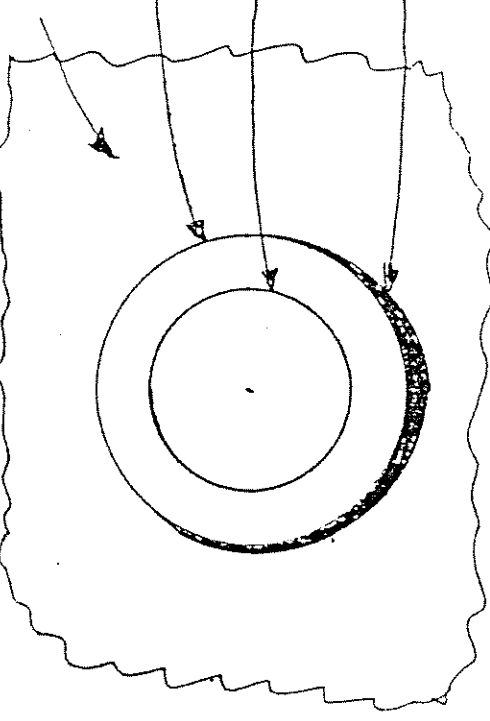
FIGURE 5

STRUCTURAL
STEEL
O.D. OF 20" DIA
TRUNNION PIN
O.D. OF THREADED
PORTION OF TRUNNION
PIN
I.D. OF HOLE IN STRUCTURAL
STEEL. SHOULD BE THE
SAME AS O.D. OF PIN

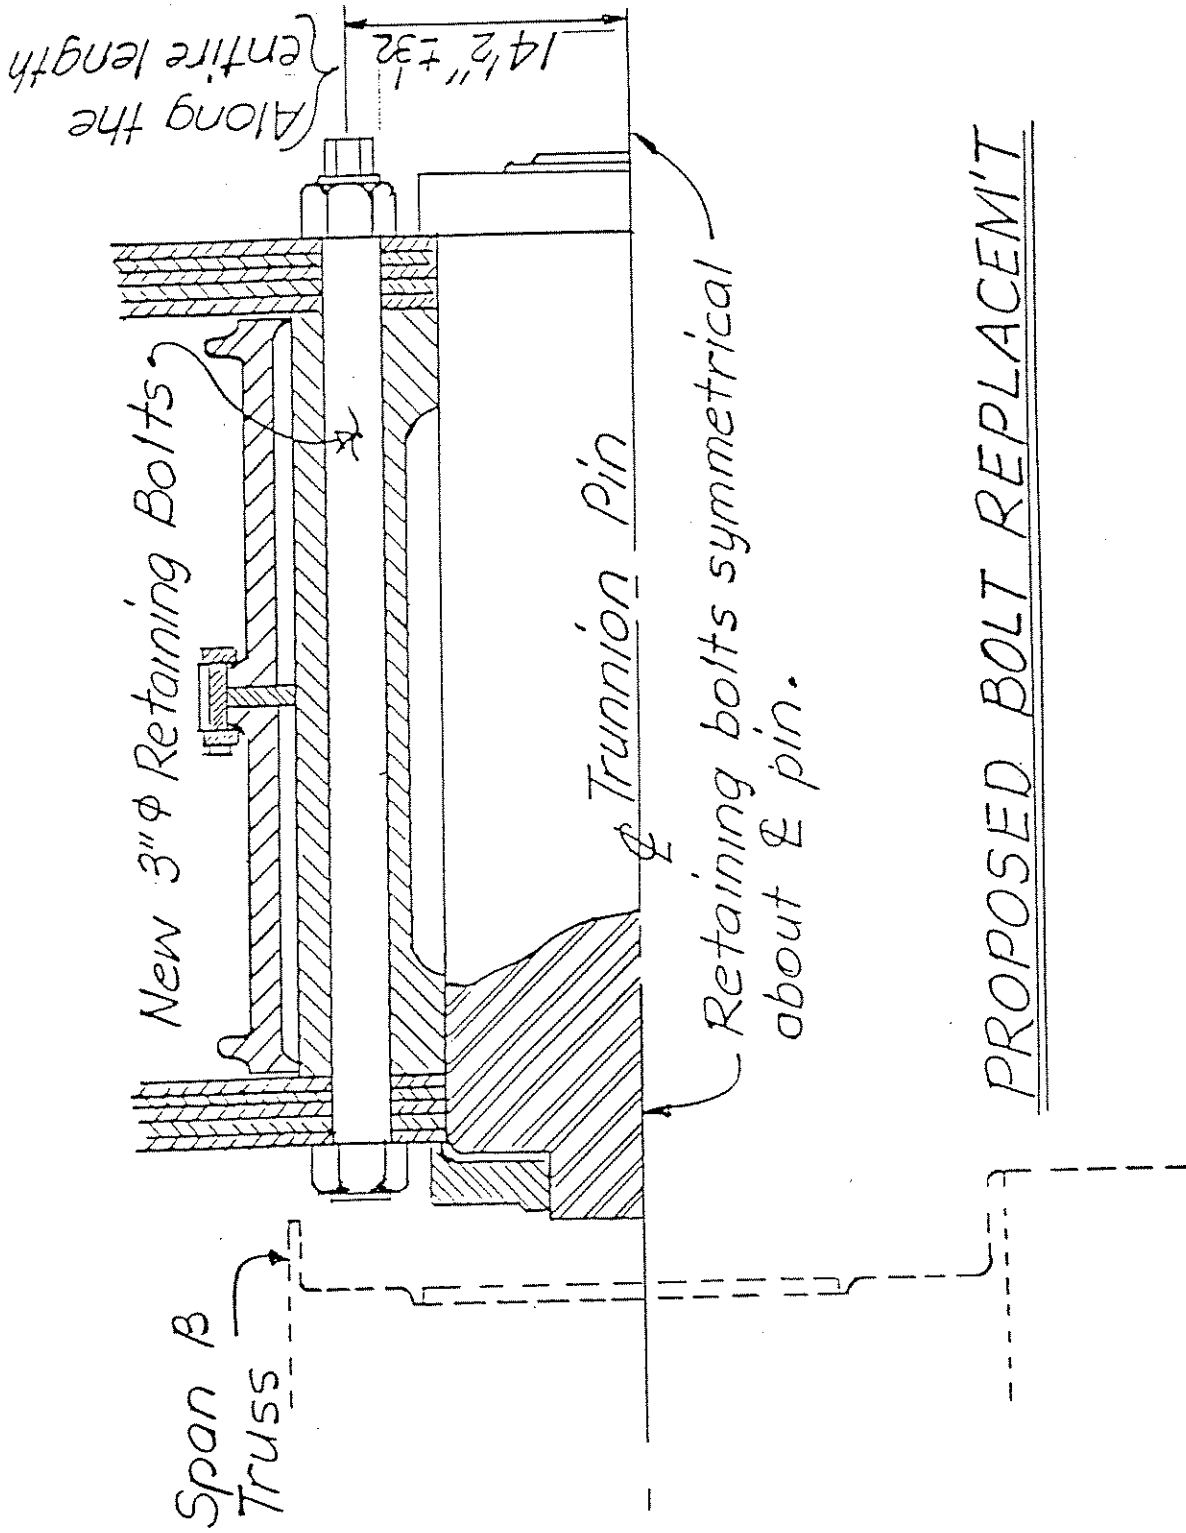
FIGURE 6

During the period of June 13-July 11, 1990 alternative repair procedures were investigated and a position paper was presented to Amtrak's upper management for a final decision. One alternative was to design and install new bearings. Due to a U.S. naval submarine base located up river no extended construction outages could be obtained and therefore a temporary system to operate the movable span would be required during construction. The estimated cost to replace the bearings and provide a temporary operating system was \$8.6 million. The second alternative presented was to remove the existing 2-1/4" bolts, enlarge the bolt holes, and install 3" diameter high strength bolts as a temporary repair so that additional alternatives could be investigated. The estimated cost of installing the new bolts in both trunnions was \$300,000.00.

The recommendation was to replace the existing 2-1/4" bolts with high strength bolts so that a more permanent solution could be investigated including the possibility of constructing a new vertical lift span to replace the existing span. Amtrak's management agreed with the recommendations of the position paper. A detail of the proposed bolt replacement can be seen in Figure 6.
