"EMERGENCY REPLACEMENT OF DEFORMED, CRYSTALLIZED SCHERZER TREAD PLATES"

by PAUL M. BLAIR, P.E.
A.G. Lichtenstein & Associates, Inc.

LOCATION: BLYNMAN BRIDGE - GLOUCESTER, MA
MA ROUTE 127 OVER BLYNMAN CANAL

OWNER: MASSACHUSETTS HIGHWAY DEPARTMENT (MHD)

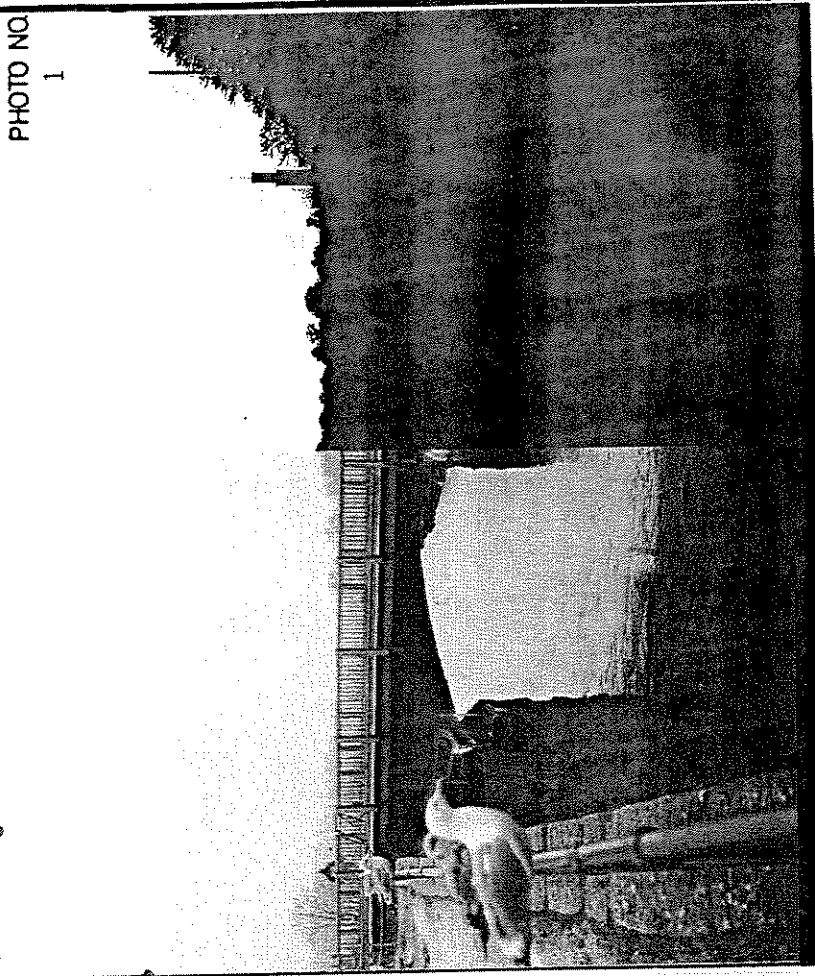
PHOTO NO.
1

This paper is an account of one such case and the innovative interim solution necessitated by circumstances which caused delay in scheduled rehabilitation of a heavily distressed Scherzer Rolling Lift Bridge in Massachusetts. Photo 1 is an elevation of the Blynman Bridge, a skewed double leaf Scherzer in Gloucester, Massachusetts. The structure was rehabilitated in 1980 by others. The method selected was in-kind replacement of treads with a high strength tread material of the same thickness (1-1/2 inches) as the existing tread. For various reasons, the material supplied and installed in

DESCRIPTION:
SOUTH ELEVATION, BLYNMAN CANAL BRIDGE

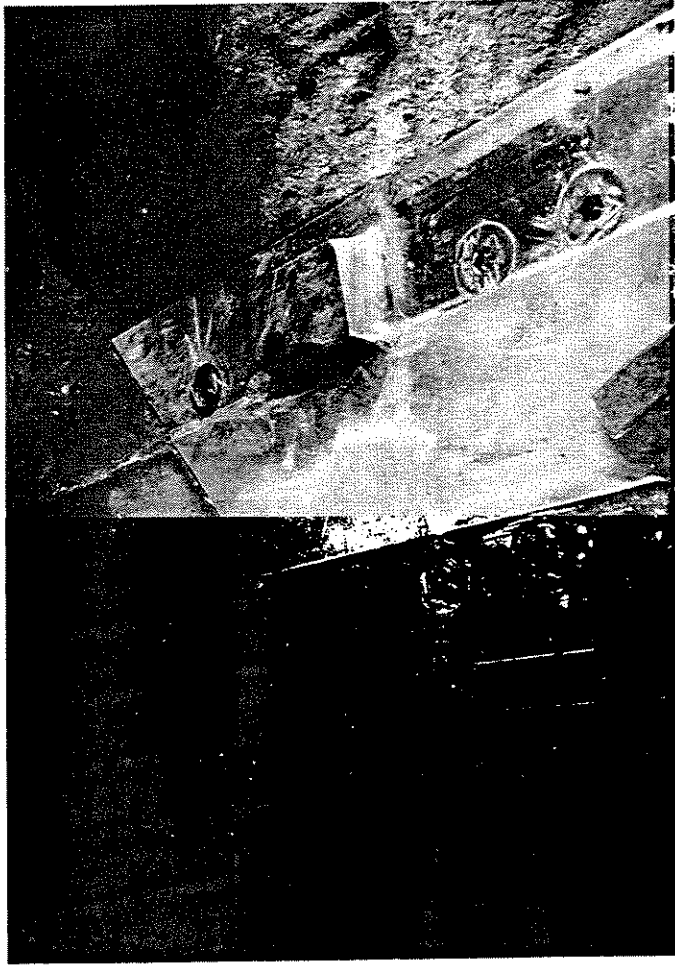
PHOTO NO.
8

DESCRIPTION:
MACHINED HALF SECTION OF NORTHEAST TREAD PLATE, HEEL
END, WITH HOLES, FASTENED TO TRACK GIRDER

When the model was fully set, it was placed on the bed of a RAMBAUDI turn spindle Rammatic 800 mirror image CNC with FIDIA controls for digitizing coordinates of all critical points on the tread. The lug teeth were duplicated exactly, but the rolling surface was smoothed slightly to eliminate some of the existing irregularities which increased rolling resistance. Once the digital setup was completed, a blank of T1 steel was inserted and milled to produce a half section of new tread as shown in photo 7. The corresponding half section of existing tread was removed, the new tread was taken to the bridge and positioned on the existing flange angles of the track girder. An air driven end mill was used in a small hand held air drill to mark the exact location of existing holes using the existing holes in the flanges angles as a template. The T1 plate was then taken back to the shop and drilled. This procedure was necessary due to the fact that plastic flow had pushed the bolt heads at the surface of the existing treads out of alignment, making direct measurement impossible until after removal of the existing tread. The half section was then returned and bolted in place as shown in photo 8. Due to the marking procedure the bolt-up went smoothly with no alignment problems. The span was then rolled to the open position and a similar procedure employed to replace the toe segment of tread as shown in photo 9.

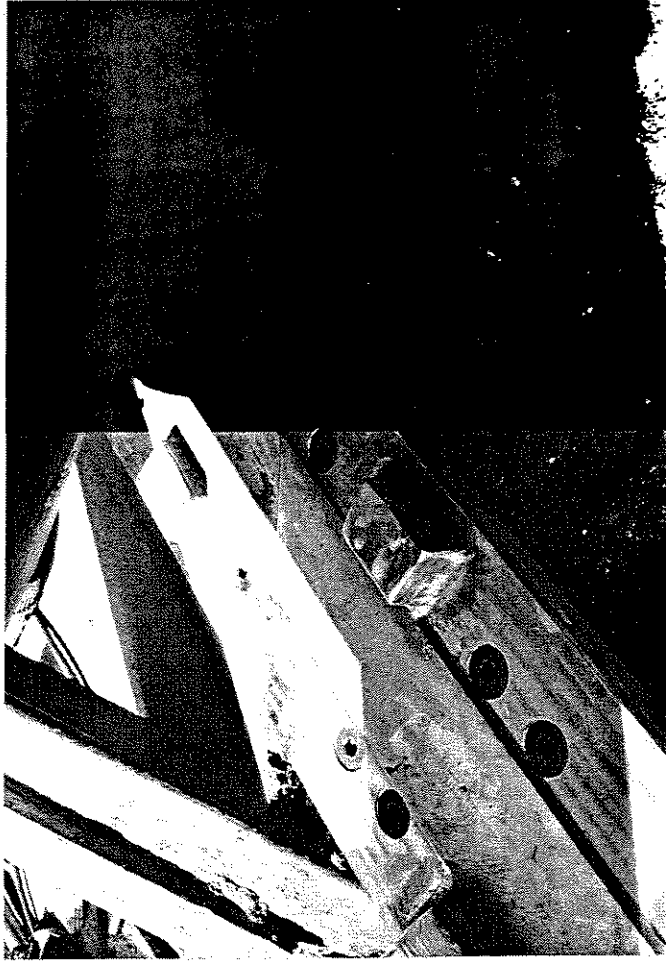
PHOTO NO.
9

DESCRIPTION:
FIT OF THE TWO HALF SECTIONS OF THE NORTHEAST
TREAD PLATE, TOE SECTION IN THE FOREGROUND

The fit of the two new half segments was so precise after assembly that it was difficult to feel the joint with a fingernail. This procedure was employed in this instance as a stopgap measure to maintain safe operating conditions until a full rehabilitation could be accomplished. We believe it may have some usefulness for other applications where exact match to an existing complex shape is desired and there is room to place molds. The time schedule and construction costs for this work are attached as Appendix 1.
