"SPEED REDUCER: FAILURE INVESTIGATION AND ANALYSIS"

by BILL DOHERTY, P.E.
Doherty & Associates, Inc.

This paper is an abridgement of the original investigation and final report written by the author (dated June 15, 1990). He was also responsible for the on-site testing reflected in the report. The project involved was Florida Department of Transportation Bridges: FDOT #87170-3529 & 87170-3530, Sunny Isles Boulevard.

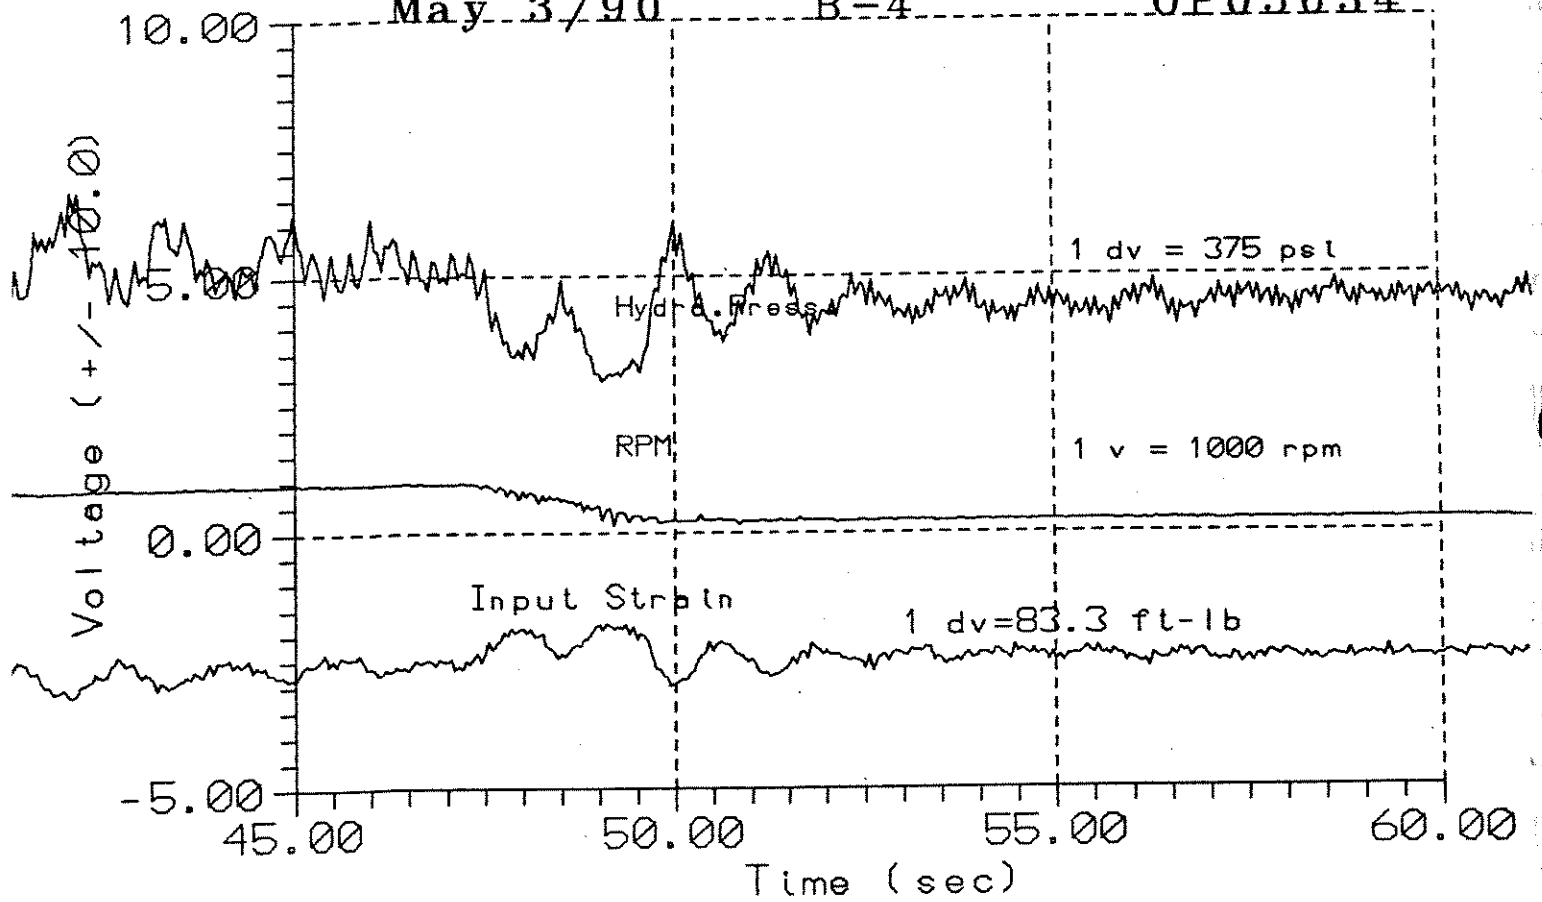
Dynamic Test - Sunny Isles Blvd
Profile - Opening NE Span (20/s)
Start Transients - Spur Input
May 3/90 B-4 OP05034

All design calculations were adequate for size of the speed reducer loads. Tests revealed; full motor speed was obtained (approx. 900 RPM) in 1 to 2 seconds, whether opening or closing, thus placing higher than normal torque transients cycles on the input pinion. The input acceleration RATE of loading or "acceleration ramp" did NOT meet specifications. This acceleration rate is set by the manufacturer.

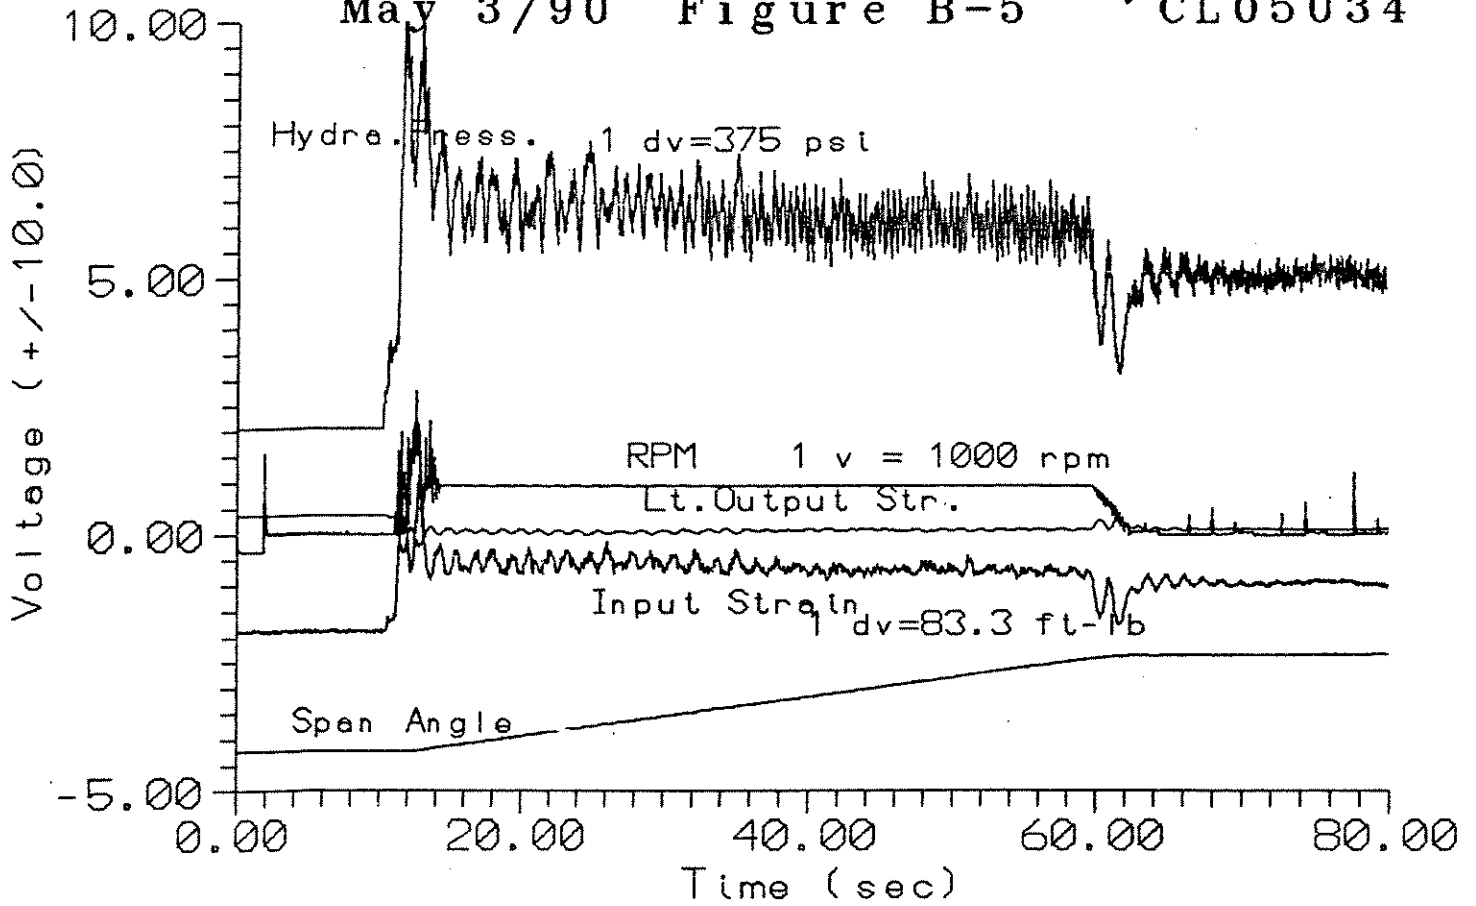
Dynamic Test - Sunny Isles Blvd.
Recording During Closing NE Span
Start Transients - Spur Input
May 3/90 Figure B-5 ' CL05034

Specifications indicates 0 - 870 rpm should take 15 seconds. Measurements reflected it only takes 1 to 2 seconds (Figure B-3 & B-6). The total time of opening or closing is NOT in accordance with specifications. Stress calculations submitted by the manufacturer did NOT reflect full stress reversal capability, nor did the submittal(s) address, adhere, acknowledge or take exception to the contract requirements or limits. The attached calculations, which doubles the stress obtained using AASHTO tooth load equations, reflects a lack of full stress reversal capability; an out-of-spec condition (Appendix C, Figure 1 & 2, rows 38 & 40; Appendix B-2, B-5, Input Strain).

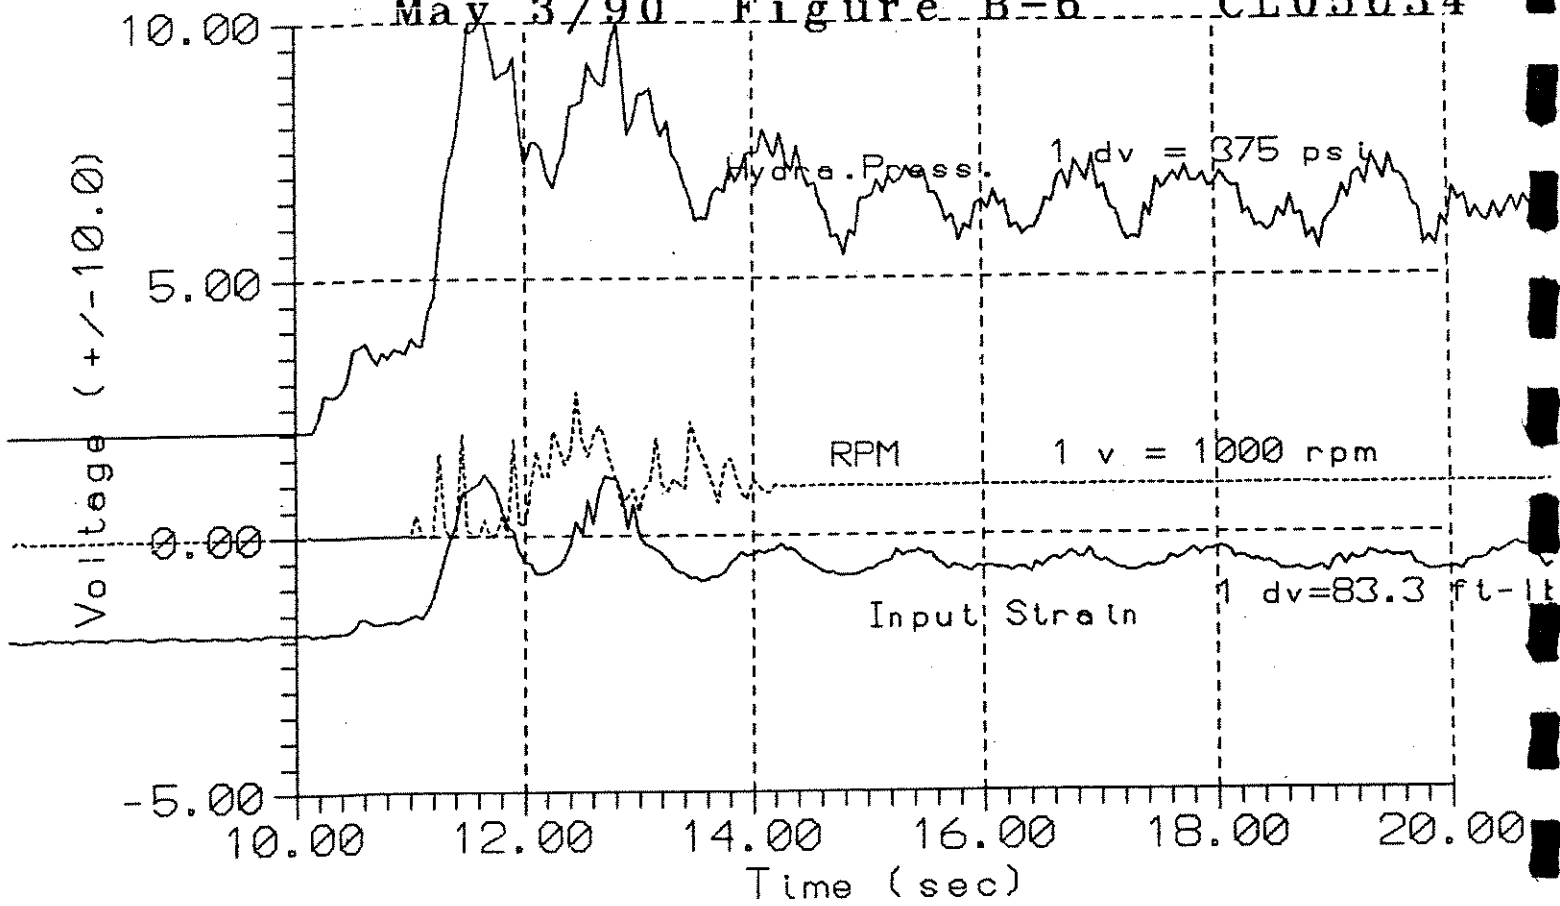
Dynamic Test - Sunny Isles Blvd.
Recording During Closing NE Span
Start Transients - Spur Input
May 3/90 Figure B-6 CL05034

The hydraulic system start transients developed sufficient torsional loading to cause repeated cyclic stress on the input pinion, if the rate of acceleration (ramp) was not set properly. The contract specifications required the ramp (acceleration) time for the input shaft was 15 seconds. The field tests of all spans were measured at 2.0 seconds. This high acceleration rate was NOT without added strain on the input shaft (ref. Appendix B-3 & B-6).
