"145th STREET

BRIDGE REPAIR"

by MICHAEL S. HERSHEY, P.E. New York City DOT, Bureau of Bridges

NEW YORK CITY DEPT. OF TRANSPORTATION BUREAU OF BRIDGES

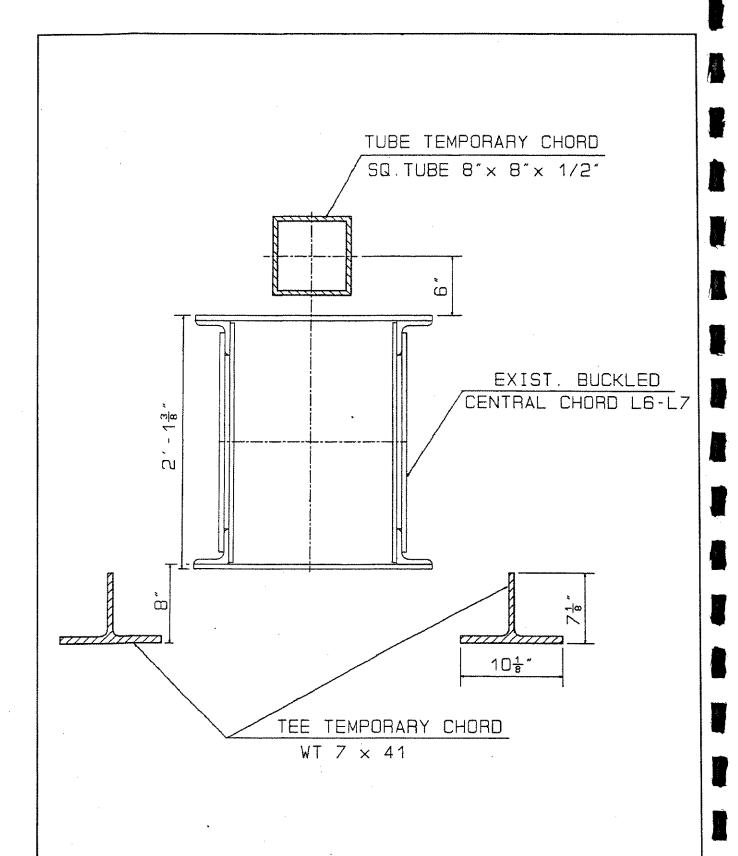
TEMPORARY CHORD MEMBERS

The object of this repair was to replace the damaged lower chord of the center truss at the middle of the bridge. It was therefore necessary to provide some means to stabilize the truss during the time the damaged chord was being removed and the new chord was being installed. To accomplish this, a three-part temporary chord was designed. This temporary chord consisted of an 8" square tube member located above the existing chord and two tee sections below and on each side. Details of the temporary chord members are shown on Figs. 4 and 5 Placement of these temporary members had to allow sufficient clearance to work on the permanent steel chord.

The upper tube member served as an adjustable strut between panel points. Adjustment was accomplished by incorporating a 100 ton hydraulic jack into the east end of the tube. After the bridge was jacked up to relieve the load in the damaged member, this strut was installed and given a preload before the damaged chord was removed. At the same time, the two tee sections were secured by tightening their connection bolts.

Although not anticipated, it became necessary to install jacks in the tee sections also. It became apparent after the damaged chord was removed that the distance between panel points was about 3/8" less than the required 24' - 0". Due to the unexpected stiffness of the lower chord, it was necessary to apply additional jacking capability to increase the distance between the panel points by even a small amount. A 50 ton jack was installed at each tee section to provide this extra force.
