***Emergency Repair of a 7 Million
Pound Swing Span (I-Street Bridge
Center Bearing Repairs)***

Jeffrey S. Mancuso, P.E., Southern Pacific Lines

Jeffrey W. Newman, P.E., Modjeski and Masters,
Inc.

LOCATION: I-STREET BRIDGE – SACRAMENTO, CA

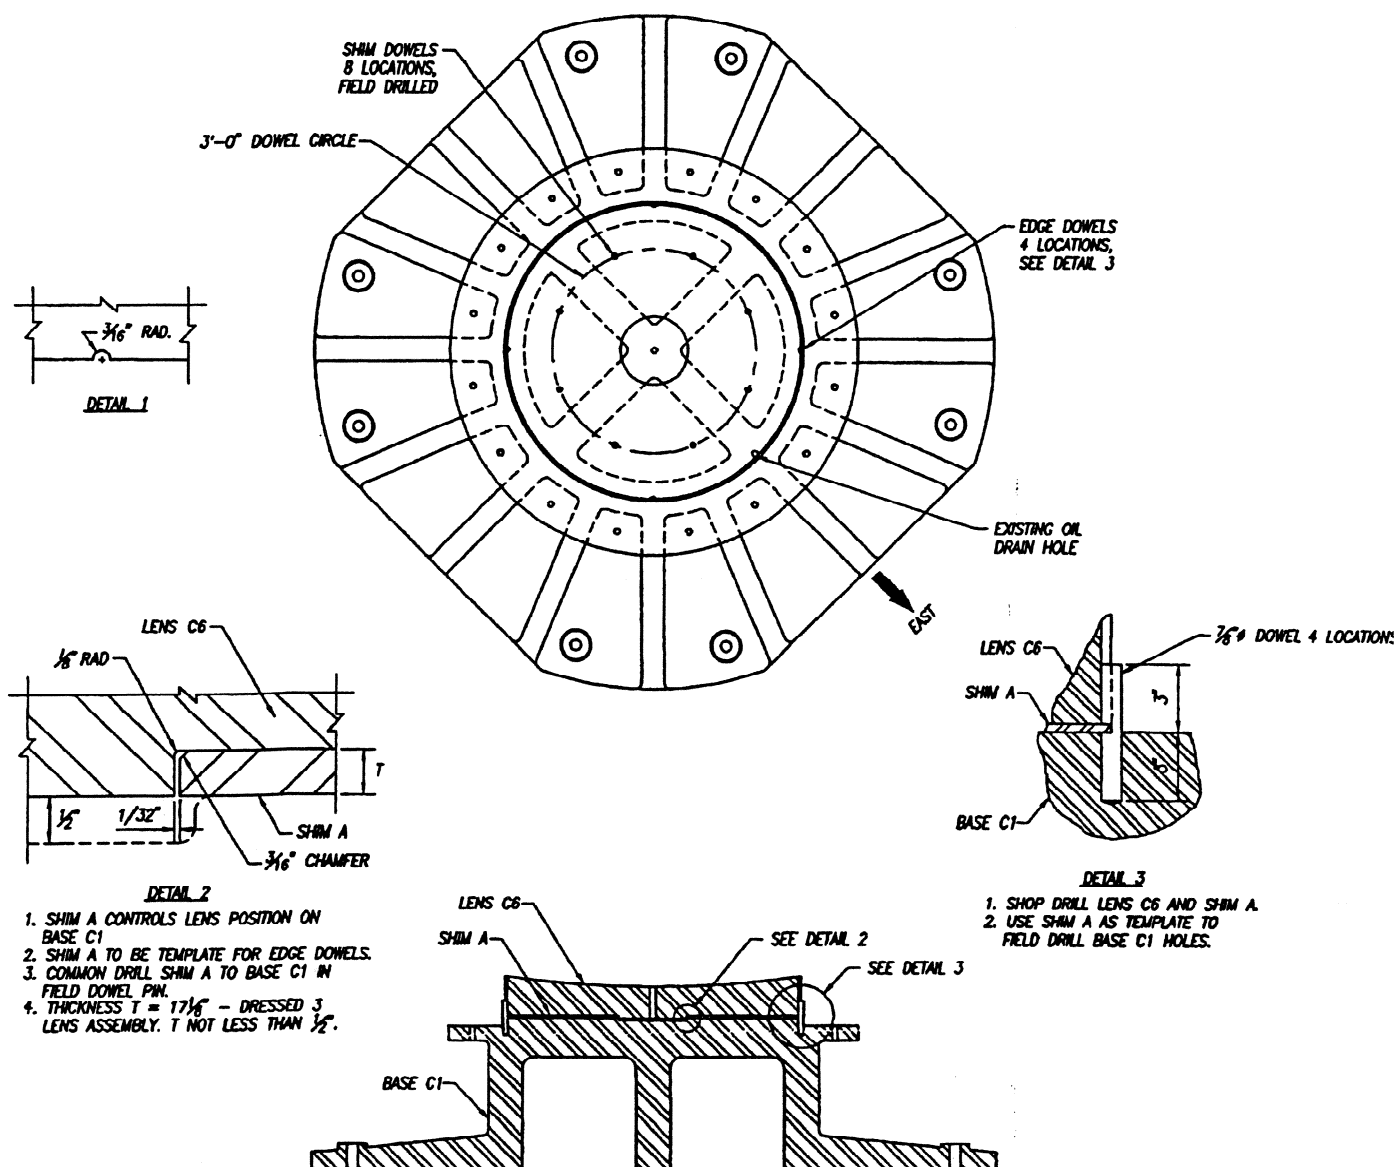
Figure 2

Two significant problems had to be addressed in redesign of the center pivot assembly. First, as previously mentioned, there would be losses in the height of the assembly due to material removal required to clean-up all three disks. Secondly, the fit between the lower steel disk boss and the lower pivot casting counterbore had been destroyed. The boss/counterbore fit is what locates and holds the lower disk captive.

A plan was developed to install a new shim between the lower steel disk and the lower pivot casting. This shim would address both the assembly height problem and provide a new counterbore for centering the assembly (see Figure 2). The new shim thickness would be a minimum of 1/2 inch, but the final thickness would be held until final machining of the other components was complete. The new shim would be fixed to the lower pivot casting with snug fit dowels that were field drilled. The boss on the existing lower steel lens would be machined to the first clean diameter. The new shim plate would have a locating hole to accommodate the new boss. Also included in the new design were four "edge" dowels that would aid in keeping the lower steel disk in place and restrict rotation.

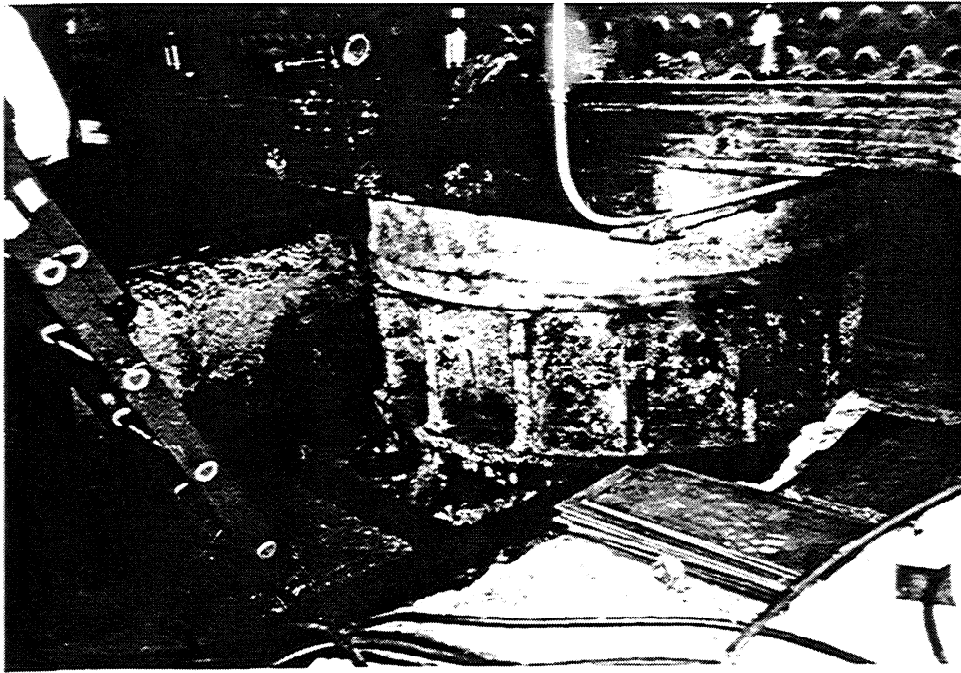
Photo 2 - Area of concrete that had to be removed to access the center pivot assembly.

In order to access and repair damage, concrete encasing the center bearing assembly had to be removed. It was determined that an area of 14 feet by 8 feet of concrete that was 2 feet deep (approximately 7 cubic yards after accounting for the volume of the center pivot assembly) had to be removed (see Photo 2). This would provide sufficient working space to remove the oil box and the three disk lens assembly for inspection and repair. Southern Pacific personnel began this work immediately.

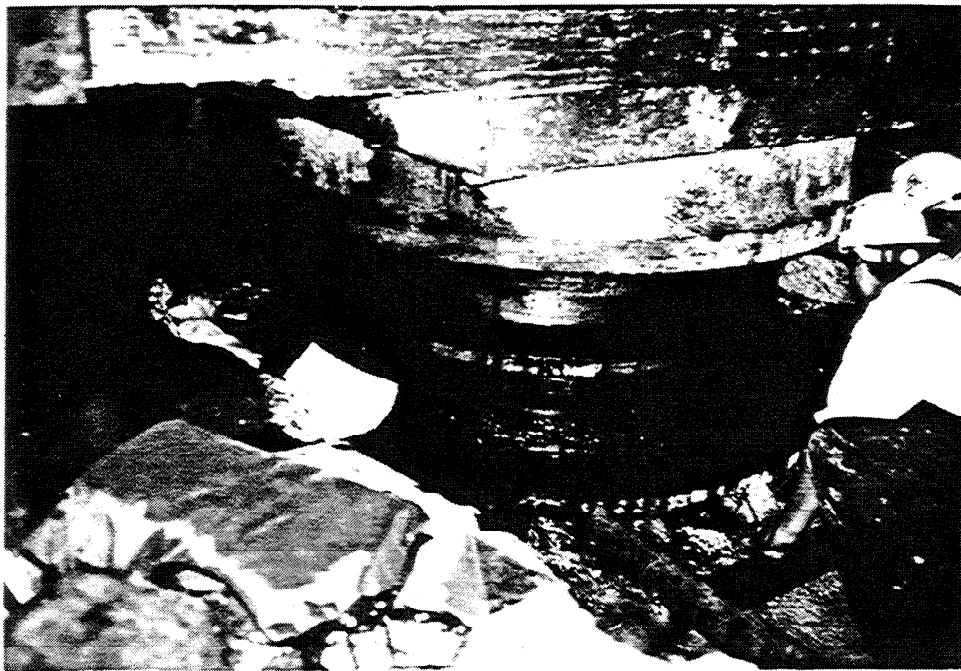
Removal of the oil box revealed the highly contaminated condition of the pivot lens assembly (see Photo 5). Inspection of the oil box halves (each weighing approximately 3,400 pounds) showed that the top disk of the lens assembly was in hard contact with the inside wall of the oil box.

Photo 5 - Half of oil box removed. Note the high level of contamination found inside. Also note that the top steel lens was "stuck" to the upper pivot casting.

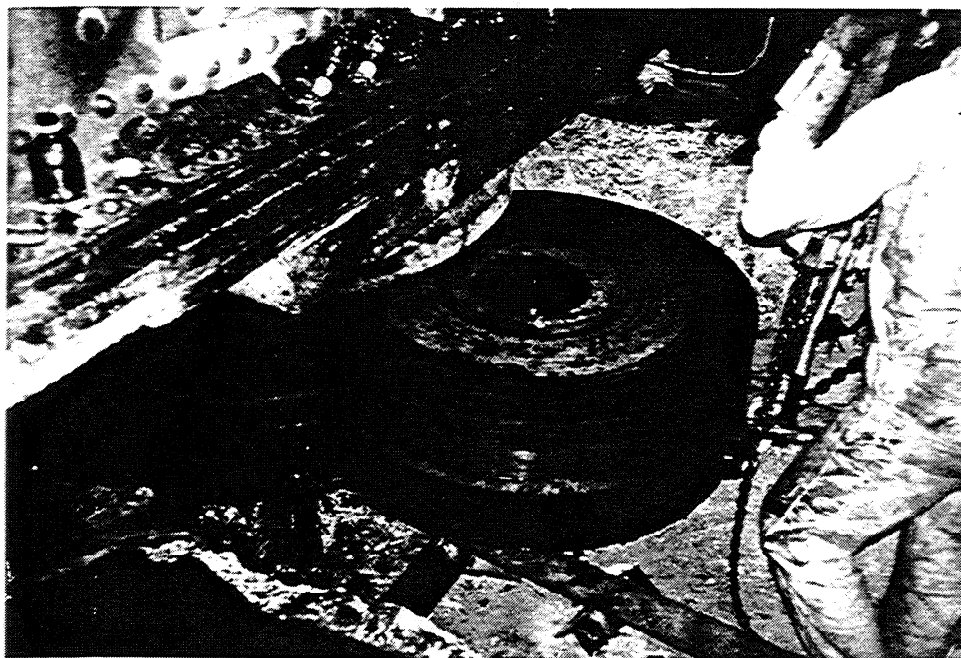
Top pivot casting, C2, surfaces were all in "mint" condition.

Photo 6 - Removal of the pivot lens assembly. The top steel lens boss and top surface were in "mint" condition. Note the steel slide rail assembly for removal and installation of lens assembly.

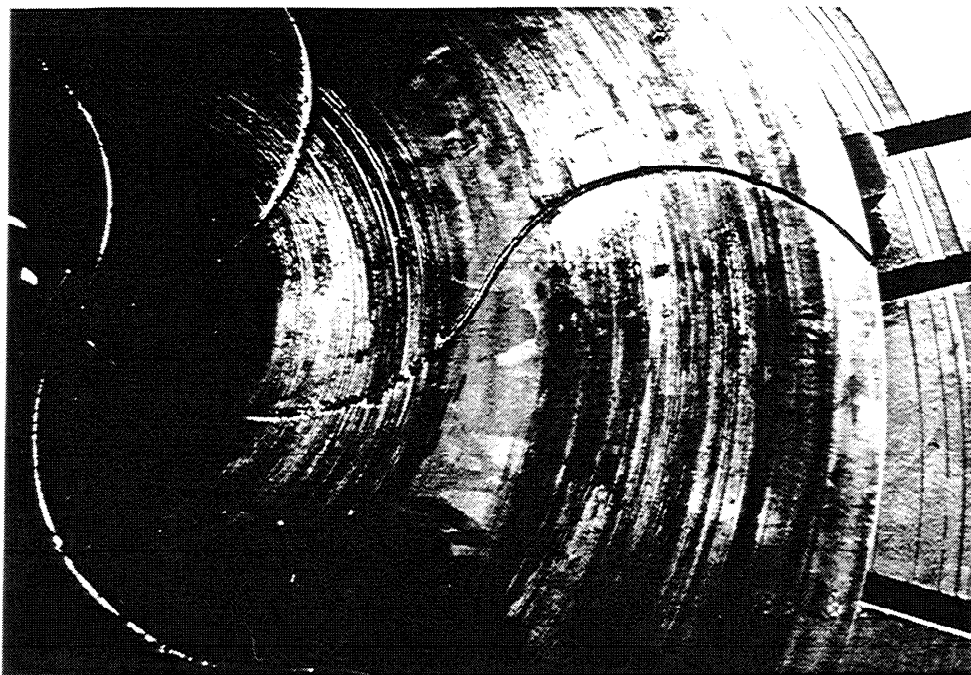
The center bronze lens, C5, had scoring on both surfaces with bronze particles and hardened lubricant in the oil grooves. After cleaning, deep scoring was evident in the center portion and a band of discolored bronze was revealed towards the out half of the wear surface (see Photo 7).

The center bronze disk had some deep scoring and areas of moderate porosity from the original casting process. However, it was determined that the existing piece could be remachined and reused. This would help in getting the bridge back in service according to the June 30th deadline established by the Coast Guard, but presented the problem of how to make-up the loss in height due to machining.

Photo 7 - Top surface of bronze disk after cleaning.

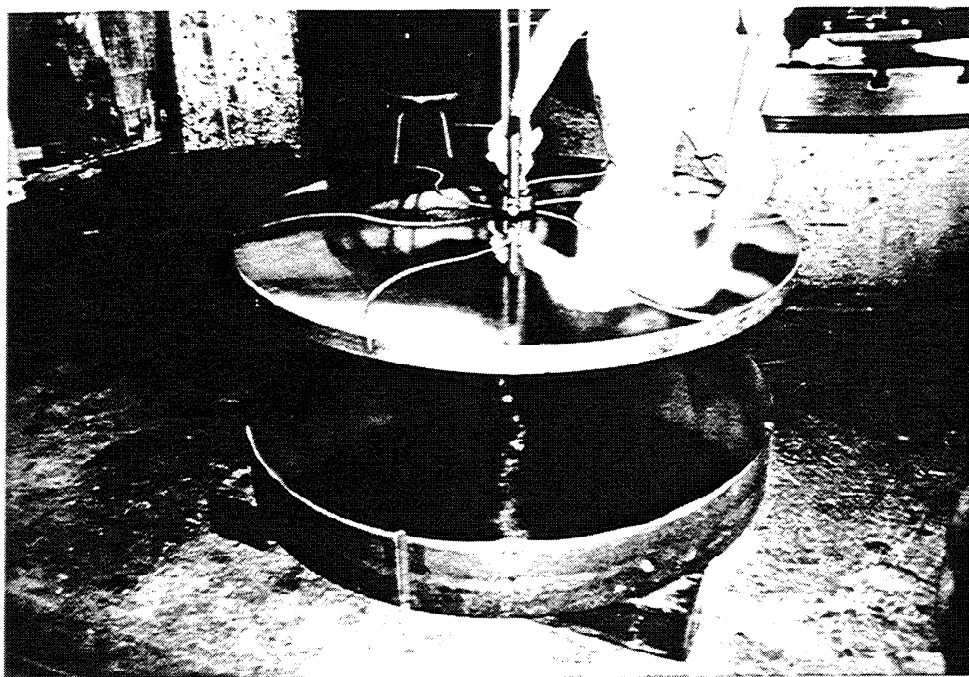
Photo 8 - Bronze disk and bottom steel disk after remachining.

Stewart Tool Company, Inc. located in Rancho Cordova, CA was selected to perform the required machining. They had the capacity and sophisticated equipment required to produce the spherical surfaces on the 52 inch diameter lenses. Two cutting passes were made on each surface of the bronze to clean-up the surfaces. In order to keep as much of the bronze material as possible, some surface imperfections were left "as-is". The oil grooves were recut to obtain the original 3/8 inch depth, all edges were given generous radii, and the wear surfaces were polished to a mirror finish. The upper and lower steel disks had their outer edges rounded to a 1/2 inch radius and their wear surfaces polished to a mirror finish. The lower steel disk also had its bottom resurfaced to remove the scoring, the boss was refinished, and four slots were machined on the outside diameter for the "edge dowels" (see Photo 8).

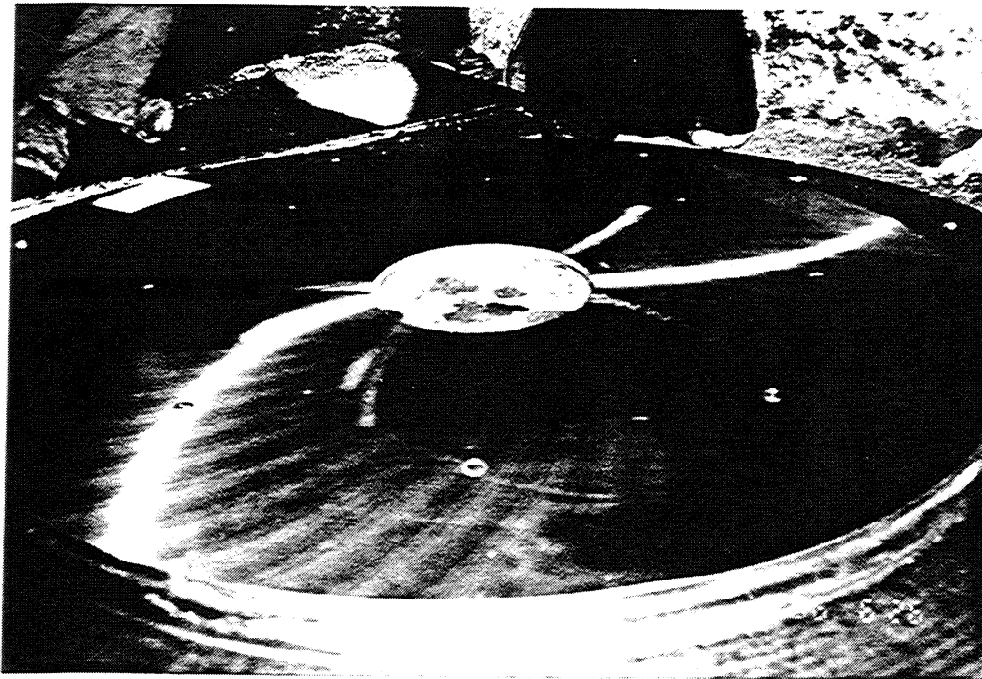
Photo 10 - The new 1/2" thick shim plate doweled to the lower pivot casting.

All machining to the three piece lens assembly was finished on June 26, 1996 and the assembly was delivered to the bridge at 2 PM. A 12 hour work window starting at 8 PM that evening had been established ahead of time. The swing span was raised 4.25 inches using the jacking procedure previously detailed. The oil box was removed and the temporary shim stack removed from the center bearing cavity. The lower pivot casting was cleaned and high spots removed by hand grinding. The new shim plate was then centered on the base pivot casting and the dowel holes were drilled and reamed. The shim plate was removed, burrs from drilling were ground smooth, the area was thoroughly cleaned, and the shim plate was doweled in place using the center dowels only (see Photo 10). All eight center dowels obtained a very nice light driving fit.

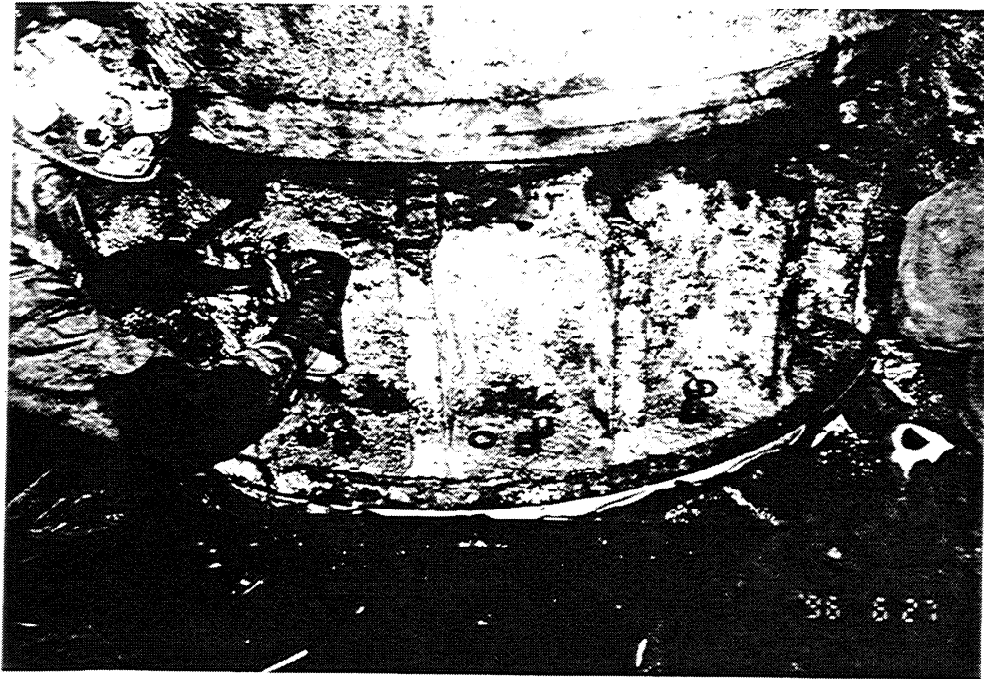
Photo 12 - Oil box in place.

Installation of the three-piece lens assembly (weighing nearly 11,000 pounds) was accomplished using teflon strips to slide on to prevent damaging the machined surfaces. The assembly was then positioned for installation of the edge dowels. The edge dowels were installed and the assembly lowered onto the bottom pivot casting. Strap angles that had been tack welded onto the outside diameters of the steel lenses were ground off and the top steel lens was jacked up to seat in the upper pivot casting (see Photo 11). The area was thoroughly cleaned and gasket sealant was applied to the oil box to prevent oil leakage (see Photo 12). The oil box was filled with fresh oil.
