SIXTH BIENNIAL SYMPOSIUM

***106th Street Bascule Bridge -
Emergency Repairs***

B. Robert Tessiatore, S.E., P.E., HNTB
Corporation
and
Stan Kaderbek, S.E., P.E., City of Chicago

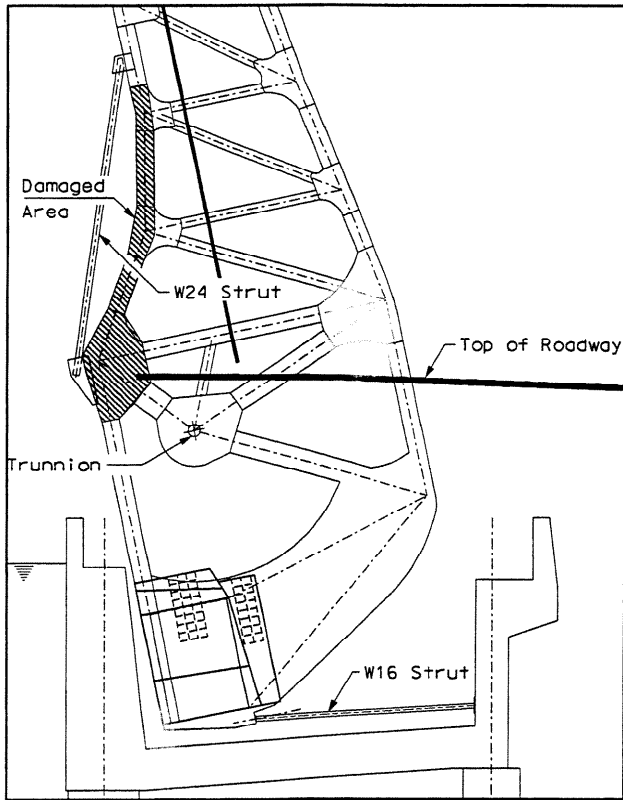
Figure 1.
TRUSS STABILIZATION

In the initial assessment of the collision damage, it was noted that the two-inch-diameter trunnion bearing anchor bolts had sheared off, and the north side of the east leaf had shifted nine inches to the east. The lower chord of the east leaf had been entirely smashed in with the distance between panel points shortened by as much as four inches. The immediate concern was to safely stabilize the east leaf in the up position. The danger was two-fold: one, the bottom chord had lost its axial load capacity and the entire truss could collapse; and two, since the north rack and rack-and-pinion had become disengaged, the leaf may not have adequate control to maintain an upright position, and could rapidly crash downward.

To maintain the truss in an upright position, a bracing system was immediately sized and installed between the back wall of the pit and the counterweight. This system consisted of two steel wide flange sections at each truss end and laterally braced off the pit walls.

Concurrently, a strut system was designed and installed to brace the damaged chord. The strut system consisted of a steel wide flange section bolted to the gusset plates and spanning the damaged chord section. The design and installation of the strut system was the first of many cooperative efforts between the City, the designer, general contractor, specialty contractor, steel fabricator, and steel erector.
