Span Lock Failure - A Case Study

Eric T. Kelly, P.E., HNTB Corporation

The Woodrow Wilson Memorial Bridge spans the Potomac River between Jones Point in Alexandria, Virginia, and Rosalie Point in Prince George's County, Maryland. The total length of the structure is 5,900 ft. and was opened to traffic in 1961. The bridge carries a six lane highway whose original typical cross section consisted of two 38 ft. roadways, a 4 ft. median, two 3 ft. safetywalks, and two 1.5 ft. parapets for an overall width of 89 ft. This is the last movable bridge on the 42,500 mile interstate system (The Fuller Warren Bridge in Jacksonville, FL is also a movable bridge, but is presently being replaced). Present traffic counts on the structure exceed 167,000 vehicles a day (17,000 being trucks). The structure opens to marine traffic over 200 times a year. The allowable time for bridge openings are restricted to keep the

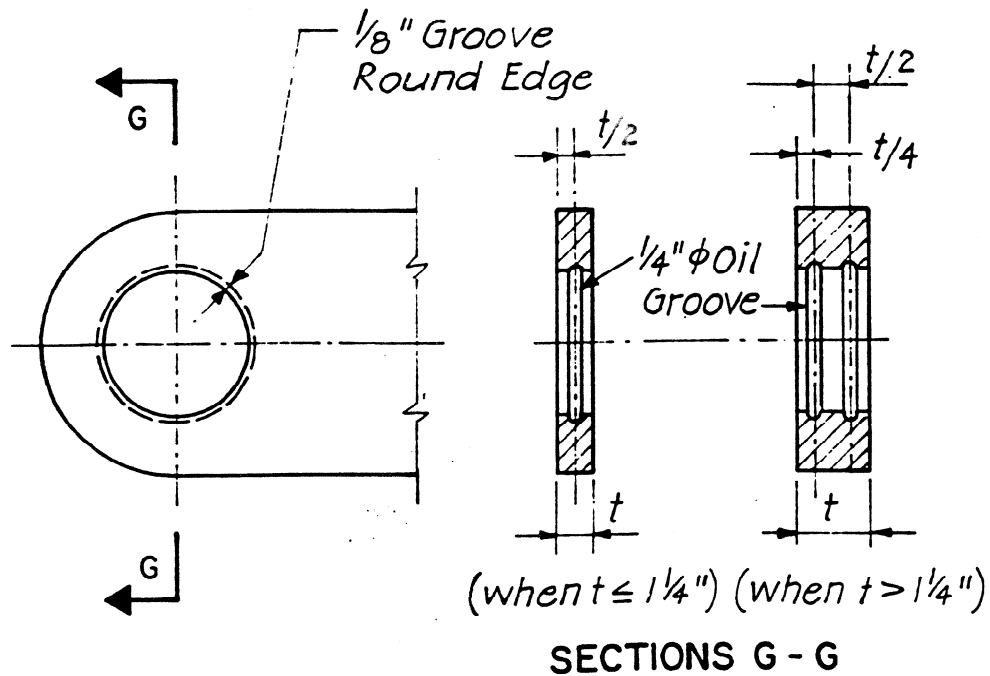
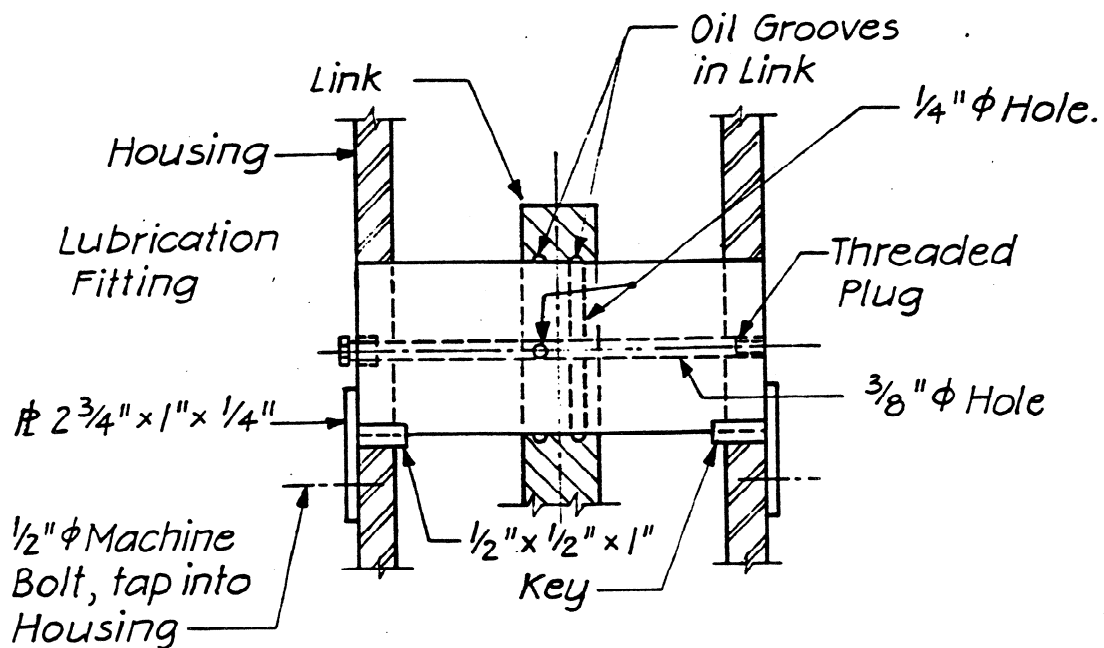
Figure 5: Modifications to links and pins to provide lubrication to surfaces.

Lubrication was provided by putting a grease groove in the circumference of the link and jaw bores. Due to the tight constraints and the moving parts, grease fittings could not be installed on the links. Rather, each pin had a hole drilled through its center and radial grease ducts were drilled to supply the grooves in the links (See Figure 5). This provided a lubrication film to the steel on steel contact areas in the hope of eliminating the hole enlargement from fretting corrosion.

Where the pins were in fixed contact with components, keys were installed. This was also performed to prevent the possibility of relative movement between components which were meant to remain in stationary contact. Again this was to prevent the possibility of fretting corrosion at the remaining non-lubricated locations.

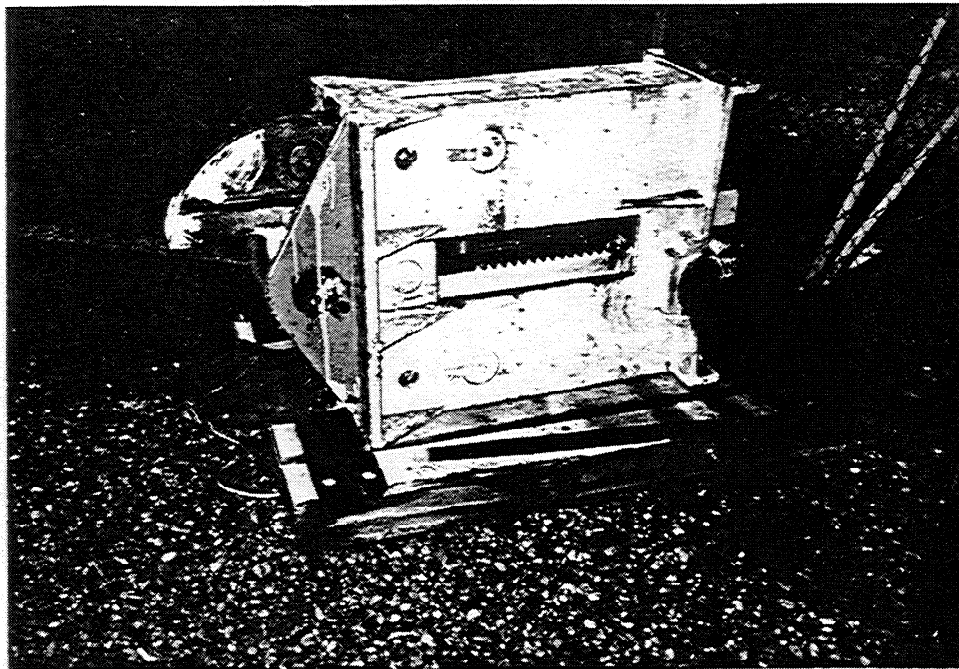
A year went by (it is assumed for fabrication, assembly and delivery) when in December of 1988, we received a phone call, notifying us that the jaws on one of the center lock failed. Luckily, this did not turn out to be a catastrophic event. As part of the sequence of construction, the contractor installs a temporary lock bar to remove and replace the center locks, one at a time. This temporary lock bar was reinstalled as a substitute for the failed center lock, until a resolution could be developed. A few days later though, the second new center lock also failed in a similar fashion (See Figure 6, 7 and 8). An old center lock had to be re-installed to act as a substitute. At first there was a belief that the first lock failed due to material inconsistencies or imperfections, but when the second failed, questions were raised into how the design was altered from the original and could that have been the cause.

Figure 6: Center lock assembly removed from bridge due to broken jaw.

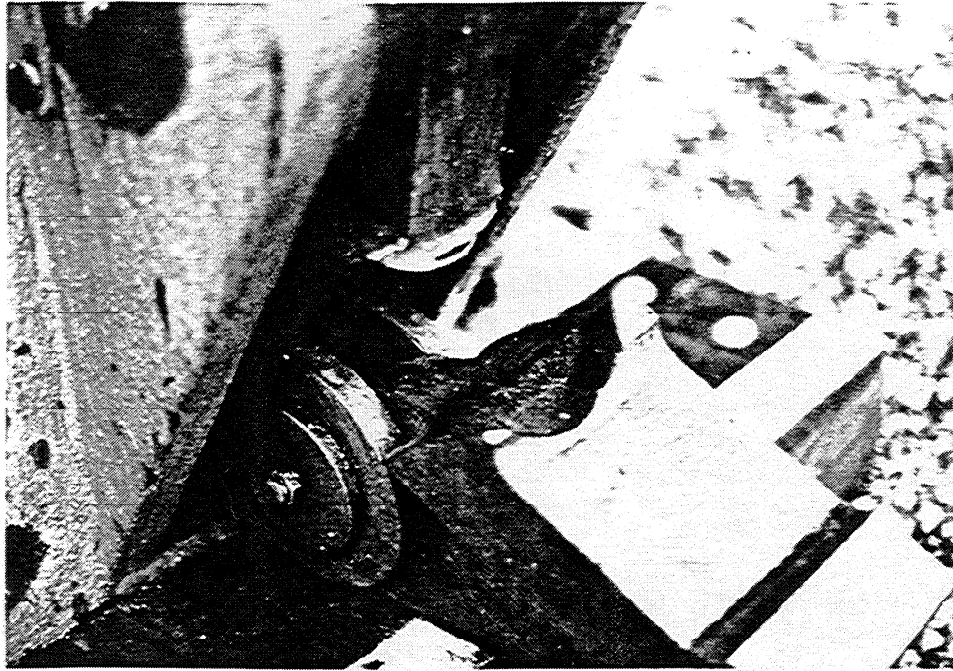
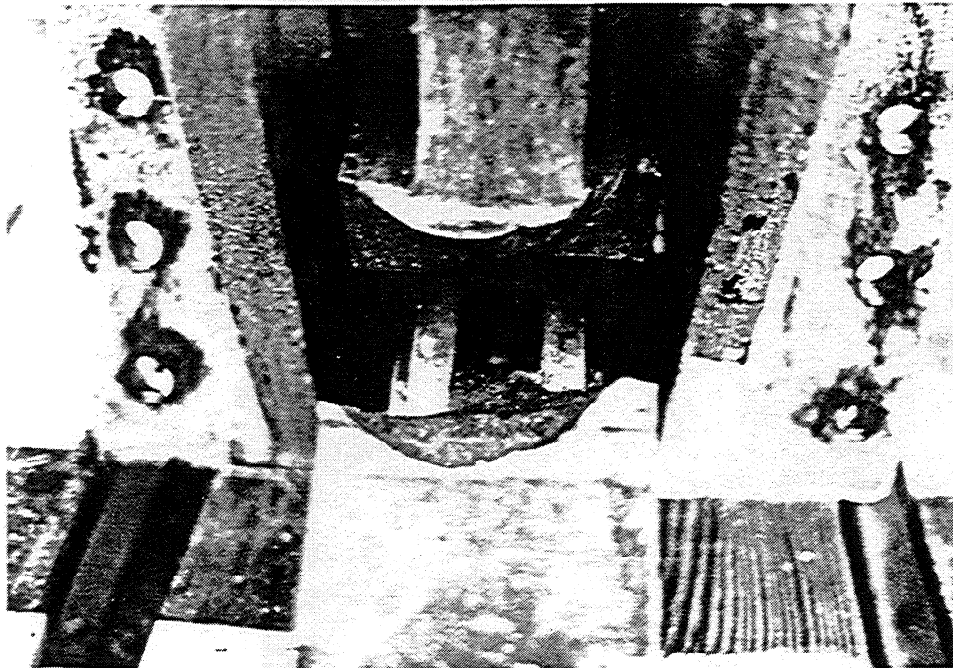
An interesting finding into the cause of the failure was that the jaw forgings had their surface repaired at numerous locations by welding. One weld repair measured 11/16" deep. It turns out that the failure of one jaw initiated at a weld repair. Hardness tests of the weld area showed it to be soft (approximately 225 BHN), while the surrounding area was at the 480 BHN. This resulted in "residual stresses in the weld area which contributed to initiation of fracture." It should be noted that repair welding of forgings is not permitted by ASTM for A668 forgings.

The second jaw had heavy rough machine marks located at the initiation of the fracture and these marks can be attributed to the failure. It is believed that the jaw, due to having the high surface hardness throughout, was difficult to machine and subsequently not fully finished, allowing a stress riser to remain.

Figures 7 and 8: Close up view of jaw fracture.

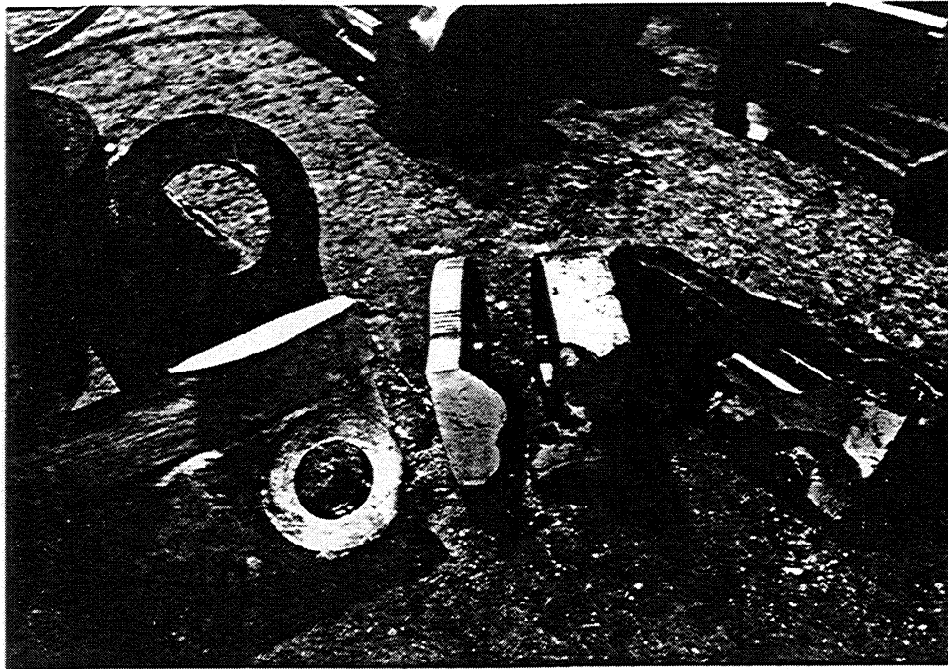
While the recommendation to utilize an alternate material was being decided, one pair of the broken jaws was sent to an independent testing laboratory to have them tested and possibly determine the cause of failure (See Figure 9). A report which described the condition of the jaws and the tests performed with results followed. Specifics of that test report are discussed here.

First, the chemical analysis of the jaws performed by the testing laboratory matched the material's certified test report from the original forging manufacturer, which called for ASTM A668 Class M. No error in the material could be blamed.

Second, hardness readings were taken on the components and the following results were obtained. The contact areas (or bores) had the specified hardness of 480 BHN. Areas not to have the added hardness were tested and showed extremely high readings, indicating the entire jaw surface was hardened to the 480 BHN instead of just the local areas of the bores. One excerpt from the report expresses the situation. "The jaws and links were extremely difficult to cut into smaller pieces for purposes of metallurgical evaluation using tungsten carbide tipped saw. The narrow section at the fractured surface of the link was cut at a very slow rate, took several days with many saw blades being worn off and discarded. The cutting off the wider and thicker portion of the jaws was abandoned as being impractical."

This finding clearly indicates that the jaws, rather than being locally hardened, were hardened over their entire surface. This was a deviation from the design. Also, although the depth of the hardness was not determined, from the inability to cut the material, the hardening process can be

assumed to have been deeper than intended. It was not determined or understood how the entire member was hardened rather than just locally, but this entire hardening surely modified the jaw's behavior to absorb impact.

Figure 9: Pair of fractured jaws out of assembly and prior to being sent for testing.

As previously mentioned, the jaws for the two fractured locks were replaced with new jaws. The two remaining new locks had been installed, but had not failed. These jaws had their hardness tested in the field and were also hardened over their entire area. For that reason, although they had not failed, they were also eventually replaced.
