## **“Movable Bridge Rehabilitation in Florida: Four Case Studies”**

**G. Alan Klevens, P.E., A.G. Lichtenstein & Associates, Inc.**

# **BASCULE BRIDGE REHABILITATION IN FLORIDA: FOUR CASE STUDIES**

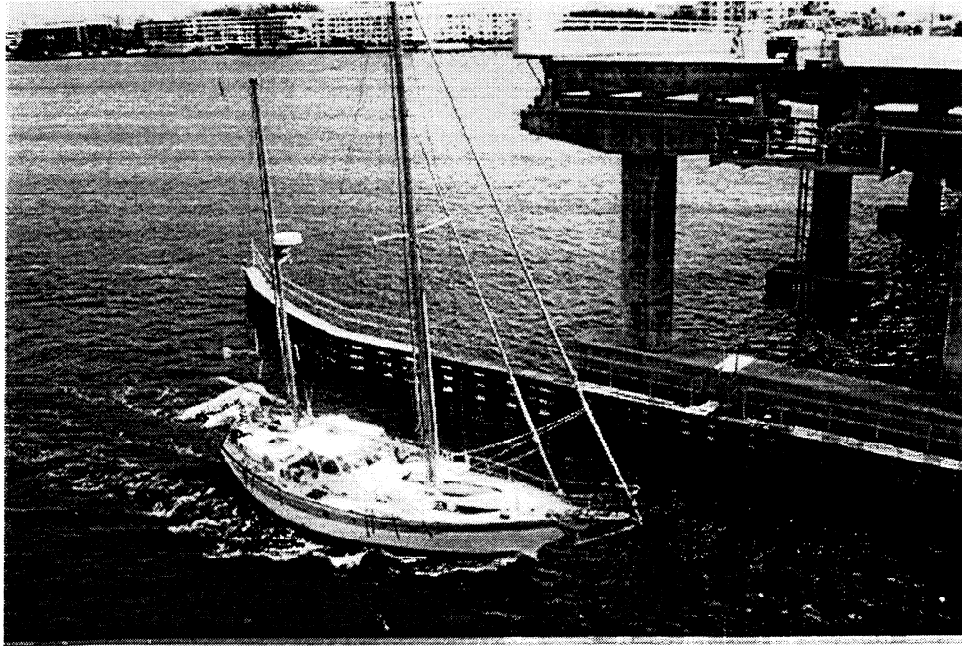
**Photo 1:** *View of new fendering. Also note pier encasement in the background.*

catwalks. The piles and wales were in poor condition. Lichtenstein proposed using recycled plastic timber for the wales and spacers, with prestressed concrete piles. Lichtenstein also designed fiberglass hand rails for the catwalks on the fendering. Although recycled plastic timber is more expensive than timber, the recycled plastic has a fifty year design life. Also, using recycled plastic is more environmentally responsible for two major reasons. First, the timber is made of recycled plastic which reduces the amount of plastic going into landfills. Also, the plastic lumber has no chemicals that will leach into the environment as the product ages. The recycled plastic was easy to work with and should be maintenance free. See Photo 1.

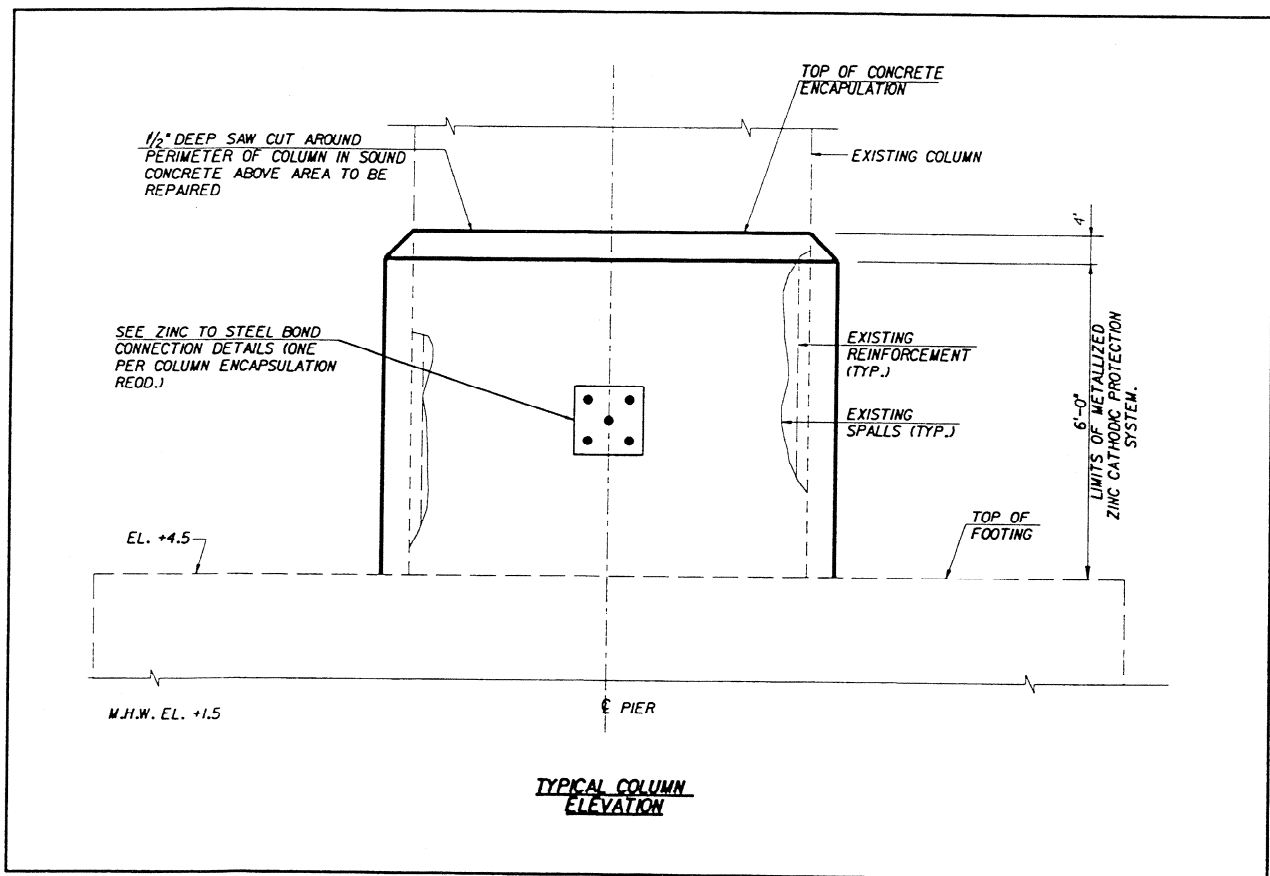
The lower 1.8 m (6 ft.) of the 18 approach piers were heavily deteriorated due to salt water splash and insufficient concrete cover over the reinforcing. In order to ensure a long term repair, the cover was completely removed from the reinforcing, the area cleaned, and new concrete was placed

increasing the cover over the steel. This resulted in the columns being 100 mm (4 in.) thicker all around the bottom 1.8 m (6 ft.). Zinc metallizing was applied to the lower 1.8 m (6 ft.) of the columns. See Figure 1 and Photo 1. The zinc coating was electronically connected to the rebar cage by welding a stainless steel rod to the cage, and connecting this rod to an external galvanized steel plate. Uniform contact between the plate and the zinc coating was achieved by placing a lead plate under the steel plate.

**Figure 1:** Typical column repair with metallizing.

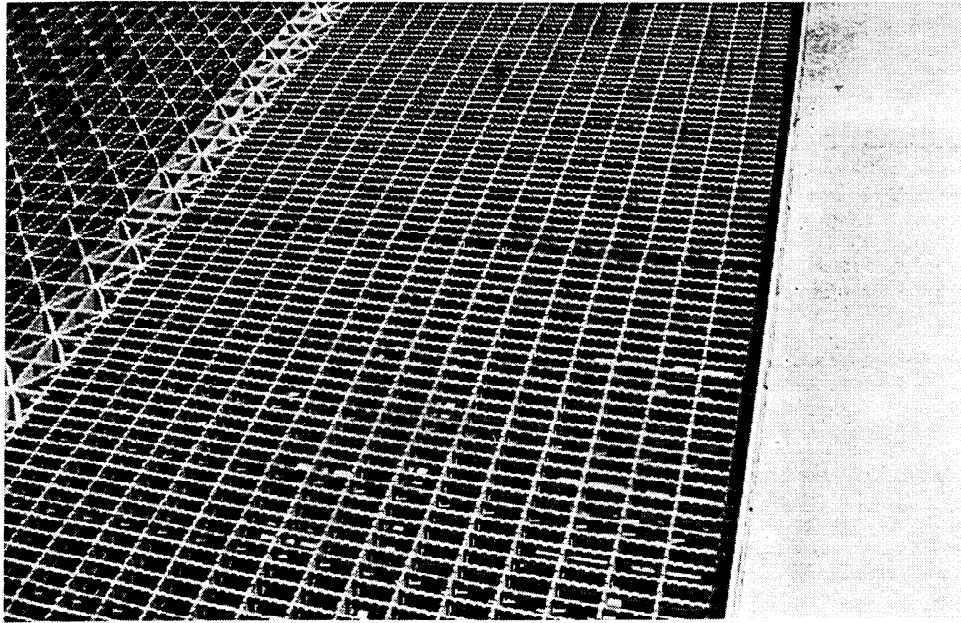
*Photo 2: Rectangular deck designed for the bicycle lanes.*

There was concern regarding the difficulty of riding a bicycle over the new steel grating as this grating includes diagonal tertiary bars. To solve this problem, Lichtenstein worked with IKG Greulich to design a rectangular grid deck within the bicycle lane, with normal 4-way deck in the vehicular lanes. See photos 2 and 3.

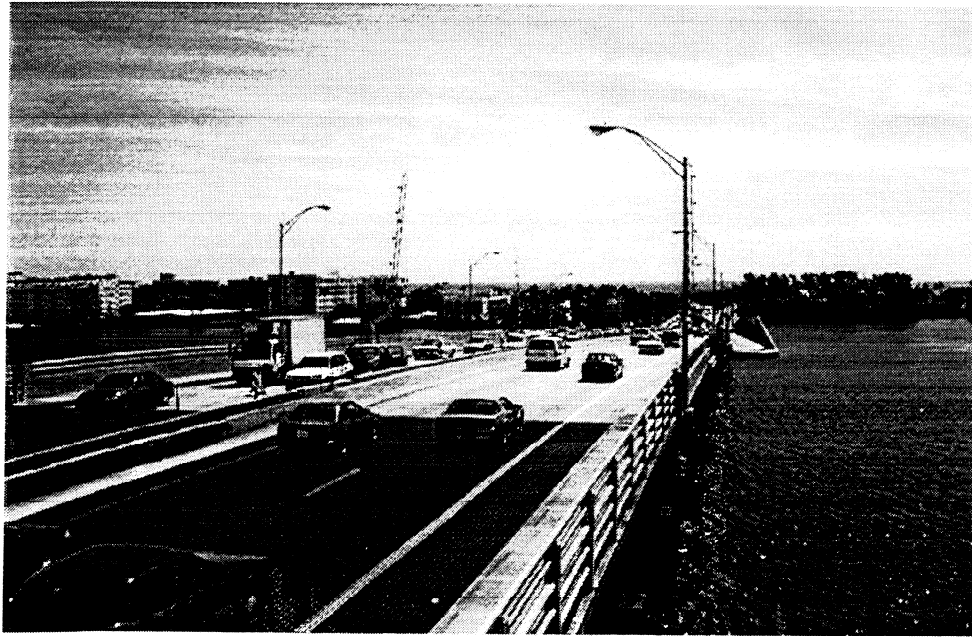
**Photo 3:** *View of bascule deck. Note metal barrier and bicycle lane.*

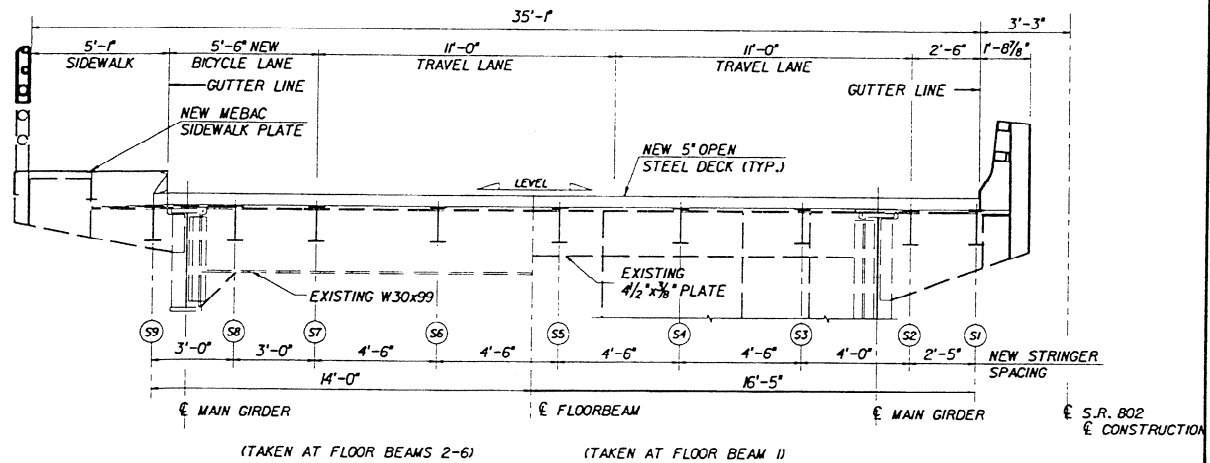
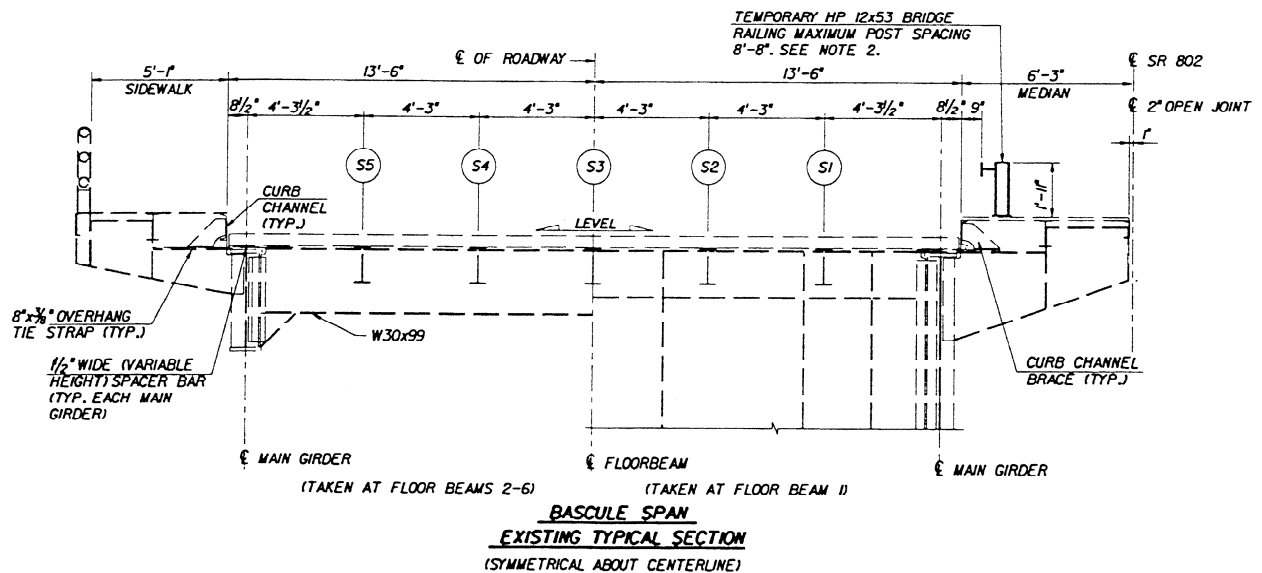
into the existing median. Widening to the outside was not possible due to the location of the Operator's house. In order to provide bicycle lanes, the existing raised median was removed. A standard FDOT shaped barrier was designed, and installed. To save on weight, this barrier was designed using steel posts and rails to carry the AASHTO loads with an aluminum face. New stringers were installed outside of the main girder lines to carry the new deck. This detail was used to remove the fatigue sensitive detail created when the deck spacer bars are welded to the top flange of the main girders. See Figure 2.

BASCULE SPAN  
NEW TYPICAL SECTION  
(SYMMETRICAL ABOUT CENTERLINE)

Figure 2: Typical bascule span cross sections before and after rehabilitation.

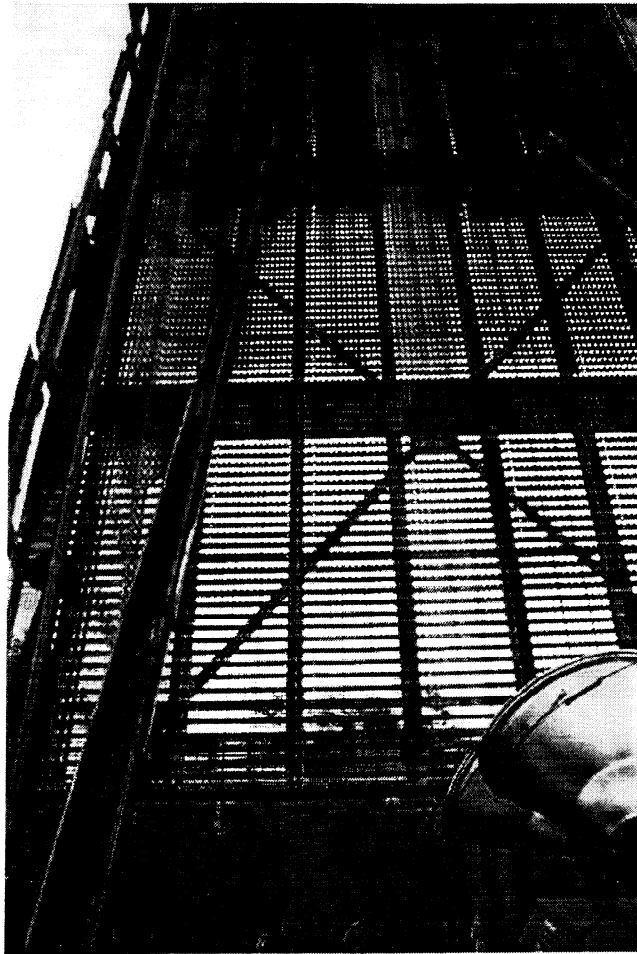
***Photo 4:** Tubular steel struts used to secure the bascule span in the open position.*

A complete bascule span jacking scheme was designed and shown on the plans, along with jacking loads. This was necessary to prove that the jacking plan was feasible and to provide a uniform basis for bidding. As expected, PCL proposed a different jacking setup and design. As specified in the plans, PCL submitted calculations for the proposed scheme. Lichtenstein reviewed the calculations and returned comments in a reduced time frame to allow the short bridge closure schedule. PCL needed to be able to reuse the span tie-downs during the second closure. They used a strut system of structural steel tubing. See photo 4.

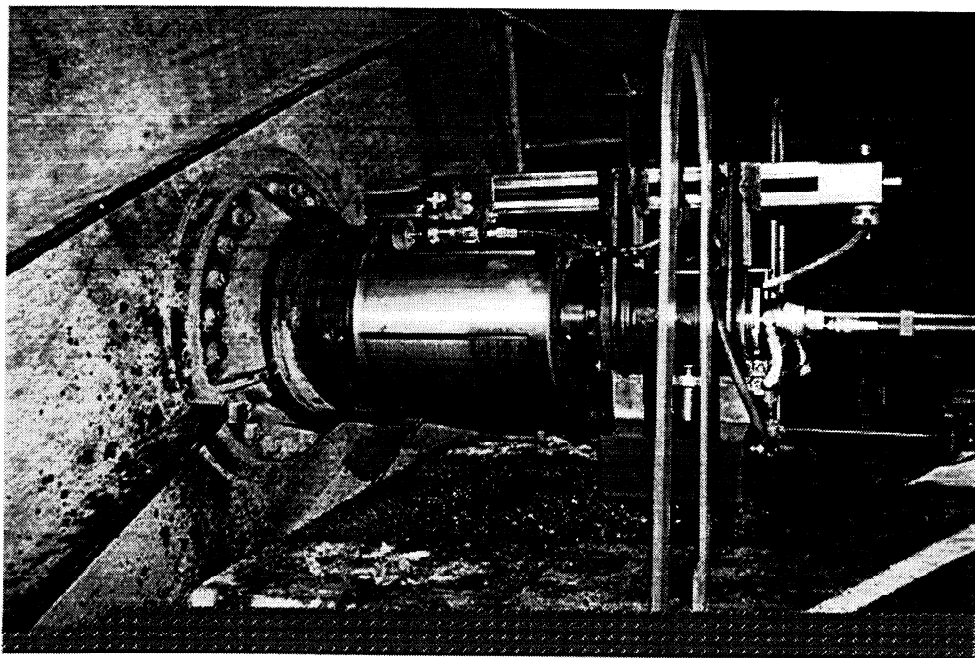
*Photo 5: Machining of the trunnion journal in place. Note that the bearings and anchor bolts were removed.*

Once the span was jacked and secured, the trunnion bearings were removed, and the trunnion journals machined in place. See photo 5. Minimum and maximum amounts of machining were specified. After machining and finishing, the journals were measured to finalize the bushing fabrication. These were installed in the bearing housing at the shop, and brought to the site. See photo 6.

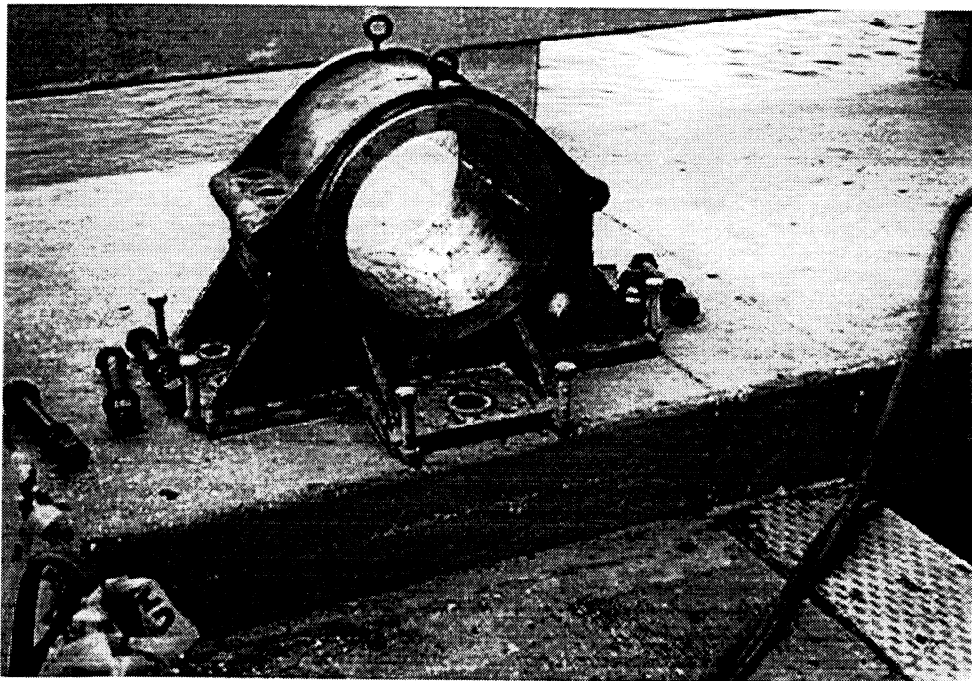
*Photo 6: Finished trunnion bushing and bearing, ready for installation.*

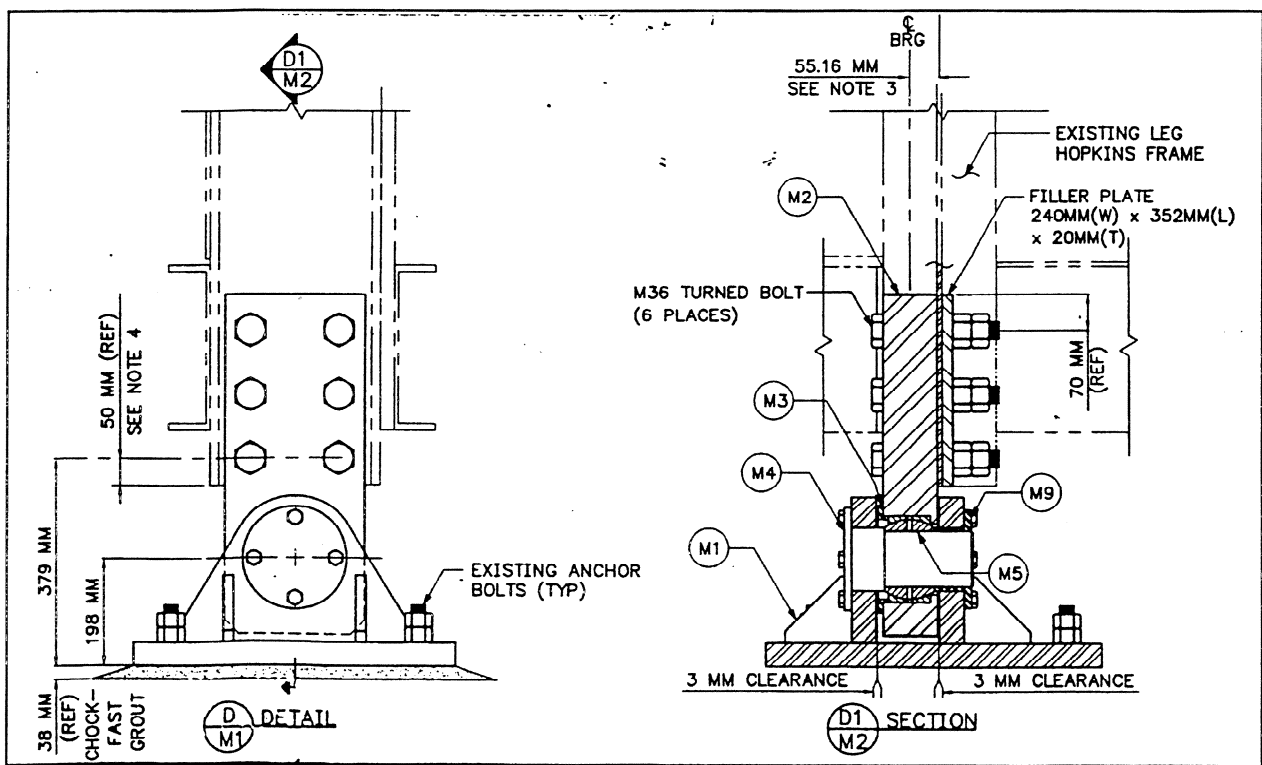
Traditionally, Hopkins frames experience large amounts of movement at the base of the frame. These two bridges open very frequently all year for marine traffic, and the movement at the bottom pin of the Hopkins frame has become excessive due to wear at the pin. The anchor bolts have been replaced in the past, and cracking in the frames has also been repaired in the past. The traditional Hopkins frame bottom pin connection has been designed as a structural element, similar to a pinned truss joint, with steel rotating on steel. Steel truss joints typically do not undergo as much rotation as the Hopkins frame. Lichtenstein are replacing the steel-on-steel pin connection with a spherical bearing, designed using machinery allowable stresses rather than structural steel allowable stresses. See Figure 3.

**Figure 3:** Spherical bearing at the base of the Hopkins frames.
