EIGHTH BIENNIAL SYMPOSIUM

TEAM TACKLES COMPLEX BNSF SWING SPAN REHABILITATION

Authored by: Mr. Darryl E. Cain, P.E. – HDR Engineering, Inc.
Co Authored by: Mr. Michael C. Harrison, P.E. – HDR Engineering, Inc.

BNSF Bridge 9.6 was originally constructed in 1908 and is a 462-foot rim bearing through truss swing span that holds double mainline tracks which carry nearly 80 BNSF and Union Pacific Railroad (UPRR) freight trains plus 8 Amtrak trains per day. This span is located between Portland, Oregon and Vancouver, Washington crossing the Columbia River. The bridge is over one half mile long and provides a major link for the BNSF and UPRR West coast operations. The swing span is also operated approximately 15 to 25 times per day to allow for passage of navigation vessels. This crossing is a major transit point on the Columbia and Snake Rivers for barge traffic coming into port or going out to sea.

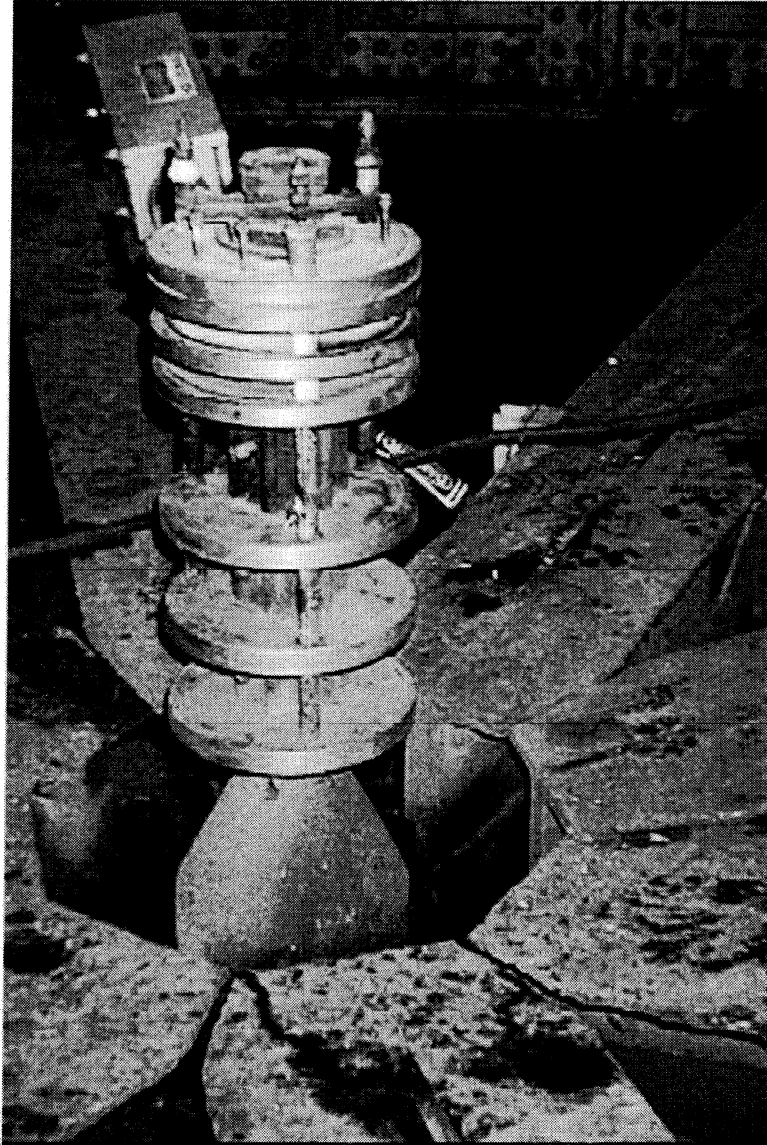
One of the more noticeable problems was that the electric slip ring at the center of the bridge was not always making contact. The slip ring allows the electric power from the shore onto the swing span without using an aerial cable or dragging a loop cable on the center pivot pier. The power on this span comes from an underground submarine cable rather than from an overhead aerial cable. This allows vessels of nearly any height to pass through the navigation opening. The slip ring was known to be in fair condition, however, closer examination indicated that there were other concerns.

The rim bearing swing span is guided by a bearing located in the center of the bridge and is partially buried in the center pivot pier concrete. This bearing was worn to the point that the span could move nearly 2 inches out of round. This was sufficient to cause the slip ring to lose contact with one or more of its power conductors. The worn center bearing also attributed to some of the rail locking difficulties. The center bearing wear has caused the span opening and closing failures to quadruple in less than six months time. It was determined that a worn center bearing pin was the cause of the out of round movement. A new center bearing pin was installed in March 1999. This additional immediate work was unplanned for in the rehabilitation sequence and therefore a new adjusted work sequence was made.

Photograph 3: Old Slip Ring Located at Center of Bridge

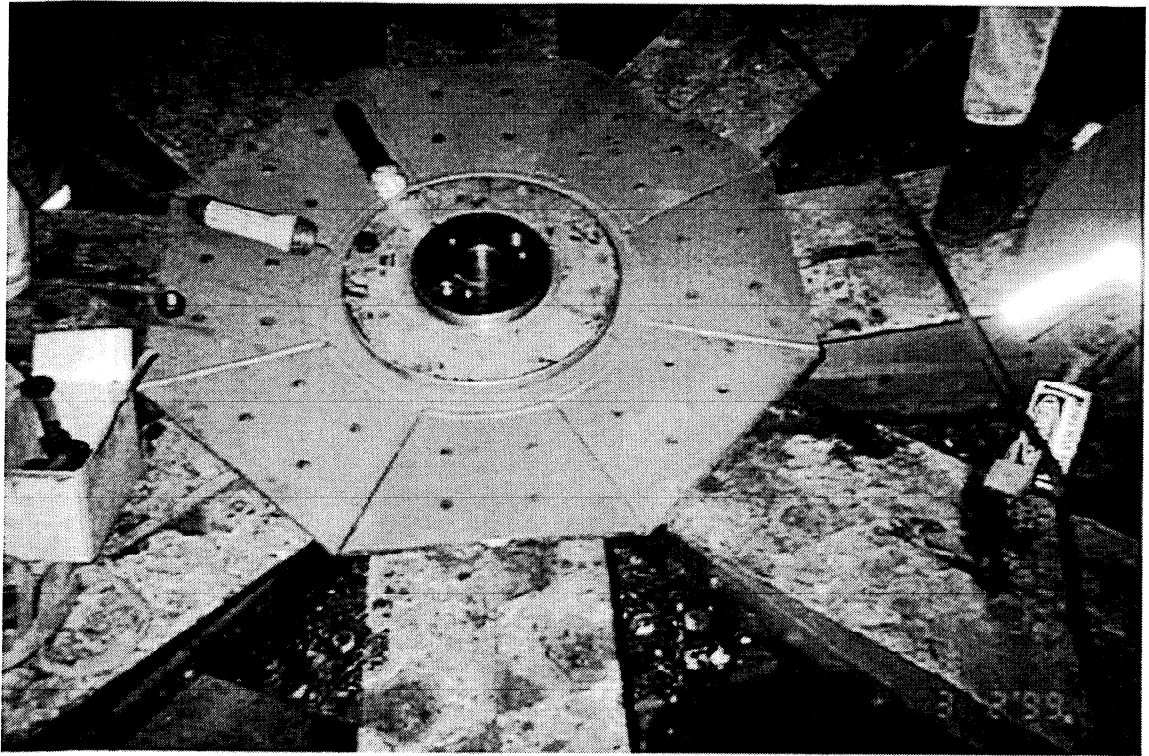
Photograph 4: New Center Bearing Repairs

- ◆ March 1999 – Replaced the Center Bearing Pin. Delayed installation of the end lift machinery until March 2000.
- ◆ July 1999 – Finished Phase I of the new electrical control and power distribution center.

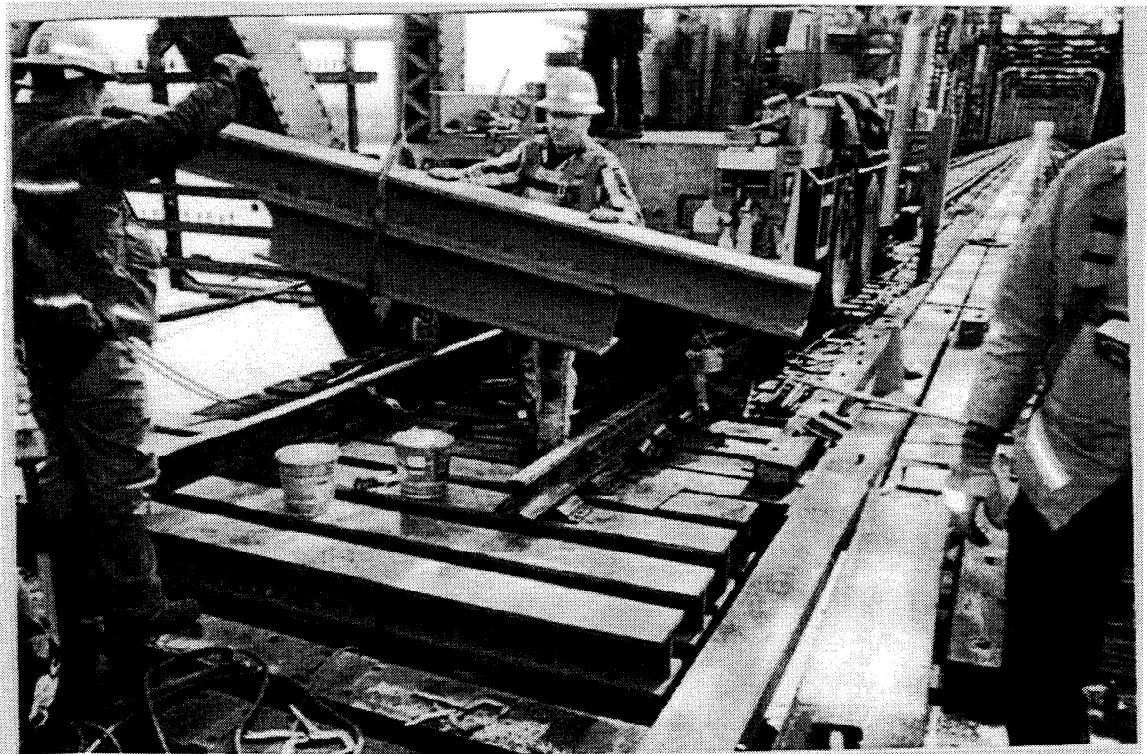
Photograph 5: Installation of New Steel Belly Beam Ties

- ◆ March 2000 – Install end lift machinery. During installation of the end lift machinery, remove the existing rail joint assemblies and replace the steel supporting ties with new ties modified to accommodate the existing rail joints and the new 3 piece rail joints planned for installation in March 2001.

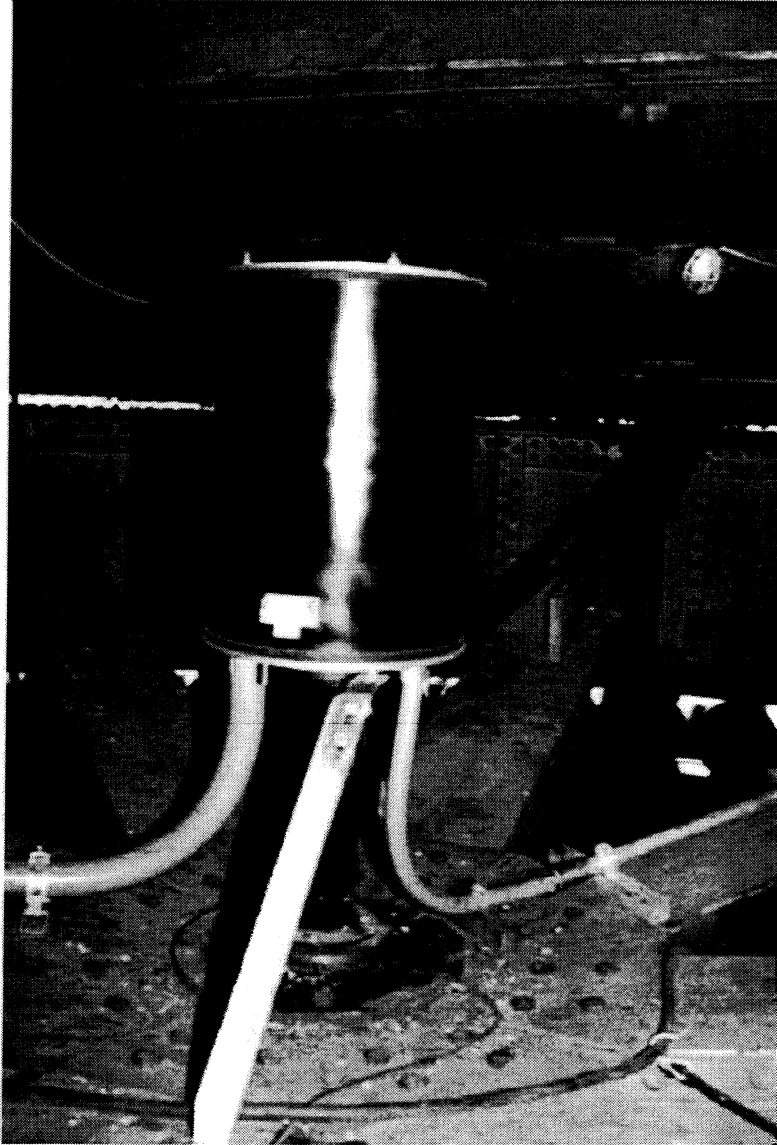
Photograph 6: New Slip Ring Placed on Top of New Center Bearing Pin

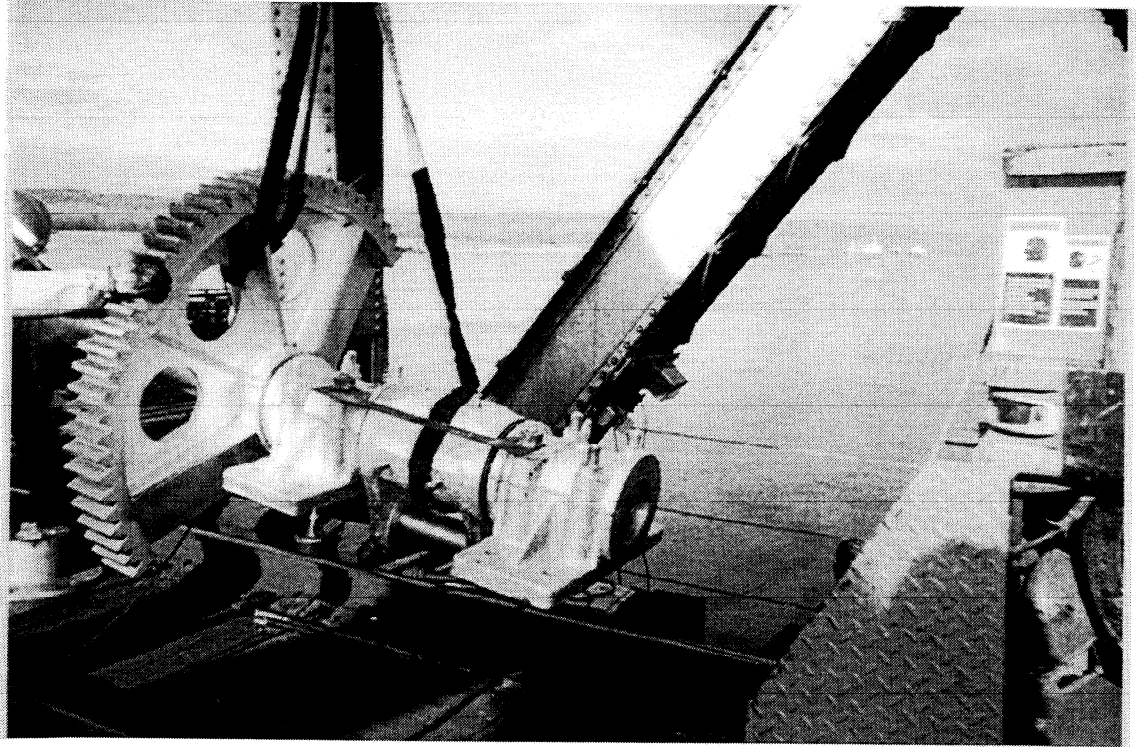
Several years ago the BNSF started to experience operational difficulties with the movable span. The movable span occasionally would not re-align with the rest piers and failed to line up the rails for passage of rail traffic. In 1991, a segmental gear on the Vancouver end lift operating mechanism fractured and consequently halted vessel navigation through Bridge 9.6 for 4 days. The segment gear had to be field welded back together in order to restore span operation. Several other less severe mechanical and electrical equipment problems have also occurred prompting additional concern about the continued reliability of the swing span. The original equipment was designed for 600 Volts AC. The Power Company can no longer furnish this voltage to the bridge, so the current line is feeding the bridge at approximately 535 Volts. Over the years, this voltage difference combined with the wiring problems from the shore to the span has decreased the reliability of the electrical system.

Photograph 7: New Quadrant Gear for End Lift

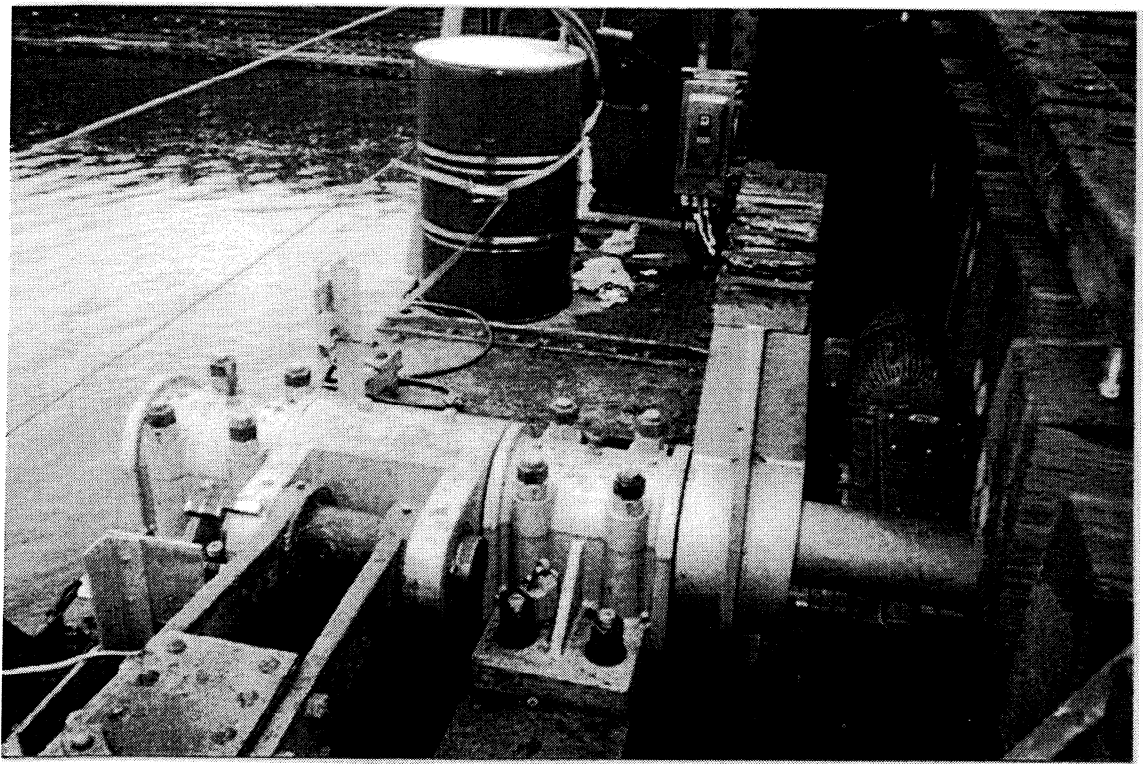
Photograph 8: New End Lift Machinery Installed

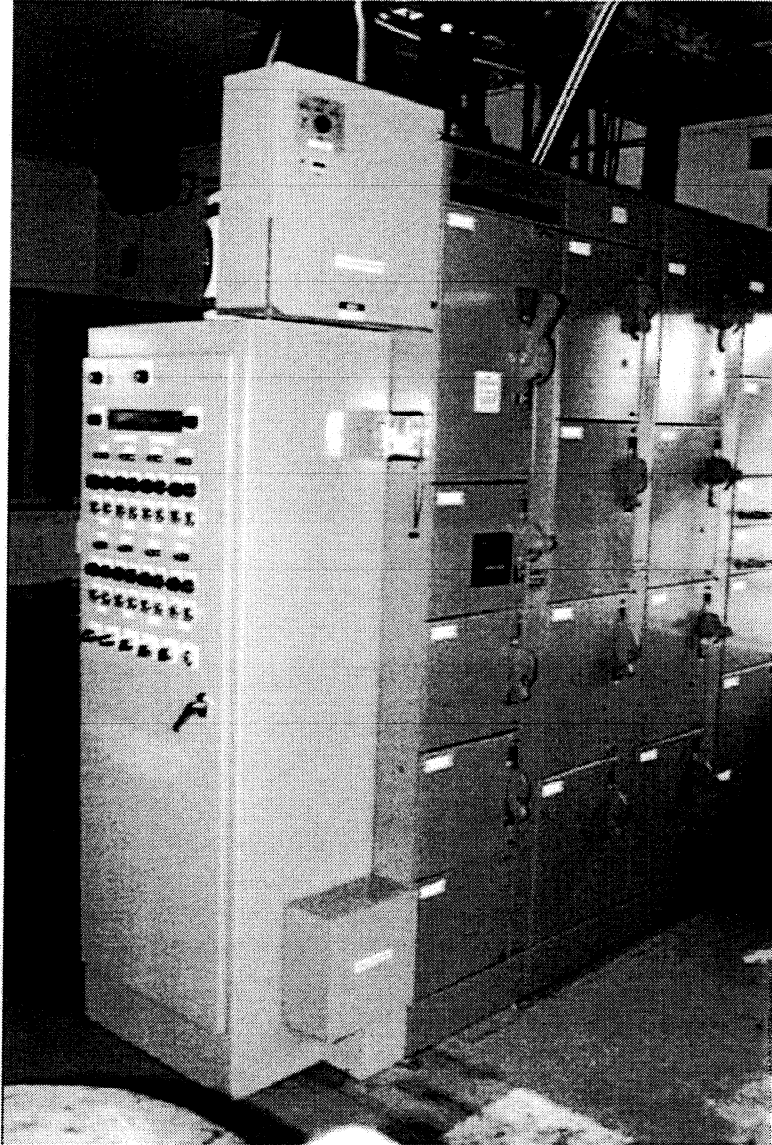
Photograph 9: New Control System PLC Cabinets

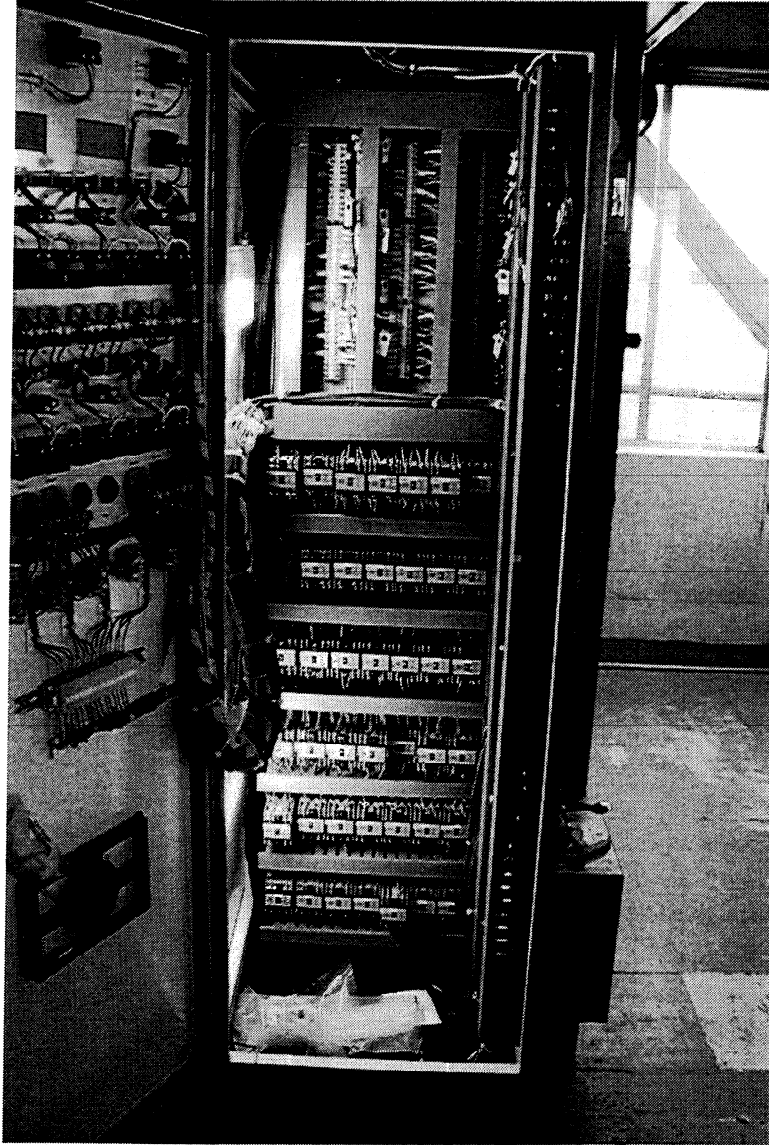
Photograph 10: New Control System PLC Cabinet

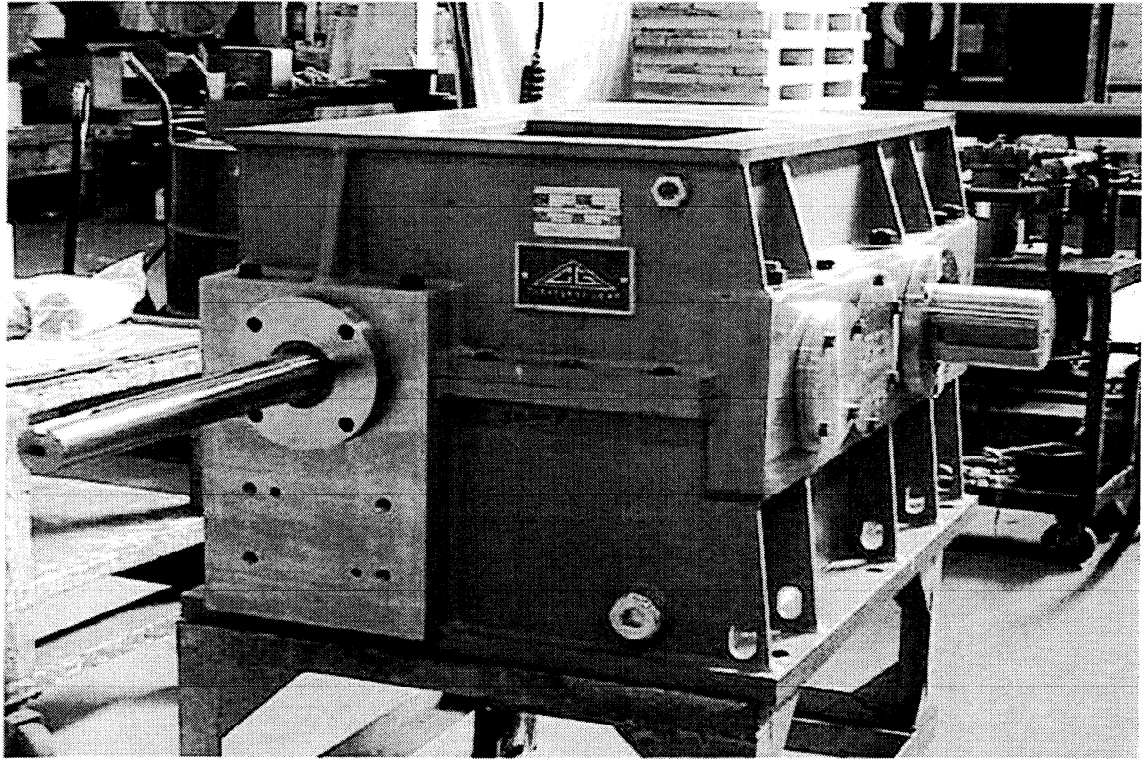
Photograph 11: New Main Drive Enclosed Gear Box

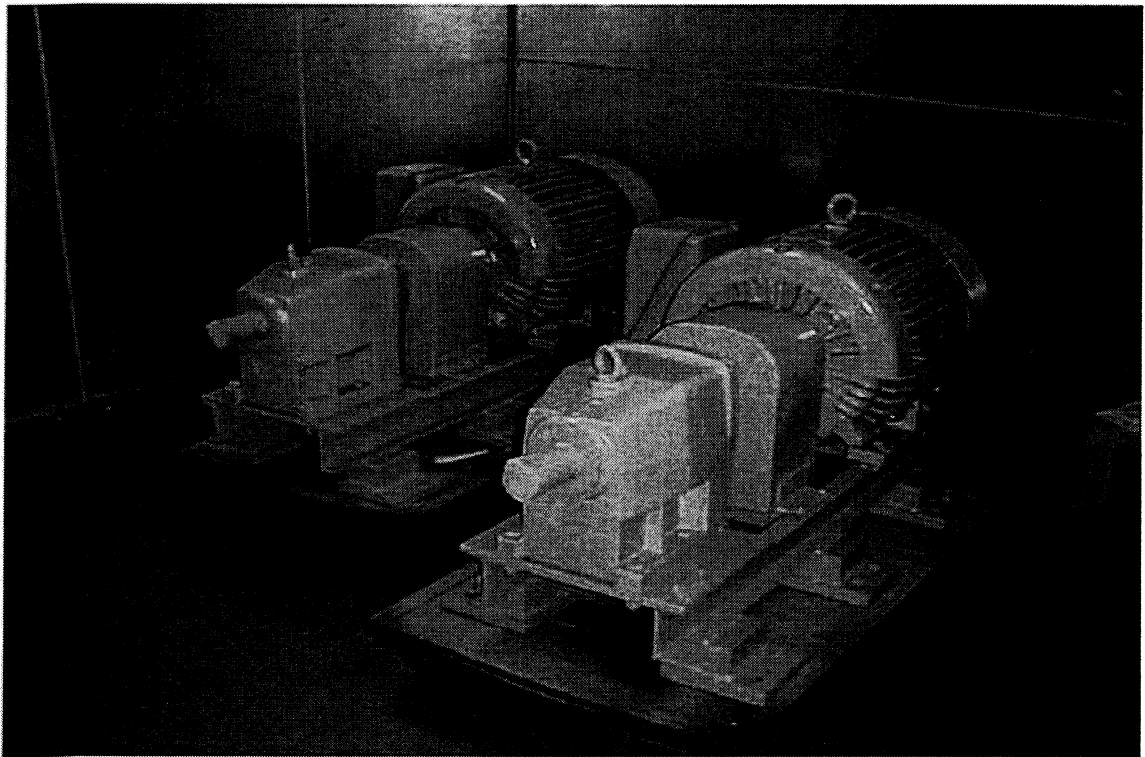
Photograph 12: New Auxiliary Drive Equipment
