**NINTH BIENNIAL SYMPOSIUM**  
"Preserving Traditional Values with New Technologies"

VERTICAL LIFT BRIDGE REHABILITATION

Kevin R. Eisenbeis, P.E. & Steven M. Warger, P.E.  
Harrington & Cortelyou, Inc.

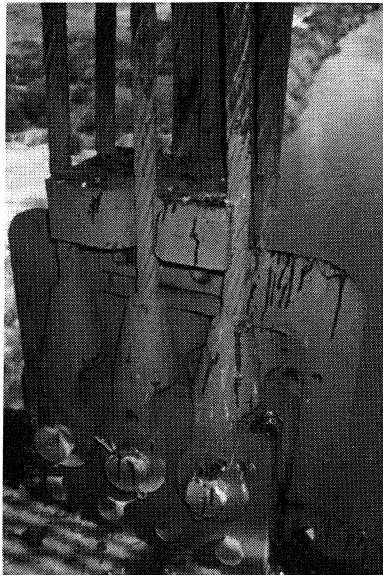
**Figure 1**

When initially inspected in 1996, the lift bridge utilized streetcar type controllers, original motors, drive machinery and an auxiliary gasoline generator. A complete rehabilitation of the bridge was made in 2000, with conversion to fully programmable controls. New motors, brakes, electrical system and bridge ropes were provided. A diesel auxiliary generator was also installed. Inspection of the counterweight ropes revealed significant deterioration in the ropes at the anchorages to the counterweight. Counterweight ropes consisted of six, 1-1/4" diameter, 6x25 filler wire construction with hard fiber core ropes at each of the four corners. Several complete strands had broken due to deterioration, at the northwest corner. (Figure 1)

Deteriorated Counterweight Ropes

Further investigation showed significant deterioration to the northwest sheave ring gear located above the deteriorated rope anchorages. Gear teeth were approaching knife edge conditions, with probability of breaking teeth imminent. Problems with the ropes and ring gear are attributed to an extended lack of lubrication early in the life of these components.

Replacement of the northwest ring gear and all counterweight ropes was necessary. Plans for the 9'-0" diameter ring gear were developed for replacement in two halves, to allow the sheave to remain in place. The contractor proposed to remove the sheave and install the ring gear in one piece at the suggestion of the gear manufacturer. A more precise machining and fit up could be provided with the one piece gear.

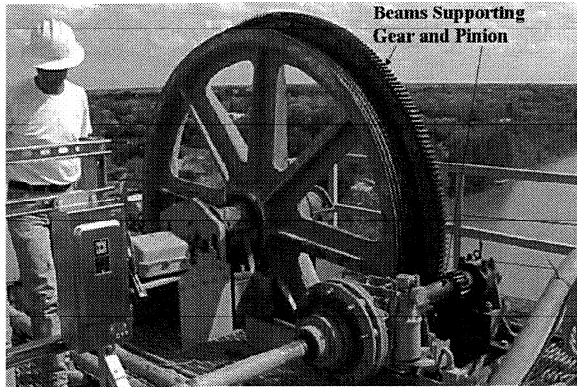
Figure 2

Original Ring Gear

After the counterweight was supported from the tower and the bridge ropes were removed, the northwest sheave was removed and transported to the machine shop. The old gear was removed and the new gear installed. **(Figure 2 & 3)** Sheave was returned and reinstalled over a 24 hour period. New ropes were then installed on the bridge.

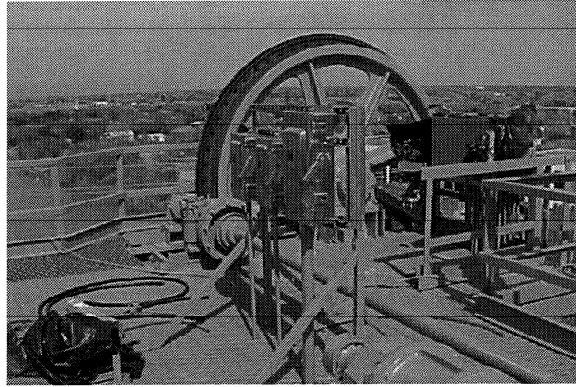
Figure 3

Replacement Ring Gear

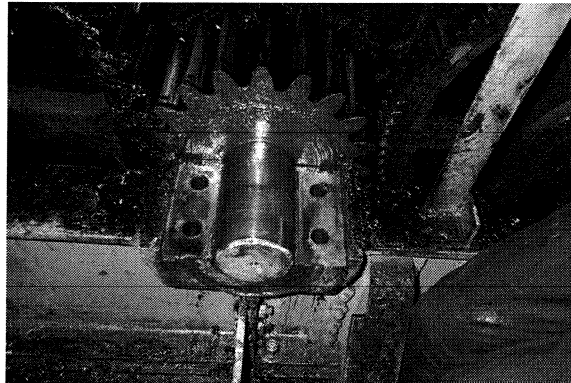
**Figure 4**

Subsequent inspections have been performed for the Port of Corpus Christi Authority. Several items of interest have been observed. A recent inspection revealed a damaged shaft journal when a bearing cap was removed. While discussing possible reasons for the damage, a workman noted that he had found one of the cap bolts on the floor a couple of weeks prior. Two other bolts were loose, with the remaining bolt still tight. The bolt was reinstalled and all bolts tightened at that time.

After removing the bearing cap, damage observed at the 5" diameter shaft included a 1 3/4" wide x 1/8" deep missing piece of the steel shaft. **(Figure 4)** The damaged area extended circumferentially over half of the visible journal, with the remaining 1 3/4" wide portion somewhat loose. The total width of the shaft in the bearing is 9".

Damaged Shaft

A replacement shaft is currently being machined. In order to minimize bridge down time at the busy port, repair of the existing shaft was not desirable due to the length of time required for transporting the shaft and making the repair. A new shaft and gear assembly will replace the existing gear and damaged shaft. Minimal bridge closure to navigation traffic was deemed a top priority by the owner. All cap nuts and bolt stick-thrus are being painted with a vertical stripe. As bridge maintenance crews lubricate the bearings, they also now look for possible loose nuts by checking the alignment of the nuts.

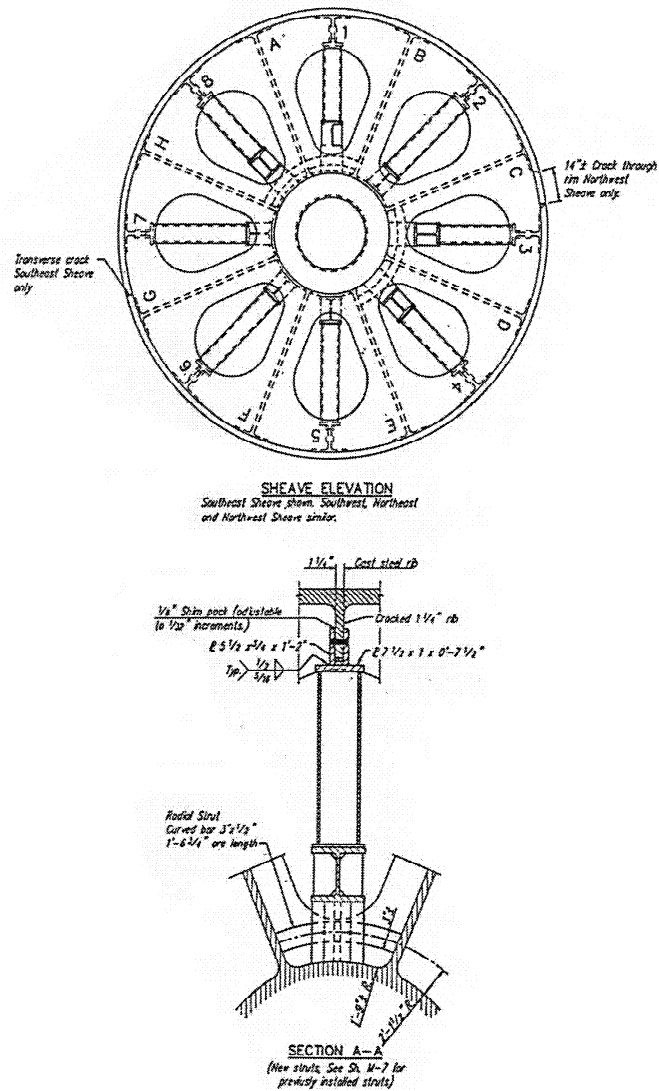
Figure 5

During an inspection of the sheaves, cracks were detected along the centerline of the sheave. Original sheaves were constructed in two halves. Cracking was detected along the weld where the two halves were connected. To avoid the high cost of replacing the sheaves, a repair was developed to strengthen the sheaves, after the cracks were repaired.

## Sheave Reinforcement

Steel pipe struts, extending radially from the hub, were inserted between the existing spokes. Welded shim plates were used to develop a tight fit to the hub and outer portions of the sheaves. The struts reduce localized deflections as the sheaves turn and the counterweight ropes load the sheaves. **(Figure 5)**

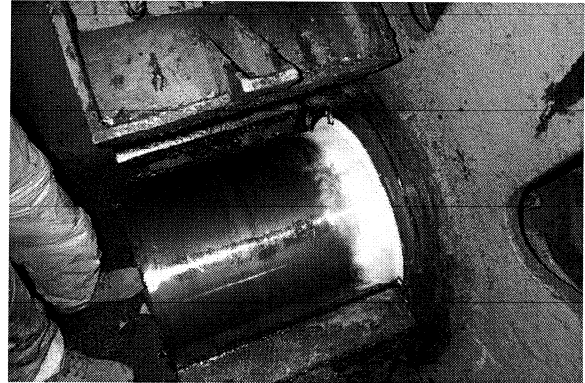
**Figure 6**

Routine inspections of the bridge include non-destructive testing of the sheave shafts. Dye-penetrant testing of the fillet on the shaft is performed. (Figure 6) Sheaves are rotated through 120 degrees of rotation with shafts observed and tested at each location.

### Dye-Penetrant Testing on Sheave Shaft Fillet
