HEAVY MOVABLE STRUCTURES, INC.

STRAIN GAGE MONITORING FOR LOWER CHORD  
REPLACEMENT AT MARINE PARKWAY BRIDGE

Ryan Kanagy  
Stafford Bandlow Engineering

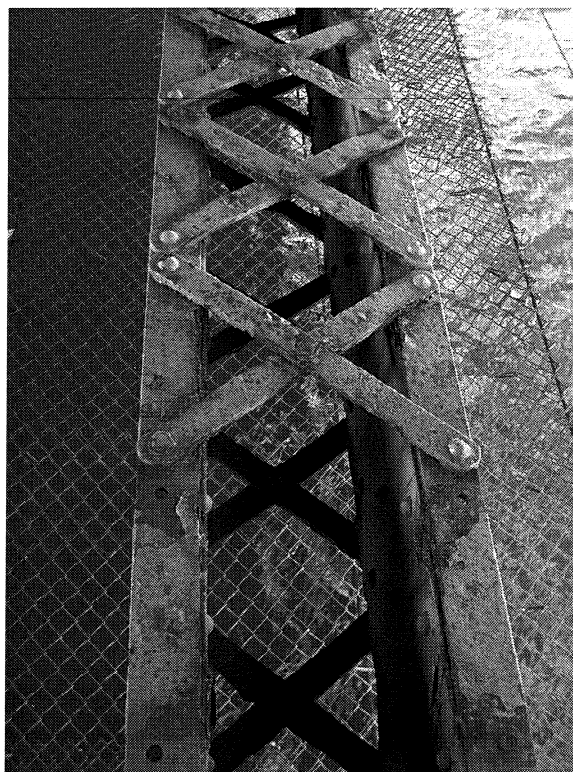
Inspection of the Marine Parkway Bridge structure identified 32 approach span bottom chords as being deteriorated to an extent necessitating replacement. The bottom chords are comprised of two channels stiffened by backing plates and connected by lacing bars. The deteriorated chords exhibited severe corrosive deterioration and pack rust. See Figure 2. The following steps outline the methodology for the bottom chord replacement:

**Figure 2: Typical Condition of Lower Chords, Before Replacement**

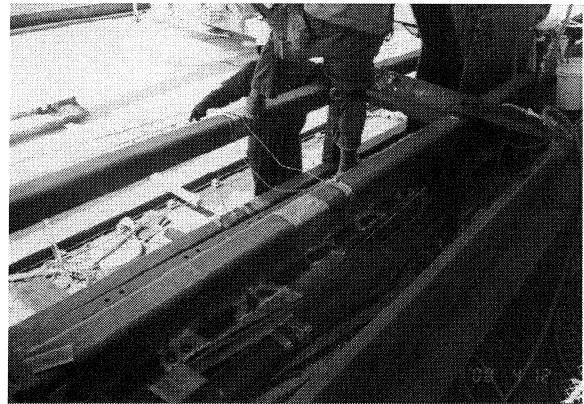
**Figure 3: Compression Jacking Frame Testing**

The use of the jacking frames was validated at the outset of the project through strain gage testing. Strain gages were installed on the square tubes of the compression frame (see Figure 3), and axial strains were

monitored as a function of jacking pressure throughout the jacking cycle. The forces in the compression frame members determined from the axial strain measurements corresponded very well with the jacking force calculated from the jacking pressures. This test validated the theoretical relationship between axial strain and applied force and between jacking pressure and jacking force. Additionally, the test confirmed that the jacking force transferred through the frame and was therefore applied to the truss at the frame connection points.

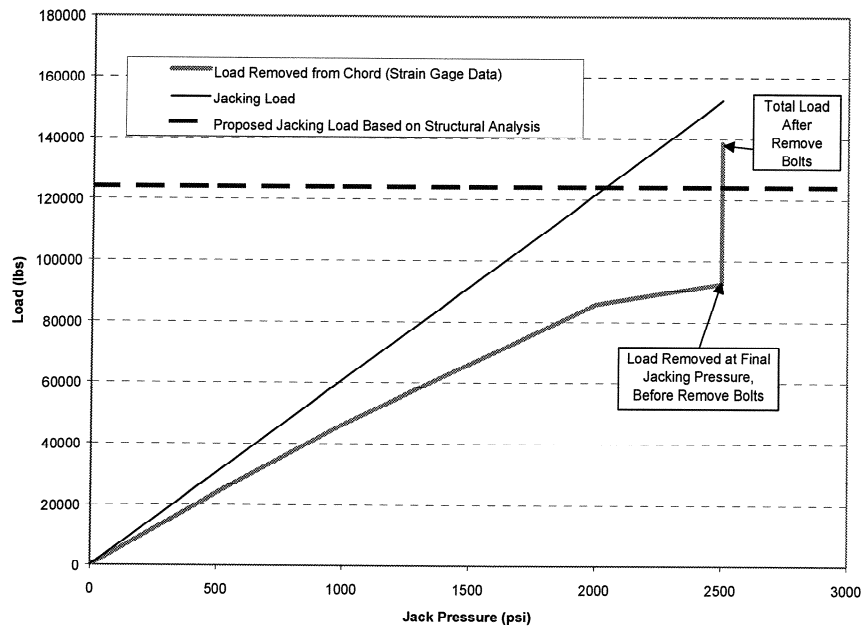
Figure 7: Unloading of Existing Bottom Chord

- The removal of bolts at existing deteriorated chords resulted in a significant load change in the chord. This indicates that the full load of the existing chord was not removed by jacking.

Per the test procedure, existing chords were to be jacked to the theoretical pressure that would remove the entire load from the chords and result in loose bolt connections. During the actual implementation of this procedure in the field, this condition was not achieved. While some bolts were loose, others still held load and these fasteners had to be forced out. In Figure 7 the remaining effect of driving out the tight bolts on chord load is illustrated by the vertical spike in “Load Removed from Chord” after the jacking pressure had been finalized.

- The final measured load in the existing lower chords was consistently lower than the load provided by the jacks. See Figure 7.

This discrepancy is attributed to the fact that some portion of the jacking load was dispersed among the additional truss members at the chord termination points.

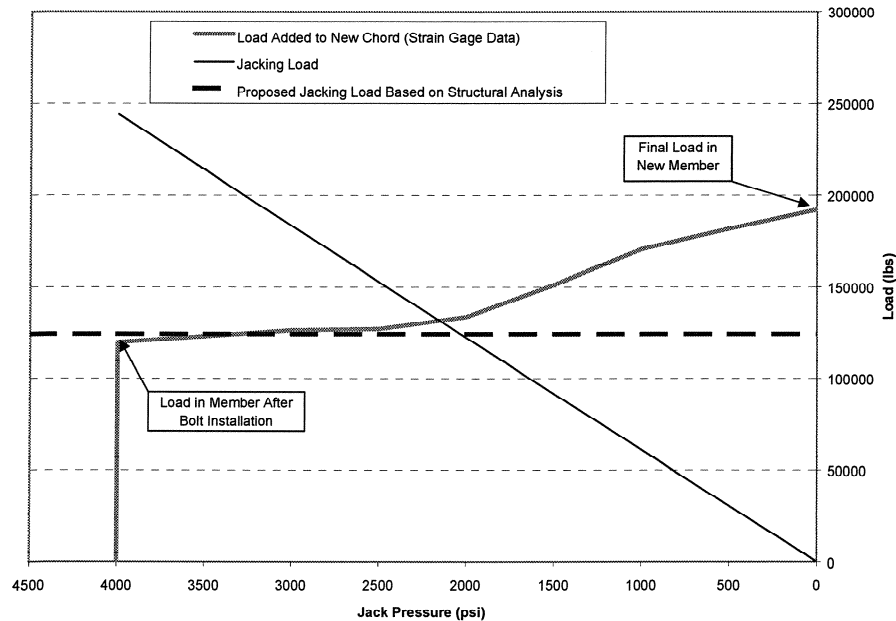
Figure 8: Loading of New Bottom Chord

- The installation of bolts for replacement chords resulted in a significant load increase in the chord.

During installation of new chords, misalignment of bolt holes or small differences in length of the new chord compared with the existing chord necessitated the forceful installation of some bolts. The effect of this process is shown in Figure 8, with the spike in “Load Added to Chord” at the start of the new installation, before any load was transferred from the jacking frame to the new chord.
