HEAVY MOVABLE STRUCTURES, INC.

NINTH BIENNIAL SYMPOSIUM
"Preserving Traditional Values with New Technologies"

**MACHINERY REHABILITATION FOR MAIN STREET
BRIDGE, DAYTONA BEACH, FL**

John R. Williams, P.E.
Lichtenstein Consulting Engineers

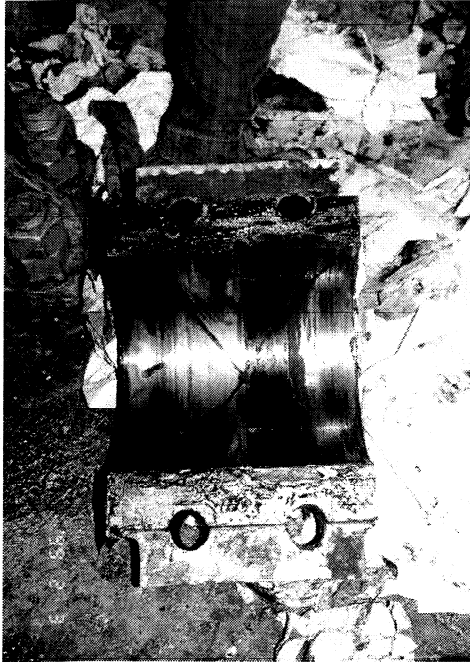
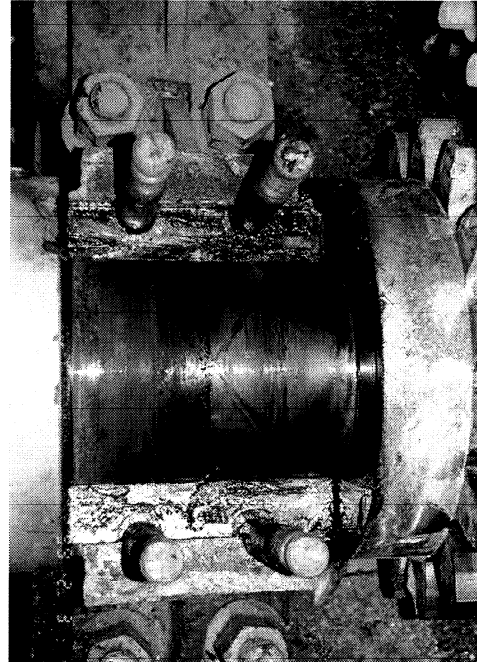
1. The wearing components for bearing B2N, West Leaf were in the worst condition of any of the opened bearings. Upon removal of the cap, it was apparent that the bearing had a problem. There was no fresh lubricant on the journal and hardened grease deposits were present on the journal and cap including in the grease grooves and lube port. These signs are indicative of excess heat build up. Although the actual clearance was not known since the bearing was

Bearing B2N, West Leaf Opened for Inspection Prior to Cleaning

inaccessible for measurement, it was surmised that inadequate clearance in the bearing was the cause of the heat buildup. The cap was re-installed and the bridge operated. The heating of the bearing during operation was confirmed. The cap was removed and the existing shims for the bearing were measured. The east side of the bearing had $1/32''$ less shims than the west side. A total of $1/32''$ of shims was added to the east side of the bearing so that the shims on each side were equal ($1/2''$). The bridge was operated through 2 cycles following the addition of shims. There was no noticeable heat buildup at this bearing following this adjustment.

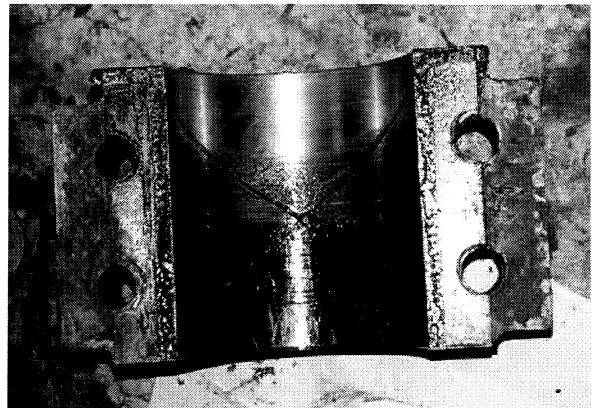
2. Two bearings that the clearance measurements indicated to be misaligned (i.e. taper across width of bearing) were opened for inspection. The wearing components at bearings B1N, East Leaf and B1N, West Leaf confirmed the measured misalignment. The wearing components for both bearings exhibited a moderately to highly polished band of wear which covered less than 25% of the available contact area. The remaining journal area was unworn and exhibited varying degrees of deterioration and corrosion.

Bearing Cap B1N, West Leaf Removed for Inspection Prior to Cleaning

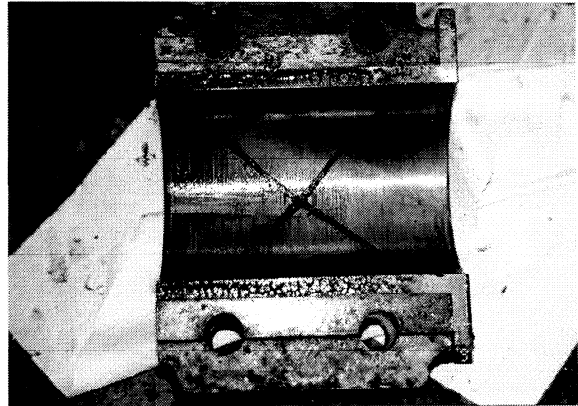
3. The remaining three opened bearings exhibited inadequate contact area. The polished wear area in the caps for B3S, West Leaf and B3N, East Leaf indicated limited and irregular contact. The wear in the cap for bearing B4S, West Leaf was limited to a 2" polished band located midway between the end of the cap opposite the thrust face and the middle of the cap.

Bearing Cap B3N, East Leaf Removed for Inspection Prior to Cleaning
