Repair of Counterweight Trunnions
on Strauss Bascule Bridge

by Ulo S. Pessa

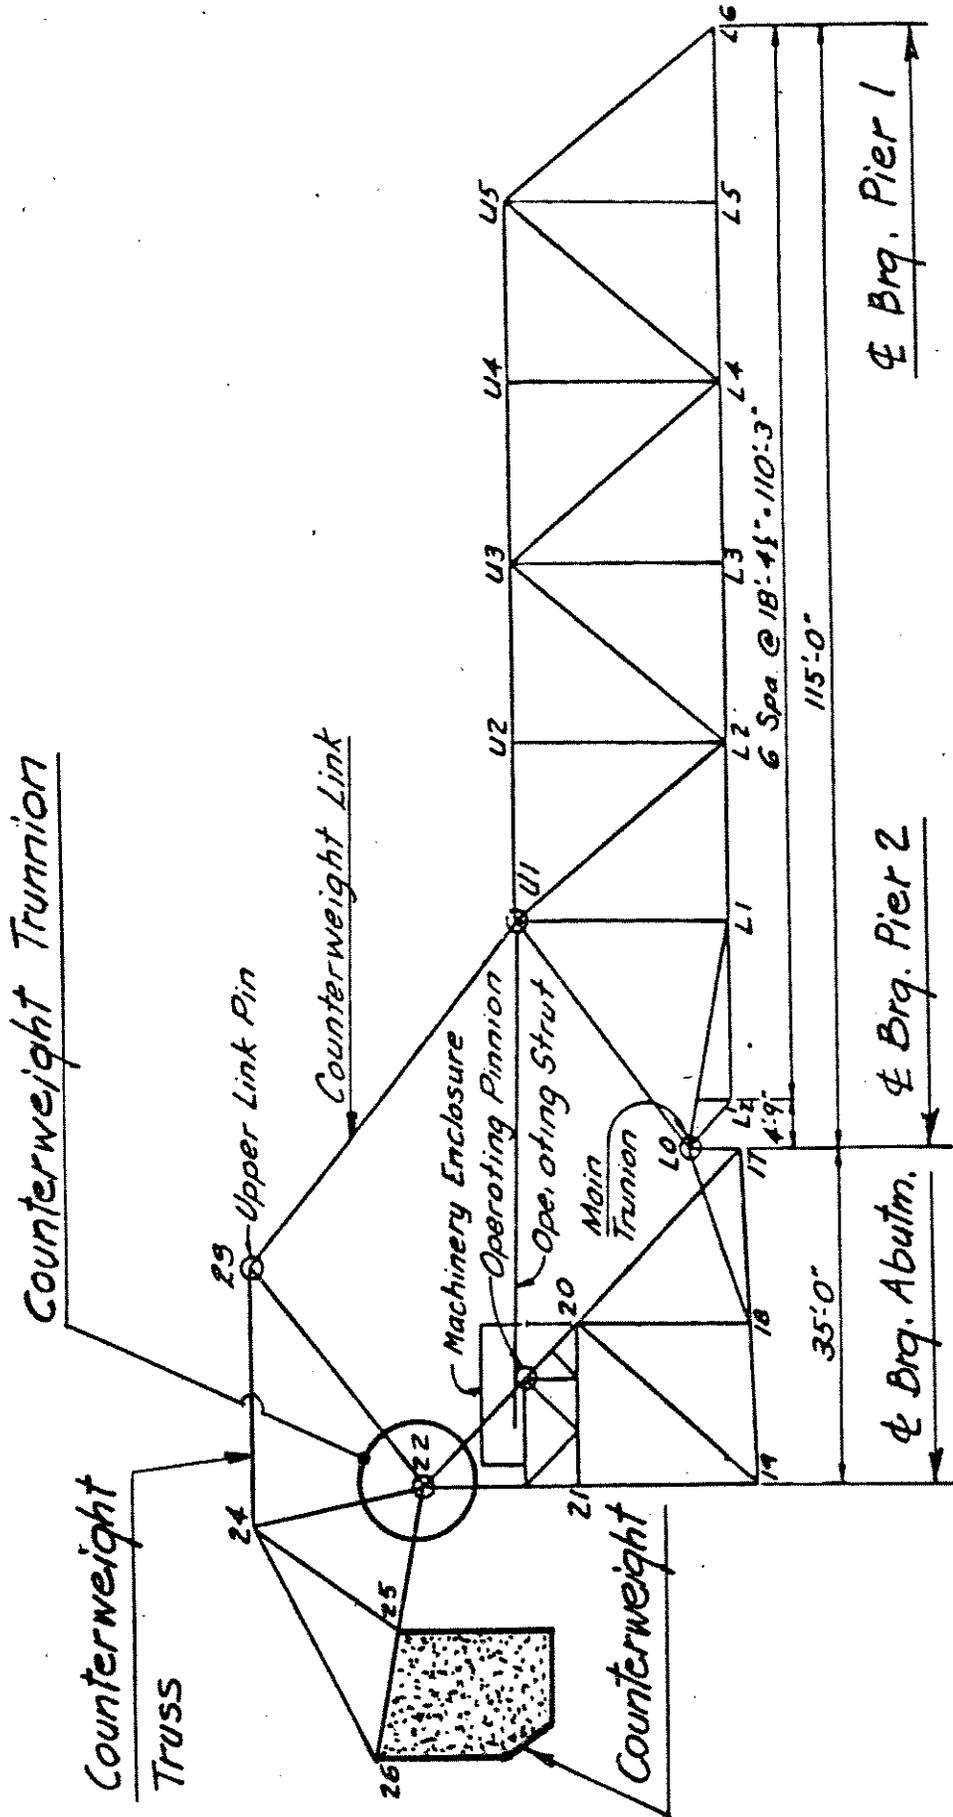
BASCULE SPAN

A schematic layout of the bascule is shown in Exhibit 1. The construction, typical of heel trunnion type bascules, consists of a 115 foot long bascule leaf which pivots on two main trunnions (LO). The leaf is counterbalanced by a counterweight attached to a counterweight truss, which in turn pivots on the counterweight trunnions (panel point 22). The leaf and the counterweight truss are connected by counterweight links with pinned connections at each end. This design has the advantage of dividing the dead weight of the leaf and the counterweight between the abutment and Pier 2. The leaf, being balanced, has no reaction at Pier 1. The reaction at Pier 2 is equal to the weight of the moving leaf and that at the abutment is equal to the weight of the counterweight and its frame.

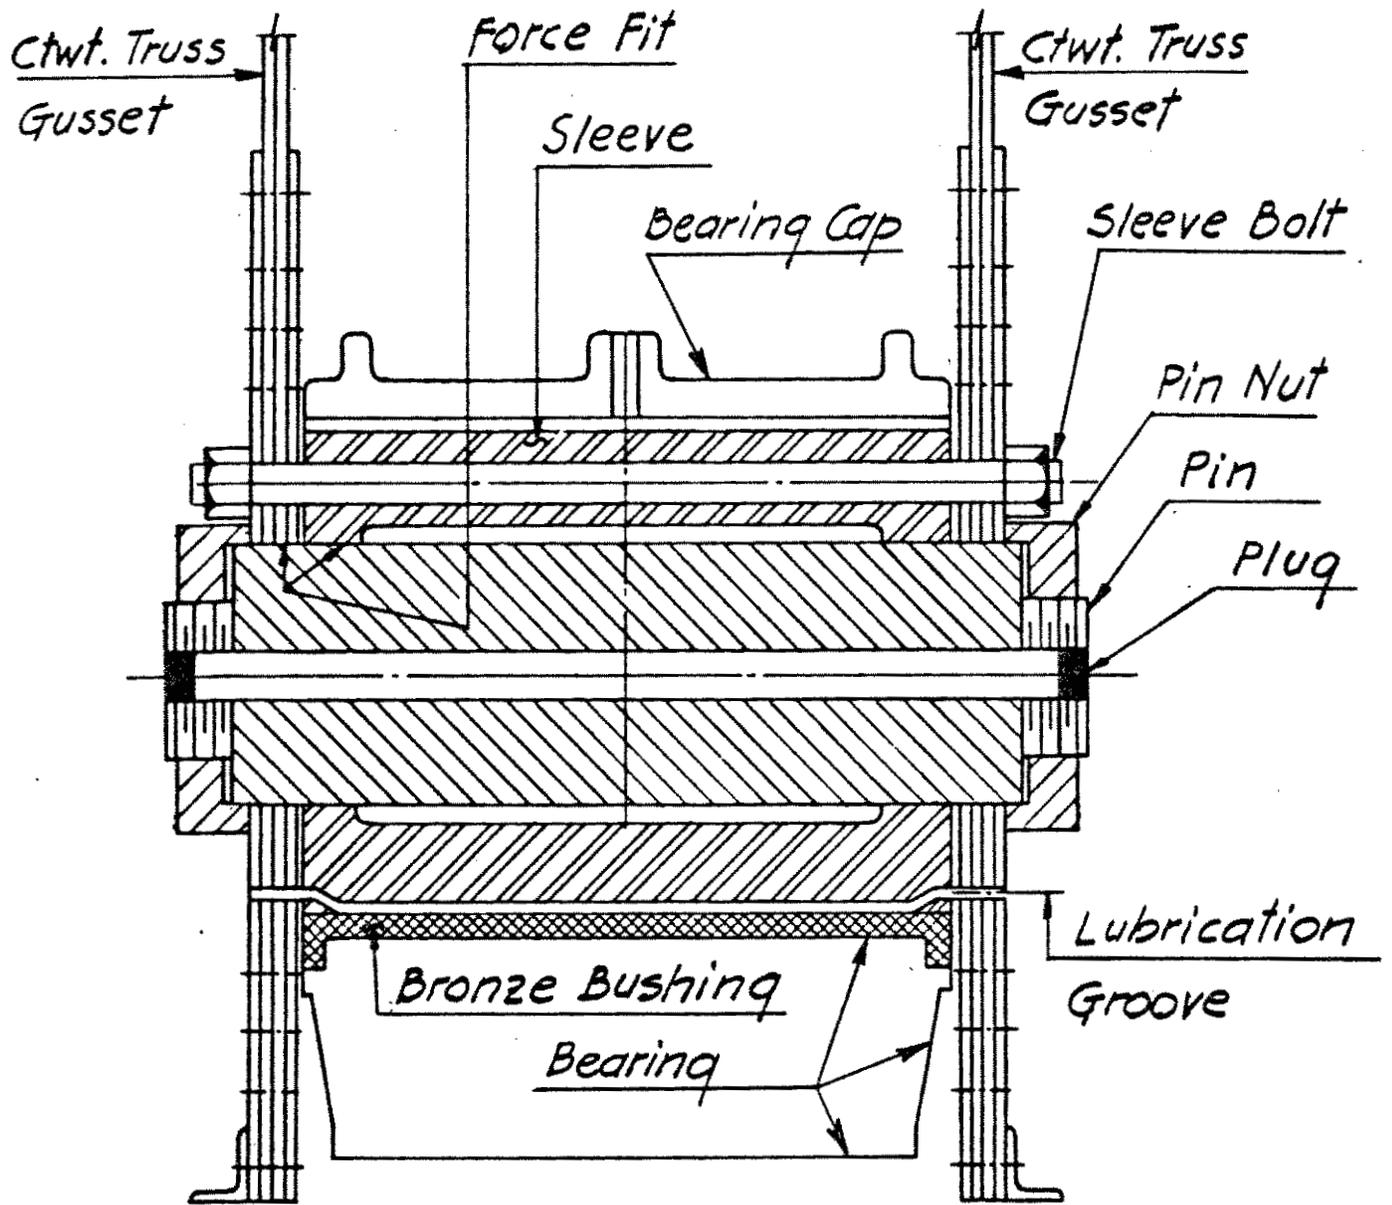
SECTION THROUGH COUNTERWEIGHT TRUNNION

A section through one of the two counterweight trunnion bearings is shown in Exhibit 2. Each trunnion consists of a bearing, a sleeve which rotates in a bushing inside the bearing, and a pin which passes through the sleeve. The pin is force fit into the sleeve and rotates with it. Both ends of the pin project beyond the bearing and pass through holes in the counterweight truss gussets. The pin is force fit into the holes in the gussets as well. The entire weight of the counterweight and the counterweight truss is introduced into the pins at this point and is distributed by the sleeves over a wider area. Bearing pressure on surfaces subject to rotation is thus considerably reduced.

A preliminary inspection of the counterweight trunnions revealed open holes at some of the sleeve bolts. The nuts and ends of the bolts were missing at these locations, but remnants of the bolt were visible inside the sleeve. At other locations sleeve bolts, apparently broken, had "walked out" and extended as much as seven inches beyond the face of the gussets. Also, the nuts of a number of the sleeve bolts were missing.

At locations where portions of the bolts together with their nuts are missing, bolt holes are exposed and can be inspected. It was noted that none of the bolts have sheared in the plane between the sleeve and the gusset, but that most have broken at locations approximately one to two inches into the sleeve. As a result, the joint between the sleeve and the gusset can be visually examined. It was found in all cases that the holes in the sleeves did not line up with those in the gussets. The misalignment of the holes was found to be about 1/2 inch at one counterweight trunnion and 1/4 inch at the other. Obviously, slippage had taken place between the sleeves and the gussets.

Inspection of the counterweight gussets and ends of the sleeve pins after removal of the pin nuts confirmed that the pin holes in the gussets were indeed enlarged. Gaps between the pin and the hole in the gusset measured from 0.09 to .12 inches. The gaps generally extended over a 100 degree area tapering from a maximum at the center to zero at the ends. The location of the gaps in the lower right quadrant (when looking at the end of the trunnion with the leaf on the right hand side) was consistent with the direction of the loads on the trunnion in the span seated position.

The plan was to jack the counterweight to remove the load from the counterweight trunnions, and then replace the counterweight truss gussets. We also planned to replace all the working parts of the bearings, consisting of the pins, sleeves, bushings, sleeve bolts and pin nuts.

The counterweight, which together with its truss weighs about 800 tons, will be jacked up to remove the load from the counterweight trunnions prior to the start of the work. Eight 150 ton hydraulic jacks will be used to jack against a temporary steel frame placed under the counterweight. In order to prevent damage to the abutment and wingwalls from the surcharge created by the weight of the counterweight, the temporary steel frames will be supported on piles driven into the approach roadway. The piles will remain in place after the temporary frame has been removed.
