**HEAVY MOVABLE STRUCTURES, INC.  
FOURTEENTH BIENNIAL SYMPOSIUM**

**Updating Portland Bridges with FRP**  
Kenneth Huntley P.E.  
Multnomah County

# UPDATING PORTLAND BRIDGES WITH FRP

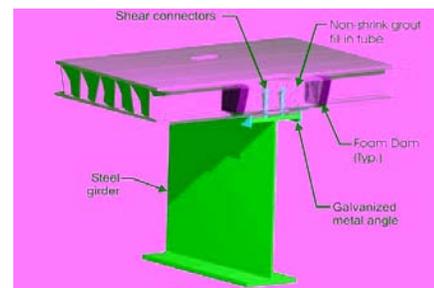
Caption: DuraSpan Deck to stringer connection detail

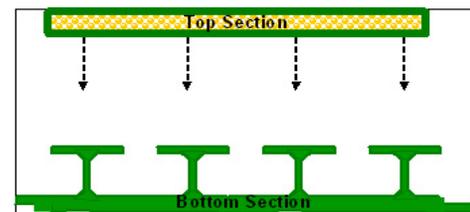
CAPTION: Zellcomp panel construction

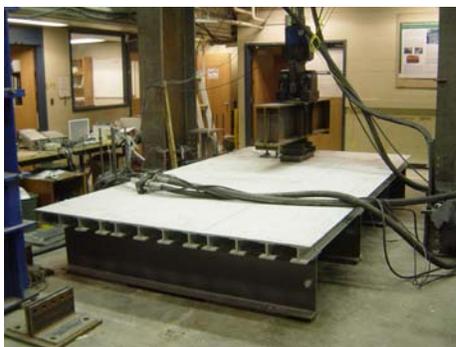
CAPTION: Testing of modified deck design

We asked ourselves “What if we eliminated the top sheet and flipped the ZellComp panels over?” This would significantly reduce the weight of the new deck as well as lower the profile by 1/2 inch, making it much easier to match the existing grade. The County presented this design change to Dan Richards of ZellComp to get his opinion. He agreed that this was a viable option given that the spacing of the stringers on the Morrison deck is only 3'-10". Some testing would need to be done to determine the load capacity of this configuration. Both ZellComp and the County did some mock-ups with this configuration and subjected them to loads that would take them to failure. Both sets of test data concluded that these

panels had the capacity to handle vehicle live loading on the Morrison Bridge. The next question to answer was fatigue life. What kind of life expectancy could be achieved with the modified deck design?

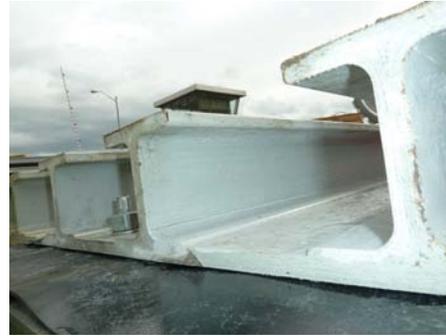
When the first ZellComp panels were delivered, the County noticed that several of the panels had cracks that ran, in many cases full-length, along the corners between the webs and the flanges. In some cases, cracks were observed in both the top and bottom of the panels. This was cause for serious concern for the County. The specifications called for no cracks or other imperfections in the panels. ZellComp and Strongwell assured the County that these cracks were not structural, but only cosmetic, and would not adversely impact the performance of the panels. This was not enough for the County to feel confident that there would not be immediate or future problems with the panels. The County requested that destructive testing be done on one of the panels that exhibited the worst cracking to determine if indeed there was no reduction in capacity.

CAPTION: Cracked FRP Panels

From the isolated "I" section tests, the results showed a reduction of capacity of 16.6% with the crack in the tension region and 15.8% when the crack was in compression. When the cracked panels were tested as part of a complete system, we estimated a reduction of about 8% when compared to the Creative Pultrution test sample.

Fatigue test results showed no reduction in capacity over the cycle life and there was no visible damage to the panel. Based on the completed test results, the County concluded that, although there may be some minor reduction in capacity, the cracked panels are still capable of performing as intended for the design purpose with no significant risk.

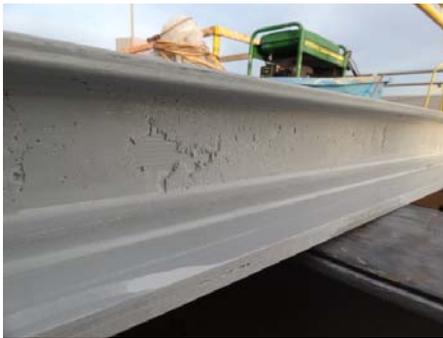
CAPTION: FRP Panel with web voids

The next set of panels to be delivered had two panel sections with voids within the webs of the panels. This condition also was out of specification and raised the issue again as to whether these panels should be installed or not. We did not have the option of doing further testing to determine the effects these voids might have, as there were no more replacement panels available. It would also be several months before new panels could be produced if these panels ended up being rejected or destroyed through testing. The risk that is posed by this type of void in the panels is that under bending load the web could buckle and create a weak spot. Though

there most likely would not be an immediate failure, fatigue could be an issue in a relatively short time period.

The first option presented by ZellComp was to sandwich the webs with FRP sheets on either side of the voids. This would require drilling holes into the webs which would not be ideal, but better than the voids. Then one of the County inspectors came up with the idea of filling the cells next to the web voids with grout. This would provide resistance against buckling of the webs and offered a rather inexpensive fix that was easy to install and required no holes being drilled into the panel webs.
