MAINTAINABILITY OF A MOVABLE BRIDGE  
by  
Lynn W. Biwer, PE  
Administrator, Mechanical/Electrical Section  
Bureau of Structures  
Florida Department of Transportation

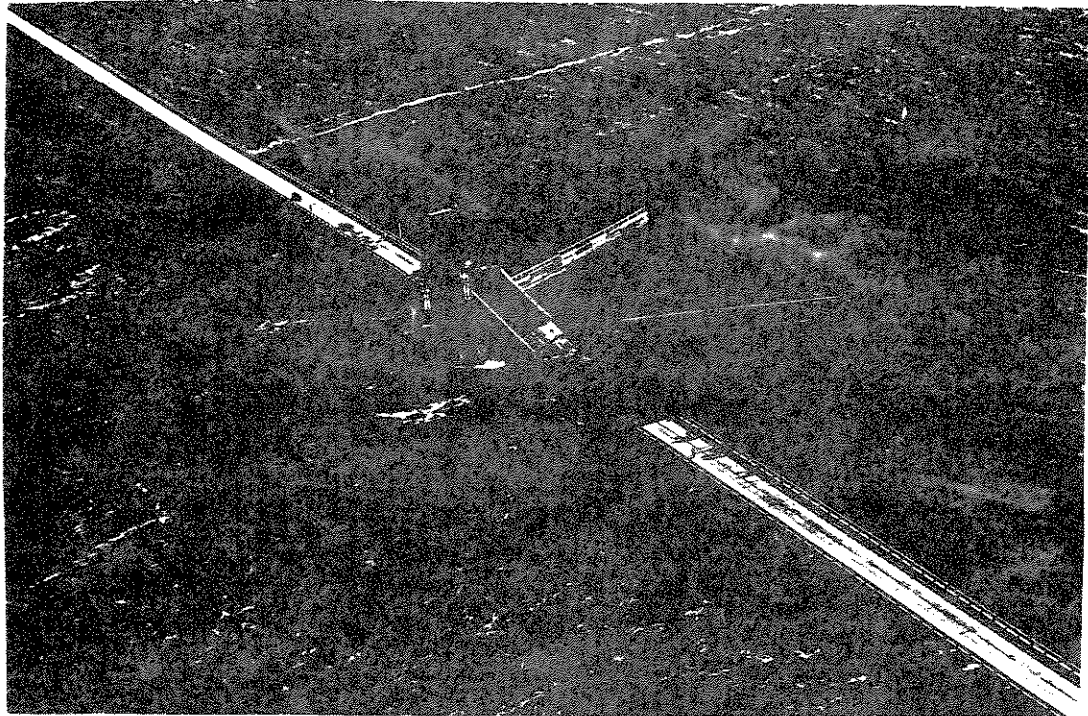
FIGURE 1

The breadth encompassed by the above definition of maintainability will be appreciated from Figure 1, a photograph of Choctawhatchee Bay Bridge following impact by five barges pushed by a tug.

As the barges approached the span, the bridge tender raised the bascule; it is believed that unpredictability of cross-currents and wind were responsible for off-course vectoring of the barges

toward the bridge fender system and the bascule pier. Eight approach spans were destroyed.

There were no cost-effective maintenance procedures which might have avoided this catastrophe. Marine and vehicular traffic were certainly interrupted! Considerations in design of this bridge, as it relates to the accident, involve impact capability, visibility factors, channel width evaluations, wind effects, hydrography, marine and vehicular traffic and operator safety.

This bridge, thus, is rated as "poor" from a maintainability standpoint. 27 impacts, with damage of various amounts, have occurred during a period of 12 years.

The entire control house was swept from the structure and the bridge tender was killed in this accident. It is notable that the bascule configuration was such that the hand railing and bascule leaf, in the open position, prevented the bridge tender from escaping the control house before the barges impacted the pier.

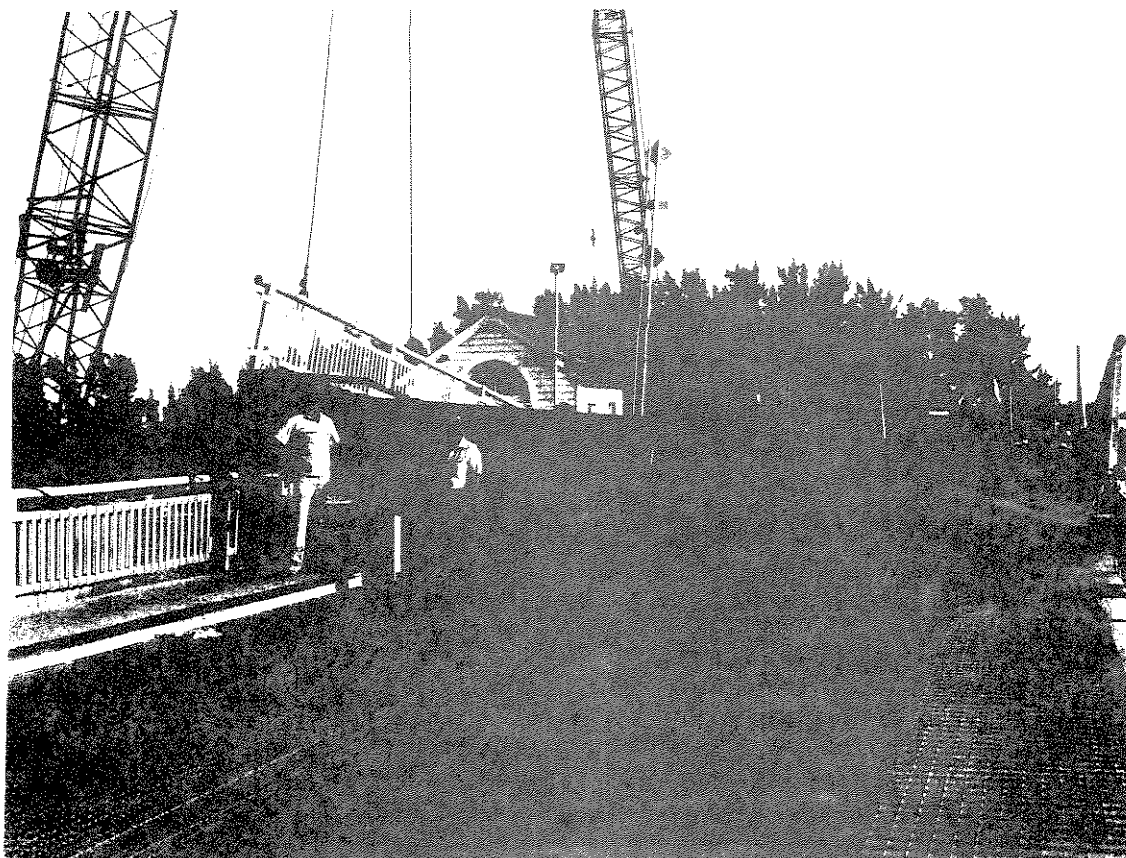
FIGURE 2

Figure 2 shows New Pass bridge following structural failure of the bascule girder. Failure resulted from severe corrosion in the region just forward of the counterweight. Following emergency repairs, the bridge was welded shut and now handles only vehicular traffic. A new bascule is nearing completion of construction.

This bridge provides an example of poor maintainability. The region between the bascule girder and the counterweight was inaccessible for routine maintenance and inspection. Moisture was retained in the region where corrosion was progressing.

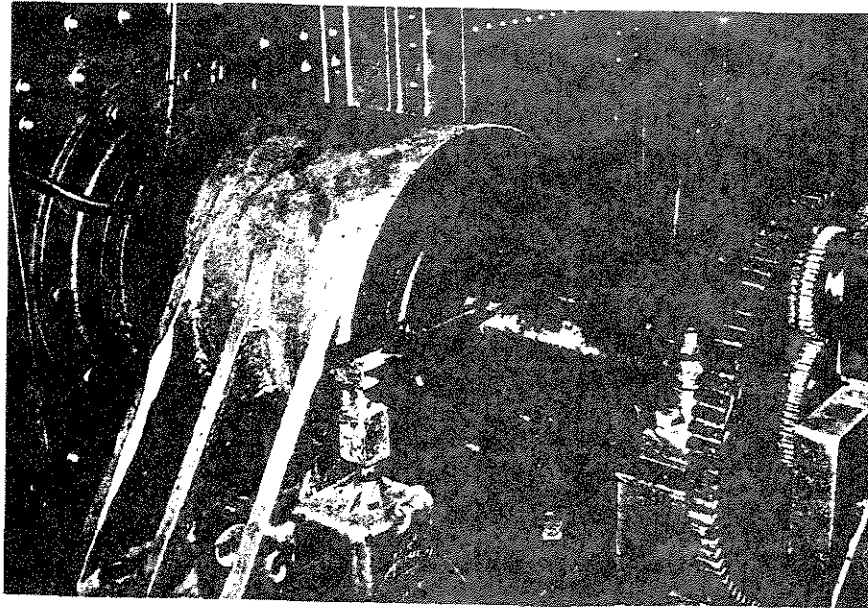
FIGURE 3

Poor maintainability of trunnion bearing lubrication results in deleterious effects such as complete stoppage of lubrication to bearing surfaces, as has been encountered in three Florida bridges. Characteristically, if lubricant passages are infrequently purged by new lubricant, a hard, impervious material deposits inside the passage. Florida's experience has shown that complete closure of lubricant passages can occur within a period of as little as three months; in two of the three cases reported, the lubricant passages were inaccessible for proper maintenance.

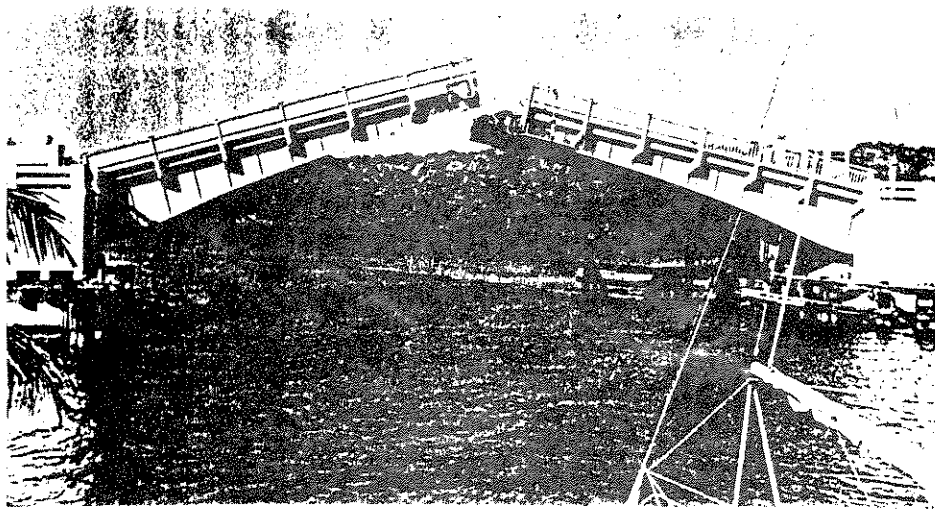
FIGURE 4

Jewfish Creek Bridge, shown in Figure 4, is located in the Florida Keys, was built in 1944, has an average daily traffic of about 11300, and opens for marine traffic approximately 800 times per month.

During routine inspection of the bridge, fractured bronze trunnion bushings were found; subsequent micrograph studies verified that the failure mechanism was fatigue.

Further inspection showed that the trunnions were considerably misaligned, and inspection records indicated that the realignment had probably existed since the bridge was constructed.

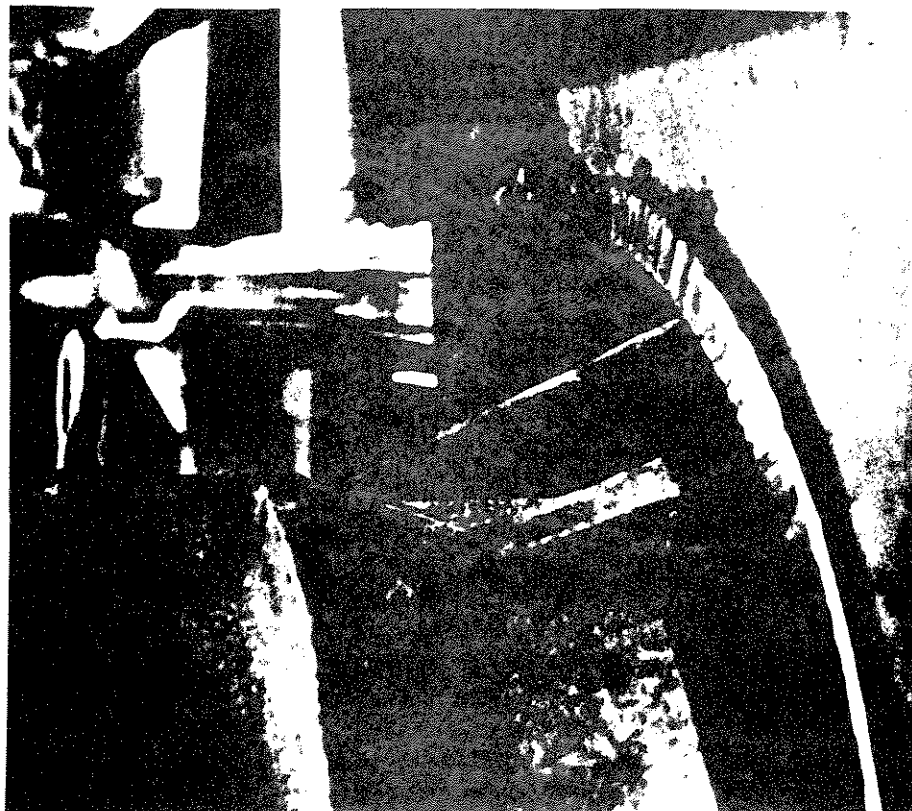
FIGURE 8

Another maintainability requirement learned through experience with Jewfish Creek bascule bridge is that protection from water drainage in trunnion bearing locations must be provided. (See Figures 8 and 9).

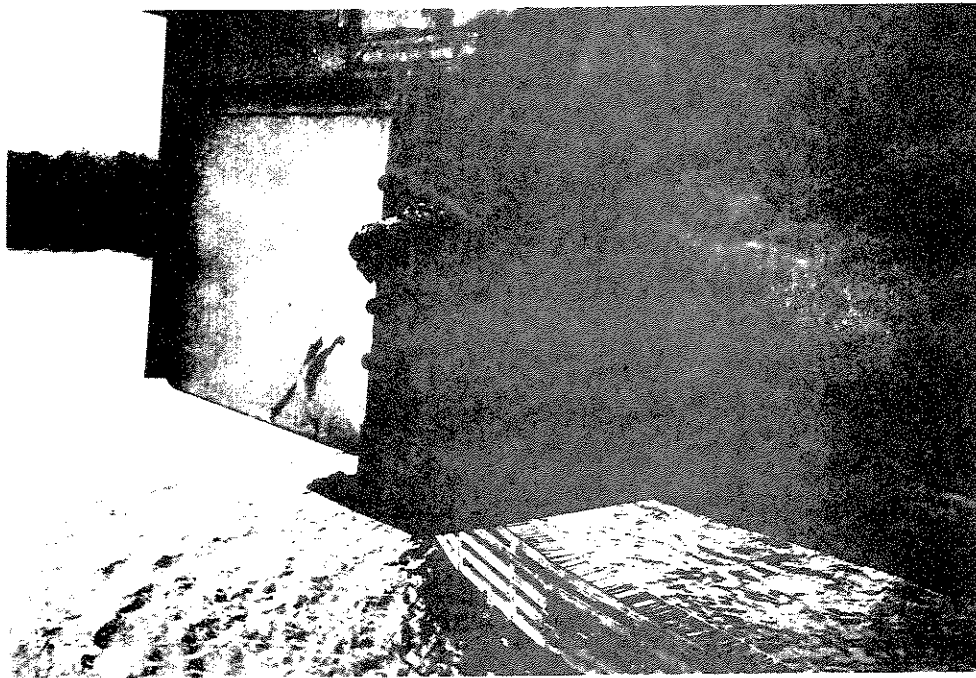
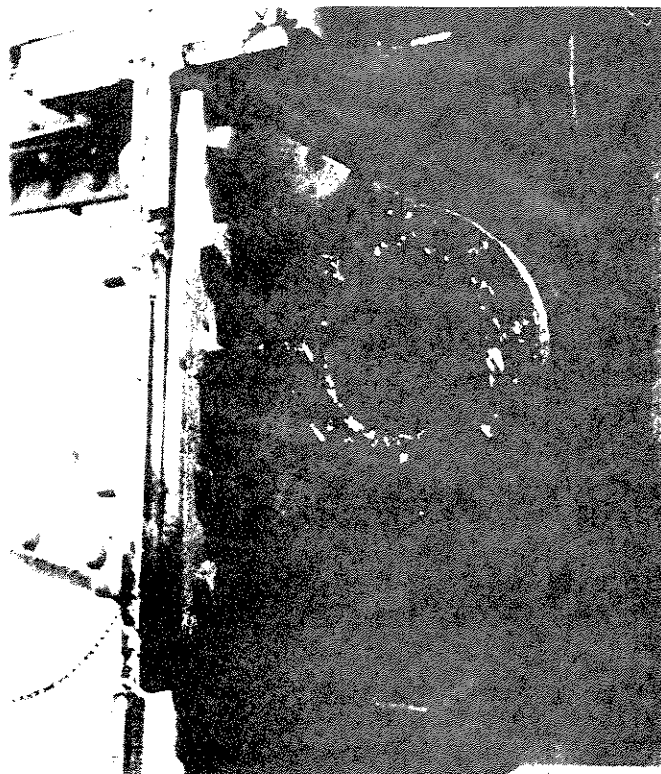
Still another maintainability problem found on a number of Florida bridges relates to span locking provision. Three bridges currently under rehabilitation contracts are Whitehair bridge, located near Deland, Wilson Pigott, located near Fort Myers, and Jupiter Beach bridge. These bridges have employed cylindrical locking bars, as shown in Figures 10 and 11.

With long term wear, lock integrity deteriorates because of lack of provisions for adjustment to compensate for wear. Of course, the current state of the art will permit application of lockbar systems having rectangular sections, for which satisfactory wear adjustment can be accomplished by the owner's maintenance forces.

Item 4 of the Maintainability Design Guide describes features to be included in lock system designs. The requirements include: accessibility; work platforms for maintenance; capability of operating a single lock (in multiple lock systems) with the remaining lock disabled; operating clearances to be adjustable for wear compensation.
