**HEAVY MOVABLE STRUCTURES, INC.  
FOURTEENTH BIENNIAL SYMPOSIUM**

**Emergency Repair of Counterweight  
Trunnion Pins on the Gloucester Draw  
Bridge**

HDR Engineering Inc.

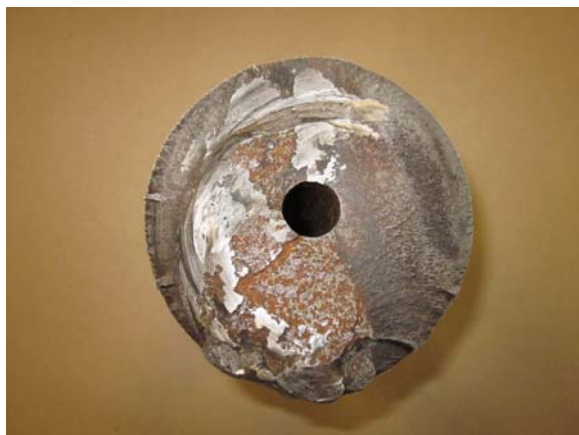
The existing stepped counterweight pins were heavily worn and scored. Scoring at the fillet provided a site for a fatigue crack to initiate, which started on the inboard side of the northern most counterweight trunnion. Over time the crack propagated through the pin until the pin failed. After the inboard side failed the outboard side seized in its' bushing and failed bending the hanger (See Figure 3 and 4).

**Figure 3 - Fatigue crack through the inboard face of the north counterweight trunnion pin**

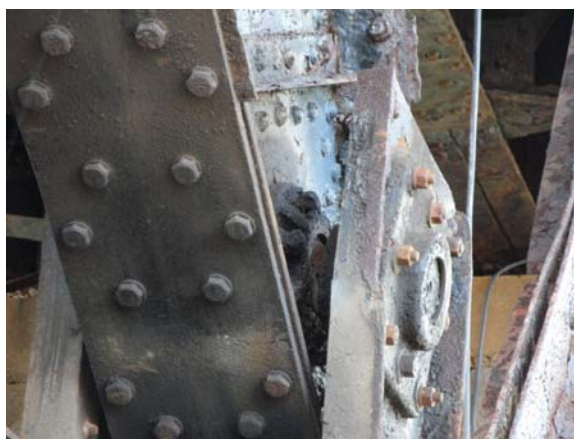
**Figure 4 – Bent outboard hanger and sheared counterweight trunnion pin**

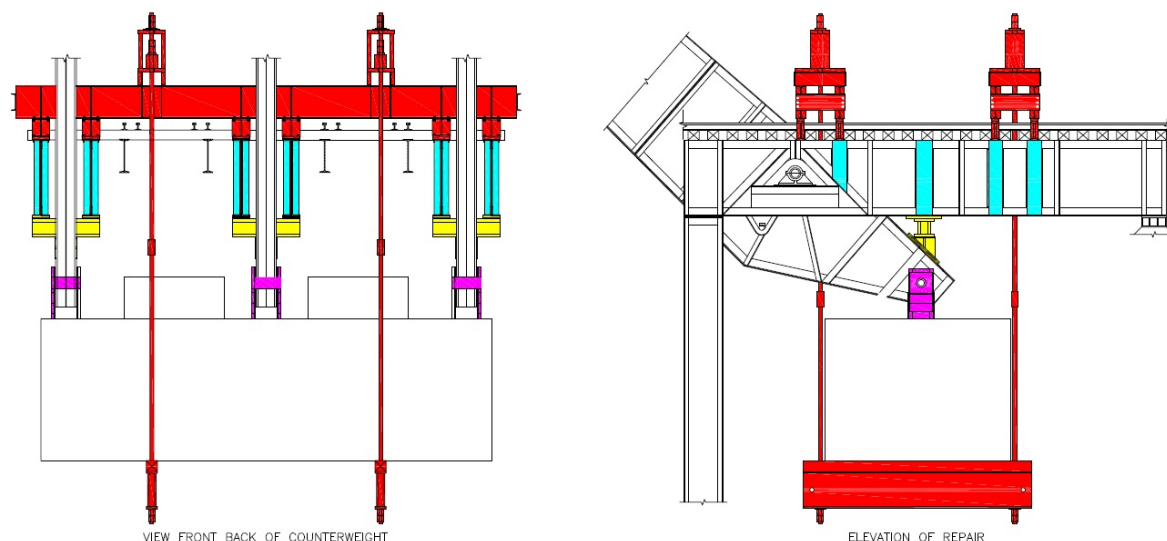
**Figure 5 – Counterweight jacking scheme**

Figure 5 shows the jacking concept used for the project which is discussed in further detail elsewhere. The items shaded in red are the primary jacking system which includes the lifting beams, threaded rods, jacking beams, jack housings, and hollow jacks. The items shaded in light blue are the timber flange and web stiffeners for the approach girders. The items shaded in yellow are the chock beam assemblies. The items shaded in purple are the counterweight trunnion pins and hangers.

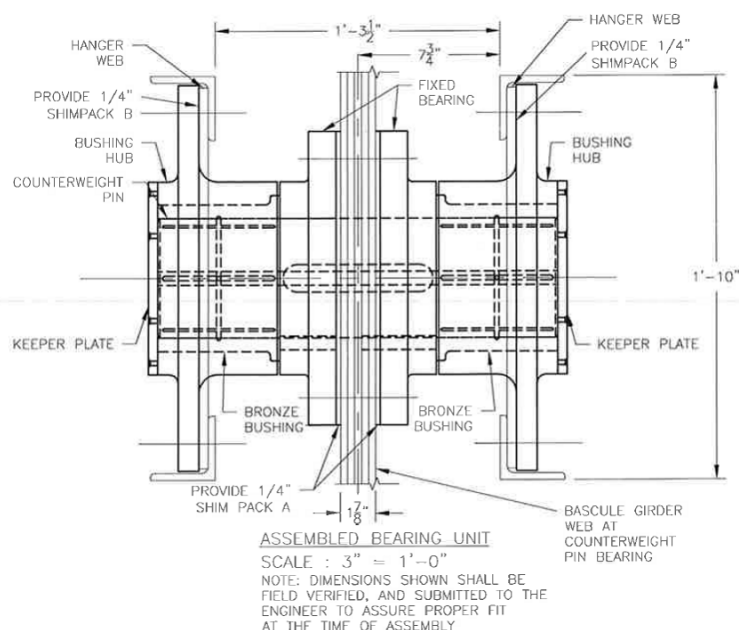
The original counterweight trunnions were found to be slightly undersized per the current AREMA specifications and the hanger bearing bushings were overloaded. It also became evident that there was likely load sharing which was not ideal. With a three-girder design the center bearing should take a little over 60% of the load, based on a 2-span continuous beam model, and the outboard bearing would share the remaining load. It is difficult to have ideal load sharing on the counterweight trunnions, and ensuring this condition requires careful alignment. Considering that the existing alignment and loading was suspect, the team decided to make all the counterweight trunnions the same. Because the bearing loads are very high, and the space for shafting limited, an 85 ksi, 6 1/2" diameter, counterweight trunnion was specified with UNS C95400 35 ksi bronze bushings. By using a constant diameter trunnion, the shoulders were removed from the shaft design to reduce stress concentrations and the shaft is retained by keeper plates attached to the ends of the bearings. Figure 10 shows the design

**Figure 10 – Section of the assembled counterweight trunnion**

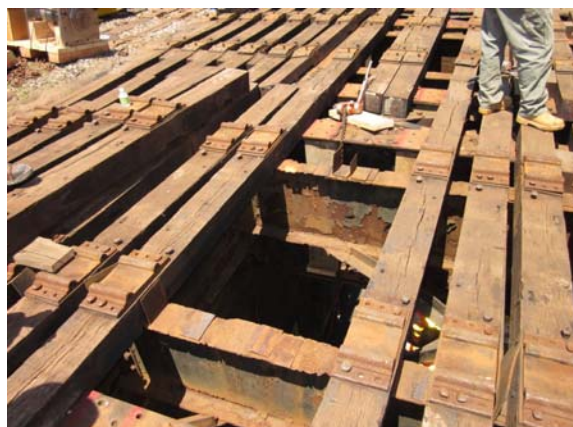
**Figure 13 – Opening in the approach span to access the top of the counterweight**

To begin the project the team awaited for the arrival of the rigging crew with the rail mounted crane. The crew arrived around midnight and began to remove the rails on the approach span. The crew cut the rails and stored the removed rails on the side of the job site for the duration of the project. Once the rails were removed the timber ties were slid out of the way to make space for the jacking beams (See Figure 13). This concluded Day 1.

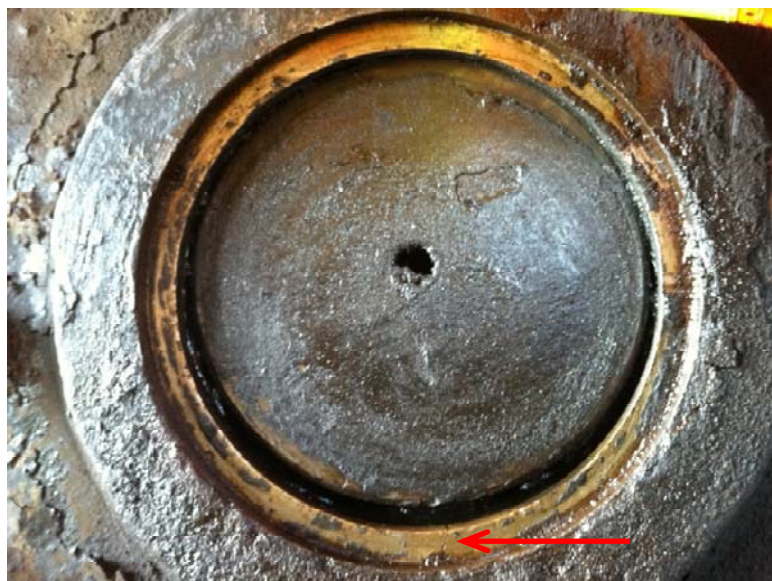
Figure 24 – The center counterweight trunnion bushings were cracked and had excessive clearances

The counterweight pin replacement was desperately needed; after the north counterweight trunnion failed the center trunnion was forced to carry nearly the entire load of the counterweight. The bushings on this center bearing were cracked and had large clearances and three of the six turned bolts had sheared.

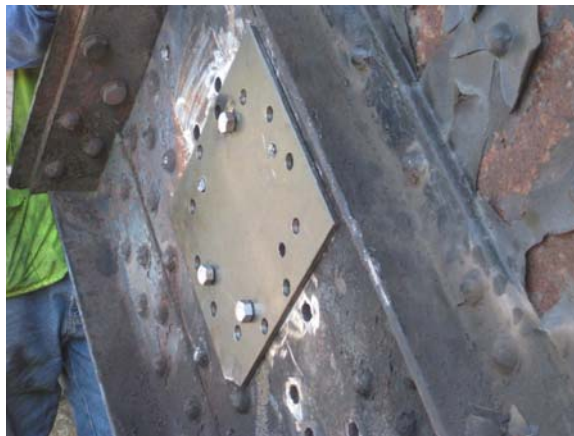
**Figure 25 – Bolt template being used to drill the new bolt pattern into bascule girders**

MBCR used a machined template that had holes which matched the original bolt pattern to ensure that the new holes were concentric with the originals. Although there was some doubt this could be done with the accuracy required for turned bolts the method proved successful and all hub bolts were installed without any issues.

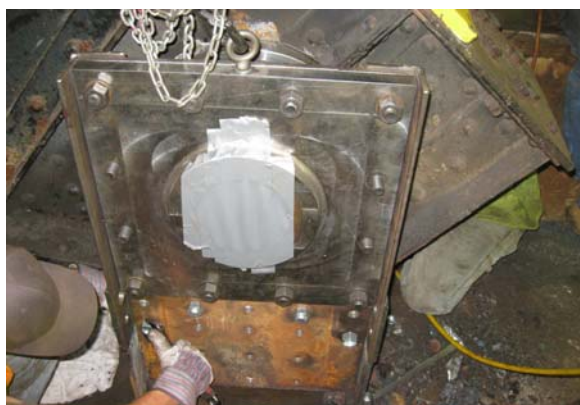
**Figure 26 – Hanger assembly being splice into existing cast-in hangers**

It was determined that the counterweight hangers could be cut off to provide improved access to remove the original counterweight trunnions. New hangers were designed to be spliced to the remaining steel above the counterweight top. The locations of the rivet holes were determined in the field and the design ensured that all available rivet holes were used and that no rivets were located along a splice.

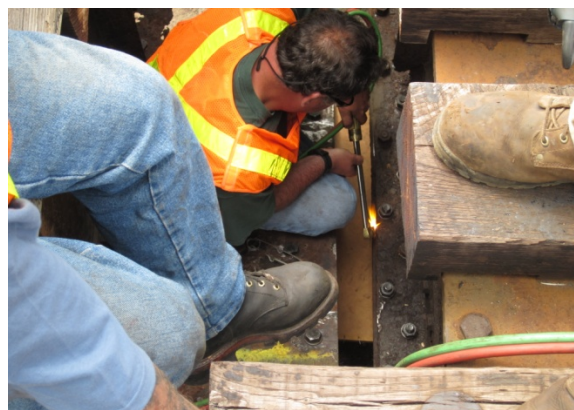
**Figure 27 – Modifications to the approach span girders**

Troubleshooting began once all the jacking equipment was removed. The troubleshooting essentially consisted of modifying the approach span girder bottom flanges and the counterweight trunnion pin hangers. The original hangers and approach span girders were modified to allow for the hangers to pass up-and-in between the bascule girders and the approach girders. The new hangers that were spliced to the existing hangers were straight, uncut, steel angle. The bridge was raised in small increments until the potential interferences could be identified and addressed. The approach span girders and new hangers were notched out to fit at all three pin locations.

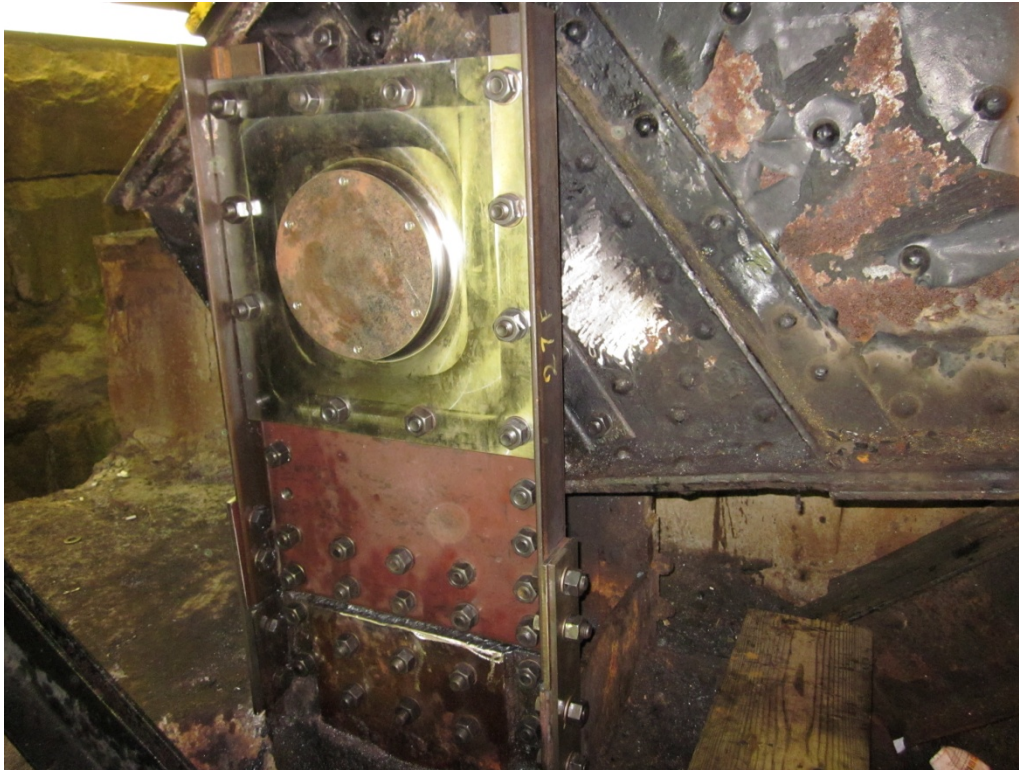
**Figure 28 – Completed installation of counterweight trunnion pin**
