**HEAVY MOVABLE STRUCTURES, INC.  
THIRTEENTH BIENNIAL SYMPOSIUM**

**Bridge Number 7  
Identifying and Correcting the Errant  
Roll of a Scherzer Rolling Lift Bridge for  
the Norfolk Southern Railroad**

Herbert Protin, P.E.  
Pete Davis, P.E.  
Mickey Harrison, P.E.  
Paul van Hagen, P.E.  
Giancarlo Schiano, E.I.T.  
HDR Engineering, Inc.

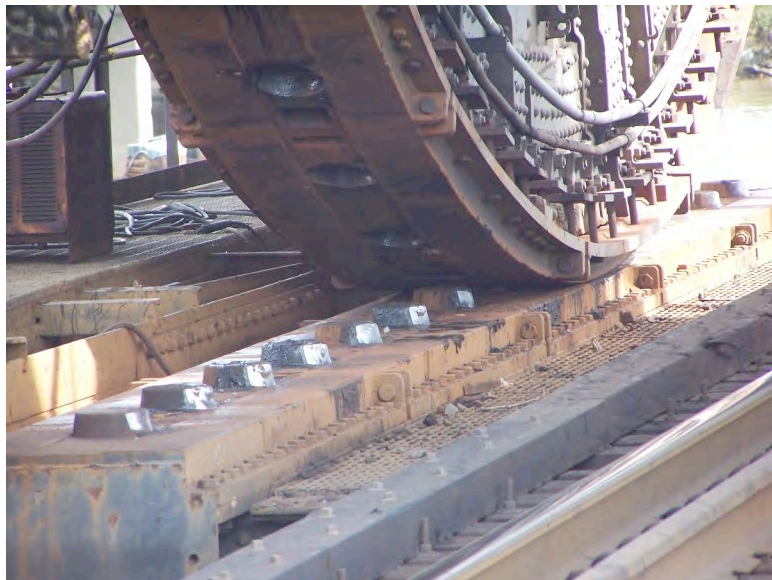
**Photo No. 1:** View looking northeast at the north segmental girder and flat track for Norfolk Southern Bridge 7. Note shiny spots indicating wear of pintles.

Based upon discussion with the local maintenance staff, the observed wear had been ongoing for many years. As the wear progressed, the bridge toe drifted to the north which resulted in seating problems. The local maintenance staff remedied the seating problem by installing shims on the bridge guides and relocated the approach track. It was noted that the shims had been adjusted several times as the bridge alignment continued to deteriorate. The bridge had walked to the north sufficiently to come in contact with the access ladder on the rack support frame.

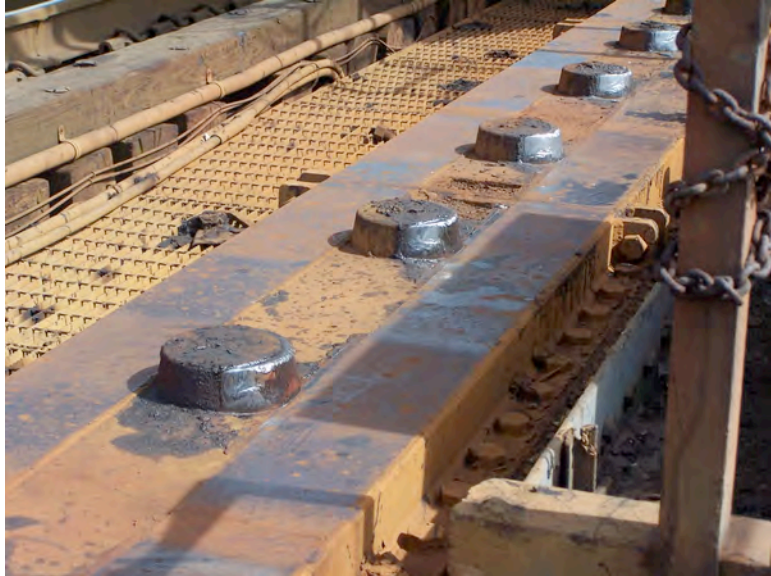
**Photo No. 2:** View looking northeast at the south segmental girder and flat track. Note shiny spots indicating wear of pintles.

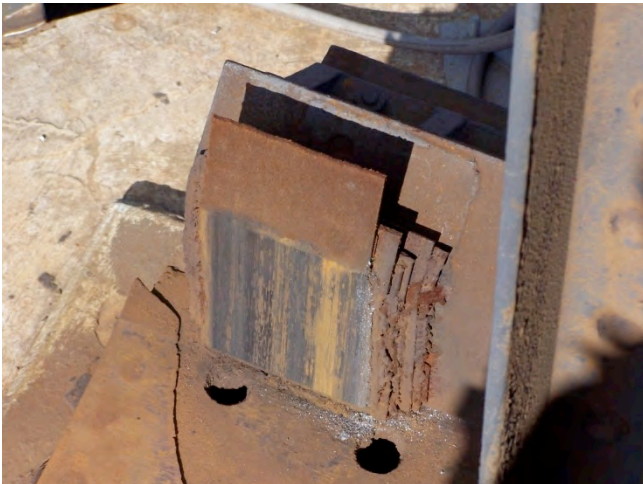
**Photo No. 3:** Shims installed at the span guide at the toe of the bascule girder.

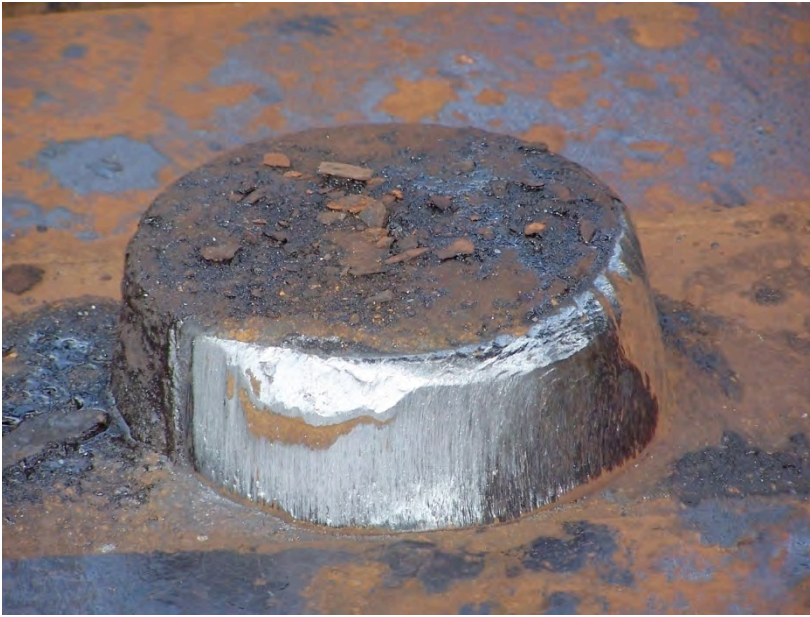
**Photo No. 4:** Close up view of Pintle. Note extensive plastic flow.

It was concluded that the pintle wear was the result of an induced rotation in the movable span during opening and closing operations. Since the south tread plate radius was larger than the north tread plate radius the south tread plate would have traveled a greater distance during opening and closing. This means the bridge would have experienced a clockwise rotation during opening and a counterclockwise rotation during closing. During opening the center of the socket would have moved into Quadrant 3 which would have caused wear in Quadrant 1. During closing the center of the socket would have moved into Quadrant 2 causing wear in Quadrant 4. This combination of wear in Quadrant 1 and Quadrant 4 closely matched the wear pattern observed in the field. The interference between the pintle and socket as the bridge opened/closed was approximately 0.16 inches.

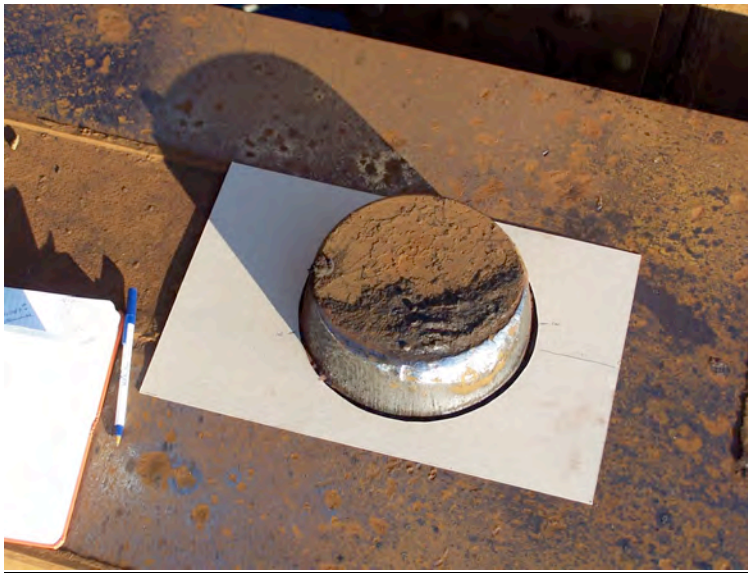
**Photo No. 5:** Pintle Wear Measurement – Note Template Used to Locate Extent of Wear.

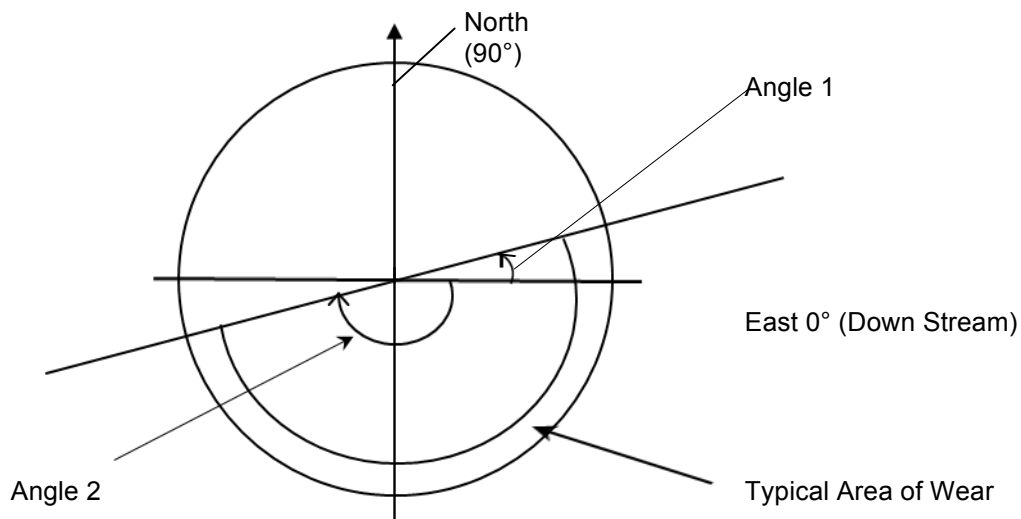
**Figure 1: Pintle Wear**

The results of these measurements are presented in Tables 1 through 3. Tables 1 and 2 indicate the location and magnitude of pintle wear at the north and south flat tracks respectively. Table 3 shows the remaining pintle width at the north and south track pintles. The most severe wear occurred on the south track pintles. The wear pattern for the north pintles indicate decreasing wear to the front side of the pintles as the span is opened (See Table 1). The wear pattern for the south pintles is consistent along the length of the track (See Table 2).

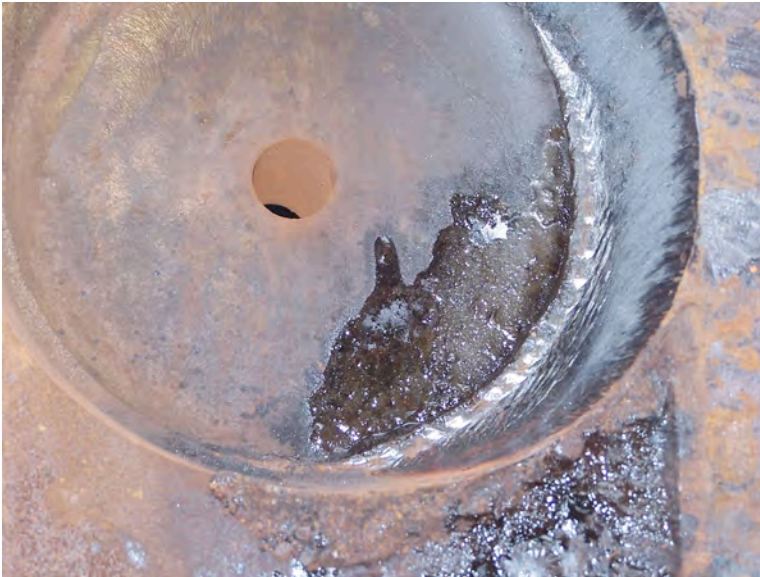
**Photo No.6:** Close-up view of socket wear

The interference between the pintles and the sockets caused wear and plastic flow of the socket material (See Photo No. 6). The socket wear was, as expected, consistent with the pintle wear. In addition to the wear inside the sockets several of the curved tread plate segments had broken fasteners (See Table 4). The bolts appear to have failed in tension. The NS staff reported that the tread plate bolts had been breaking and they had been replacing them on a somewhat regular basis (See Photos No. 7 and 8).

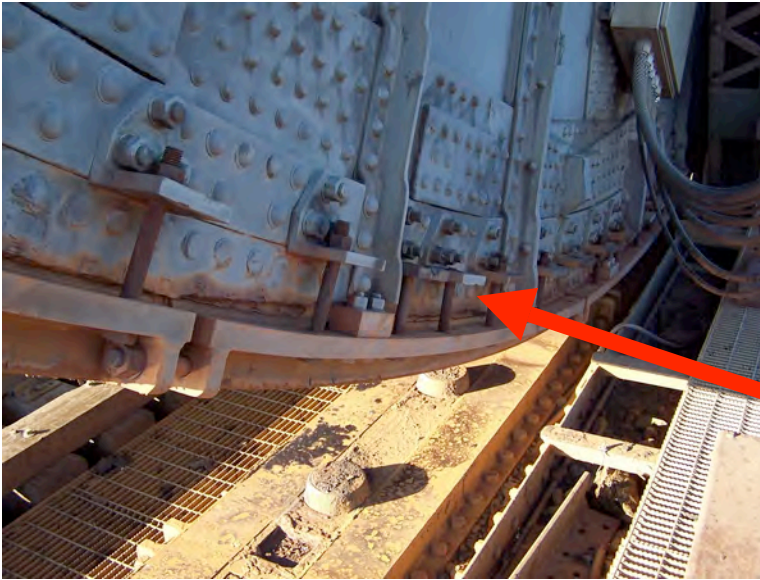
**Photo No. 7:** Missing connection bolt between curved track plate and segmental girder

Additionally, as the tread plate passes interferes with the pintle, there is an increase in bending of the tread plate. This bending would increase the tension in the bolts resulting in the breakages observed.

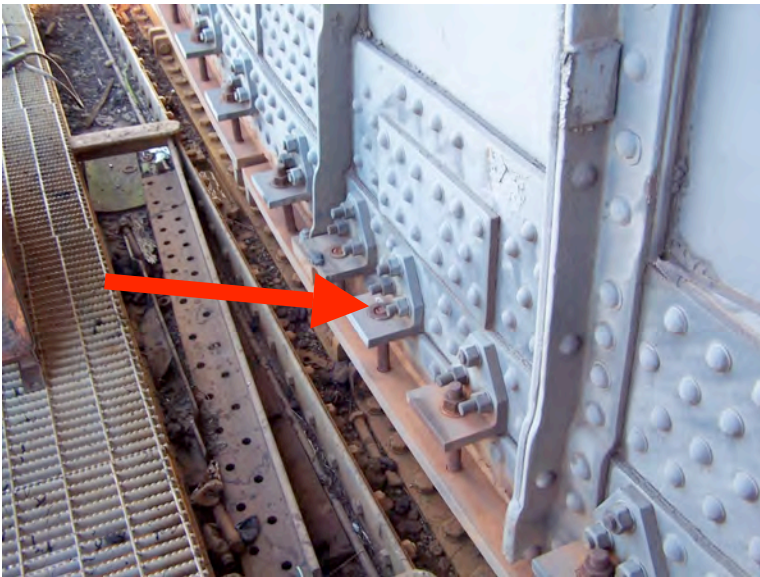
**Photo No. 8:** Broken connection bolt between curved track plate and segmental girder. Note number of broken bolts alongside flat track

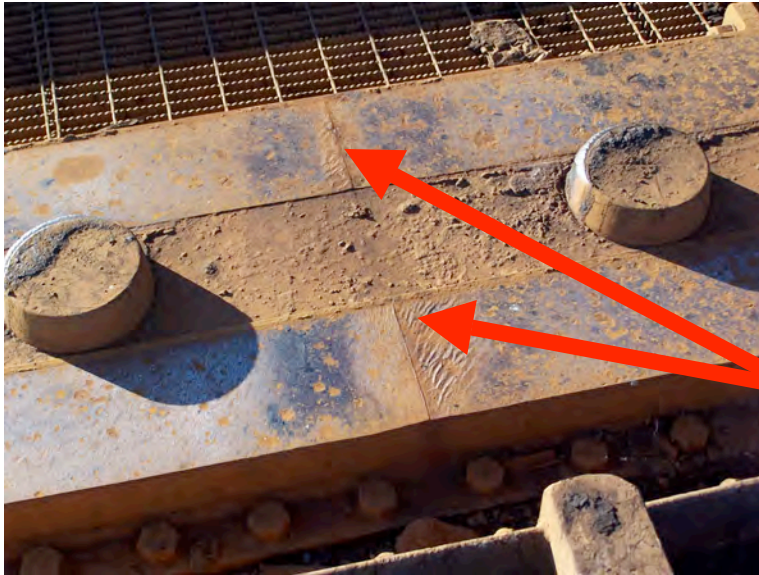
Plastic flow

The flat tracks were visually inspected for signs of abnormal wear. The first few segments of the flat tracks exhibited plastic flow of material at the joints (See Photos No. 9 through 11).

It is interesting to note that the front side (towards the channel) of the joint indicates a sliding motion where the back side of the joint indicates a rotation motion. This wear pattern is consistent for both the north and south tracks.

**Photo No. 9:** Looking south at north flat track. Note: plastic flow pattern at the joint in the casting

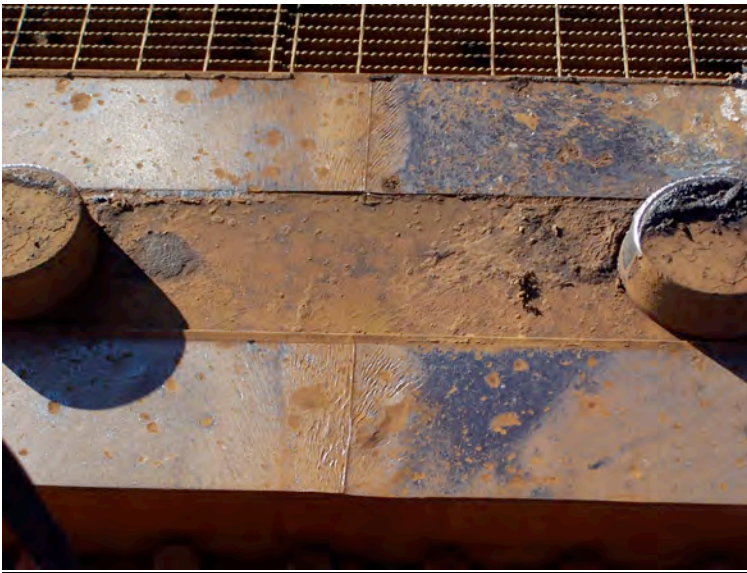
**Photo No. 10:** Looking north at south flat track. Note: plastic flow pattern.

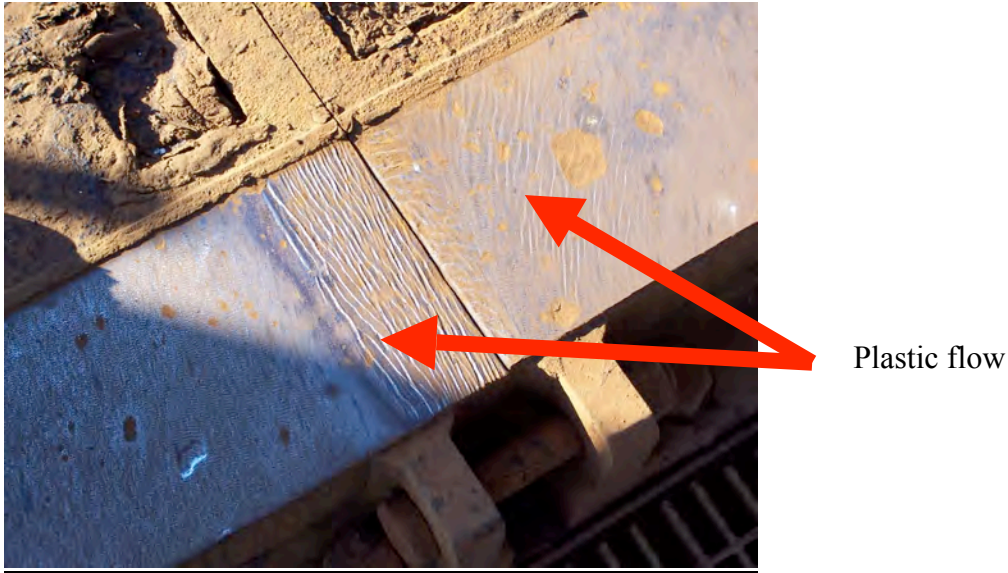
**Photo No. 11:** Looking south at south flat track. Note: the change in plastic flow pattern.

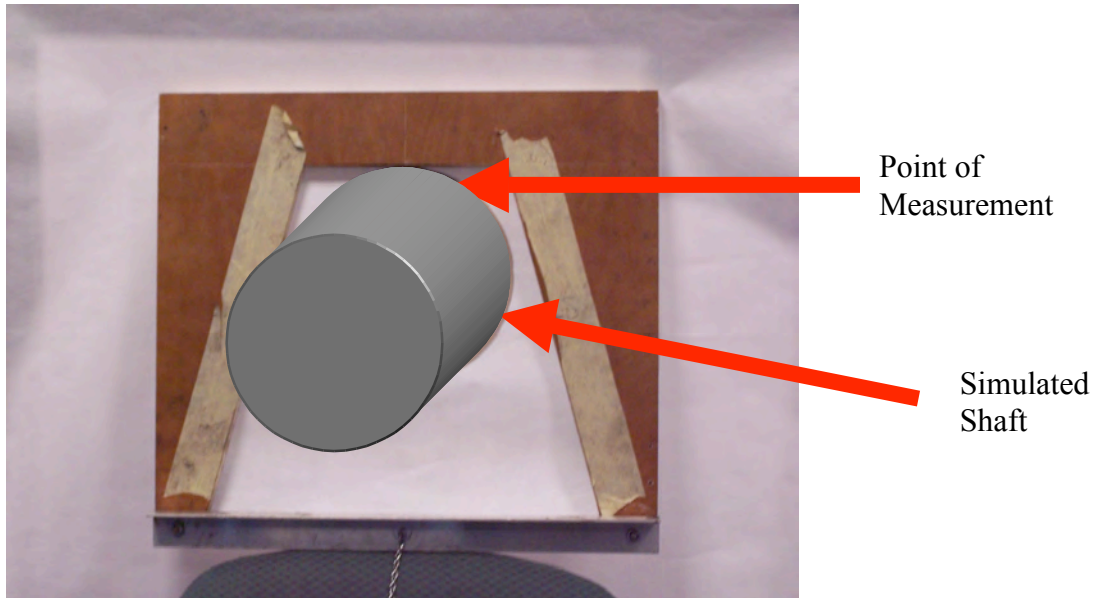
A second site visit was conducted to confirm the original measurements. For the second site visit, a fixture was used to perform the radius measurements (See Photo No. 12). The measurements taken are as follows:

These measurements confirm the difference in radius between the North and South curved tracks. The average difference between the measurements taken at similar locations in the North and South tracks is approximately equal to 1 ½". This difference in tread plate radius causes the south track to roll approximately 1.9" more than the North track when the bridge is opening, thereby inducing a clockwise rotation of the span. The other significant finding was that the radius was not consistent. The most likely explanation for the radius difference between tracks is that during

**Photo No. 12:** Fixture used to measure the radius of roll

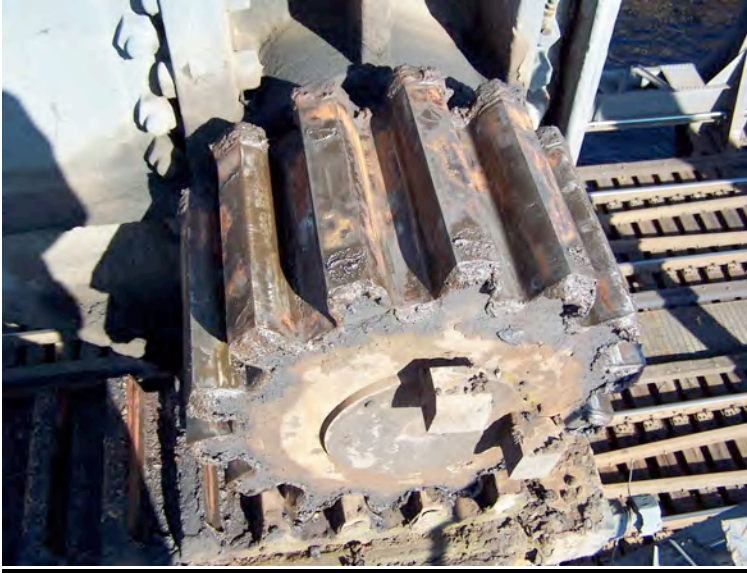
**Photo No. 13:** View looking North at South pinion. Note wear on top of gear from contact with rack gear.

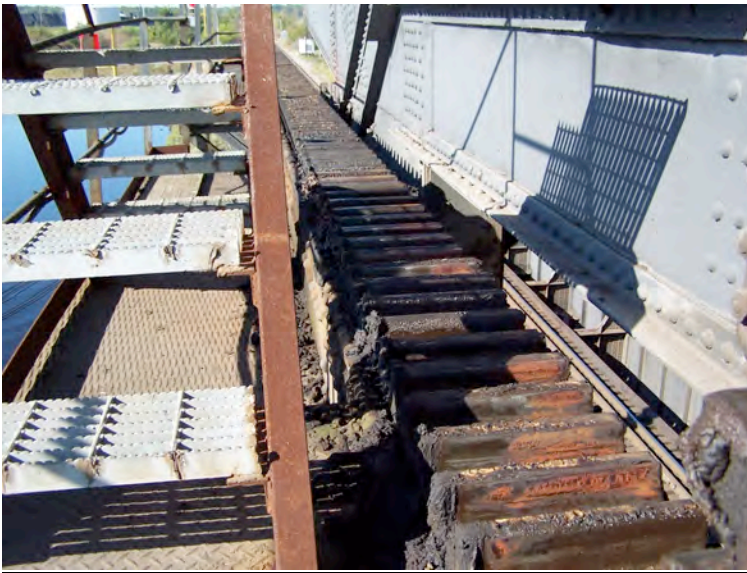
In Photo No. 14 the corrosion on the face of the rack gear teeth indicates little contact between rack and pinion during opening. The polished tooth face on the closing side of the rack gear is shown in Photo No.15. Photo No. 18 indicates light contact between the north pinion and the rack during closing, as compared to the polished surface in Photo No. 15.

**Photo No. 14:** South rack looking west. Note: wear from tooth number 30 to the end of the rack indicating no contact between pinion and rack while closing.

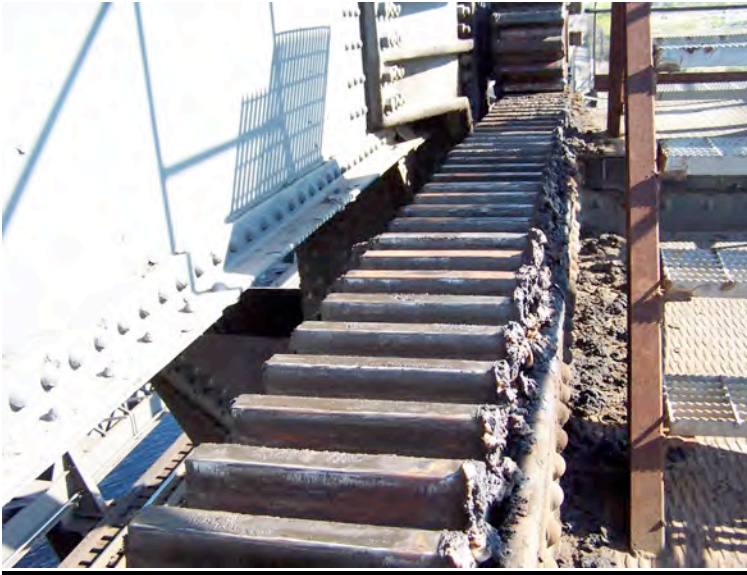
**Photo No. 15:** South rack looking east. Note: wear of rack teeth indicates contact between pinion and rack during opening.

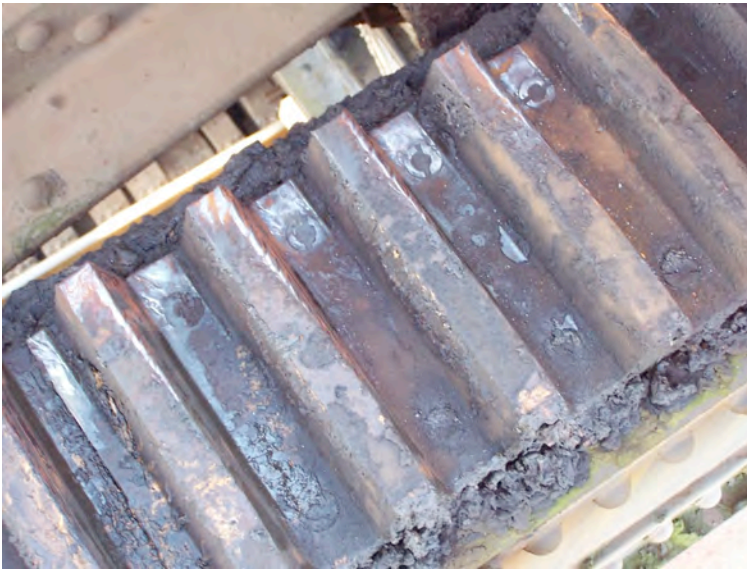
Photo No.16 shows the damage at the root of the gear tooth for the south rack. The lubrication patterns on the rack indicate that the south pinion is doing most of the work to open the span while the north pinion is doing most of the work to close the span. The exception to this observation is the first few degrees of opening where both pinions are bottomed out.

**Photo No. 16:** South rack/pinion interference at gear tooth 13 through 20. Note: severe binding between pack and pinion during opening, and damage to countersunk bolt heads

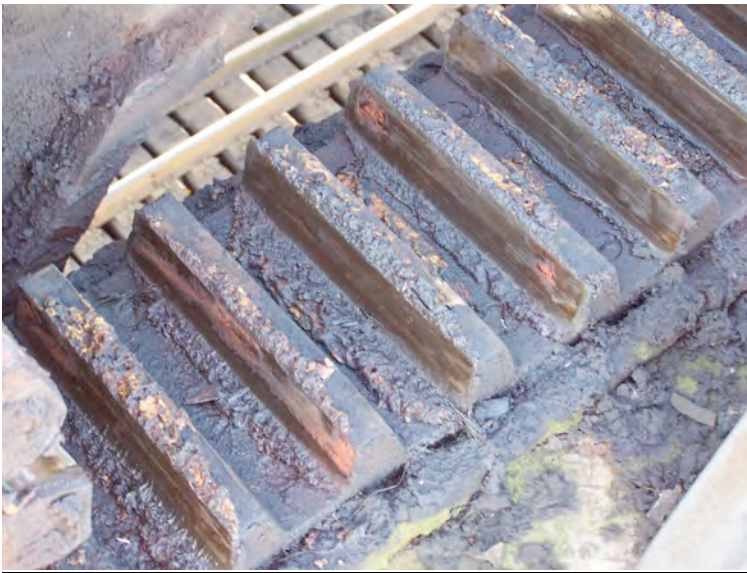
**Photo No. 18:** View of the North rack at the fully opened position. Note gear contact for closing and minimal contact on opening.

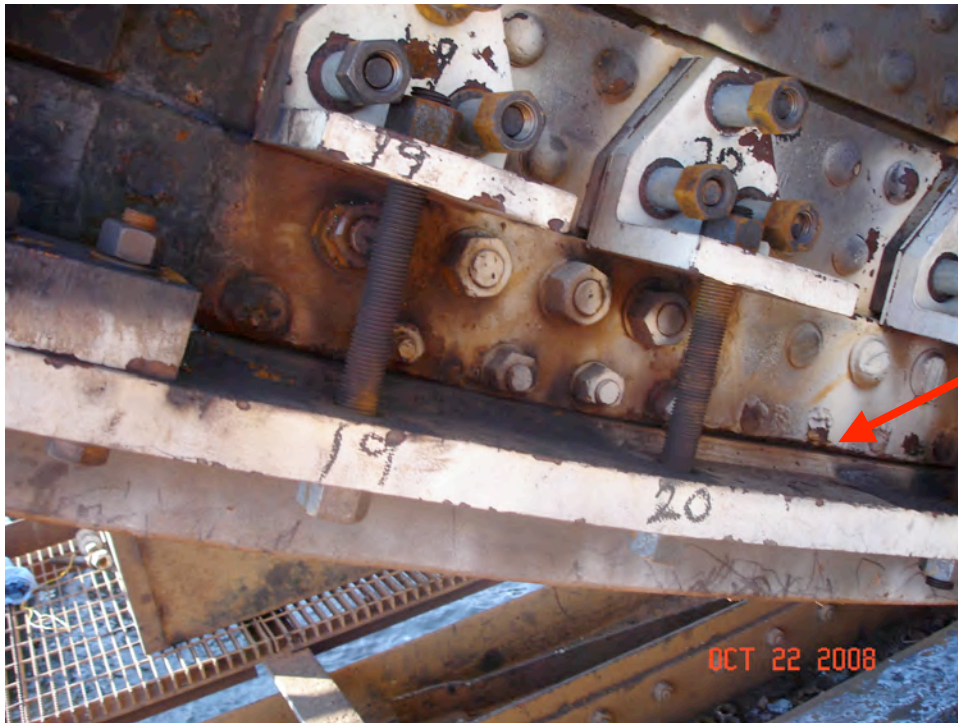
Flame Cut Web

**Photo No. 19:** Looking at the edge of the curved tread plate. Note the irregular radius cut to the bottom of the segmental girder web.
