**HEAVY MOVABLE STRUCTURES, INC.
13th BIENNIAL SYMPOSIUM**

October 25-28, 2010

**Pennington Avenue Bridge
Trunnion Bearing Replacement**

John A. Gimblette, PE, Associate
Hardesty & Hanover, LLP

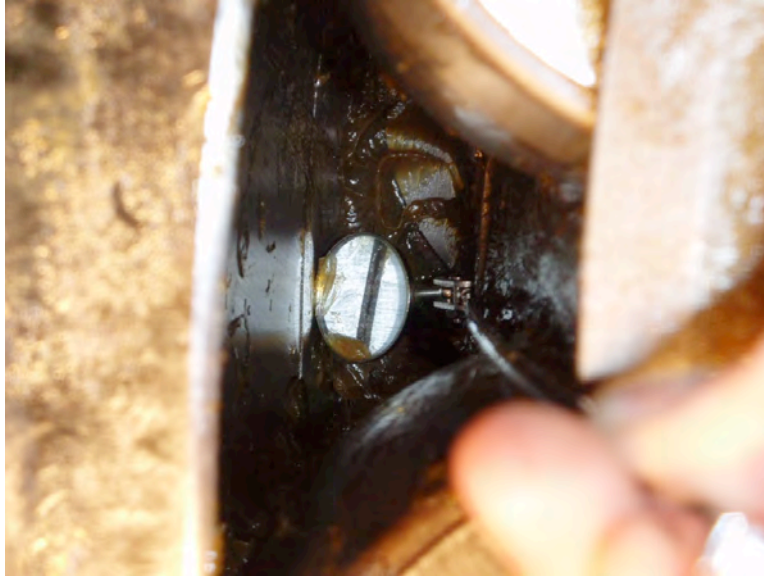
| Location | Date | Internal Clearance | Approx. Location | Inspection Findings (abbreviated) |
|---|---|---|---|---|
| SW Outboard | 8/21/08 | 0.051" | 12 o'clock | Outer ring roller path with circumferential crack noted at 6 o'clock position and extending 240 deg. Crack appears to be located in center of W33 groove. |

Photo 3: SW Outboard Location, Outer Ring, Crack Location

- in all cases, the bores were out-of-round between 0.011” to 0.016”
- in all cases, the out-of-round shape, if exaggerated, was elliptical
- in all cases but one, the larger diameter of the ellipse was in line with the vertical axis of the bearing assembly
- in only one case, the larger diameter of the ellipse was offset from the vertical axis of the bearing assembly
- the noted offset occurs at the SW outboard bearing and for all practical purposes was in line with the center of the noted crack
- in all cases the removed caps retained their circular shape

Still, having considered several short and long term recover plans, it was recommended that the failed bearing be replaced in-kind, i.e. with a modern day spherical roller bearing of proper interfacing dimensions and that the necessary analytical and measurement steps be taken to determine whether or not the existing bearing housing required any remedial work or replacement.

Based on the inspection findings, it was recommended that the circumferential groove be incorporated into the trunnion shaft, that minor hand dressing of the housing bore be performed, that original machine marks located on the housing bores inboard end be blended smooth and that the replacement bearing be installed.

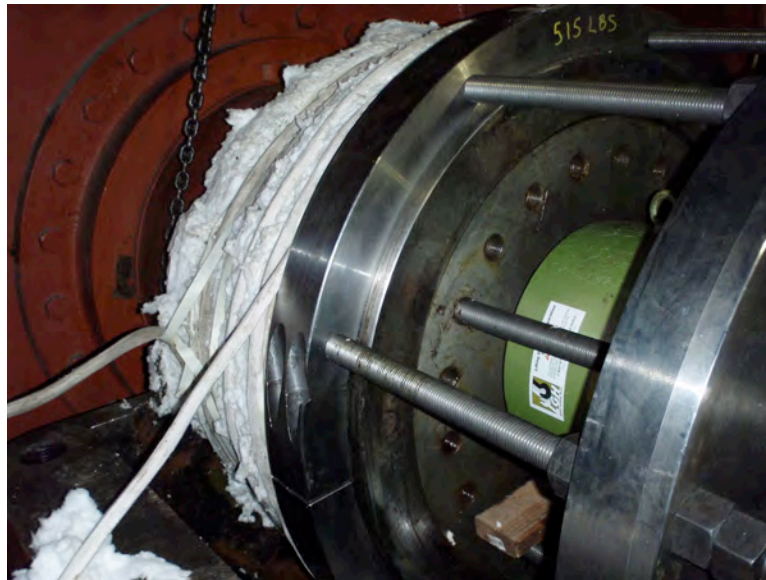
Photo 4: SW Outbound Bearing, Heating Coils and Puller Device

- wrap inner ring with insulating material
- wrap inductive heating coils around insulating material
- install custom hydraulic pulling device
- heat inner ring to approx. 400-500 deg. F and then methodically pull inner ring

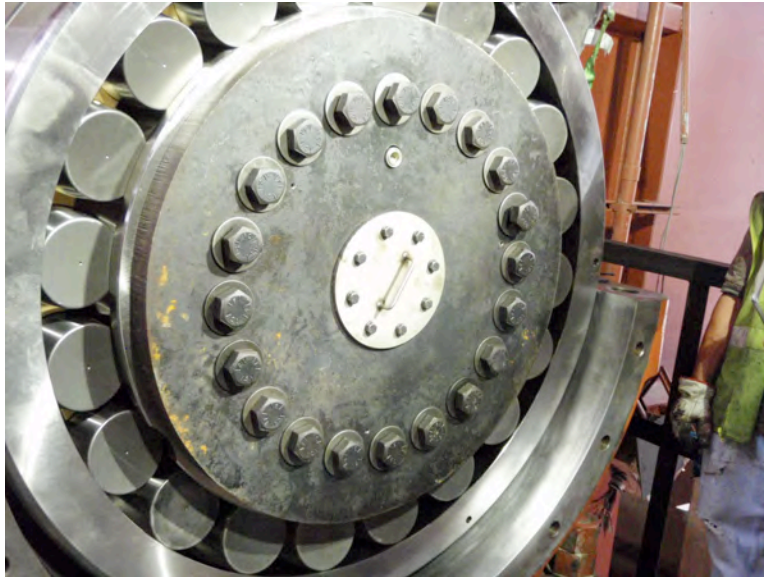
Photo 5: SW Outboard Bearing, Partially Rehabilitated

- install new inboard seal
- using nylon slings and overhead hoist, slide bearing assembly onto trunnion shaft until there is line-to-line contact
- secure end plate onto trunnion shaft end
- set up dial indicator to measure axial movement of bearings inner ring
- incrementally tighten lock plate bolts using a star pattern and note axial movement of bearing relative to trunnion.
