**HEAVY MOVABLE STRUCTURES, INC.
THIRTEENTH BIENNIAL SYMPOSIUM**

**Rehabilitation of Historic Components at
the Bridge of Lions**

Steven Shaup, PE
TranSystems
Fort Lauderdale, Florida

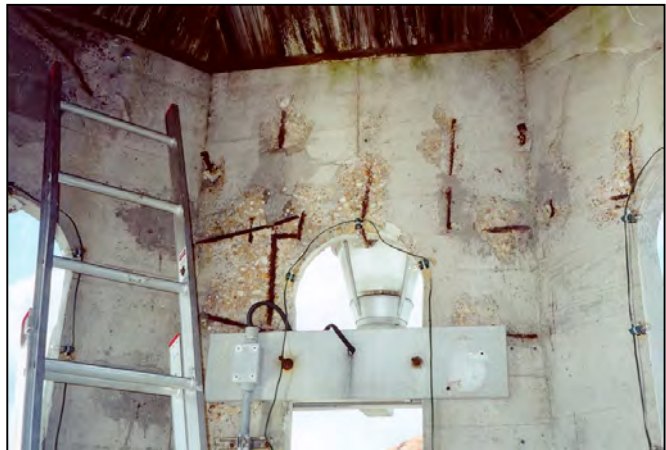
The 83 year old bridge suffered from widespread deterioration to its components. The structural steel for the approach span girders and the bascule span had widespread areas of section loss. Where members consisted of built-up plates and angles, pack rust was found between the plies, causing deformation due to expansion of the rust byproducts. As would be expected, the worst conditions were found in the vicinity of deck joints. Cracks and spalls were widespread on all concrete components. See Figures 5 and 6. In addition, the concrete in the substructure units was found to have chloride levels above the threshold for chloride ions facilitating corrosion in concrete. Figure 7 includes a sampling of chloride content at selected depths taken at the bascule piers.

Figure 0 - Typical deterioration inside bascule pier towers.

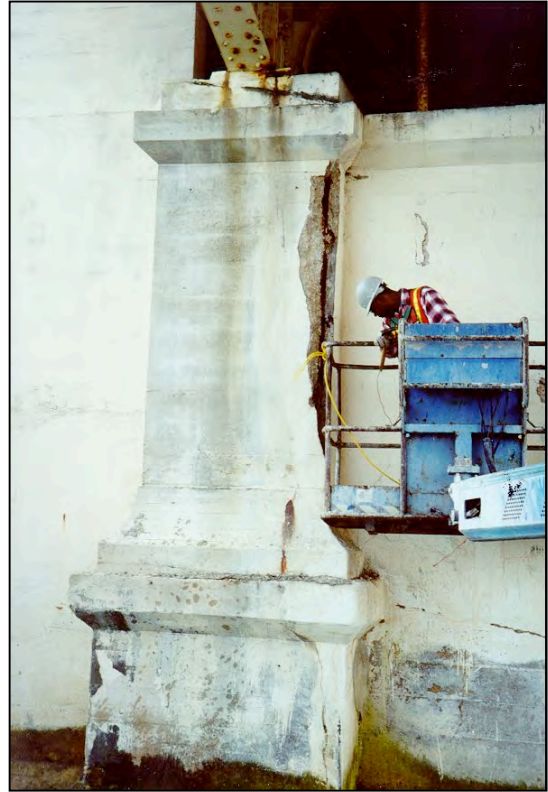
Figure 0 - Large spalls at bascule piers.

Cracks and spalls were repaired using epoxy injection and latex-modified mortar repair materials. Original detailing was documented prior to demolition for replication.

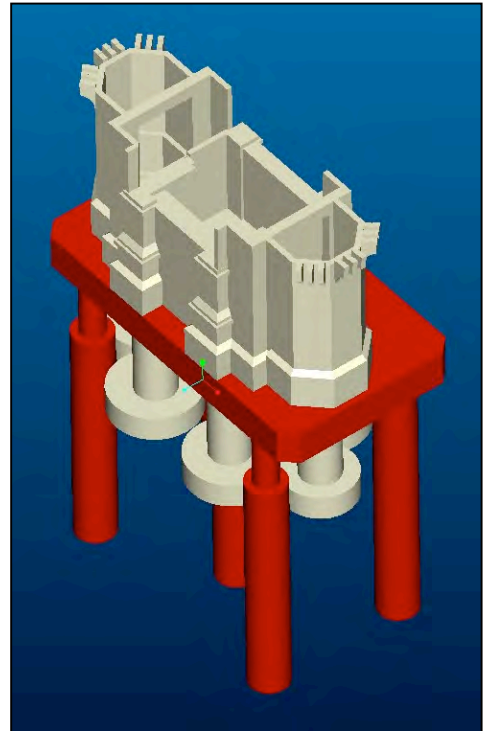
The bascule piers needed repairs to retain strength and integrity. Analysis showed that the bridge would not meet current vessel impact standards or withstand the 100-year channel scour event. The bascule piers were strengthened by the addition of a new reinforced concrete footing at the waterline that is supported by five new reinforced concrete drilled shafts that extend deep enough to support the piers in case of an extreme scour event. The new footing is located just below the existing bascule pier footing and undergirds the existing footing, so that should the existing caissons fail due to deterioration or lose supporting soil, the new footing will continue to support the piers. See Figure 16.

Figure 0 - Schematic of supplemental footing below existing bascule pier. New elements shown in red.

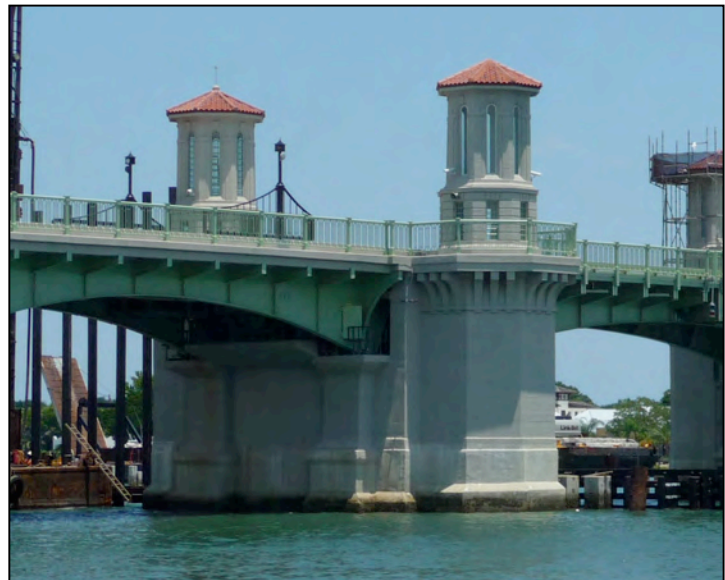
The reinforcing steel in each bascule pier wall was located only 1 ½-inch below the surface. The chloride intrusion was enough to begin the corrosion process. To address this, the existing concrete at surfaces exposed to water was removed to a depth of 6-inches, which removed the chloride infused concrete. On the exterior faces of the piers, new concrete was added to provide 3-inches of cover over the existing reinforcing steel and an impressed current cathodic protection system was installed over it to provide additional protection. This type of cathodic protection uses a titanium mesh cast inside a 1 ½-inch thick layer of latex modified epoxy mortar that is wired into the electrical system. The system prevents charged ions in the chlorides from reaching the reinforcing steel and starting the corrosion process. See Figure 17.

Figure 0 - Completed overlay containing impressed current cathodic protection system. Because of the size of the bascule piers, the addition of the overlay and build out of concrete cover did not affect overall appearance of pier.

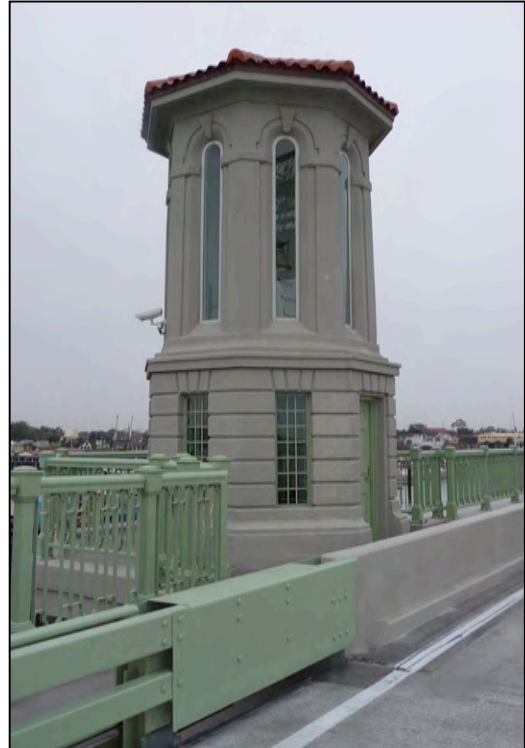
The towers had numerous cracks and spalls. These deficiencies were repaired using methods similar to the bascule piers. The goal for repairs was to conserve and retain as much of the sound original material as possible.

After repairs were completed, all concrete above the waterline for the bascule piers and towers were coated to achieve a uniform appearance. The coating was required to match the coloring of a test area on one of the bascule piers, which the contractor sampled and the engineer had to

Figure 0 - Completed bascule pier tower. A coating that was color matched to the original bascule pier concrete was applied to all concrete surfaces above waterline for uniform appearance.
