**HEAVY MOVABLE STRUCTURES, INC.
THIRTEENTH BIENNIAL SYMPOSIUM**

**Rehabilitation of Bridge Street Bridge
Preserving a Nineteenth Century Historic
Bascule Lift Span**

Paul van Hagen, PE and Herbert Protin, PE

HDR Engineering, Inc.

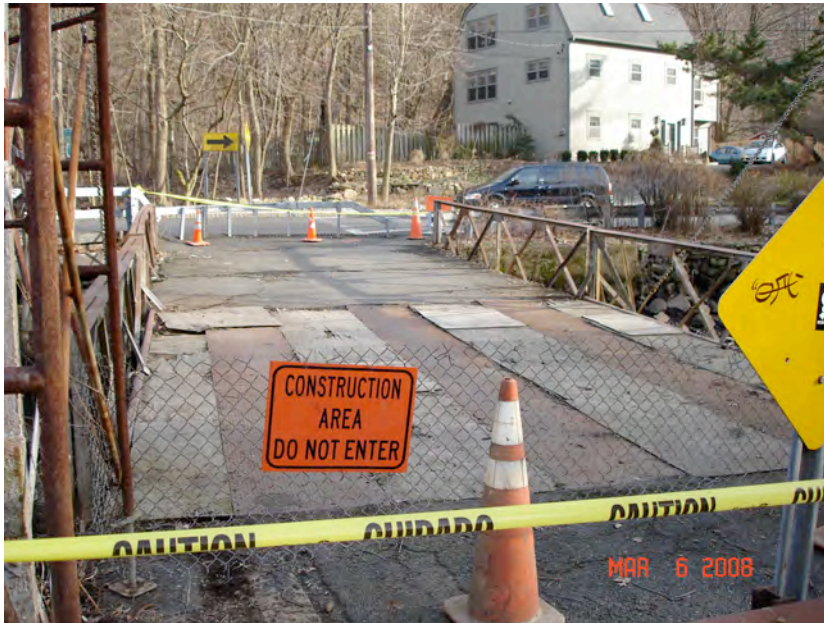
FIGURE 5: View looking South across the deteriorated timber deck on the bascule span at the start of construction. Also note the asphalt overlaid concrete approach deck and lateral deformation of the approach truss.

In September 2005 after the contract had sat a while and a new Project Manager took over for the County, some modifications were made to the design approach. It was decided that the existing approach span and the counterweight tower would be removed and rehabilitated in the shop. This would eliminate the cleaning and painting operations in close proximity to the residential properties at the north side of the bridge. The existing concrete bridge would be replaced with a lightweight concrete reinforced deck to reduce the loading on the potentially overloaded approach span trusses and center pier foundations.

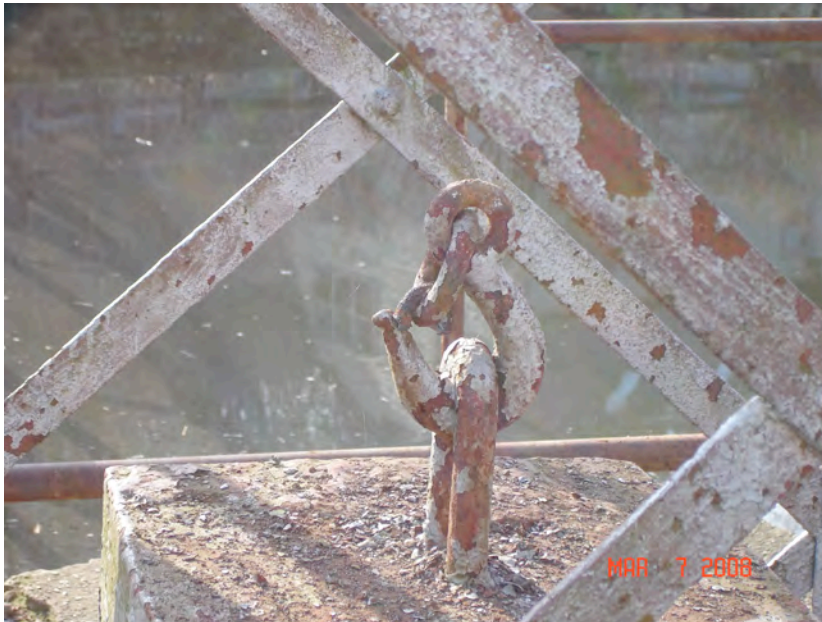
The first step was to remove the steel towers (see Figure 6), including all machinery and counterweights, all carefully stored for delivery to the Contractor's yard for restoration later. Pieces to be reused were all marked and photographed. On the second day the Contractor cut the counterweight chain at the Northwest Tower Leg (see Figure 7). Since the chain is a historic element that was to be reused in the reconstruction of the bridge, the Contractor was informed that he would have to restore the chain to its original condition.

FIGURE 7: Severed link at northeast counterweight chain

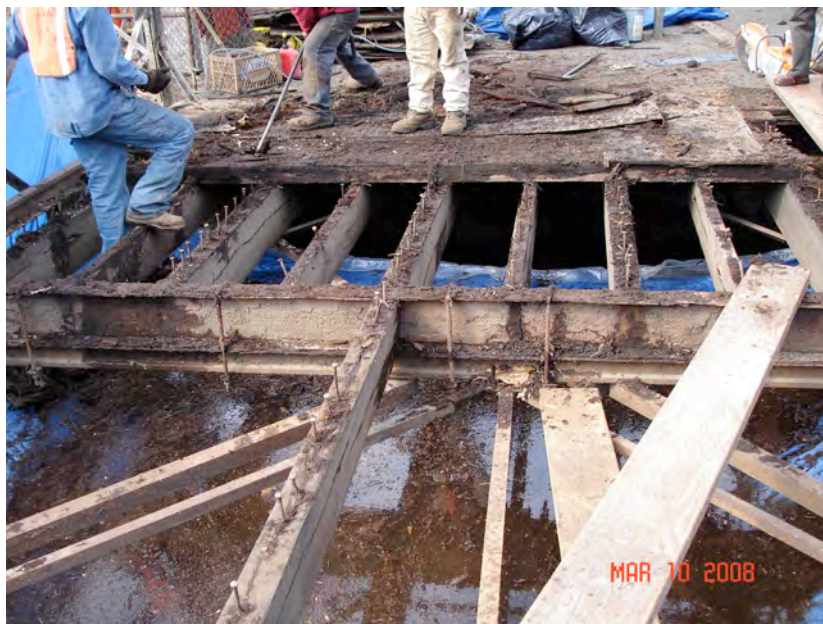
After the removal of the Counterweight Towers, the bascule span was removed. The timber deck was dismantled and discarded, and the steel floorbeams and trusses were carefully brought onto land. Existing ornate cast-iron movable bridge bearings were uncovered and it was decided that they would be reused. At this stage it was apparent that the condition of the existing steel was much worse than had been expected. All of the transverse W10 floorbeams were so badly corroded they had to be replaced (see Figure 8). The lower chord, end angles, many diagonal members and gusset plates on each truss would have to be replaced. All bracing members including lateral bracing and truss knees braces would require replacement.

FIGURE 8: Demolition of timber deck

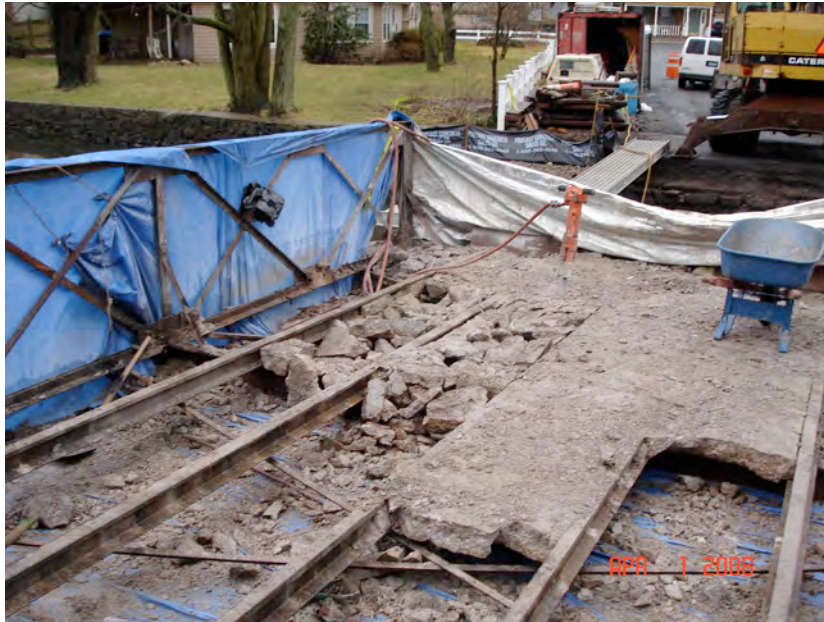
The approach span deck and steel framing was then removed, starting with the concrete slab spanning between the south abutment and the concrete center pier. The concrete deck was removed using saws and small jack hammers in an attempt to avoid damage to the existing steel trusses and steel beams embedded in the deck. During removal of the approach span concrete deck, the expected W12 steel beams embedded in the slab were not found. In fact the slab was supported by steel railroad rails cast into the bottom of the slab (see Figure 9). These rails apparently came from the dismantled Erie Rail Line into Piermont. It was immediately apparent that the concrete deck was not the original deck, but was rather from rehabilitation work in the first few decades of the twentieth century. It was also apparent at this time that a redesign of the approach span framing would be required.

FIGURE 9: Demolition of the concrete approach deck uncovered used rails in the deck

The concrete approach span was a recent addition to the bridge. It was determined that the concrete span was built c. 1930, and replaced what we believe was the original timber deck. It was suggested that for sake of consistency and bridge integrity that the approach span would be redesigned to provide a new timber deck and timber stringer system supported by transverse steel floorbeams similar to the drawspan. Several remaining steel elements strongly suggest that the original structure had been framed this way. It was also apparent that the weight of the concrete deck had caused truss buckling.

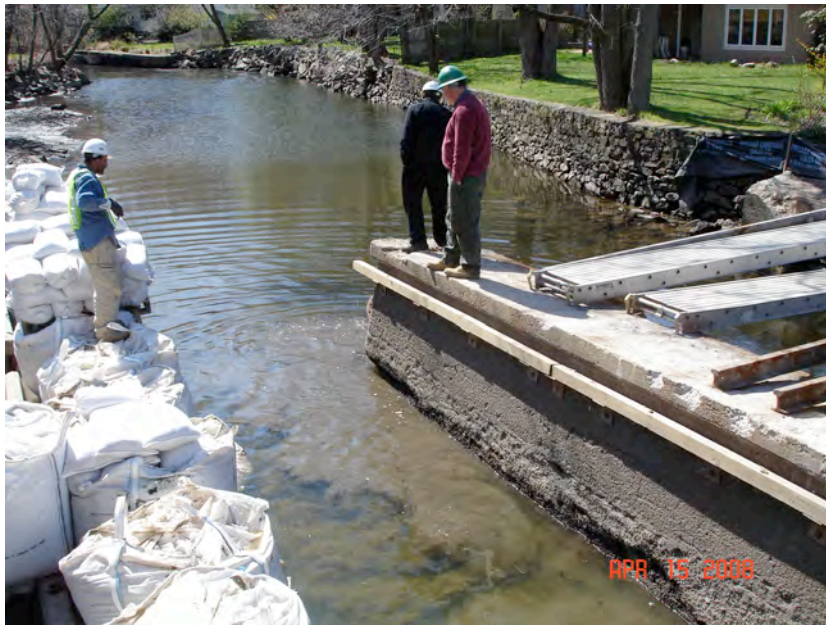
Several days after the removal of the approach concrete slab the center pier started to rotate about the bottom north edge of the pier (see Figure 10). The approach slab had provided lateral restraint to the pier, and once removed the pier was free to rotate and translate. Exacerbated by an undermined condition, the top of the pier translated sideways approximately twelve inches.

FIGURE 10: Concrete pier leaning toward the north

The collapse of the center pier was the most significant change to the scope of the project. The concrete pier, a more recent replacement of the original pier, was removed while the plan for its replacement was considered. Once removed, it became clear that the concrete pier had no significant foundation. It was merely sitting on top of two timber piles which had been cut-off below the base of the newer pier foundation. The presence of the timber piles suggested that the original pier was a timber pile bent. It was decided to redesign the pier and replace it with a timber pile bent. In order to determine the type and depth of the piles required, a boring and a geotechnical design was performed. The final redesign consisted of five-12" diameter piles with a timber piles cap and cross bracing (see Figure 14 and 15).

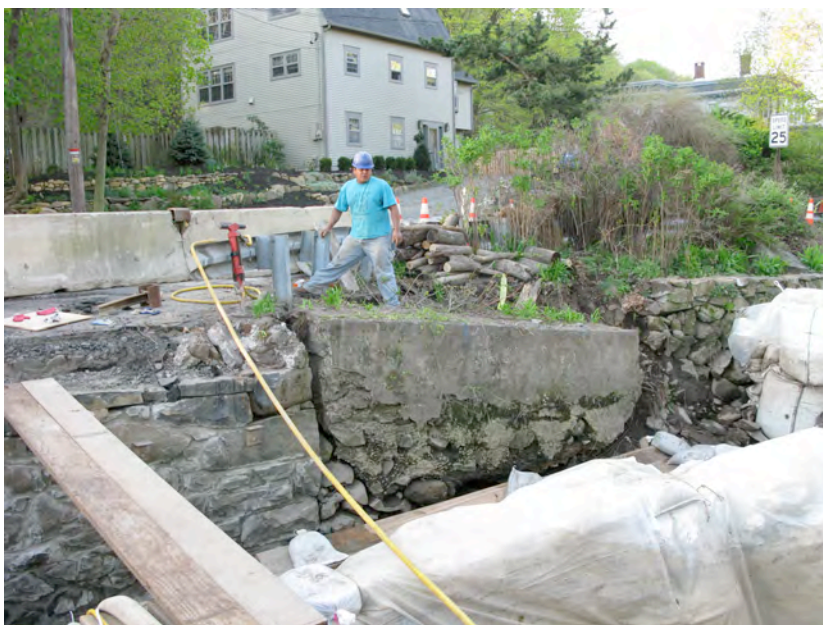
The existing abutments consisted of dry stone walls seated just below the streambed. The contract called for pointing of the stone walls and construction of a new concrete bridge seat, including installation of stone riprap at the base of the wall. The contractor installed cofferdams and dewatered to gain access to the stone walls. During clearing of the riverbed with a backhoe for installation of the cofferdam, the wingwall adjacent to the abutment wall, which was constructed of loose stone with concrete stucco facing, was undermined and moved laterally several inches (see Figure 11). This wall had little foundation and eventually crumbled and collapsed into the river.

FIGURE 11: Movement of the Southwest Wingwall

The collapse of the wingwall adjacent to the south abutment necessitated a design for the replacement of this wall. The wall was on the property of an adjacent landowner and so close coordination with the landowner and the local authorities was important. A gravity stone wall on a concrete foundation was designed to provide support the riverbanks and an adjacent local road.

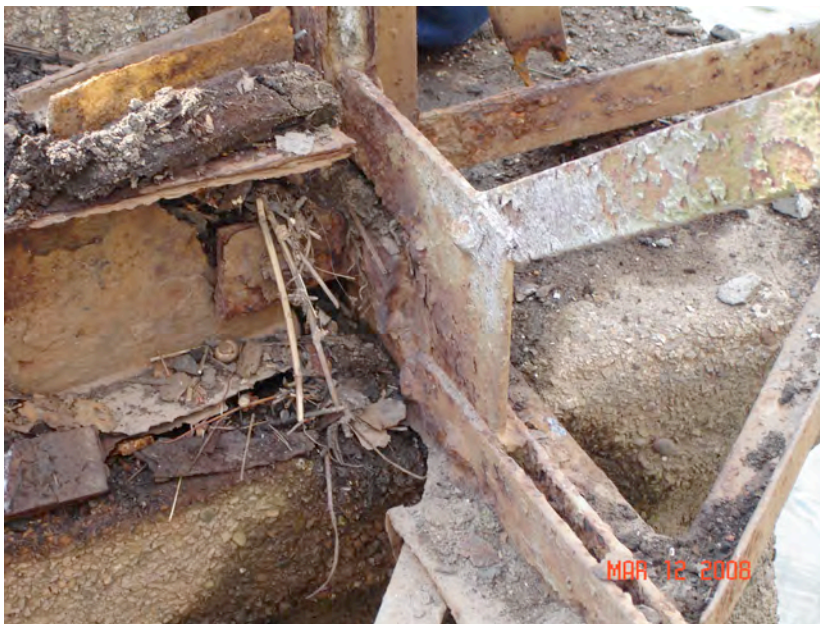
Due to a significant amount of deteriorated steel, many structural steel elements were replaced that were not included in the original design (see Figure 12). After the exact configuration of the structural elements to be replaced was determined, existing deteriorated steel pieces were carefully measured and redetailed. Elements that were redetailed were as follows: Bascule and approach steel trusses, including transverse steel floorbeams, angle knee braces, outriggers that attach to steel bascule span to the counterweight chains, and all lateral bracing members. Several machinery support members at the tops of the towers were badly deteriorated and were replaced.

FIGURE 12: Severely corroded end floorbeam and truss gusset plate that were buried at the north abutment

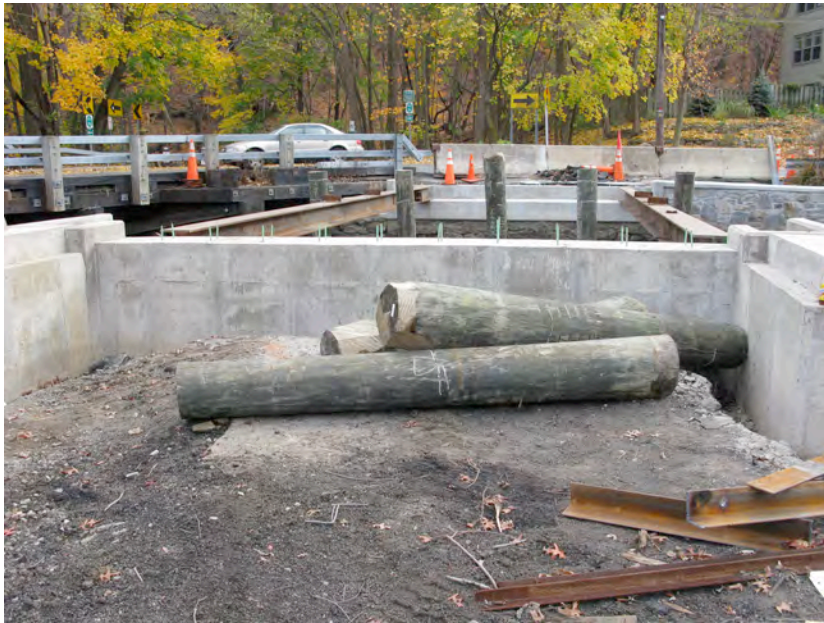
FIGURE 14: View looking south from behind the north abutment. Note new timber piers and the reconstructed southwest wingwall

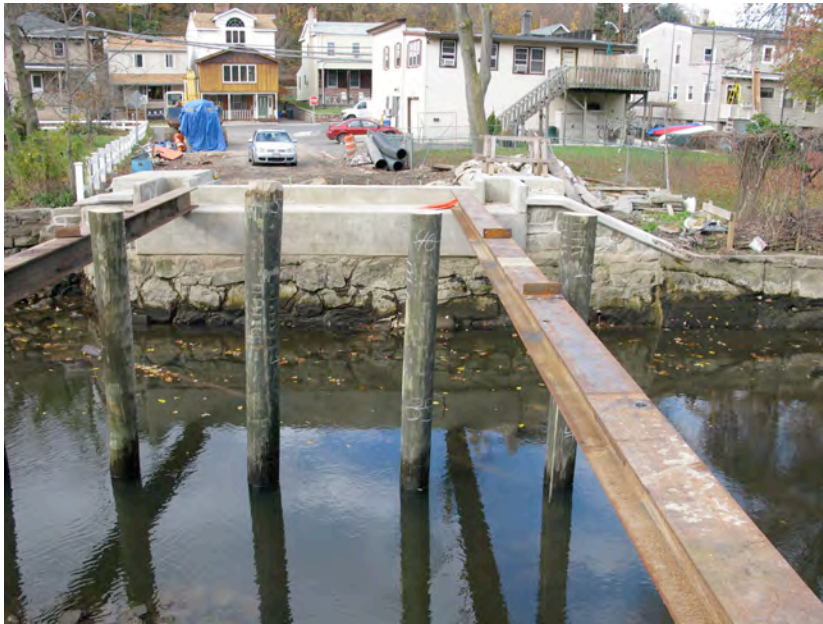
FIGURE 15: View looking north at piles for new timber pier

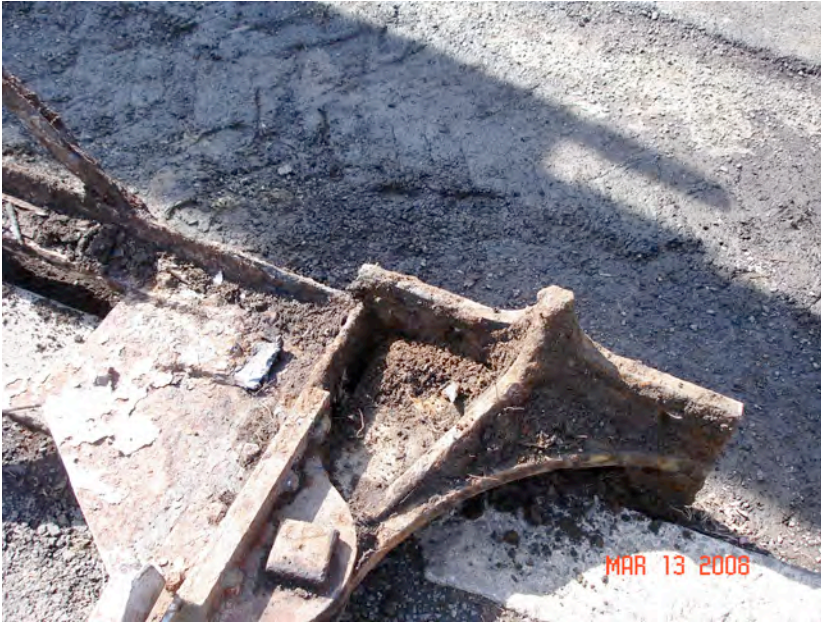
FIGURE 17: Existing movable bridge bearing uncovered during the removal of the existing draw span

The existing cast-iron bridge bearings uncovered during demolition were found to be ornate and an integral part of the bascule span (see Figure 17). They had been planned for replacement but these were retained. In order to do so the new concrete abutments were redesigned to accept older and larger bearings.
