Emergency Repair of the I-695 Drawbridge over Curtis Creek

By:
Scott Reynolds, PE
Hardesty & Hanover, LLP

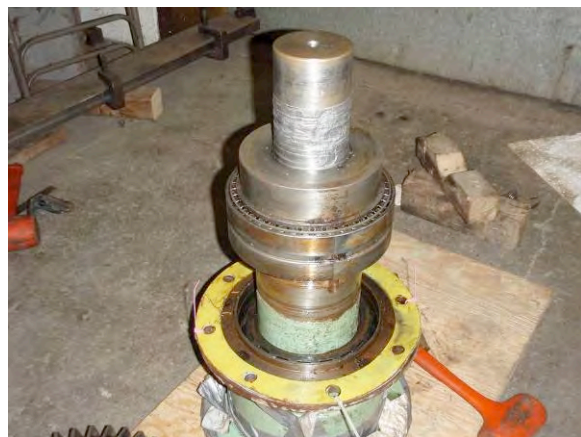
The gear box cover was removed and floating shafts were uncoupled from the output shafts to allow for the differential assembly to be removed and disassembled. It was discovered that the interference fit and key securing the bevel gear to the output shaft had failed resulting in the bevel gear spinning on the output shaft.

CM&W was able to recondition the bore of the existing bevel gear, refinish the journal of the existing output shaft, recondition the differential bushing, re-machine the keyway and fabricate a new key, and reassemble the box by the 10th of July.

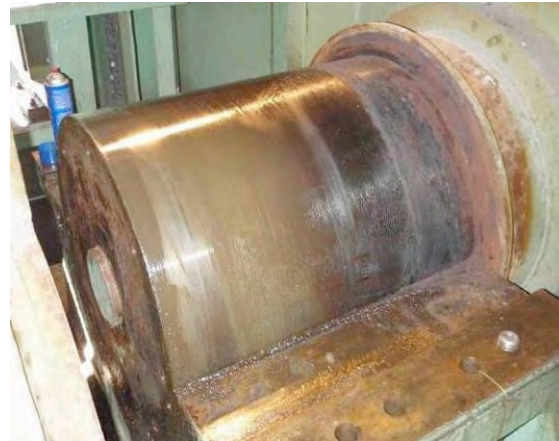
During the six week navigation closure that began in late July 2009, the trunnion bearing caps were removed to allow observation of the top half of the trunnion shafts. Extensive corrosion with pitting approaching ¼” in depth and circumferential scoring of the trunnion shafts was observed at all eight locations. Minimal lubrication was evident and it was found that clogged grease grooves were preventing the introduction of new lubricant.

With the bearing caps removed, the exposed portions of each trunnion shaft and bushing were cleaned with hand tools, emery cloth, and solvent. Each leaf was then operated to expose the two forward grease grooves for manual cleaning. Lubricant was then applied over the entire surface of the shafts and the bearing caps were reinstalled. This work was all completed before the end of the six week navigation closure in August 2009.

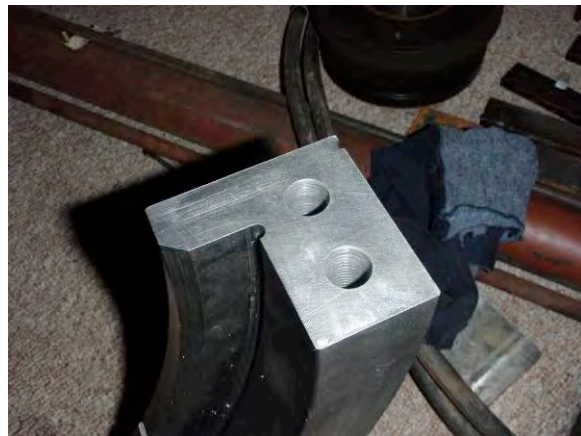
Due to the original trunnion thrust plates having extensive corrosion, a new split collar was designed. The new design was split for future removal for inspection of the trunnion shaft fillet. Additionally, grease grooves were supplied to provide grease to the thrust surfaces of the collars to prevent possible binding with the bearing.

The thrust plates located on the front face of the trunnion shaft were modified to have grease ports and fittings at the thrust surfaces to provide grease to prevent possible binding of the thrust plates as well.
