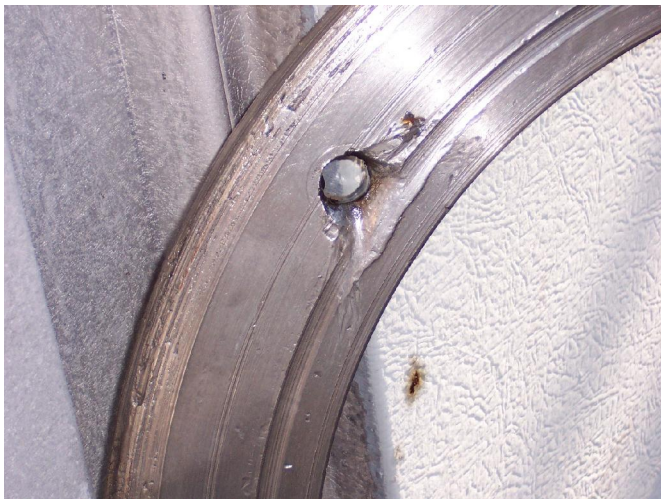
1. Seven lock plate bolts were broken off at the heads and a portion of the bolts still protruded from the trunnion shaft end. One lock plate bolt was broken off flush with the trunnion end.
2. The lock plate holes and mounting surface had significant damage. The outside edge of the lock plate had significant damage from contact against the inside of the end cover.
3. The inner race had moved axially 1-7/16" off the end of the trunnion shaft.
4. The thrust bearing races and rollers had no wear staining or apparent scratches, pits, spalls or other destructive damage. Light rust was beginning to form on the races.

Photo 1: Southern Most Outboard Lock Plate.
Note severe damage to hole and outside edge.

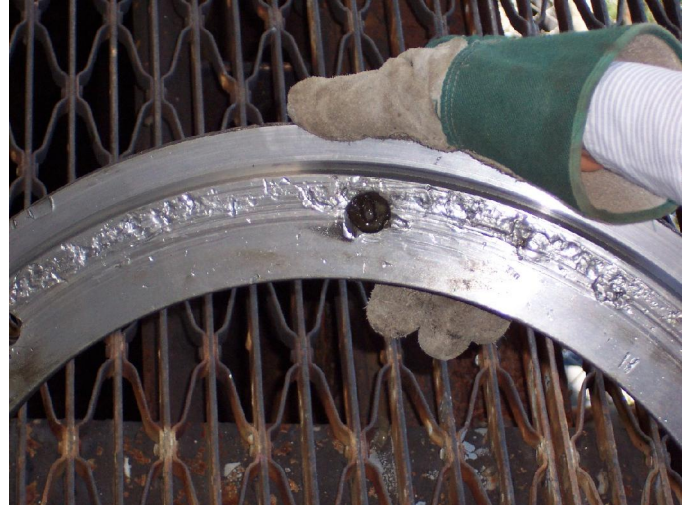
Photo 2: Southern Most Outboard Lock Plate
Note severe damage to mounting face.
