**HEAVY MOVABLE STRUCTURES, INC.
12th BIENNIAL SYMPOSIUM**

**Considerations during Gravity
Lowering of Movable Structures
Stickel Bridge, Newark, New Jersey**

**Robert J. Tosolt, P.E.
Stafford Bandlow Engineering, Inc.**

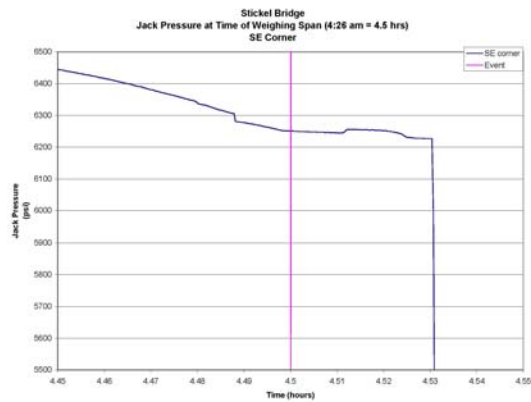
Initial Jacking Pressure, SE Corner

The initial balance of the lift span was determined via dynamic strain gage bridge balancing. The initial and final weighing of the lift span was conducted by monitoring the pressure at the four jacks used to raise the lift span; the pressures were recorded via electronic pressure transducers. A graphical depiction of the initial and final weighing of the SE corner are presented below; the red bars indicate the weigh points. For the initial weighing, only one weigh point was utilized due to the necessity to lower the bridge to clear traffic. The final weighing was conducted as part of its own bridge closure prior to the initial rope termination attempt. Therefore, there was sufficient time to utilize three separate weigh points with the bridge raised to a different height at each point. The average of these three weigh points was then utilized to determine the final span weight.

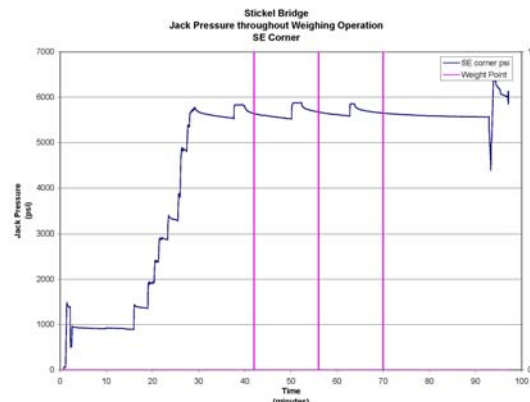
Final Jacking Pressure, SE Corner

The test results indicated that the refurbished span was in fact span heavy and therefore corroborated the basic project approach.

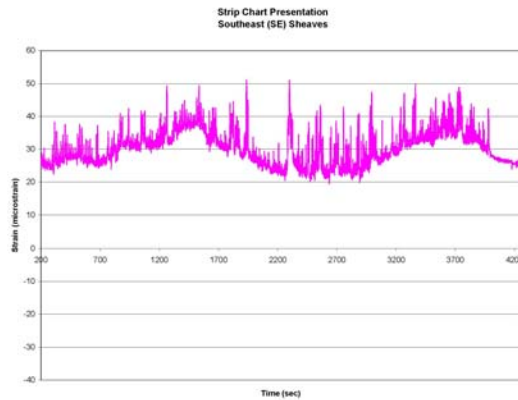
Friction Testing, SE Sheave

CORNER			
		NE	SE	NW	SW
SHEAVE FRICTION	Actual Strain	22.2	30.3	28.6	28.1
	AASHTO Calculated Strain	12.5	12.5	12.5	12.5

The results presented in the above table indicate that the actual frictional loading results in a frictional coefficient that is 2.24 times greater than that recommended by AASHTO. When considering the sheaves in their fully loaded condition, this would result in cumulative trunnion friction of 47,000 lbs per tower. Therefore, a comparable amount of weight would need to be added to the lift span to offset this friction as part of the forthcoming rope termination work.

2. The contractor would need to be prepared to add additional weight to the lift span to compensate for the jacking tolerances, as well as the results of the frictional testing, as presented in the table below.

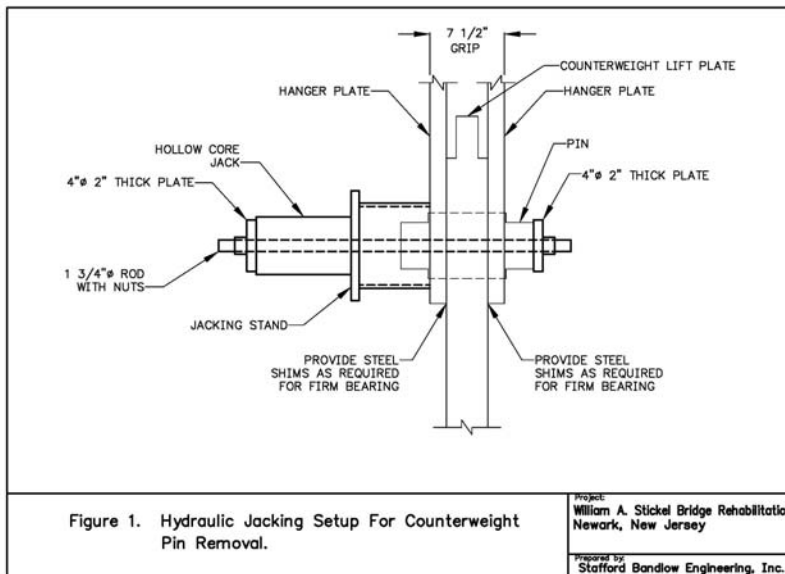
3. A jacking assembly was designed to retract the counterweight pins. The jacking assembly was sized for a load of 75,000 lbs, based on the assumption that deformation had resulted in a light interference fit (.00015 to .0003") between the pin and hanger plates with a frictional coefficient for clean steel (0.8). The jacking assembly utilized a 50 ton hollow core jack (which would be limited to 7500 psi) seated on top of a pipe stand which would bear against the counterweight hanger plates; the 1 3/4" diameter jacking rod would extend through and bear against the backside of the pin. As the existing pins were not fabricated for this purpose, the pins needed to have a 2" diameter hole drilled along their axis to accommodate the jacking rod, and this needed to be performed in place.

Calculations were performed to verify that the material removal would not compromise the integrity of the pins. The calculations indicated that the pins had adequate capacity and the holes were drilled without event.

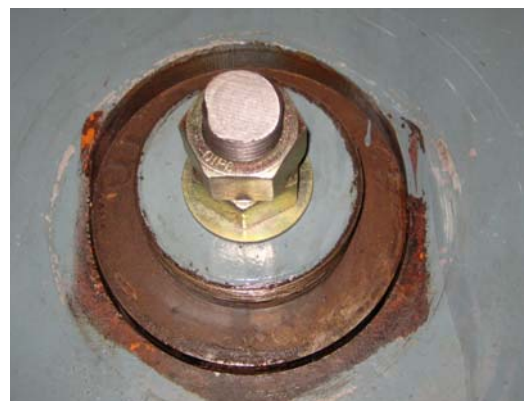
On the evening of March 29, 2008 a second attempt was made to connect the ropes at the West Tower. Upon loading the ropes, movement was immediately noted at the counterweight pins so that, when the ropes were fully loaded, clearance was visibly present at the underside of each pin. This eliminated the prior concern with the pins not being fully unloaded. The pin jacking assembly, which was already in place, was then utilized to pull the pins. At the NW pin, despite the clearance at the underside of the pin indicating that it had been unloaded, a significant force

Clearance at underside of Counterweight Pin

was still required to retract the pin. Therefore, the jacking assembly was clearly a prudent choice.

Once the pins were pulled, the span was lowered via the jacks without much effort. The additional weight of the concrete barriers was not required. The work was completed before the end of the allotted closure. The East Tower work was then performed during a separate night closure on April 5 with similar successful results.
