**HEAVY MOVABLE STRUCTURES, INC.  
SIXTEENTH BIENNIAL SYMPOSIUM**

**Counterweight Sheave Trunnion  
Rehabilitation to Correct  
Poor Operating Behavior**

Robert J. Tosolt, P.E.  
Stafford Bandlow Engineering, Inc.

Norfolk Southern Bridge DH-514.47 is a through truss span drive vertical lift bridge that carries one track of rail across the Mississippi River in Hannibal, Missouri. For the purposes of this paper, the bridge is oriented east-west with Hannibal to the west and Springfield, Illinois to the east in accordance with the established direction of the railroad. The lift span truss is 406'-0" long (center to center of end truss points) and 20'-6" wide (center to center of trusses) and weighs 3 million pounds. The bridge was erected circa 1959 in Florence, Alabama, but was relocated to its present location in 1992. At its present location, the lift span raises 41'-4" to allow passage of primarily commercial marine traffic on the Mississippi River.

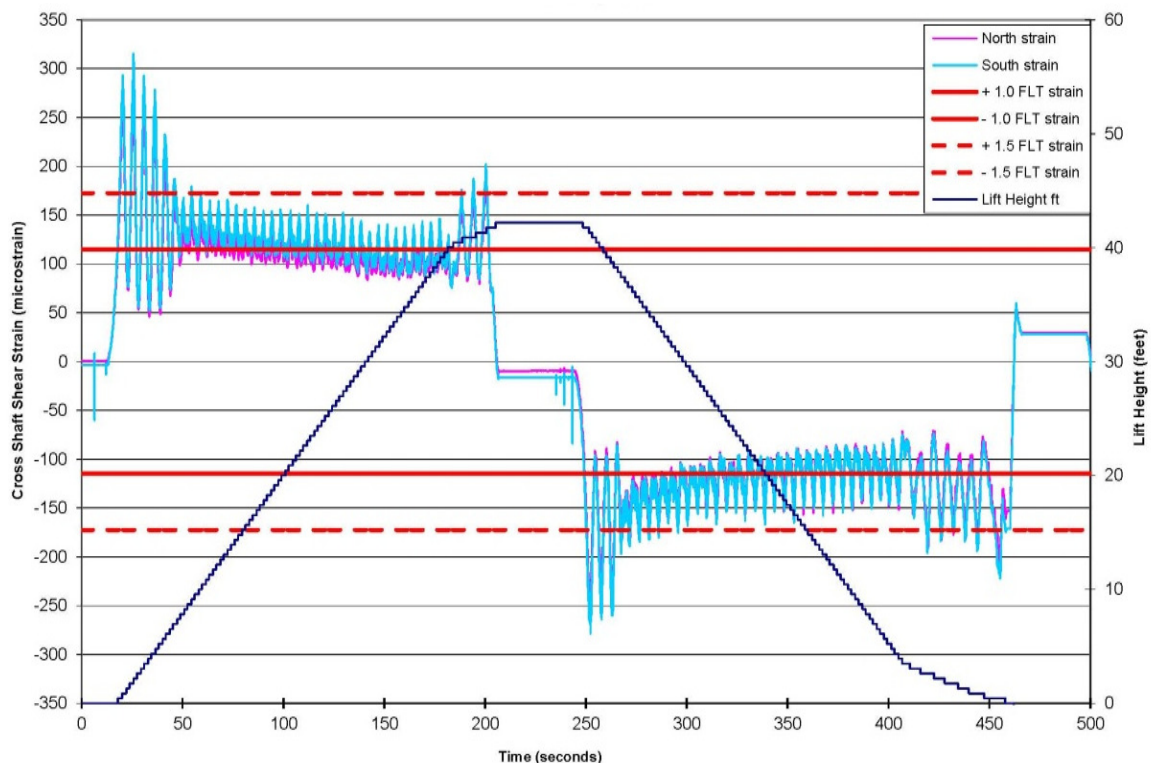
**Figure 1.** Chart recording of machinery operating loads at outset of work in September 2011.

Review of the chart recording shows that the shaft strains exhibit a saw tooth pattern due to the oscillating loads in the machinery resultant from the stick-slip behavior of the bridge during operation. The loads are greatest at the initiation of movement when raising the span from seated or lowering it from fully raised. It is notable that the peak loads are over twice the nominal operating loads.

Full load output of the 60 HP main motor produces approximately 115 microstrain in each instrumented cross shaft, assuming an equal load split through the primary reducer. Solid bar lines are provided on the chart recording to denote the full load motor output. The peak strains due to the fluctuating loads are as much as 2.78 times greater than that produced under full load motor output, and the nominal operating loads approach or exceed full load motor output for the duration of span operation in both the raising and lowering directions of span travel.

Machinery is typically designed for 150% full load motor torque. Dashed bar lines are provided on the chart recording to denote the machinery design load. The load fluctuations when accelerating the span from rest and decelerating the span from full speed exceed this threshold on greater than an intermittent basis. Loads in excess of the machinery design loading can result in accelerated wear and/or outright failure of machinery components.

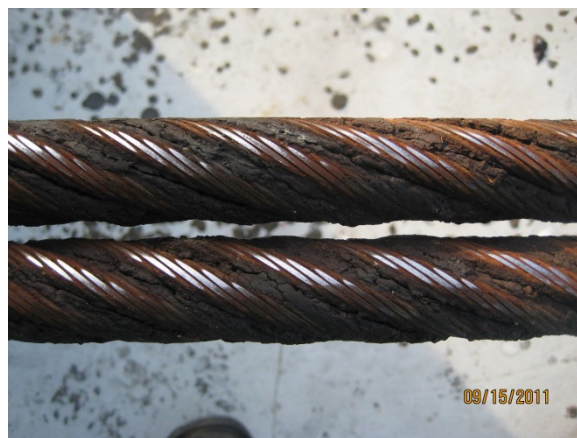
While the assessment of the nominal rope tensions did not generate any concern, the assessment of the varying rope tensions during operation was a concern. The operating rope assemblies at several corners of the bridge made loud creaking noises in the vicinity of the deflector sheaves during the load/unload cycle. Investigation of the noises found that during the load cycle, the uphaul sheaves rotated relative to the downhaul sheaves as load was induced in the uphaul ropes prior to the span moving (this is the portion of the cycle when the ropes creak), and then when the span moved incrementally the load in the uphauls was relieved and the downhaul deflectors rotated to catch up with the uphaul deflectors. Normal behavior is for both deflectors at a given corner to move simultaneously since the uphaul and downhaul ropes should pay-in and pay-out at the same time. The observed behavior is indicative of a significant alternating load imbalance between the ropes at opposite ends of the span during operation. A cursory visual inspection of the operating ropes revealed that the load imbalance had resulted in substantial wear of the operating ropes as evidenced by the extensive wear flats across the majority of the exposed wire crowns attesting to the substantial load under which the ropes were operating.

Figure 2. View of wear flats on crowns of operating ropes.

Of the two items, the integrity of the main operating ropes were regarded as being more time sensitive in maintaining the reliability of the bridge. In addition the replacement of the operating ropes did not require any special engineering support. Therefore, Norfolk Southern opted to perform the main operating rope replacement as a stand-alone work item in 2012.

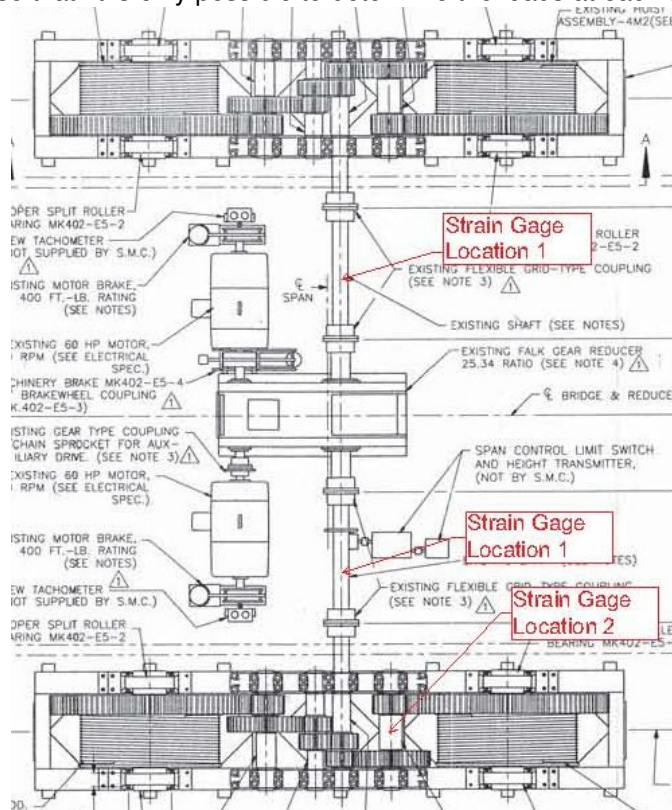
**Figure 3.** Span Drive Machinery Arrangement. View of strain gage installation locations.

- Testing conducted using the gages at Location 1 as identified in Figure 3 did not determine any appreciable difference in the loading at either side of the lift span (i.e. the transverse loading). In contrast, testing conducted using the gages at Location 1 and Location 2 did indicate a disparity in the end to end loading of the lift span. In particular, the data from the Location 2 gage was used to determine that there was a significant disparity in the measured friction between ends of the span with the friction at the west end being almost twice as high as at the east end. This disparity is consistent with the condition of the trunnion bearings which are discussed below .

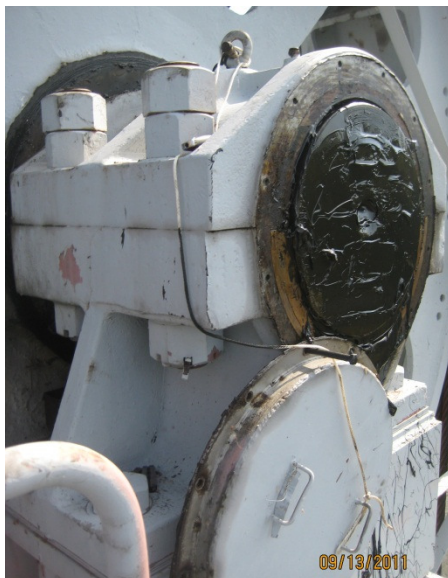
**Figure 5.** View of trunnion bearing with end plate removed.

The trunnion bearings are plain bearing assemblies which consist of bronze bushings mounted in a pillow block housings. Each bearing assembly has a bronze bushing in the base, but no bushing in the cap. An end plate is provided to seal the housing and act as a grease reservoir. All bearing end plates were removed as part of the inspection to evaluate the state of lubrication and allow an assessment of bearing clearance as well as a limited assessment of the journal surface.

Bearing clearances ranged from 0.365" to 0.420" and were well in excess of the anticipated plan value of 0.090". The large clearances indicate the bearings were either assembled with greater clearance than indicated on the original plan or that the bearings exhibit substantial wear.

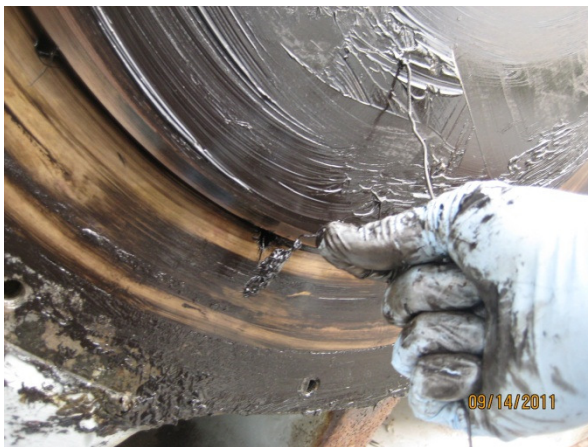
As part of the inspection, the probe wire was also inserted in the grease grooves at the bottom of the bushings to determine if the grease passages were clear. At multiple locations, the grease grooves were clogged with metal shavings from the abrasive wear which had the appearance of steel wool. The metal shavings were also found mixed in the lubricant at the top of the journals. The presence and location of the metal shavings indicated that the abrasive wear was an active, on-going process, and that the condition of the journals was steadily deteriorating.

**Figure 6.** Metal Shavings pulled from Trunnion Bearing Grease Groove.

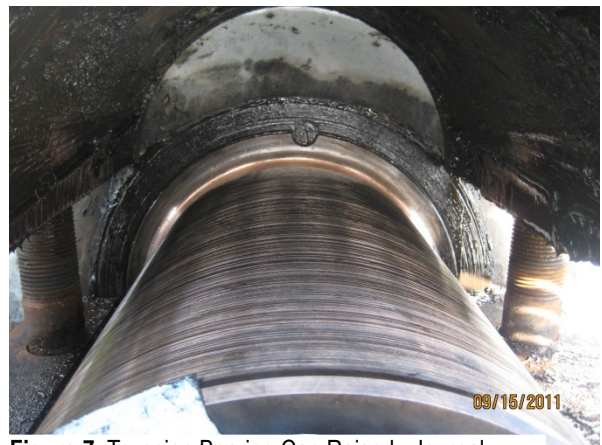
A probe wire was inserted into the gap between the bearing cap and the trunnion journal at the top of the bearing and run across the top of each journal surface to provide an assessment of the journal condition. The probe wire detected significant abrasive scoring at all West Tower bearings as well as one bearing in the East Tower. While all bearings exhibited substantial clearances, it was notable that the nominal clearances at all bearings with significant abrasive scoring were 0.060" to 0.090" greater than at the bearings which were not noted to have significant scoring.

**Figure 7.** Trunnion Bearing Cap Raised. Journal exhibits severe abrasive scoring along entire length.

On the basis of these findings, a decision was made to remove several bearing caps to establish the extent of the scoring. Removal of two bearing caps at the West Tower exposed severe abrasive scoring that extended across the entire width of the journals. The fillet regions exhibited corrosive pitting, metal rip-out and light abrasive wear. Removal of one bearing cap at the East Tower exposed similar, albeit lesser, wear.

The full scope of the rehabilitation work encompassed unloading of the sheaves, re-machining of the trunnion journals to eliminate the severe abrasive scoring, outright replacement of the bearing bushings, limited re-machining of the bearing housings to accommodate the new bushings, and replacement of the main counterweight ropes which was performed as a supplementary item given the effort required to support the counterweights. Specific areas of the rehabilitation design that were necessary to make the work viable and achieve an acceptable end product are discussed below.

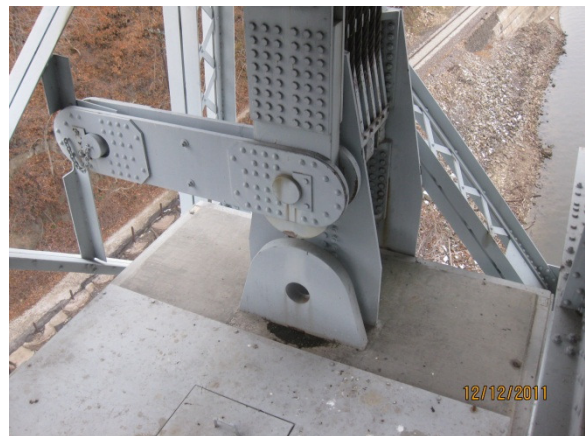
**Figure 8.** Existing Counterweight Hanger Link in Stowed Position. Lower link is notably longer than distance to clevis connection on counterweight.

The necessary jacking stroke is dependent upon the elastic stretch of the ropes, the constructional stretch/shrinkage of the ropes, and the height which the span had to be raised in order to make the pinned connection of the hanger links with the counterweights. The length of the existing lower hanger link was substantially longer than required to pin the counterweight in its existing position and would have required the lift span to be raised 25" solely to make the pin connection, not considering rope stretch. The largest available commercial jack in the required size (600T) had an 11" stroke. Therefore, over 2 full strokes of the jack would have been required to lower the lift span once the counterweight was pinned. To eliminate

this unnecessary work, the design incorporated a new lower hanger link that was shorter than existing and reduced the required jack stroke to 1.5" to make the connection. In consideration of this new reduced pin height, and the anticipated constructional and elastic stretch, it was regarded that the counterweight could be unloaded in one stroke of the available commercial jacks.

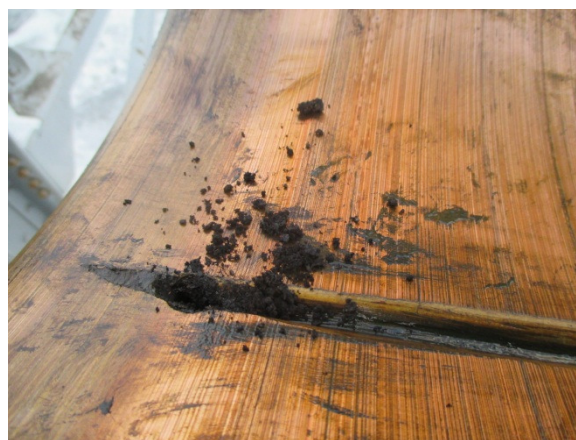
Upon disassembly for rehabilitation, the grease arrangement was evaluated. Each of the four grease grooves in the lower bushing was equipped with a dedicated button head grease fitting. The two grooves closest to the split line were equipped with short piping runs so that the fittings were accessible from the sides of the bearing; these are the fittings which were commented above. The two grooves closest to bottom dead center of the bushing had their fittings located in a cored cavity in the bearing housing that was essentially inaccessible once the sheave was installed. The two grease grooves serviced by these grease fittings were found packed with old hardened lubricant that had to be forcibly removed. As a result, whereas the overall amount of lubrication found on the bearings upon disassembly appeared adequate, the lack of lubrication to the bottom of the bushing, which is the most heavily loaded region, was a likely contributor to the observed deterioration of the contact surfaces.

**Figure 9.** View of hardened grease that has been forcibly removed from the grease port at bottom dead center of the bushing.

Rehabilitation of the bearings as part of this work had originally included replacement of the worn bushings and re-use of the existing housings. The bushings had been detailed with four axial grease grooves with a note to match whatever lube holes existed in the housings. Based on the field findings, the rehabilitation of the bearing housings was expanded to include extension of lube lines so that all grease grooves could be directly lubricated. For the two grease ports at bottom dead center, this required drilling holes through the bottom web of the housing to allow the grease lines to be piped out to the face of the bearing.

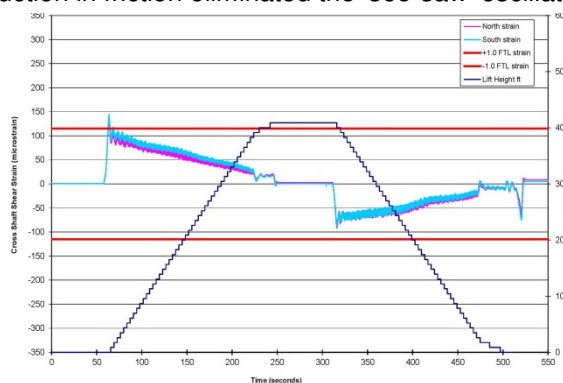
The chart recording of the loading from the post rehabilitation test also provides a striking comparison to the pre rehabilitation test depicted in Figure 1. The reduction in friction eliminated the 'see-saw' oscillatory nature of the span operation that was present prior to the rehabilitation and was the primary factor in initiating the initial investigation in 2011. This behavior is apparent in the sawtooth appearance of the strain traces on the strip charts for the test runs prior to the rehabilitation and is notably absent from the test run following the rehabilitation. The significant reduction in friction has also resulted in a corresponding significant reduction in load required to operate the bridge. The nominal operating loads have generally been reduced by half, and the accelerating spikes have been largely eliminated. All operating loads remain within full load torque of the drive motor.

Figure 12. Chart recording of machinery operating loads at completion of work in February 2014.
