**HEAVY MOVABLE STRUCTURES, INC.  
ELEVENTH BIENNIAL SYMPOSIUM**

**In Place Machining of Trunnion Journals  
On Bascule Bridge Rehabilitation**

## Wappoo Creek Bridge

## Wrightsville Beach Bridge

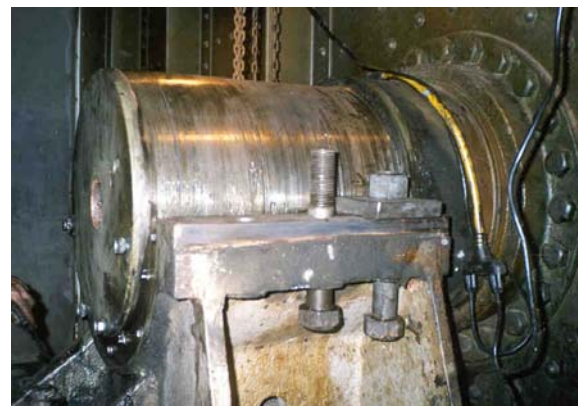
PHOTO 2: Condition of South Trunnion at Wappoo Creek Bridge prior to machining.

that the interior bore of the bushing could be machined to the proper tolerance. Both north trunnions were in very good condition with only slight scoring present. When the south, or farside, trunnion caps were removed, the journals were in very poor condition (See Photo 2). These journals had scores up to 0.060" deep and pits up to 0.010" deep throughout the full length of the journals and the shoulders had been gouged. Condition of the bushing could not be determined but based on observations of the trunnion journal the bushing was not going to be in good condition.

It was determined that the trunnion journals for the south leaf could not be left in this condition. Replacement of the trunnion was determined to be too timely and cost prohibitive. The only viable option was to remachine the existing trunnion on the bascule span. Although the trunnions on the north leaf were in good condition, it was decided that all trunnions should be remachined to the same diameter. The condition of the babbitt in the caps was good and it was determined no work would be performed on the caps except for cleaning of the babbitt and grooves.

The first task was to estimate the amount of material that would be required to be removed to eliminate the scoring. Based upon the field conditions the largest visible score was 0.060" deep. Therefore it was determined that 1/16" of material was to be removed all around or reduce the trunnion diameter by 1/8" maximum allowed by the stock in the bushing. This amount was to be taken from the full width of the trunnion and the fillet radius was to be feathered to accommodate the new diameter of the trunnion. The bushing bores had not yet been machined at this time and extra stock had been placed to allow final machining of the bushing bore after field measurements were obtained. This allowed the inside diameter of the bushing to accommodate the revised diameter without having to fabricate new bushings.

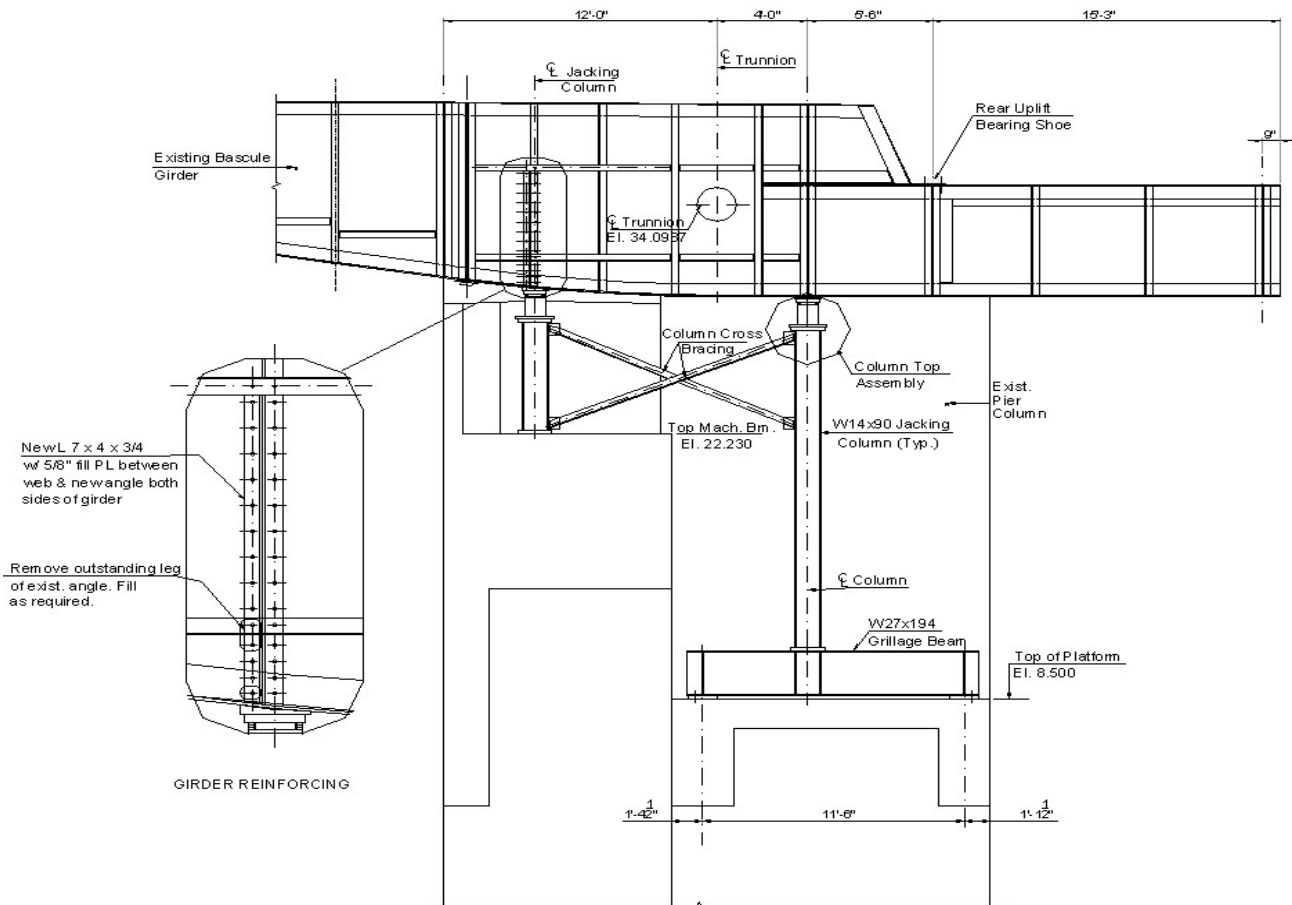
FIGURE 2: Elevation view of jacking system under one girder of Wappoo Creek Bridge.

The jacking was to be performed by installing two jacking columns under each bascule girder. Four 280 ton jacks were utilized to lift the span, one place on each of the jacking columns. Two of the jacks were set in front of the centerline of trunnion and two were set behind the trunnion. This was done to provide stability about the span's center of gravity when lifting. All four jacks were powered from the same power unit, but each jack was individually controlled to allow for controlled raising of the span. The front column was short and mounted on the pier at machinery level. The rear column was about three times longer and mounted on a shelf of the pier near water level. A beam had to be installed under the column to ensure the load of the span was transferred to a portion of the pier thick enough to resist the jacking loads. Both columns were then longitudinally braced to one another (See Figure 2). To ensure the load would not locally overstress the bascule girder, an additional angle was installed to act as a web stiffener for the front jack. The rear jack was already acting on a heavily reinforced section since the front counterweight floorbeam connected to the bascule girder at that location.

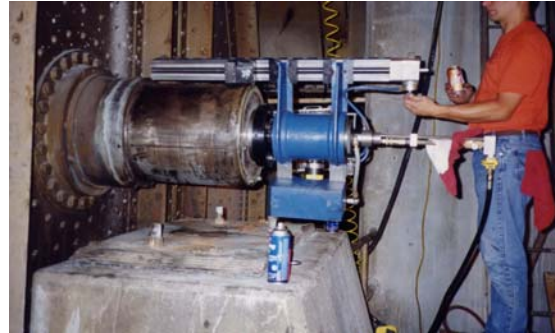
PHOTO 3: Machining equipment set on trunnion for Wappoo Creek Bridge

The machining of the trunnion was performed in 5 nights of work in August of 1999 that would be done in five steps. Step 1 was the rough cut. On this pass 0.050" was removed from the trunnion diameter (See Photo 3). Step 2 was to remove 0.030" from the trunnion journal diameter, step 3 removed 0.010", step 4 was to recut the trunnion shoulder and step 5 was to grind and polish the machined surface and grind out the lubrication grooves (See Photo 4). Each pass took approximately 4 hours to complete.

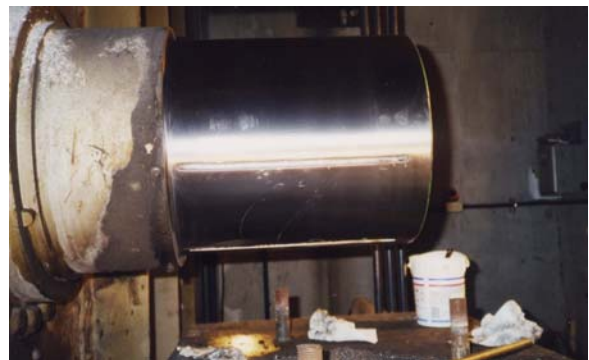
PHOTO4: Trunnion journal for Wappoo Creek Bridge after completion of machining

After both trunnions were finished and the final diameter of the shaft established the bushing was machined for the proper tolerance and set into the bearing base. The base was brought back to the site and over night the bridge was jacked up again to install the bearings and then lowered. The existing shims under the trunnion bearings were previously removed and the bearing was realigned at the proper elevation and grouted into place.

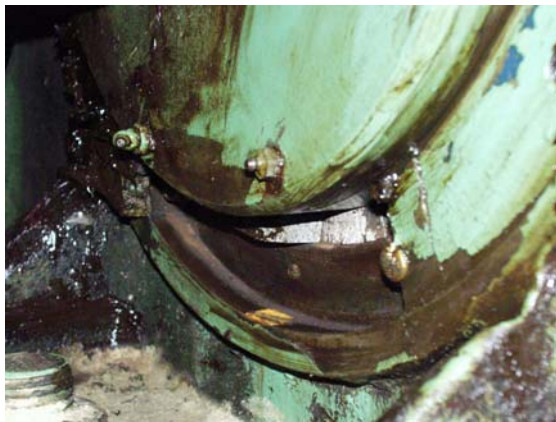
PHOTO 6: West Trunnion of Wrightsville Beach Bridge showing cracked bushing and section of flange missing.

The trunnions had shown signs of distress and continued inspection showed the southwest trunnion was damaged with a cracked bushing that also had a portion of the flange broken off (See Photo 6). In September 2000, NCDOT contacted TIC- The Industrial Company to provide a cost estimate for the repair to the west leaf trunnions and replacement of the bushings. The estimate was \$226,415, but NDCOT decided against proceeding with a negotiated contract and advertised for bids in a special December 21st letting. TIC was low bidder (\$313,395) and was

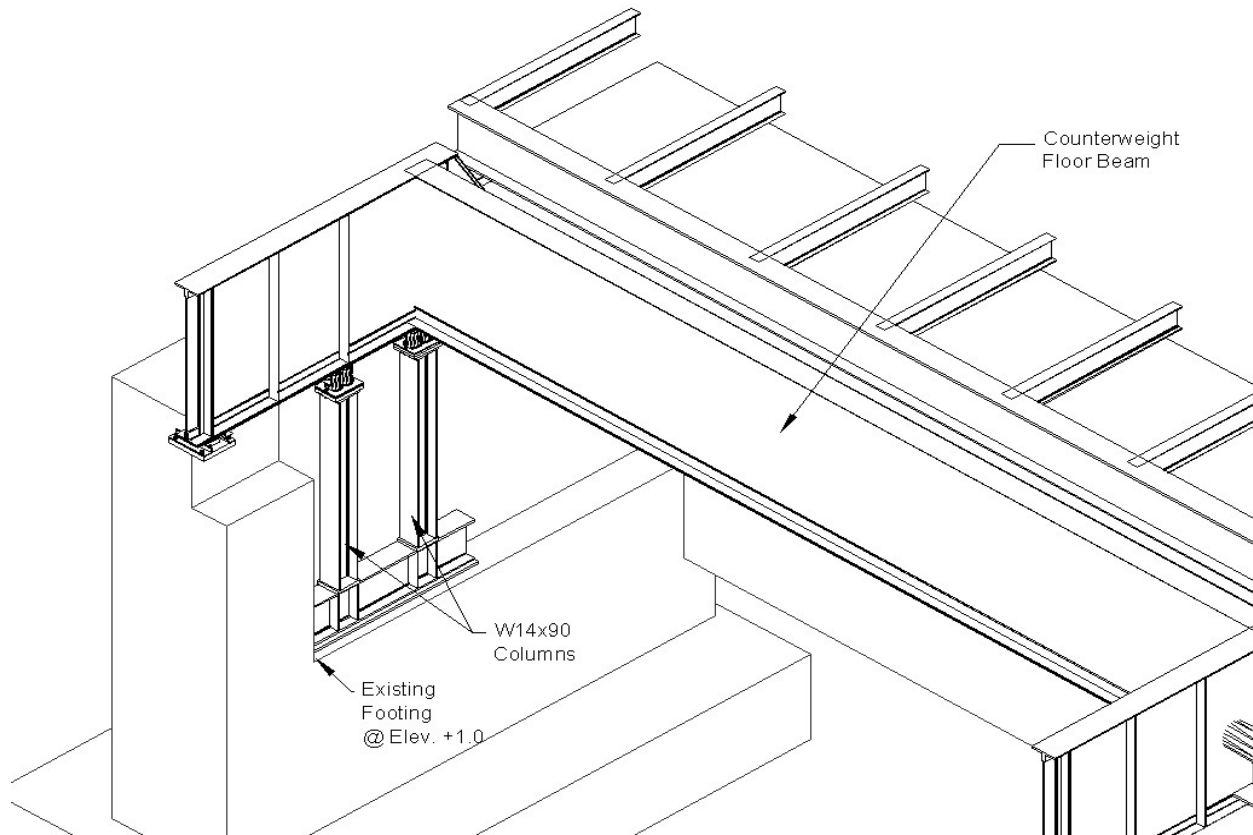
FIGURE 4: Isometric view of jacking system for Wrightsville Beach Bridge

As with Wappoo, four jacking columns were to be utilized, but due to the increase in the span weight, eight jacks of 150 tons each were utilized. These were set up in pairs on each column. Although it would make the jacking a little more difficult due to coordinating more jacks, this was done to facilitate the load distribution to the girder as well as make the size of the jacks more manageable to handle.

The substructure was quite different on Wrightsville and the development of the jacking columns load transfer required some more conservative design than on Wappoo. This was due to the portion of the pier directly below the bascule girder being only a small ledge (approximately 26 inches wide). The original contract documents called for all concrete to be 3,000 psi, but there was a note on the footing plans calling for the

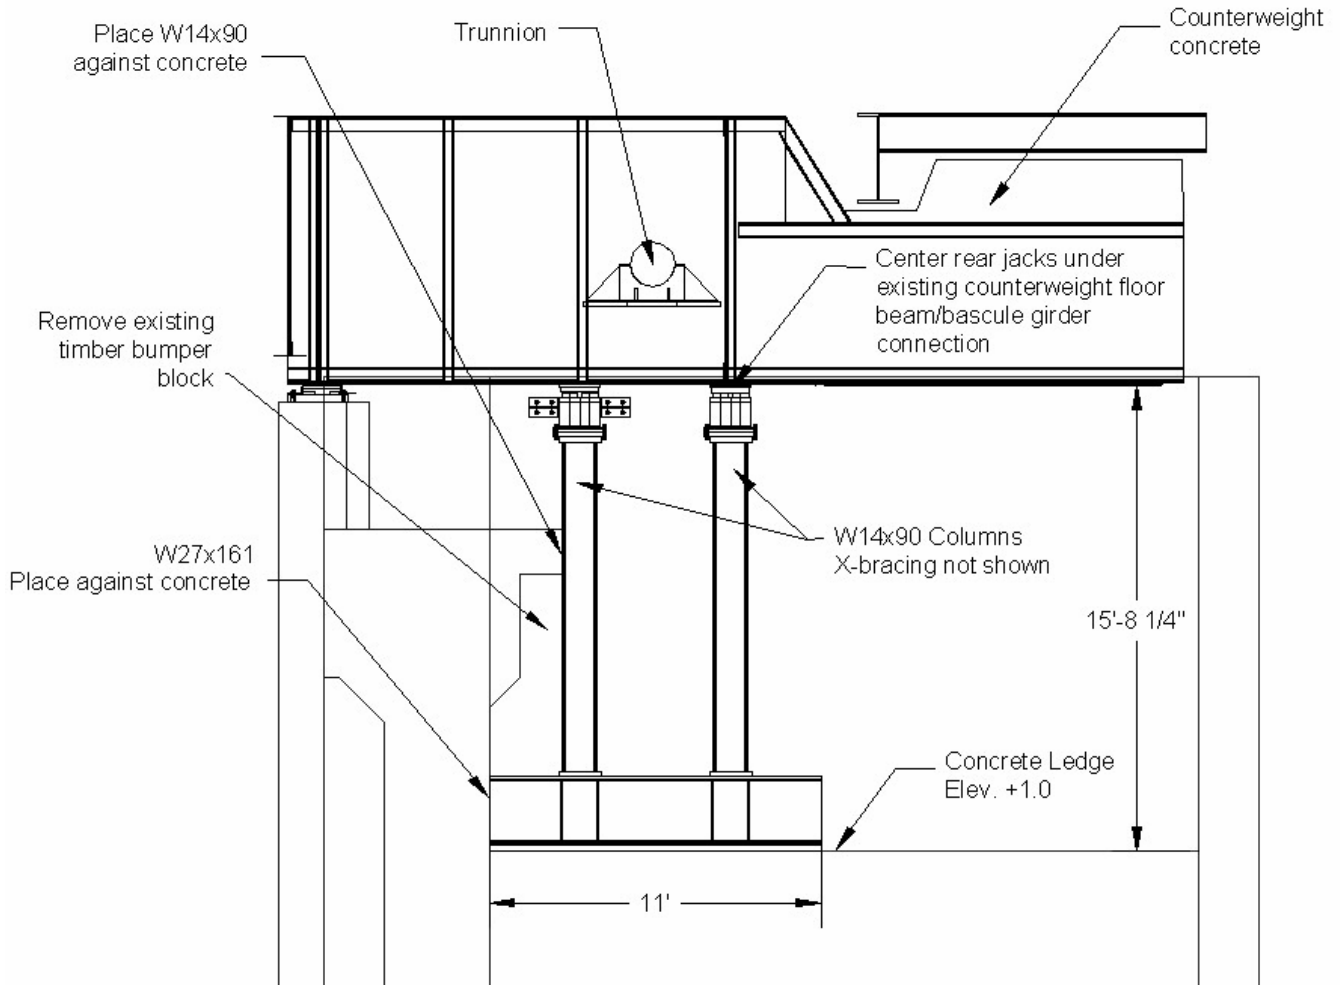
FIGURE 5: Elevation view of jacking system. Note transverse beam directly above counterweight

The jacking procedure was also more complex due to the structural conditions. The rear live load shoe is mounted to a transverse beam that is directly above the counterweight. Even with removing the rear shoe there was inadequate clearance to properly clear the anchor bolts when the span was raised. To obtain even greater height of the lift, the span was slightly rotated by raising the front jacks higher than the rear and then raising both simultaneously. This allowed the bascule span to go higher while keeping clear of the transverse beam.

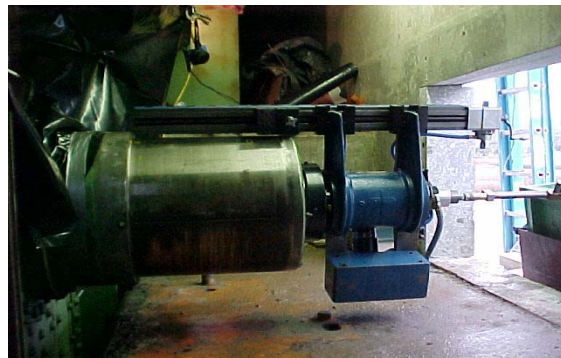
PHOTO 7: Machining system in place on trunnion. Note hole in pier wall to provide clearance.

The structure configuration proved to make things difficult for the repair. First was that there was limited room around the existing trunnions for setup of the required machining tools. The south side had a plywood wall separating the pit area and the electrical room. The north side had the exterior wall of the bascule pier. The south plywood partition wall, span lock and span limit switch were removed to provide room at the SW trunnion. A section of the north wall was removed providing not only room to set the machining bar but also provided an access hatch to remove the bearing (See Photo 7). Second was the span lock system consisted of a series of cranks and linkages that passed through the trunnion on the south side of the span. To perform the machining, the portion of the span lock going through the trunnion

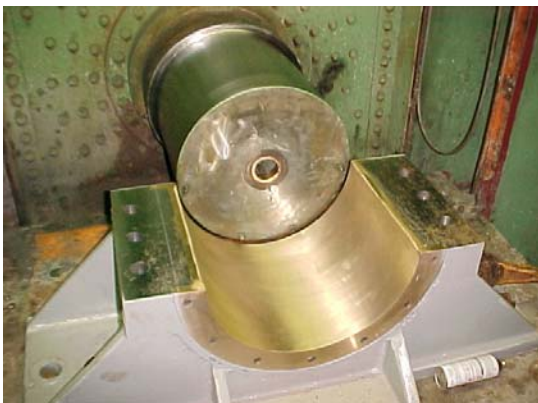
PHOTO 8: Completed Trunnion and Bearing for Wrightsville Beach prior to assembly.

Both repair contracts proceeded well and the machining of the trunnions was a success (see Photo 8).
