**HEAVY MOVABLE STRUCTURES, INC.  
ELEVENTH BIENNIAL SYMPOSIUM**

**Failure of the Control System on the East  
Half of the Hood Canal Bridge**

Tim Benson, P.E.  
Washington State Department of Transportation  
and  
Mark Van De Ree, P.E.  
Parsons, Brinckerhoff, Quade and Douglas

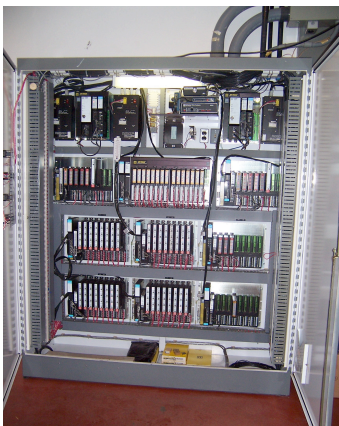
Photo 2: East Structure Control Cabinet

The control system for the east structure is a hybrid single phase, 60Hz, 120/240 volt a.c. grounded system. A portion of the control system uses two pole, 240 volt a.c. circuits for PLC outputs. The PLC system installed in 1985 replaced most of the hardwired relay controls and interlocks with software based control logic. The PLC power originates at a UPS (Uninterruptible Power Supply), is filtered by an Islatrol brand power filter, feeds through Square-D brand power supplies and connects to the PLC CPU (control processing units) racks and PLC I/O (input/output) racks. Refer to Figure 2 for the PLC system architecture, and Photographs 2 and 3.

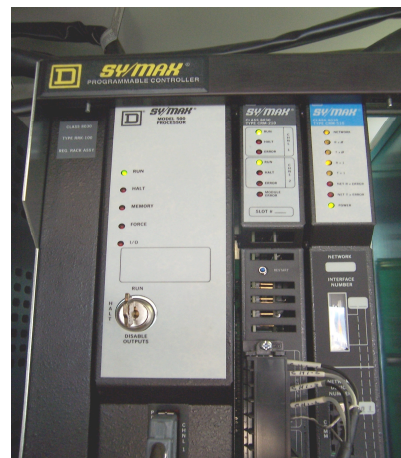
Photograph 3: Square D SyMax Model 500 (Type SCP-523) PLC w/CRM-210 LI Module (Local Interface)

The Local Interface modules (LI) CRM-210 were found to be old revisions. The LI modules communicate PLC commands to the I/O. The most current revision for this module is level O, but the level O module is not compatible with the balance of the installed PLC system according to the manufacturer's representative to Modicon/Schneider Electric, Telemecanique Automation Services. The most current compatible revision for the LI module is level N. The revision for one of the installed LI modules was revision level H and the other level N1. The LI module with revision level H was installed in the rack with the primary PLC processor which was in control at the time of the fault.

Discussions with PLC representatives and their company associates raised the possibility that the LI level H modules may have been defective. Subsequent revision to the module may have corrected the defects when they were last produced over ten years ago. The SyMax Equipment Survey report by the representative recommended the CRM-210 revision level H module be removed from service immediately. Refer to Table 1 for the SyMax Equipment Survey report.

One suspected cause of the failure is a Square-D communications module CRM-210. CRM-210 LI modules have image tables for I/O commands that are independent of the PLC processor. It is conceivable that a fault in a CRM-210 module could result in energizing all of the PLC system outputs.

4. Three CRM-210 revision level N modules were located for sale through the local distributor. It was recommended that WSDOT purchase two of these modules, one to install and one for a spare.

The CRM-210 Local Interface module which was found to be revision level H was replaced with a revision level N module and the PLC is operational at this time.

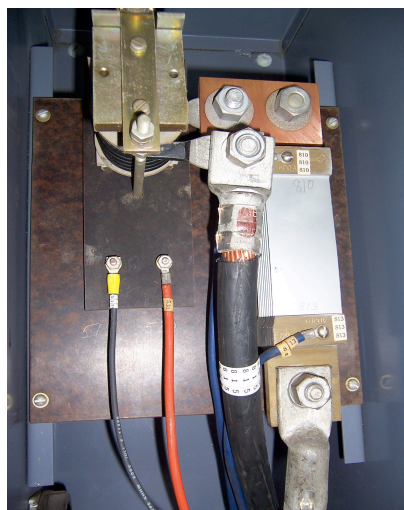
Photograph 4: 1E (West Loop) D.C. Overcurrent Relay (E-C75-E)  
Square D Model SJ 8542 w/ Calibrated Shunt

- d. The d.c. drive motor overcurrent protection did not function during the fault. The overcurrent relays are believed to be operational, but the relay contacts are connected through the PLC and are not hardwired to the motor contactors. This configuration essentially bypasses the overcurrent protection regardless of the overload relay condition. The fault caused the PLC outputs to the motor contactors to be energized, therefore commanding the contactors to remain closed.

The d.c. drive motor overcurrent relays are very old (early 1960s) and should be sent to an electrical shop to be tested. Refer to Photograph 4. Testing should include insulation resistance (megger), and load testing. Preliminary megger testing in the field showed no signs of insulation failure. The existing overcurrent relays can be put back into operation if they pass the load test, but should be removed from the PLC.

Originally, each overcurrent relay contact was hardwired to the motor contactor to complete a control circuit and energized the motor contactor to start the motor. Opening the overcurrent relay contacts de-energized the motor contactors and stopped the motors. With the PLC controlling the motor contactor when the fault occurred, the PLC output stayed energized and defeated the overcurrent relay. Direct replacements for the overcurrent relay with an automatic reset are available.

The d.c. drive motor overcurrent relays are very old (early 1960s). After equipment repairs were completed, WSDOT engineering and maintenance personnel observed the overcurrent relays operate while commissioning the replacement drive motors. The PLC system, when installed in 1985, replaced most of the hardwired relay controls and interlocks with software based control logic. This includes control of the overcurrent relay that should have remained hardwired to the motor contactors.

5. Refurbish both motor drive generators in a motor shop.
  6. Refurbish and rewind the four drive motors in a motor shop.
  7. The d.c. drive motor overcurrent relays should be sent to an electrical shop to be tested. Testing should include insulation resistance (megger), and load testing. The existing overcurrent relays could be put back into operation if they pass the load test, but should be removed from the PLC. If they do not pass the load test, fuses should be considered to protect the motors from high current until replacements or alternatives are found.

As an alternative, the overcurrent relays may be calibrated in the field by a trained d.c. motor technician. Near overcurrent conditions can be momentarily attained when first starting a bridge operation. The relay can be set just above the normal starting current needed to move the draw pontoon.

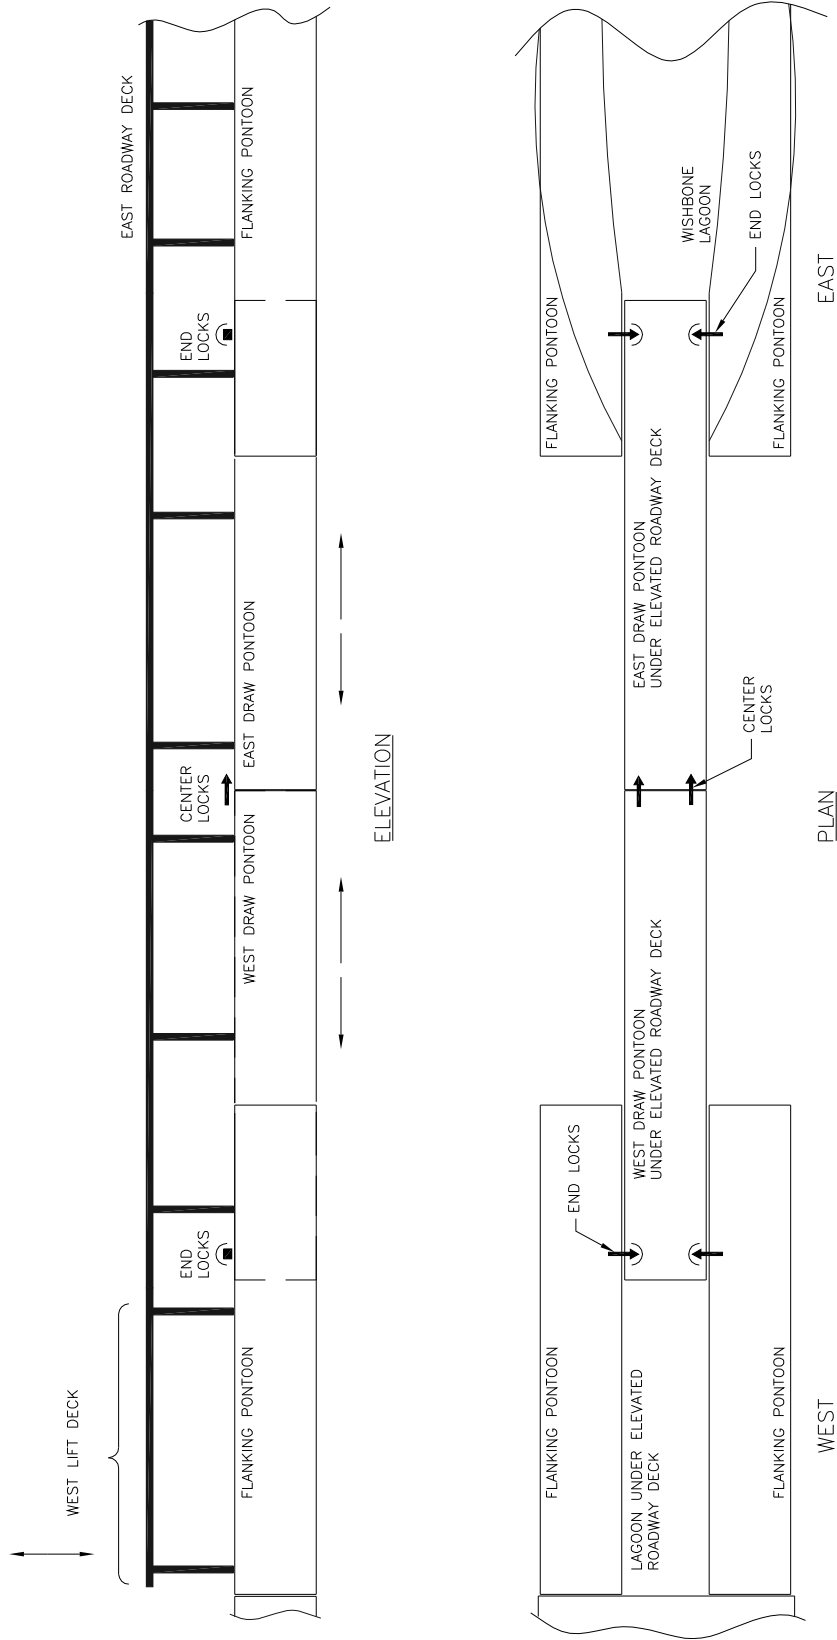
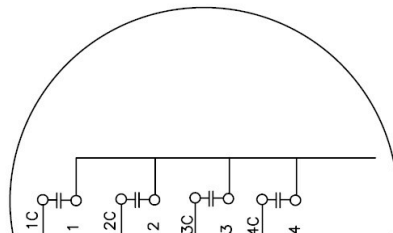
FIGURE 1: HOOD CANAL BRIDGE

With the type of control system configuration used for the east structure, all safety interlocks became bypassed as a result of the fault. The east structure end locks were released, the drive motors activated, and the traffic gate was operating – all with the bridge open to traffic. Since the west structure has a semi-independent control system, neither the west endlocks nor longitudinal centerlocks released. In fact, the west endlocks and centerlocks held the draw spans together for two hours while four 40 horsepower drive motors on the east structure were energized and trying to open the spans. Refer to Figure 1.
