Metropolitan Avenue Bridge Emergency Contract – Project  
Challenges through the Eyes of the Client and the Contactor

Nicholas J. Iaboni, Kiewit Infrastructure Co.

Rahul P. Shah, PE, NYCDOT – Division of Bridges

# METROPOLITAN AVENUE BRIDGE EMERGENCY CONTRACT – PROJECT CHALLENGES THROUGH THE EYES OF THE CLIENT AND THE CONTRACTOR

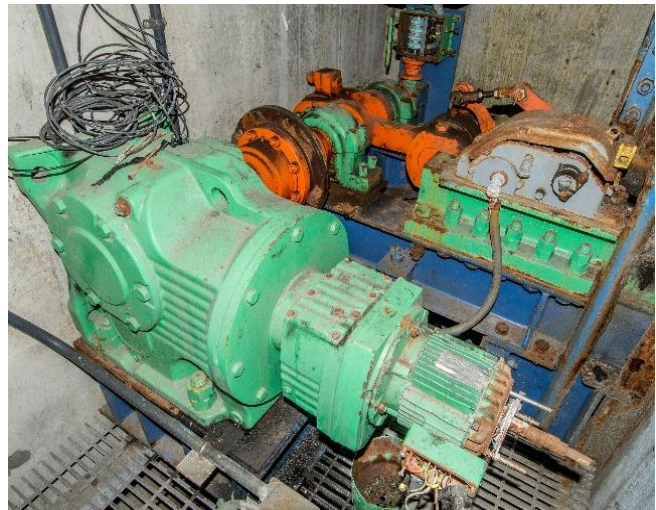
**Existing Condition of Tail Lock Machinery**

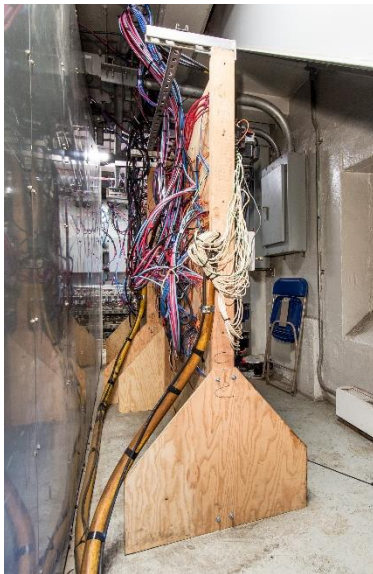
**Temporary Control Board**

In the second stage of emergency repairs, the primary electrical systems were made operational. A temporary transformer was installed to restore incoming power to the bridge and control house. Due to damage to the PLC, MCC, and drive cabinets that could not be immediately repaired, as well as flooding of conduit and electrical boxes, temporary wiring and controls were installed to bypass the primary systems. At each machinery set, the electrical motors were removed, rebuilt, and reinstalled. Temporary wiring was run to the motors, brakes, locks, traffic gates and traffic lights. A temporary board was constructed in the electrical room which housed the breakers and contactors for each of the components, and a temporary control desk was built next to the existing control desk. Following these repairs, the bridge was operable from the control room, rather than requiring crews below each end of the span at the hydraulic power units.

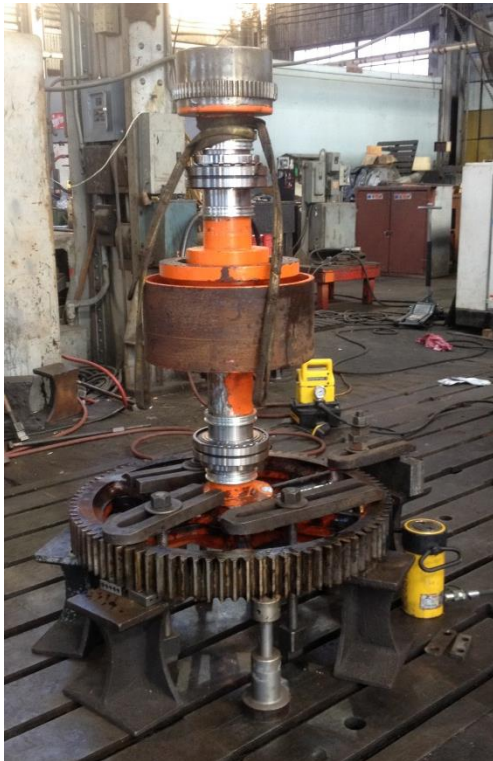
At the start of the removal work, it was found that this procedure worked for some of the existing components, but not for others. With collaboration from the client and the engineer, multiple iterations of the method were attempted, changing variables such as the heating duration, maximum heat applied, and maximum force applied by the jack. Calculations were also checked to determine the required jacking force required to overcome the friction between the shaft and gear due to an FN2 interference fit.

Using the various methods, all parts were successfully removed, however in some cases scoring occurred, requiring bore weld repairs and other fixes. Working with the client, engineer, and

**Gear Assembly Prepped for Jacking**

Prior to the start of the removal work, a procedure was submitted to the owner outlining the plan for removal of the open gears and couplings from the existing shafts in a manner that would prevent any damage to the bore of the component. As is standard industry practice, the procedure was to brace the gear or coupling, apply heat using a torch to allow it expand uniformly, and use a hydraulic jack to press the shaft out. This submittal was reviewed and approved prior to the start of work.

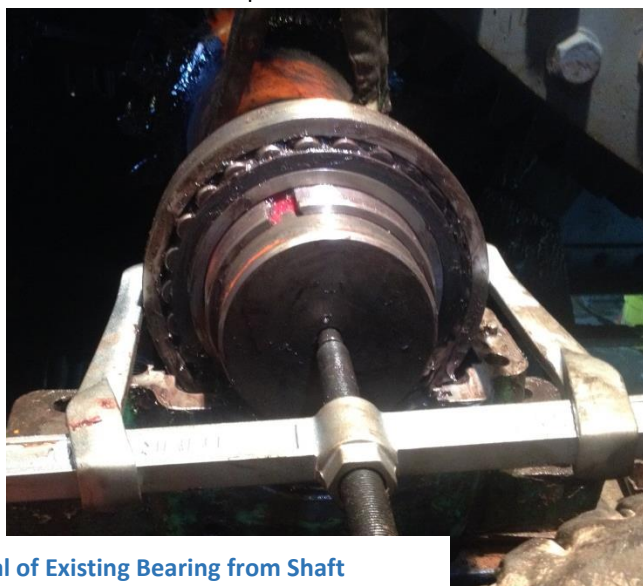
As previously discussed, all of the spherical roller bearings for the operating machinery were required to be replaced in kind. For this work, it was intended that the contractor would remove the gear assemblies from the bridge and send to a machine shop for rehabilitation. However after the start of work, the contractor found that the main set

**Removal of Existing Bearing from Shaft**

of pinion/gear assemblies could not be removed from their existing location without first removing the racks. There was no work in the current contract to remove the racks, and doing so would result in a large amount of additional work and more importantly, would greatly increase the risk of alignment issues upon reinstallation.

The bearings for the main pinion/gear assemblies were located on the ends of the shafts; therefore no other rehabilitation work was required per contract aside from cleaning and painting. Following research with the bearing manufacturer, SKF, the contractor proposed a procedure to the client to replace the bearings in location on site, to which they agreed.

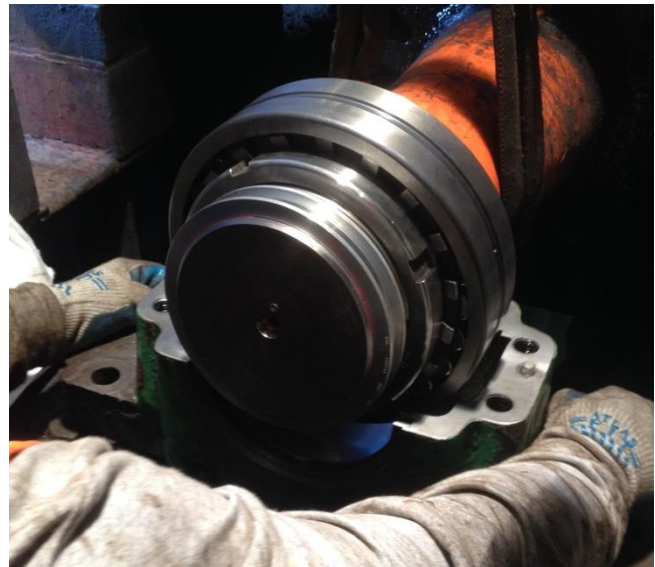
**New Bearing Installed on Shaft**

These additional measures led to a successful operation in which the client was extremely satisfied with the workmanship of the end product. All 16ea bearings were replaced to within contract requirements with no quality issues.
