**HEAVY MOVABLE STRUCTURES, INC.
12TH BIENNIAL SYMPOSIUM**

**REHABILITATION OF THE HOLLYWOOD BOULEVARD
(S.R. 820) BASCULE BRIDGE**

Roberto Vicedo, P.E.
Hardesty & Hanover, LLP

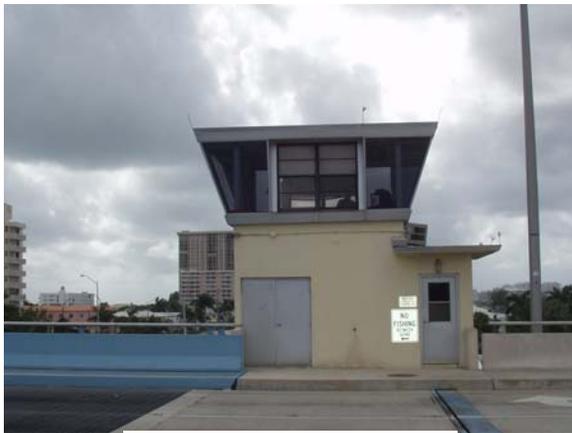
Existing Control House

The existing control house is supported by six reinforced concrete cantilever brackets located on the south wall of the west bascule pier and consists of three levels altogether. The two lower levels hold the electrical equipment that powers and controls the machinery and the top level houses the control desk and the bridge operator. As part of the aesthetic improvements, the renovation of the control house included the demolition and reconstruction of the top two levels. The structure was redesigned not only to remain operational but also to resemble the influence of the Spanish architecture that was present at one time in Hollywood. The steel framing and glass windows that surrounded the top or control room level were replaced with reinforced concrete walls and bullet resistant windows for the bridge operator to have an adequate view of the roadway and the navigable canal. The steel frame flat roof was replaced with a single ridge roof composed of wood trusses and sheathing and Spanish clay tiles.

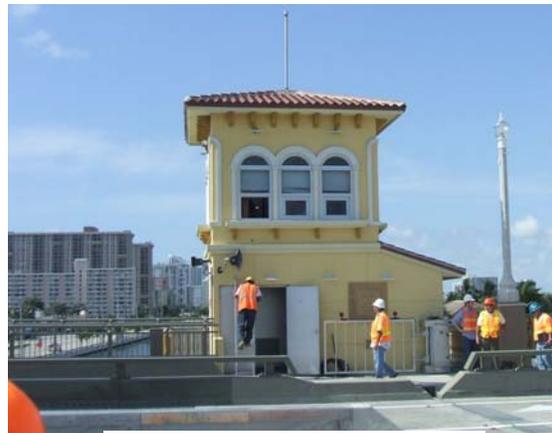
Renovated Control House

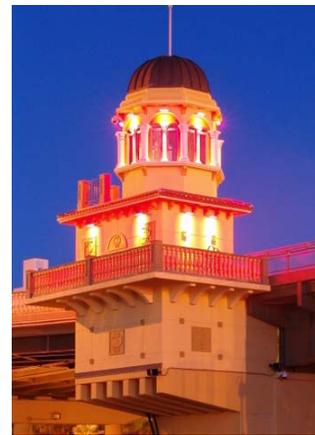
New Gate House

In addition to the control house, a second house was built on the opposite corner of the bascule span. This structure although not necessary for the mechanical operation of the bascule leaves is a key addition to the bridge aesthetics. It depicts the moor influence that was once present in Hollywood. Unlike the west bascule pier, the original design of the east bascule pier did not anticipate the construction of a three story structure to be cantilevered off one of its side walls. Consequently, Hardesty & Hanover modeled the cantilever house along with the bascule pier in SAP (a computer structural analysis program) as a three dimensional space frame. The analysis concluded the pier wall was not adequate to support the new gate house and therefore had to be reinforced. For this, the side wall with a varying thickness of three to six feet and eighteen feet wide was removed down to the machinery platform level. Fifty seven #10 steel reinforcing bars (1.27 inches in diameter) were doweled eight feet deep into the concrete in order to

increase the wall's load carrying capacity. These massive vertical bars end in a hook and get spliced with #9 horizontal bars (1.13 inches in diameter) that make up the main reinforcing for the six cantilever brackets that support the three story gate house. After the steel work was done and the formwork was in place, the wall and bracket concrete was cast-in-place monolithically. Once the concrete achieved adequate compressive strength the forms were removed and construction of the gate house began. The cantilever brackets and the first two levels mimic those of the control house. The top level is an octagon shaped structure with arched windows all around topped by a copper dome. This top level is the feature that brings back the moor architecture once present in the city.

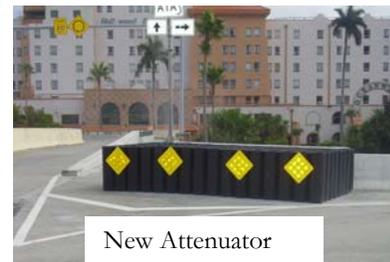
New Attenuator

The existing twelve foot lanes and the 40mph speed limit on the bridge west approach usually meant fast traveling motorists going east. These drivers had a difficult time negotiating the tight curves on the other side of the canal when they had to make a decision to either go right to Southbound S.R. A1A or left to Northbound S.R. A1A. Sometimes, an indecisive driver that would make a late right turn resulted in that driver rubbing or crashing against an attenuator, or crash cushion device, situated at the dividing point between the two ramps. In order to improve safety and minimize accidents, the twelve foot lanes were reduced from twelve to ten feet, the speed limit was reduced from 40mph to 25mph and the Southbound S.R. A1A Ramp was widened and the existing crash cushion which had become obsolete was replaced with a new more current model. Also, as a result of the widening, the new attenuator was pushed back away from traffic increasing the ramp's turning radius. In addition, the existing bascule span open grating was removed and replaced with a new hot dip galvanized grating with concrete filled wheel paths. The wheel paths provide better rideability for vehicles and at the same time reduce tire noise for the betterment of the many residents that live in the vicinity of the bridge.

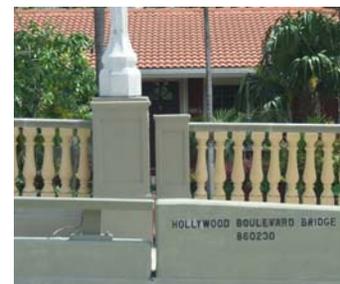
Balustrade with Columns

Construction of the interior traffic rail made possible the removal of the fascia concrete barrier which was replaced with a more architectural pleasing pedestrian balustrade. This is another key addition that truly enhances the bridge aesthetics. The 42" high balustrade consists of 32" high round balusters spaced 8" on center, 4"x9" cap rails and 6"x10" base rails. All three components are manufactured in the shop and shipped to the work site. The balustrade is then installed on a 12"x12" cast-in-place concrete curb achieving a total height of 54" which is the minimum required height for bicyclists. Balustrade segments connect to 16"x16"x57" cast-in-place concrete columns typically located at both sides of the bridge deck expansion joints.

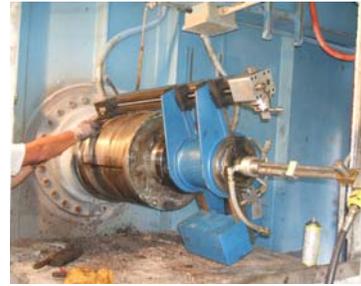
Trunnion being machined

Opening the bascule span for navigational traffic requires the hydraulic operating machinery to rotate each bascule leaf about the trunnion journals. These are the two steel shafts about which the span rotates during operation and which transfers the entire leaf dead load to the supports inside the bascule piers. All four trunnions (two per leaf) exhibited moderate to heavy wear in the form of scoring, spalling and surface corrosion. This condition increases friction and stress on the trunnion which leads to accelerated wear and possibly cracking of the journal. Field machining of the journal using a portable lathe followed by a final polishing and bushing replacement was performed in order to provide a smooth journal surface and reduce stress concentrations.

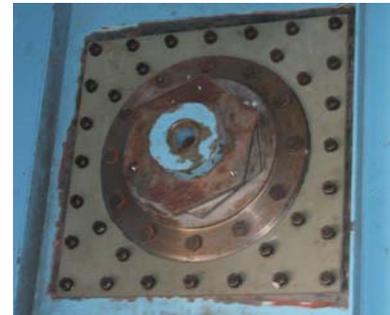
The eccentric collars were being replaced as part of the contract. Alignment of the trunnions along with replacement of the eccentric assemblies is typically done during the temporary closure of the bridge to vehicular traffic. This closure is limited in time and therefore any unforeseen problems have to be resolved quickly and effectively. During removal of the existing collars of the west bascule leaf, it was determined that the current misalignment was outside of the range of the eccentric collar's alignment capabilities (about 5/8"). Hardesty & Hanover was immediately called on site in order to assess the problem and aid the Contractor reach a solution. It should be noted that adjustment of the trunnion should be minimized since it distorts the bascule girder web. In this case, the amount of adjustment was too great (approximately 1") and after much deliberation it was decided to shift the eccentric collar axis to be in line with the trunnion rather than force the trunnion into the desired alignment.

New Web Plate with Mounted Eccentric Assembly

Shifting the axis of the eccentric collar meant a new hole was needed in the trunnion girder web at the new location. In order to provide a new hole and still maintain the required LC1 fit between the hole and the new eccentric mounting collar, a web splice was necessary. New web plates were designed and ordered. They were fabricated and delivered in just three days to the job site. An oversized hole was cut on the existing web, the new plate was attached to the web with turned bolts and the eccentric collar was mounted on the new web plate and secured with turned bolts. After final adjustments the eccentric assembly components were tack welded together and to the trunnion girder webs to prevent any movement or misalignment.

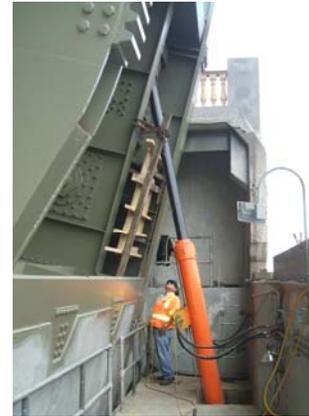
New Cylinder Assemblies

Initially the FDOT was seeking to refurbish the hydraulic cylinder assemblies as well as the hydraulic power unit. However, Hardesty & Hanover performed a cost analysis that included initial and maintenance cost of refurbished versus new cylinder assemblies. The study successfully showed that due to the high maintenance typically incurred by refurbished cylinders, providing new more durable cylinders was the more economical solution. Consequently, the hydraulic cylinder assemblies were replaced and the electric motors that along with the hydraulic pumps and reservoirs compose the HPU were refurbished.

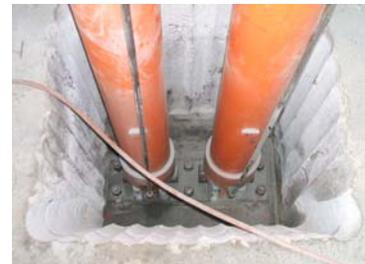
Bascule bridges typically provide unlimited vertical clearance within the navigation channel delineated by fender systems located between the bascule piers. Prior to the start of construction, it was determined that in the fully open position, the tips of the bascule leaves overhung the fenders. Thus a tall vessel navigating near one of the fender systems could potentially impact the bascule leaf tip. Field measurements showed the current angle of opening of the bridge being 67 degrees instead of the intended 75 degrees, 17 inches of clearance between the bottom of the counterweight and the top edge of the machinery platform and the bascule leaves tips encroaching the channel by approximately 5 feet. In order to increase the angle of opening, components such as the machinery platform, the hydraulic system inspection ladders and the machinery platform handrail required some type of modification or even removal. When the original Hopkins Frame mounted machinery gear train was replaced in 1988 with a hydraulic operating system there was not enough vertical clearance between the bottom of the new lift girders and the top of the existing machinery platform to accommodate the new cylinder assemblies. Consequently concrete supports were cast in place below the machinery platform to support the new cylinder assemblies, holes were cored into the machinery platform for the new cylinders to go through, inspection platforms were provided below the new cylinder supports and inspection ladders were mounted on the vertical face of the machinery platform to access the lower inspection platforms. Clearance diagrams revealed the greater angle of opening would reduce the 17 inch gap between the counterweight and the machinery platform to about 3 inches leaving no space left for the inspection ladders; thus, the ladders were removed. Next, the cored holes in the machinery platform were elongated about 6 inches towards the counterweight side to allow for the hydraulic cylinders

Elongated Cored Hole in Machinery Platform

to rotate further and achieve the required 75 degrees angle of opening. In addition, the machinery platform handrail that serves as fall protection was set back to maintain clearance between the bottom of the counterweight and the railing with the leaf in the fully open position.

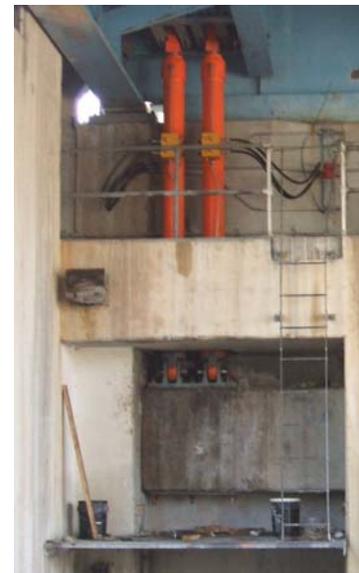
Access Ladders and Inspection Platforms

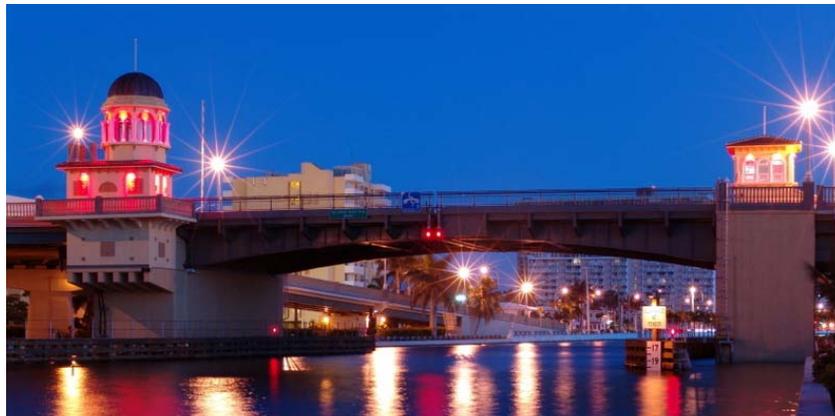
North Elevation Looking South of Rehabilitated Structure
