HEAVY MOVABLE STRUCTURES, INC.
12TH BIENNIAL SYMPOSIUM

REPLACEMENT OF SPHEROIDAL TRUNNION BUSHING
ALFORD STREET (STATE ROUTE 99) OVER MYSTIC RIVER

Edward M. Long, P.E.
Hardesty & Hanover, LLP

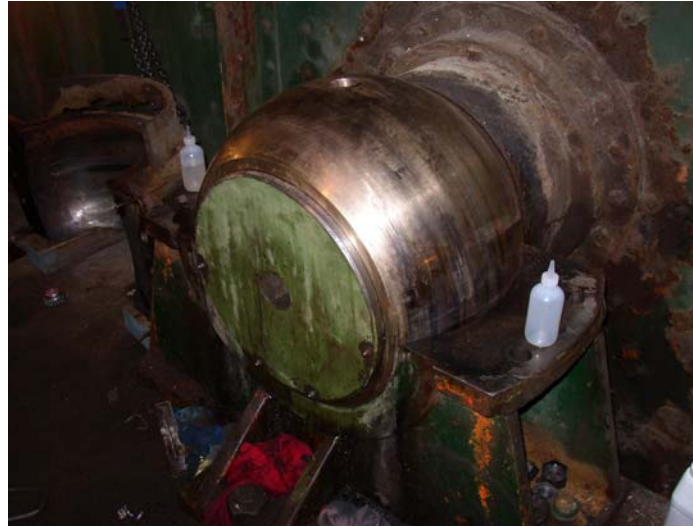
Photo – Existing Bearing

The root cause of the failure was incorrect lubrication, and corrosion of the trunnion shaft from storm water runoff, deicing salts and road debris. The original splash shield, attached to the top cap of the bearing had disintegrated allowing moisture to enter the annular space between the top of the trunnion and the bushing. The relief plugs, on the far side of the grease journals, adjacent to the bascule girders, had not previously been removed to permit lubrication to travel across the journals, through the bearing. The trunnions had never been lubricated while the navigation span was in operation, and finally, the bridge is only operated seasonally, reducing the benefits of periodic maintenance.

Mineral spirits was injected through the lock screw boss, to reduce hydraulic suction from the oil lubricant, and to simplify removal of the trunnion bearing top cap. [See *Photo – Existing Bearing*] With the top cap removed, mineral spirits was injected into the lower bearing half, between the bushing and the bearing casting.
