**HEAVY MOVABLE STRUCTURES, INC.
SIXTEENTH BIENNIAL SYMPOSIUM**

**Strauss Heel Trunnion Repairs
Jacksonville Bridge**

Geoffrey L. Forest, P. E.
Modjeski and Masters, Inc.
&
Michael Collier, P. E.
Scott Bridge Company

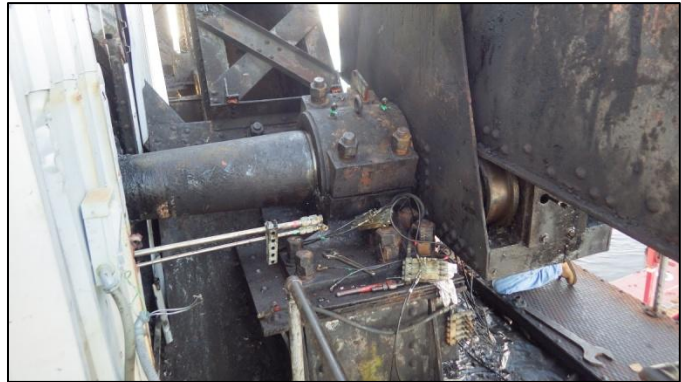
While the majority of the machinery is in serviceable condition, several issues became troublesome recently. In August 2014, FEC called Modjeski and Masters, Inc. (M&M) to investigate the west main pinion bearing (B1), which appeared to have an excessive amount of clearance. Upon inspection, the clearance was indeed excessive at just over 1/2" on the 17" diameter journal (see Photograph 2 and Photograph 3), and concern was raised for the condition of the bronze bushing at the base of the bearing, which was originally 7/8" thick.

Photograph 2 - General view of West Bearing B1

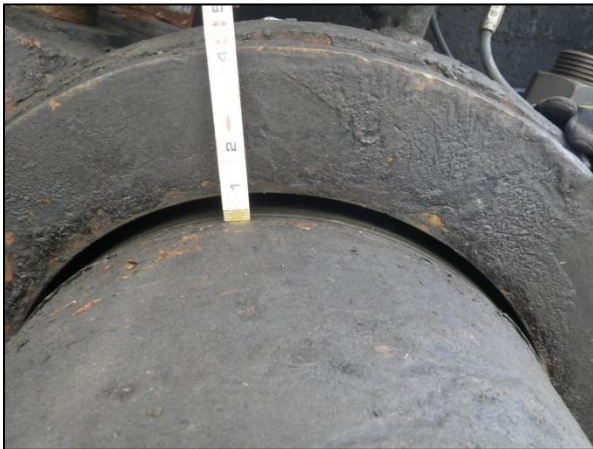
Photograph 3 - Excessive clearance at West Bearing B1

With the observed wear and deficiencies noted in the OSG, pinion, shaft and bearing, it was decided that all of these items would be replaced. Further investigation of the inboard pinion shaft Bearing (B2) revealed loose mounting bolt holes in the structure, which allows the bearing to move position over time. This bearing was added to the list of replacement items, as well as, Gear G2, since the teeth had signs of wear and this gear must be fitted to the new pinion shaft.

The total list of items to be replaced on the west side of the machinery included the Operating Strut Guide (OSG), Pinion Shaft (S1), Main Pinion (G1), Bull Gear at the inboard end of the Pinion Shaft (G2), and both Pinion Shaft Bearings (B1 and B2). With this plan, the new parts would interface with the existing

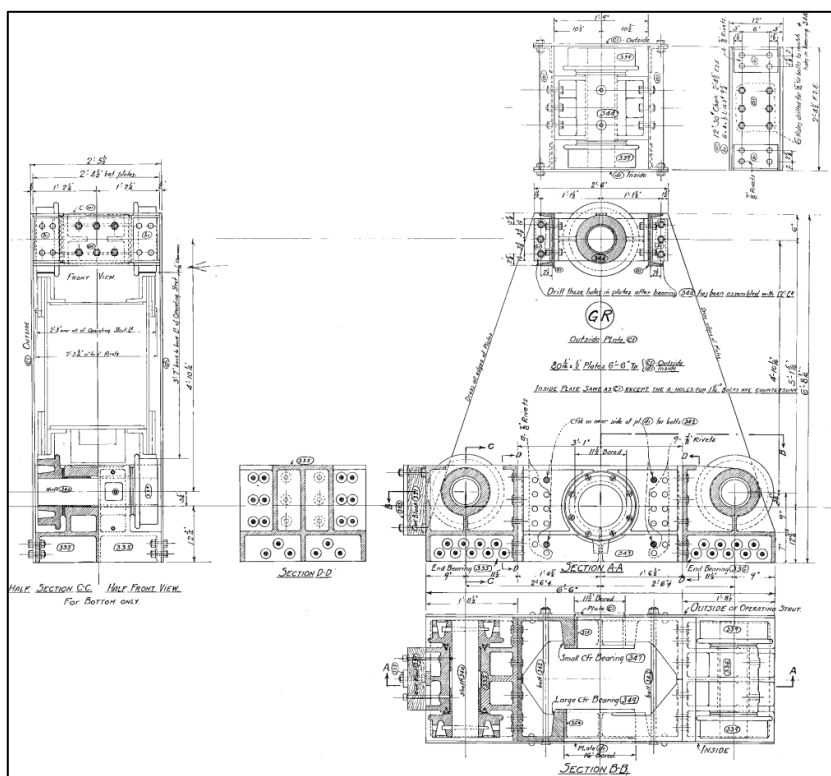
Figure 3 - Original Operating Strut Guide Assembly (OSG)

changed more significantly from the original design was the OSG (see Figure 3). The existing guide assembly was pieced together onto the pinion shaft with the pinion. The inboard half was installed first, then the pinion was put on the shaft, then the outboard half installed and the assembly was fastened

together. This cumbersome installation process would increase the field assembly time of the new parts, so the intent of the new OSG design was to simplify the installation process.

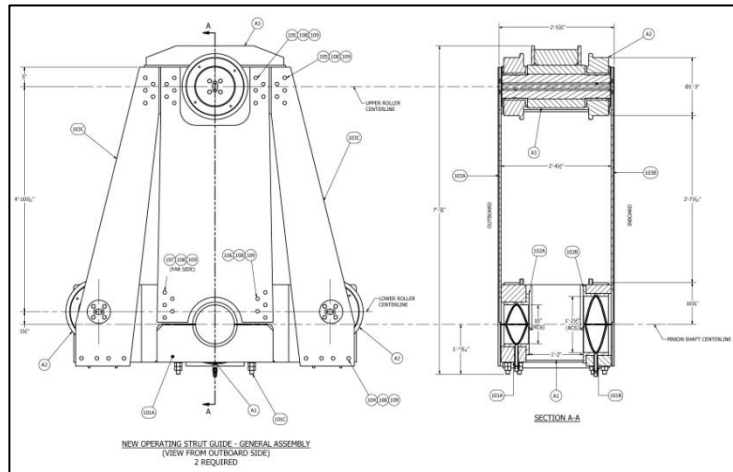
Figure 4 - New OSG Assembly

The first effort was to simplify the OSG-to-shaft installation. Instead of splitting the OSG vertically into inboard and outboard halves, the lower housing that is mounted on the pinion shaft was split horizontally, similar to a pillow block bearing arrangement. The lower housing rests on top of the pinion shaft, surrounding the pinion, and two bearings caps are installed from below the pinion shaft to attach the OSG to the shaft (see Figure 4).

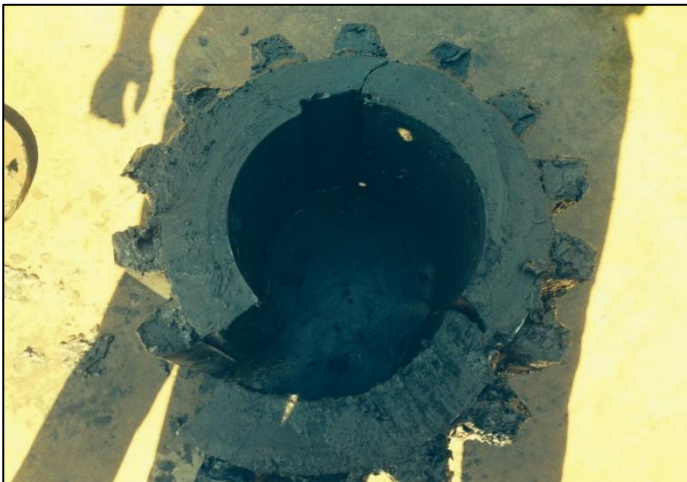
On September 9, 2014, FECR notified SBC that there was a major failure on the East Pinion G1. The bridge was completely shut down to all boat traffic requiring the bridge to open until the pinion could be repaired or replaced. The pinion had fractured in two places, one being at a keyway, and was no longer able to drive the rack gear (see Photograph 12).

Photograph 12 - View of the damaged pinion gear that was removed from the East drive shaft.

the entire pinion assembly was replaced including the B1 Bearing, B2 Bearing, pinion shaft, G2 and OSG. The outage procedure to replace the East components was the same procedure detailed above for the West components. The outage was completed successfully within the allotted time and the bridge returned to normal operations.

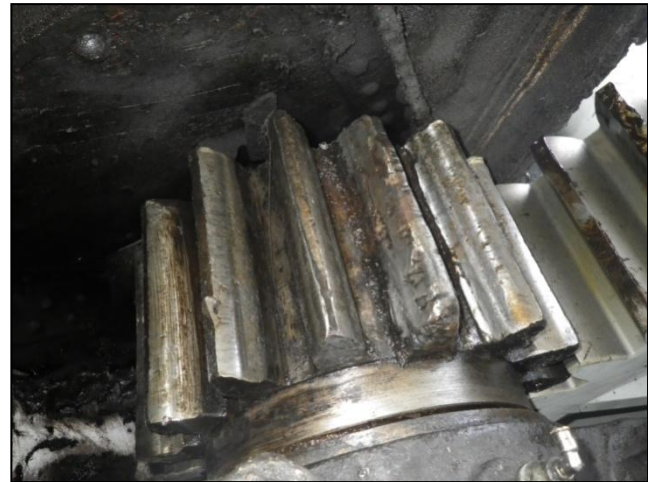
Photograph 13 - Existing condition of West G3 pinion with new G2 gear

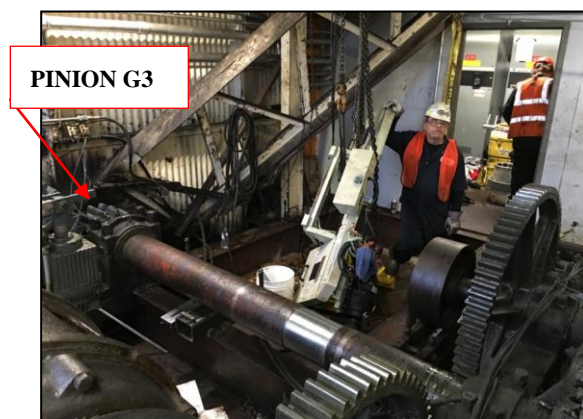
removal from the shaft impractical in situ (see Photograph 15). Removing the cross shafts would require disassembling the differential assembly, which is made up of several large gears. FEC wished to avoid removing the structural members and disassembling the differential to replace the G3 pinions, so other replacement methods were investigated.

Photograph 15 - Structural bracing members above G3 pinion impede removal

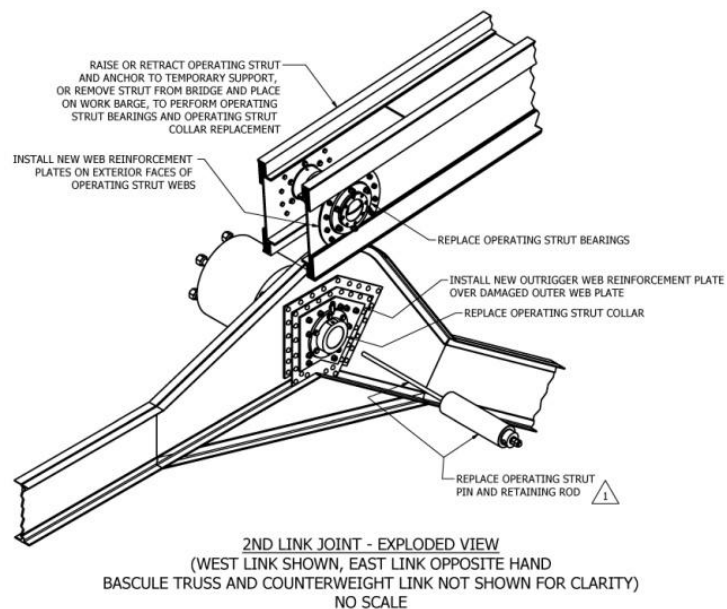
The east connection between the operating strut and the truss exhibits a significant amount of movement during operation. The operating strut rotates somewhat around a horizontal axis, moves side-to-side and bounces when the span raises and lowers. The makeup of this joint is fairly complex (see Figure 8 and Figure 9). The web of the outrigger that is

attached to the bascule truss has lost its tight fit with the collar around the operating strut pin. The loose fit has allowed unintentional movement and accelerated wear of the outrigger web plates. Also, several of the fasteners between the collar and the outrigger web are broken and not accessible for replacement. The amount of movement of the operating strut suggests that the bolt attaching the operating strut pin to the

Figure 8 - Exploded view of Operating Strut to 2nd Link Joint

2nd Link truss pin has failed. This was confirmed by FEC personnel by pulling the bolt on the inboard side of the joint. The bolt on one side of the bridge was able to be pulled out only an inch or so, while the bolt on the other side was able to be pulled completely out of the 2nd Link pin.

This bolt helps provide some restraint to the inboard end of the operating strut pin. With the bolt connection severed, the operating strut pin has very little resistance to rotate about the center of the collar at the outrigger.
