Sheridan Street Bascule Bridge Repair

**Alfred G. Banz, P.E.
Hardesty & Hanover, LLP**

TENTH BIENNIAL SYMPOSIUM

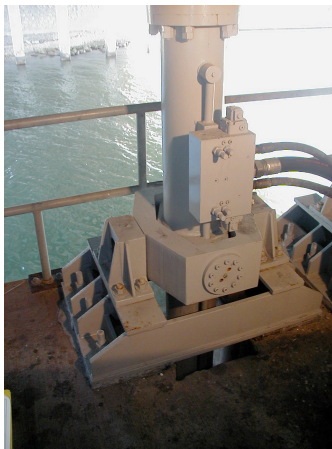
Cylinder "Gimbal" assembly

The Florida Department of Transportation had experienced cracks exhibited at the lower fillet weld connections of the cylinder wall to the inner collar of the trunnion mounted cylinder ring assembly. In one case, a crack was visible for approximately 200 degrees of the cylinder circumference, prompting

corrective action. Six of the eight cylinders exhibited circumferential cracking of the weld. An initial attempt was made to repair the welds in February 1997. The cylinders were removed from the bridge and brought back to the original fabricator of the cylinders for re-welding. The cracks in the welds reappeared shortly after reinstallation of the cylinders (March 1997).

The recurring cracks prompted the FDOT to explore the possibility of retrofitting the Sheridan Street Bridge to accept the hydraulic cylinders originally fabricated for the Las Olas Blvd. Bridge but not installed during the latest rehabilitation. Due to the similarity in size of the two bascule spans and identical hydraulic power units fabricated for each bridge, a feasibility study was commissioned by the FDOT and confirmed the retrofit was possible.

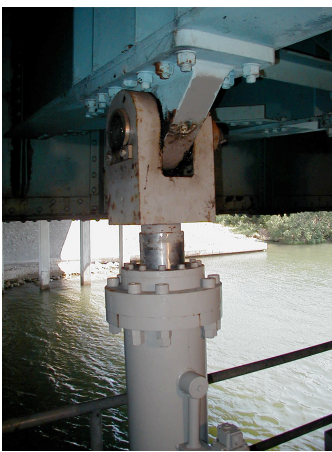
Upper cylinder clevis mount

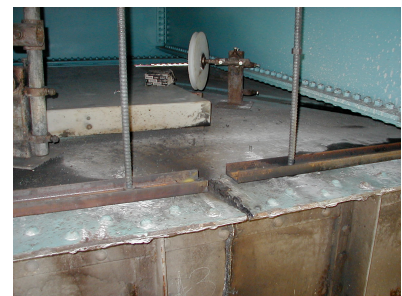
#7 Dywidag bars and channel installed to support counterweight section to be removed.

A series of holes were cored vertically through the counterweight to allow the contractor to install #7 Dywidag bars with top and bottom support channels, cast eyes nuts and grooved plates necessary to

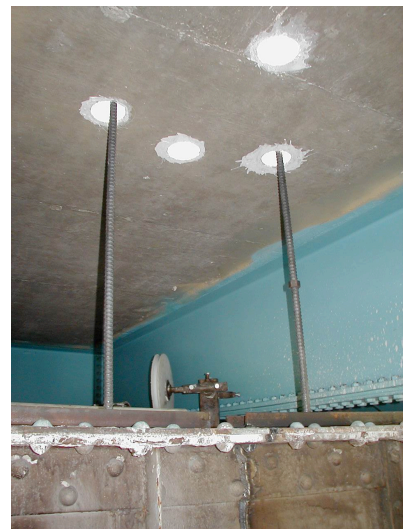
Dywidag bars extending up through flanking

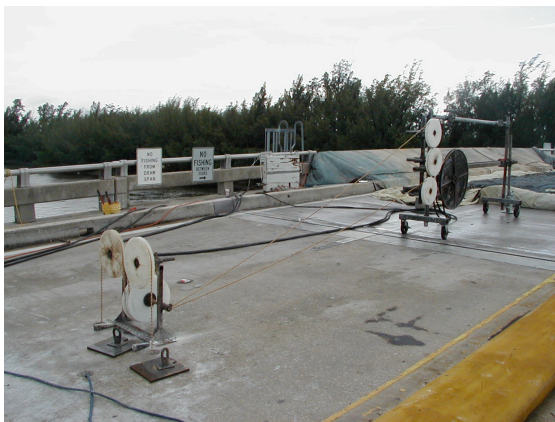
Wire saw pulley system on flanking span. Note support plates and cast eye nut in foreground.

the existing counterweight girder and one groove was cut into of the each main girders to act as guides when the counterweight was cut. The Contractor chose to cut the counterweight to be removed into thirds and was accomplished by coring two additional holes through the counterweight concrete at the proper locations and using a wire saw to transversely cut through the outer third of the structure on both sides, leaving the entire section to be removed supported by the middle third and the Dywidag bars. Two longitudinal cuts were then made into the counterweight separating it into three separate portions for removal. Each third was then lowered onto a barge positioned under the flanking span and removed from the work area.

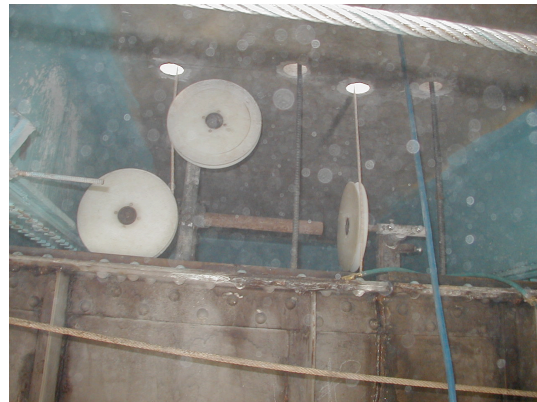
Pulley system beneath flanking span to change wire saw direction

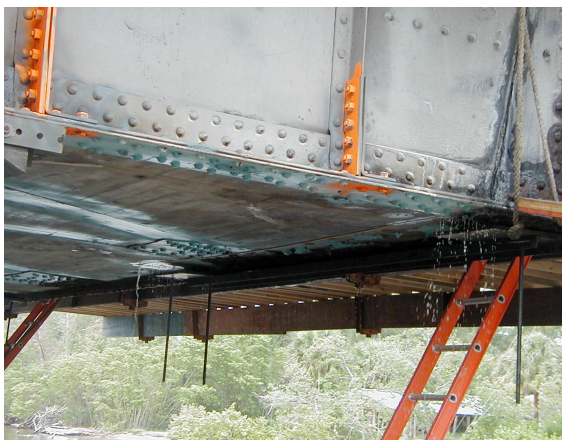
Wire saw making transverse cut through counterweight.

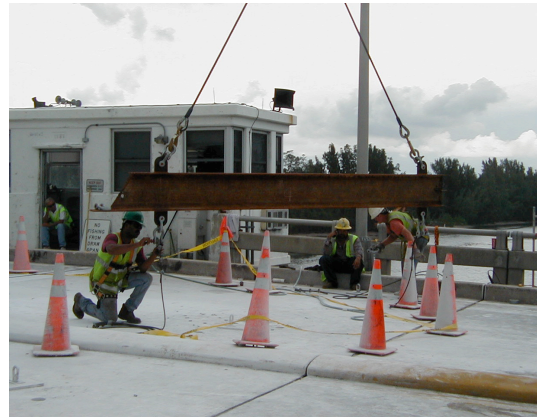
Workers attaching spreader bar and cable rigging to cast eye nuts in preparation to lower counterweight section.

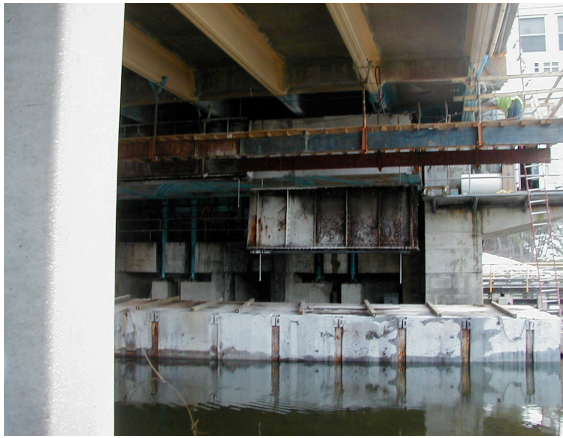
Counterweight section being lowered onto barge.

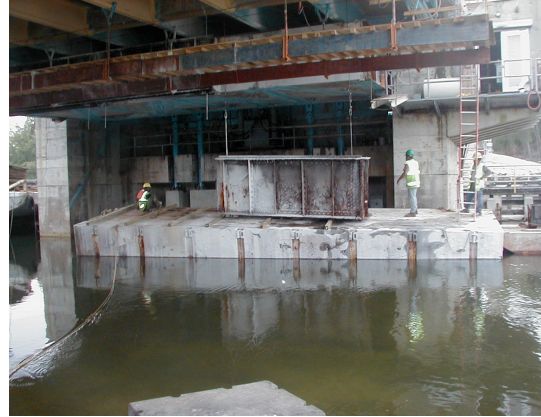
Counterweight section resting on barge.

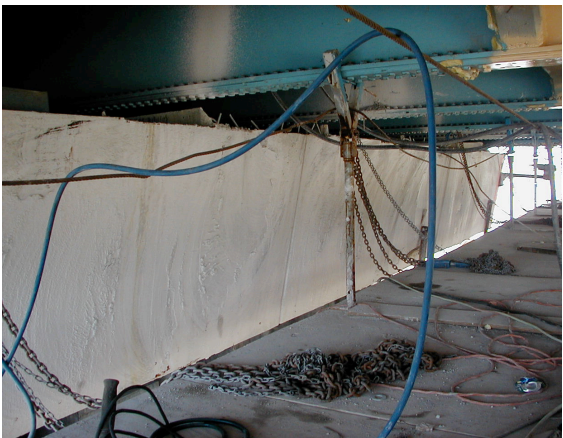
Counterweight concrete condition after saw cut

Prior to installation of the new counterweight girder, additional concrete had to be chipped away from the remaining structure for access to the bolted connections. Once concrete “clearancing” was complete, installation of the new counterweight girder was the reverse of the removal, but a larger spreader bar was used.

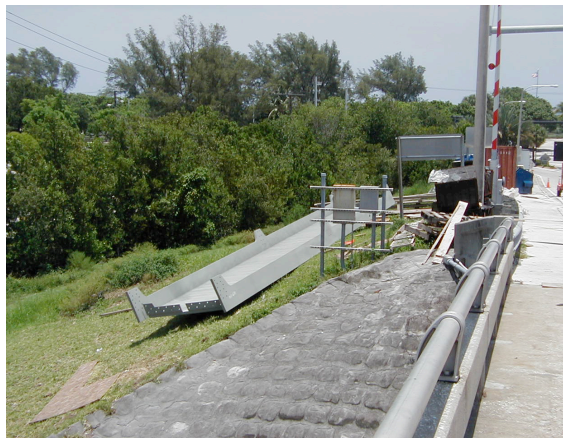
New counterweight girder on-site

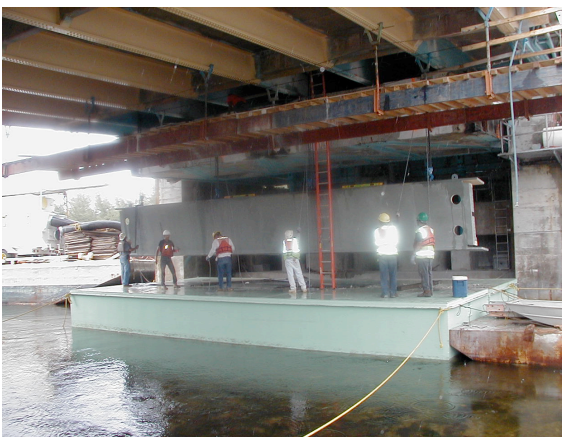
New girder being hoisted into position

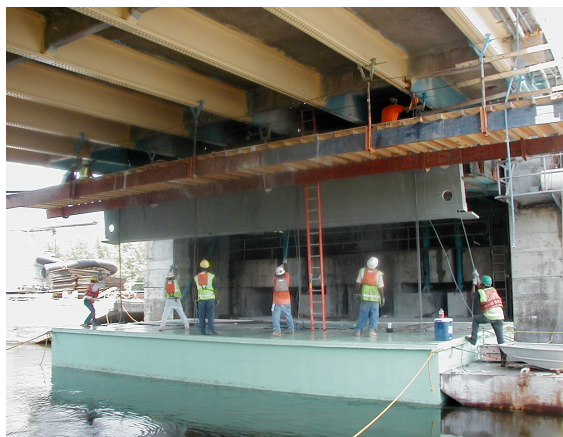
New girder being hoisted into position

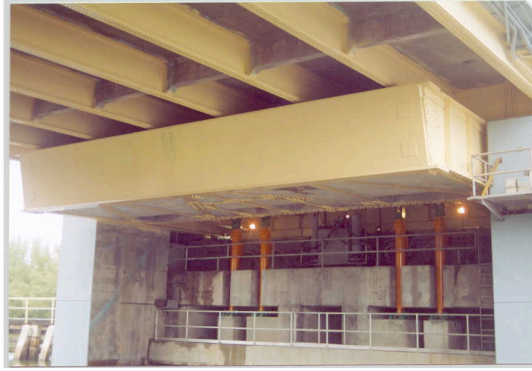
Completed counterweight, machinery area and painting.
