Structural Elements

BNSF Bridge 14.2 Live Load Bearing Replacement

**Shannon McCauley
David Magistro
HDR Engineering**

TENTH BIENNIAL SYMPOSIUM

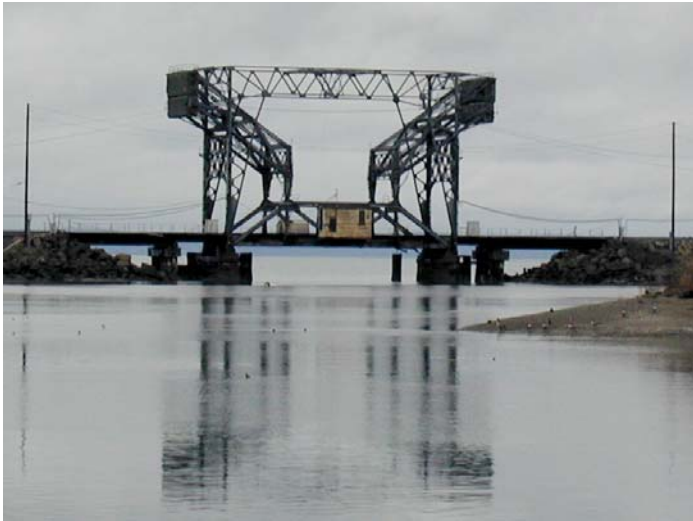
Photograph 1: Bridge 14.2 Elevation

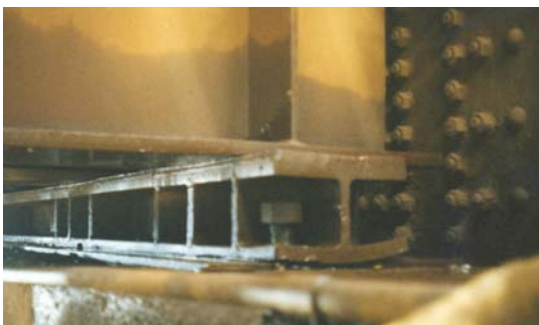
Photograph 2: Existing approach span bolster beam. Note the deformation in the bottom flange.

The movable span bearings exhibited deterioration as a result of improper seating and severe impact forces transmitted through the structure from the rail joints. The bridge had rider-style rail joints that had very short rider rails because of clearance issues between the span and the tower bracing. Additionally, the approach span rest pedestals had dislocated vertical cracks. Each approach span sat on a bolster beam that rested on relatively slender concrete pedestals which were doweled into the rest pier. Each approach span rest pedestal was made up of two pre-cast concrete blocks doweled together. The bolster beams were in poor condition due to excessive movement of the cracked pedestal supports, as seen in Photograph 2.

The dislocated vertical cracks in the pre-cast pedestals allowed considerable deflection under live load. The approach span girders actually functioned as struts to hold the pedestals in place. To make matters worse for the approach span support conditions, the pre-cast pedestals were not long enough to extend out to the two exterior approach span girders. The two exterior approach span girders were not supported by the concrete pedestal; the bolster beam carried these outside girders and rested on short H-pile columns, which also experienced significant deflection under live load.

Once the working platforms were in place, the piers could be prepared for repairs. The cracks in the approach span rest pedestals were jacked together and then injected with epoxy. Whaler beams were used to jack the pedestals back into position. The displacement of the cracks was so large that the whaler beam system had to be detailed to accommodate this movement as the blocks were jacked back together. Before the blocks could be jacked together, the approach spans had to be unbolted from the bolster beam atop the blocks. After the blocks were jacked together, the bolster beams were reset and grout was pumped under them to ensure a solid beam seat. With the approach spans re-centered on the bolster beams, they were field-welded to hold the correct position on the bolster beams.

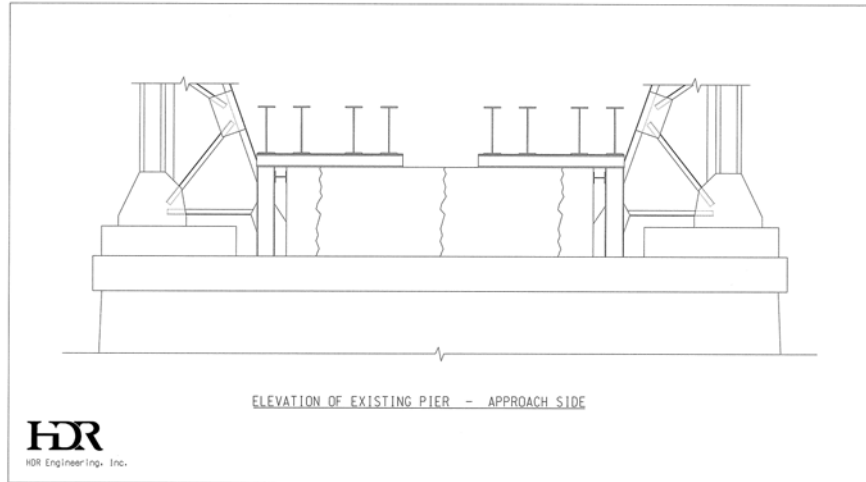
Figure 1: Approach span side of the rest pier before rehabilitation. Note the cracks in the rest pedestal and column supports at the exterior girders.

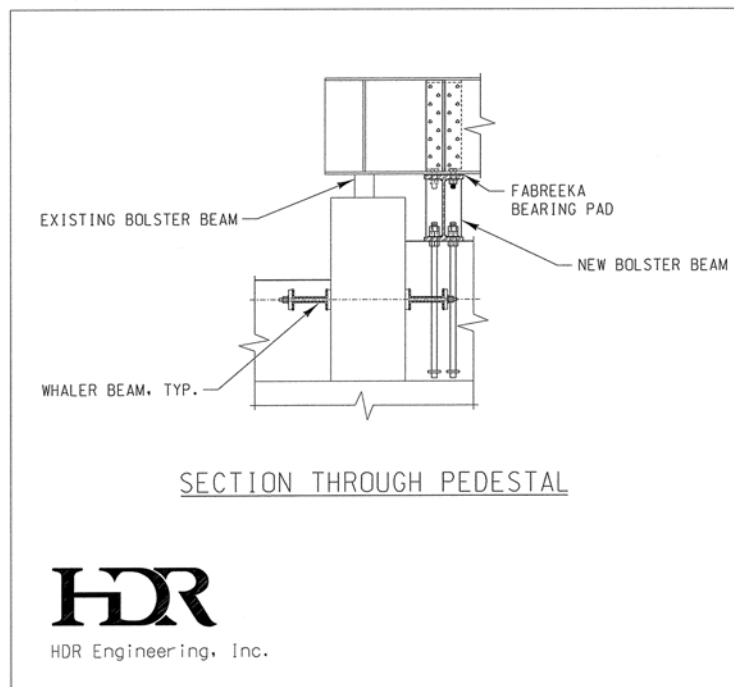
Figure 2: The new approach span bolster beam was positioned behind the existing bolster beam on the approach span side.

After the approach spans had been re-centered and reattached to the existing bolster beams, the next step was to install the new bolster beam for the approach spans, directly behind the existing bolster beams on the approach span side (See Figure 2). Stiffeners were installed for the web on the approach spans over the locations of the proposed bolster beams. The new bolster beams were installed by bolting them to the approach spans. The new approach span bolster beams would bear on new cast-in-place concrete that would be placed in the next phase of construction. Anchor bolts were hung from the bottom of the new approach span bolster beam. When the new concrete was poured, the anchor bolts would then be embedded in concrete.

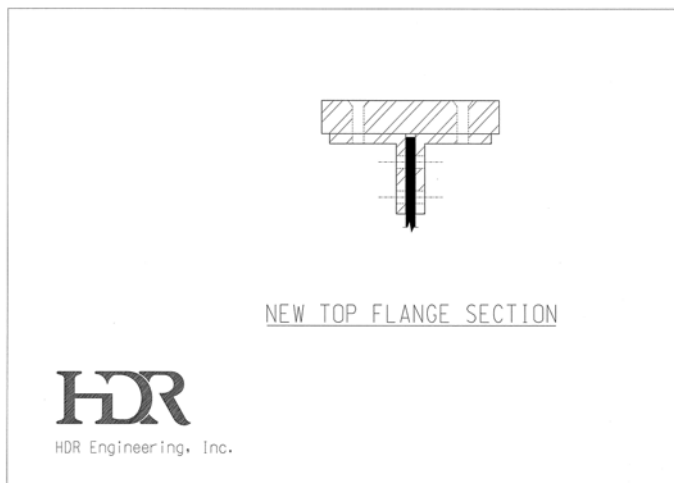
As mentioned previously, field investigations had identified a full-depth crack in the top flange of the end floorbeam. The top flange was built up from cover plates, and the crack propagated through every plate. A

Figure 3: New end floorbeam top flange. The cover plate provides a substantial cross section to resist negative bending stress resulting from the new support condition.

As part of the bridge rehabilitation program, new rail joints were planned; a new top flange would be required for installation of those joints. The decision was made to install the top flange prior to the bearing replacement to provide additional capacity to the end floorbeam.

and the end floorbeam web. Once the top flange was in place and shimmed to a tight fit, the bolts were installed. The BNSF elected to use Huck style fasteners to simplify the installation. With Huck fasteners, there was a lower probability of failing to achieving correct bolt torque. Once the top flange was installed and bolted up, the focus turned to replacing dozens of existing rivets with high-strength bolts. The rivet replacements occurred in the floorbeam-to-truss connection and in the floorbeam bottom flange connection outside the new supports. The high-strength bolts were necessary because these connections would experience a significant increase in load once the new H-pile support columns were in place under the end floorbeam.

A short construction window was established for the top flange change-out because both tracks over the entire length of the end floorbeam would need to be removed. In order to make the window as short as possible, the new top flange was assembled before the work window so that it could be dropped into place as a single piece. The new end floorbeam top flange was made of two angles bolted to a substantial top cover plate, as seen in Figure 3. The clearance between the two outstanding angle legs was made slightly larger than the thickness of the end floorbeam web to make sure that the new piece could be installed quickly and easily. Once the new top flange assembly was in place, thin shims were installed to ensure a tight fit between the new top flange angles

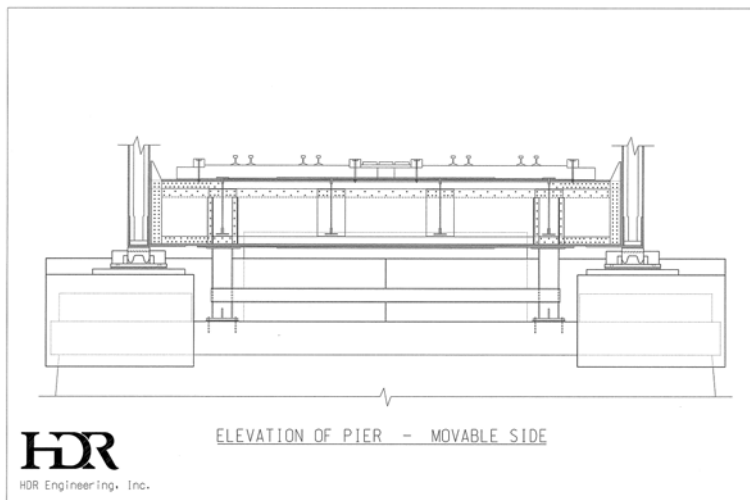
Figure 4: New concrete was poured to support the new movable span bearings. Note the temporary column supports under the end floorbeam.

lowered to check alignment. After fine-tuning the alignment, the anchor bolt locations were marked, the new masonry plate and bearing shoe were moved, and the anchor bolt holes were drilled. The anchor bolts were set in place with epoxy. After curing, the new masonry plate and bearing shoe were placed over the anchor bolts. The span was lowered onto the new bearing shoe to double-check elevations. Minor leveling adjustments were made to ensure that the bearing yoke was bearing firmly and evenly on the new shoe. At the same time, rail joint seating was inspected for accuracy. After the bearing shoe was positively in the correct vertical position and in the correct alignment with the bearing yoke on the span, epoxy grout was pumped under the masonry plate to achieve a solid uniform bearing surface. Figure 4 shows a view of the structure after the first two concrete pours.

After all of the prep work, the cap was thoroughly cleaned of all of the dust and debris. The first pour of concrete was placed where the new movable span bearings would be placed. During the short curing time while the concrete reached a minimum compressive strength of 3000 psi, the movable span was fitted with a new bearing yoke. The old yoke was severely worn, so a new yoke was required to fit properly on the new bearing shoe. With the new bearing yoke in place, the new masonry plate and bearing shoe were placed as near to their exact location as possible. The span was

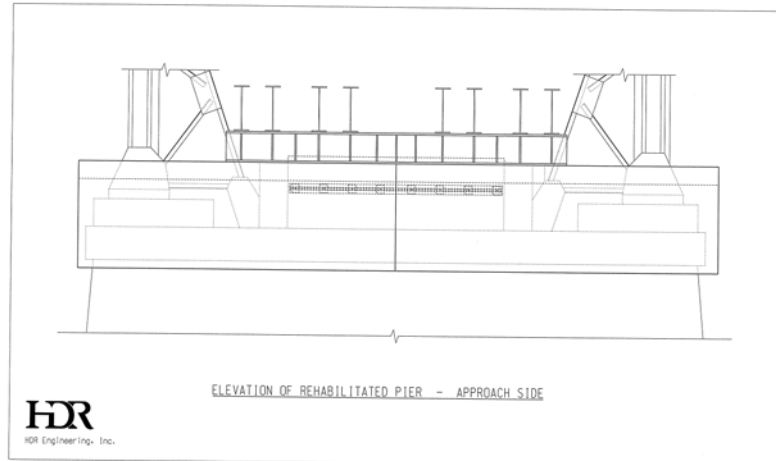
Figure 5: After the pier rehabilitation, the approach span stringers were supported on a single bolster beam which rested on a solid bearing surface of new cast-in-place concrete.

On the approach side, the new bolster beam had been installed with Fabreeka pads between the bolster beam and the approach span bottom flanges. Once the bolster beam anchor bolts were set in the new concrete, those pads were removed to allow for any live load deflection in the approach spans. This was done to ensure that no live load was transmitted to the new concrete before it was fully cured. After all of the epoxy and concrete had cured, the Fabreeka pads were reinstalled to give the approach spans a solid seating surface on the new bolster beam. The second pour followed the same procedure to reset the second new movable span bearing and the second half of the concrete under the new approach span bolster beam. The third and final pour encapsulated the bottom portion of the new short column supports under the end floorbeam and the entire movable span side of the pedestals. Originally, the short column supports under the movable span end floorbeam were going to be removed, but the BNSF was pleased with the tremendously improved ride quality and opted to leave them in. After the third pour was completed, an entirely new pier cap was present. Figure 5 shows a view from the approach span side of the pier after the pier rehabilitation was complete. The new movable span bearings and approach span bolster beam were founded solidly on new concrete. As a result of the construction, the movable span now had four bearings to rest upon, and the approach spans were actually bearing on two bolster beams. After proper curing time, rail traffic was permitted to resume normal speed. The removable pier platform on the channel side of the pier was removed, and the second rest pier was tackled in a similar process.

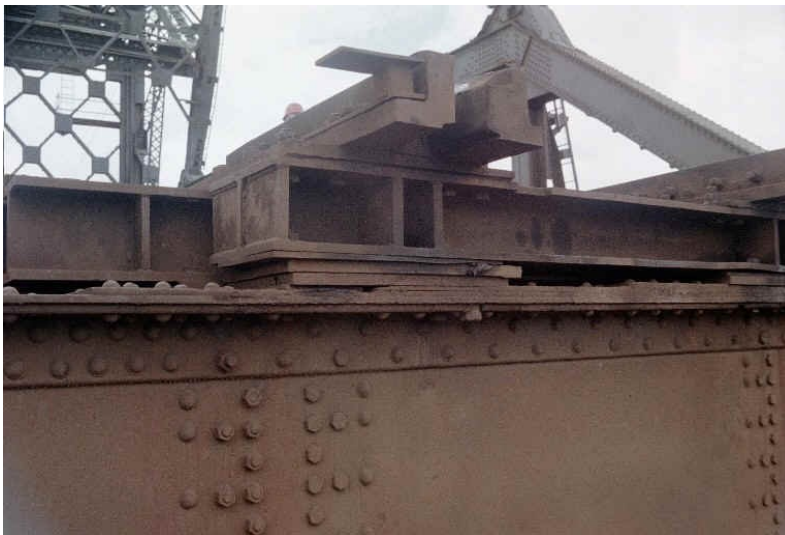
Photograph 3: The old rail joints sat atop a steel tie that was supported by several shims of various sizes and thicknesses.

top flange and the steel ties supporting the rail joints. The railroad had never been able to keep the joints firmly bolted to the end floorbeams with all of the miscellaneous fill plates under the joints at those locations. In the areas of the rail joints, the new top flange cover plate was bolted to the new top flange angles with countersunk bolts. This detail provided a flat surface to support a single fill plate, eliminating the need for a collection of shims to fill gaps. The multiple layers of shims in the old arrangement could not provide a tight fit, which was part of the reason that the live load impact forces had been magnified to levels that were detrimental to the structure and the pier cap.

After all of the pier repairs were completed, the railroad replaced the existing rail joints. The new rail joints were of a similar style as the old joints, but they had longer rider rails to ease some of the live load impact to the structure. One of the additional benefits of replacing the end floorbeam top flanges was that the new rail joints now had a uniform surface to bolt to for the entire length of the end floorbeam. The old end floorbeam top flange had been made up of several riveted cover plates of varying lengths, and a collection of shims with a variety of thicknesses had been used to fill the odd gaps between the old end floorbeam
