Stillwater Vertical Lift Bridge Rehabilitation

Todd Owens, P.E.
HNTB Corporation

TENTH BIENNIAL SYMPOSIUM

Abstract

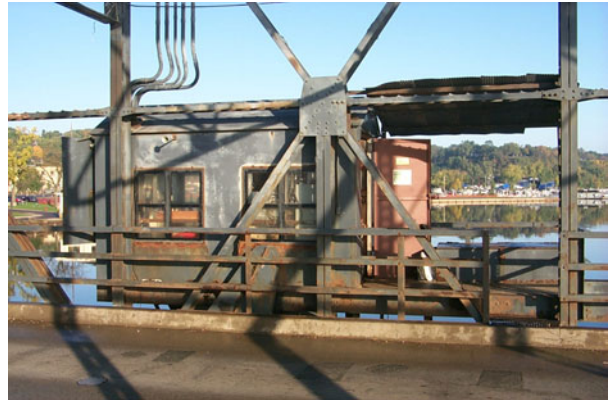
Figure 3: Tender's House. Note chain drive location

The chain drive that transferred power from the drive unit to the machinery below was difficult to access and maintain. It was located between the tender's house and the vehicular guard rail.

The eddy current drive was problematic and unreliable. It will be replaced with a 40 HP DC drive system. This power increase for the drive motor was the result of slightly more conservative design criteria than was in place from the original design. The chain drive was difficult to access and maintain due its location between the guard rail and the house. It will be replaced with a series of right angle reducers. A right angle reducer from the tender's house will transfer torque from the horizontally mounted drive motor vertically to another right angle reducer below. The layout of the machinery in the tender's house can be seen in Figure 7.

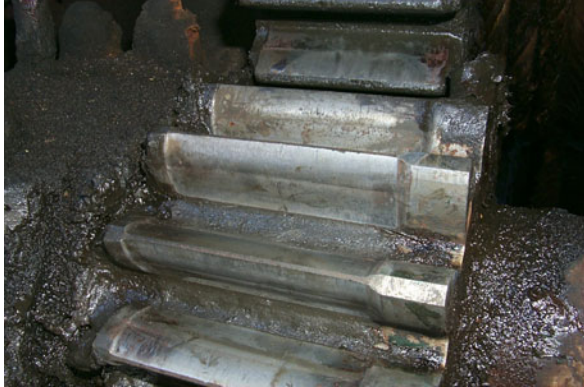
The open gearing sets showed considerable wear (Figure 4). The pinion and bull gear for the operating drums had the most pronounced wear. This could be due in part to debris from the roadway having accumulated on the gear set over the years. Additionally the open gearing underneath the bridge was worn.

Figure 4: Operating Drum Pinion. Note severe tooth wear.

From the main reducer, torque was transferred to the operating drums in an arrangement similar to the original design. New shafting, couplings and bearings were designed for this purpose. The shafting, couplings and bearings will be larger to accommodate the additional power of the drive unit. The open gearing will be replaced on the operating drums. New bronze bushings will be provided to “replace in-kind” the existing bearings that hold the pinion shafts and the operating drums.

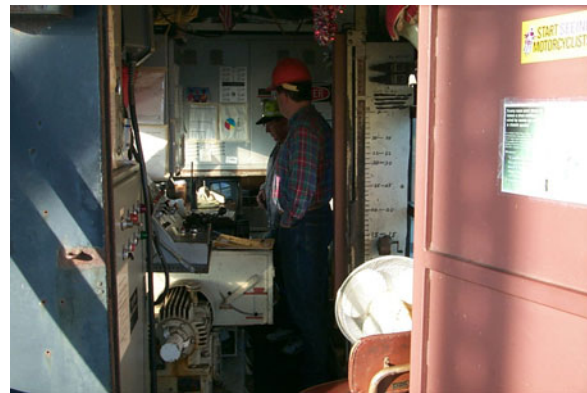
The current tender's house contains the eddy current motor, control system and the bridge operator. The house measuring approximately 12'-5" by 4'-11" on the interior, did not meet NEC code for clearances around electrical equipment and left little room for the tender and the drive equipment (see Figure 5).

Figure 5: Inside Tender's House. Note limited space.

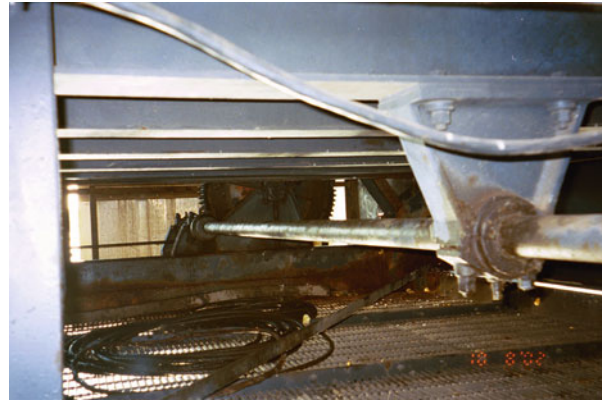
Another constraint faced in the machinery design for this structure was the limited access to and low clearance of the machinery area beneath the bridge deck (see Figure 6). There exists approximately 3'-0" of clear space between the bottom of the stringers and the top of the machinery grating. The grating could not be lowered in the rehabilitation design because it would interfere with the navigational clearance underneath the movable span when it was closed.

Figure 6: Machinery Area. Note limited space between stringers and grating.
