**HEAVY MOVABLE STRUCTURES, INC.
SIXTEENTH BIENNIAL SYMPOSIUM**

**Three Mile Creek – Pivot Bearing
Investigation, Design, and Replacement**

Tyler J. Miller, P.E.

Modjeski and Masters, Inc.

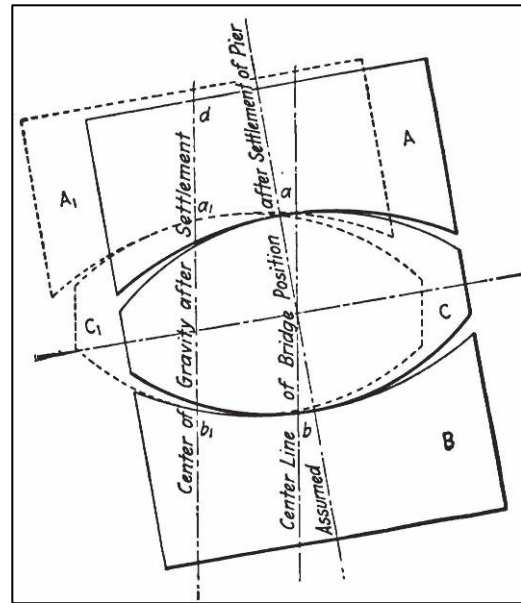
Although the three disc pivot bearing assembly is presently operational at many swing bridges, the design can become problematic due to its inherent unstable nature. Pier settlement or span imbalance will often intensify the issue. Any position adjustments are made by middle and upper discs relative to the fixed lower disc, creating a new center of rotation as shown in Figure 3. The double-convex middle disc and the downward concave upper disc are very sensitive to equilibrium changes and can become displaced. Once displacement occurs, there is no self-correcting tendency to return to an original position. The discs can protrude beyond the lower disc to the point where they apply force on the oil box. This unintended contact force on the oil box may loosen or break mounting bolts and damage the gasket seals, preventing the retention of bearing lubrication and accelerating wear. Displaced discs may also cause the swing span to lean more heavily to one side causing wedge operational issues or excessive wear in the balance wheel components. The pivot bearing discs are inaccessible due to the oil box enclosure. Therefore, diagnosis of a problem can be difficult and the shifted discs issue may be disguised as excessive span imbalance. The only potential solution to “reset” the existing bearing assembly is to jack the entire swing span and manually reposition the discs.

Figure 3. Exaggerated bearing disc position resulting from pier settlement. Retrieved from *Movable Bridges Vol. 1*, by Oits Ellis Hovey, 1926.

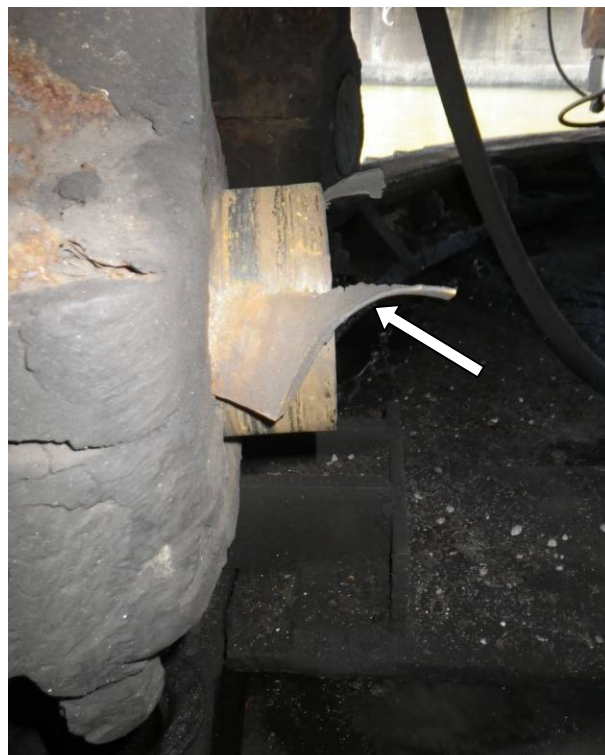
The bridge appeared to have excessive transverse span imbalance. The east balance wheels displayed signs of high loading conditions. Deterioration of the balance wheel components was noted over the course of several site visits to the point where up to 1" of metal end flow was present at the outboard edge of each wheel. The east balance wheel shaft bushings had excess clearance due to wear. Figure 4 shows the 3/8" thick bronze bushing that was worn through, allowing the shaft to press into the steel housing.

Figure 4. East balance wheel shaft bushing deterioration from excessive loading conditions.

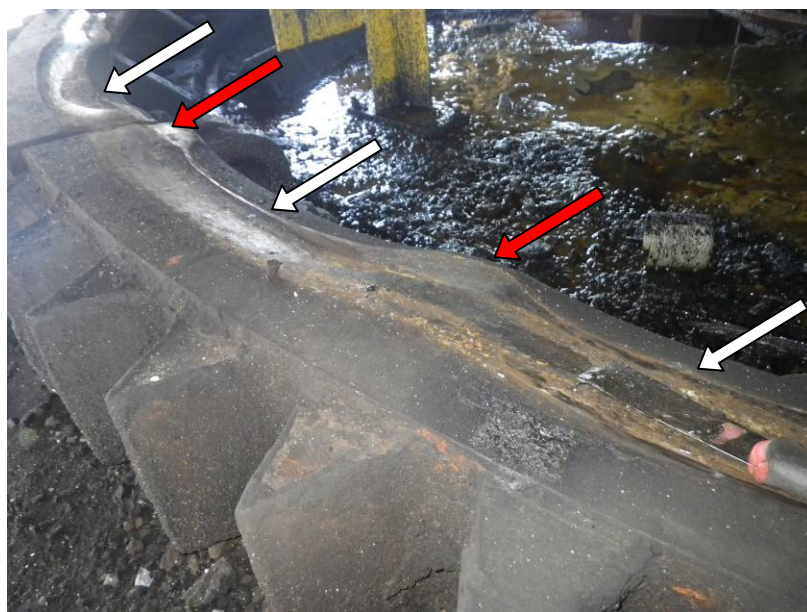
The balance wheel shaft was also shifting axially relative to the balance wheel with 2" of the shaft protruding inboard of the wheel housing. The east balance wheel track segments, in Figure 5, also displayed severe wear and plastic deformation between the radial segment stiffeners. Plastic deformation between stiffeners created peaks and valleys along the track riding surface. During operation, the span would tilt each time the balance wheels traversed a valley in the track. Increased loads in the turning machinery could be observed each time the balance wheels had to "climb" up to a peak in the balance wheel track.

Figure 5. Severe wear and plastic deformation of the east balance wheel track from excessive loading conditions. Note peaks (red arrows) and valleys (white arrows)

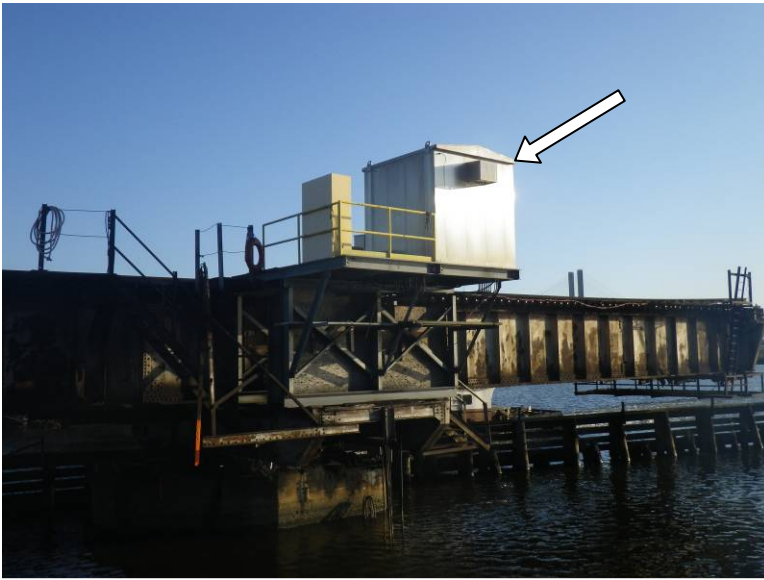
Figure 6. Hydraulic power unit room positioned outboard on the east side of the span.

At some point in the bridge's history, a large hydraulic power unit (HPU) room and platform was installed on the east side of the span, outboard of the superstructure, shown in Figure 6. This appeared to cause a significant transverse imbalance; however, balance calculations showed that appropriate transverse counterbalance weight was installed on the west side of the span. It was concluded that balance wheel and track damage was most likely a result of the pivot bearing deterioration, especially due to the noted problems associated with the three disc pivot bearing design discussed above.

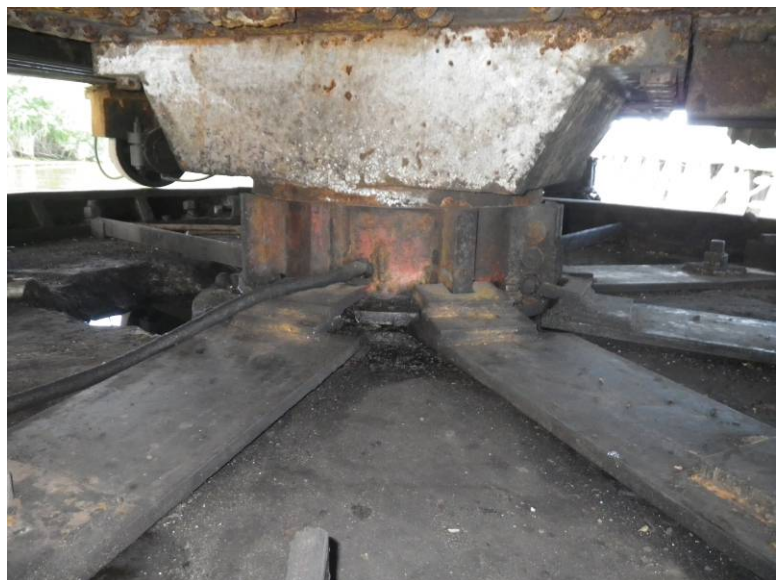
had failed and all of the pivot bearing oil box mounting bolts were loose, sheared, or missing. However, this was not a clear indication of pivot bearing issues, as described above, due to anchoring issues with the rack. The radial struts in Figure 7 had previously been installed to help secure the rack, which had only a few sound anchor bolts remaining. The struts were connected to the pivot bearing oil box and transferred torque to the box during each span operation. These conditions made efforts to retain oil in the pivot bearing futile. Improper contact between a potentially shifted pivot bearing disc and the oil box could have contributed to these issues, but the rack securing system was a major contributor.

Figure 7. Existing radial struts to secure the rack were connected to the pivot bearing oil box.

The new rack securing system is shown in Figure 13. A new center anchoring plate was bolted to the existing lower pivot bearing casting. After the rack segments were re-aligned, new radial struts locked the rack in position, bolted to the rack segment joints and the center plate. Wherever possible, the existing rack anchors were reset. New stiffening angles were bolted between each radial strut with new concrete anchors to tie the whole system together.

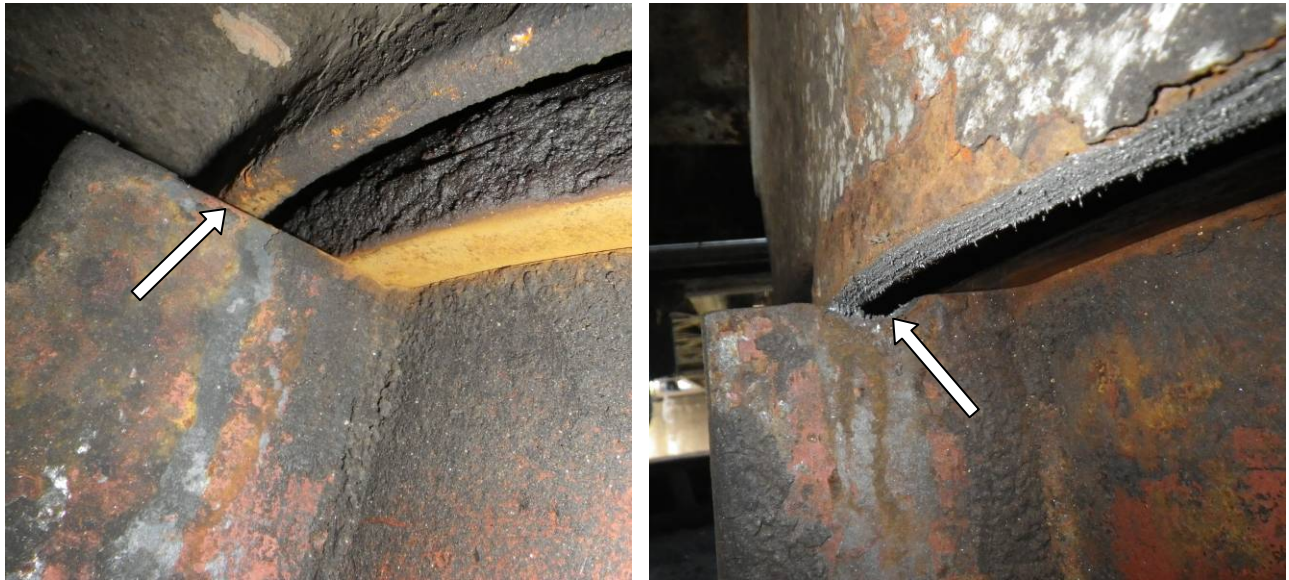
During initial visits, the east side of the pivot bearing upper casting was observed to briefly contact the top of the oil box during operations creating a periodic squealing noise. After period of a year and a half, the east side of upper casting had worn a $\frac{1}{4}$ " deep groove into the top of the oil box stiffeners and the contact

and squeal noises had become constant during operation. Figure 8 displays the increase in wear by comparing photos from those two site visits. Strain on the operating machinery was visually and audibly observed to be greater due to increased friction.

Figure 8. Change in unintended contact and wear between the east side of the upper casting and the oil box over a period of a year and a half.

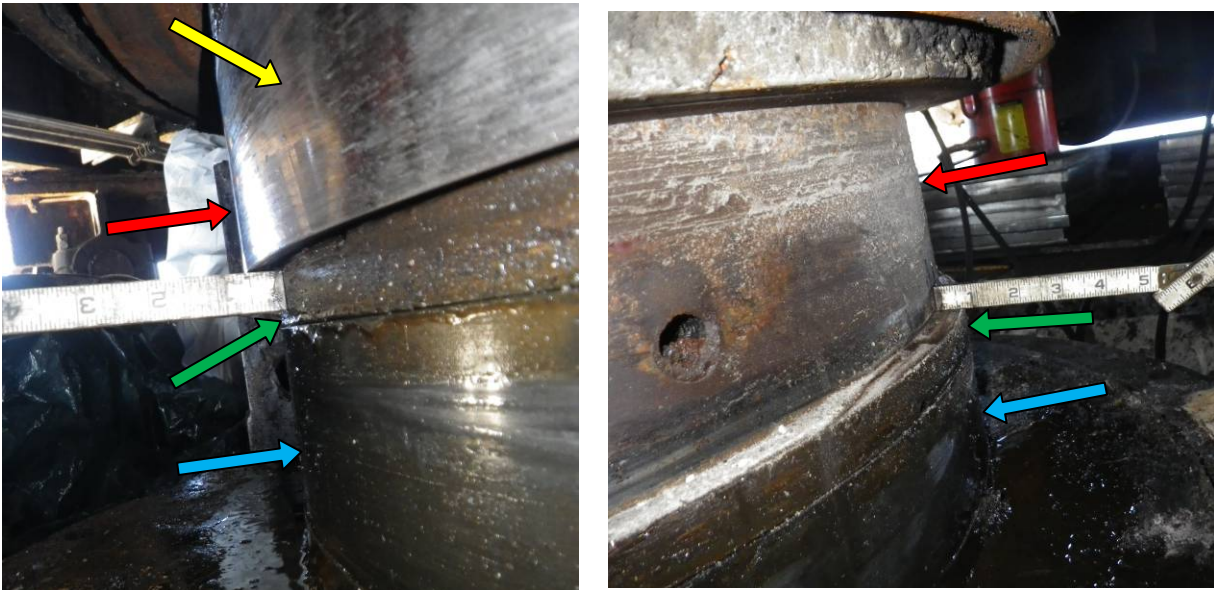
The problematic bearing assumptions were confirmed once the oil box was removed during construction. It was discovered that the existing top steel disc had shifted $\frac{1}{2}$ " horizontally and was pressing against the oil box. Once the span was re-centered on the new bearing assembly, all of the related operational issues disappeared immediately. The following sections provide highlights of the Three Mile Creek pivot bearing replacement case study.

Prep work prior to the outage included removing concrete around the lower casting to provide access to the existing oil box mounting holes. These would be reused for securing the new pivot container. Once the outage began, the span was stabilized and the existing oil box was removed. Figure 10 shows the $\frac{1}{2}$ " displaced position of the existing top steel disc that was discovered. The disc was pressing against the inside face of the oil box. This confirmed the assumption of a translated disc as the root cause of several problems. Wear marks on the bottom surface of the bottom steel disc indicated that rotation during operation was occurring at the lower casting interface. There were no keys or dowels in the existing design between the bottom disc and the lower casting to prevent this movement. The bottom disc also exhibited several significant cracks shown in Figure 11.

Figure 10. Opposite sides of the pivot bearing showing the $\frac{1}{2}$ " displaced position of the top steel disc (red arrow) relative to the bronze disc (green arrow) and bottom steel disc (blue arrow) discovered once the oil box was removed. Note signs of hard contact with the oil box on the top steel disc (yellow arrow)

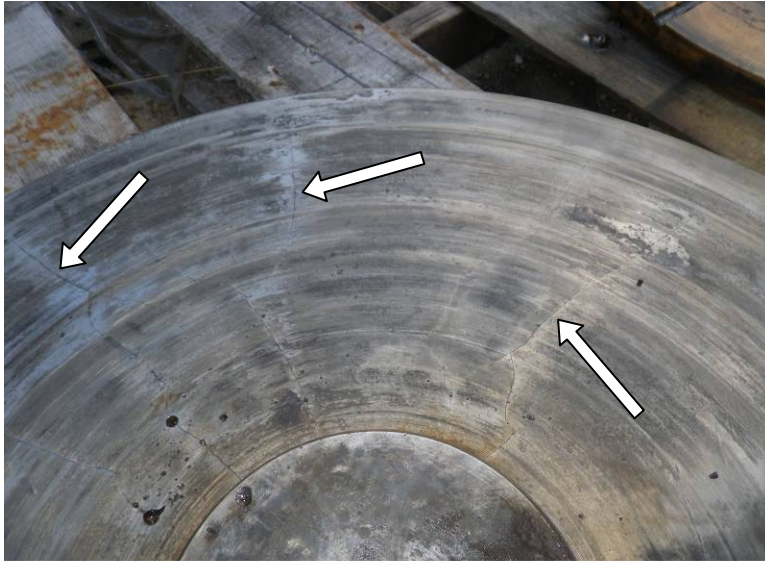
Figure 11. Bottom surface of the existing bottom steel disc with several significant cracks and signs of wear at the lower casting interface.
