HEAVY MOVABLE STRUCTURES, INC.  
SEVENTEENTH BIENNIAL SYMPOSIUM

Hood River Lift Bridge  
Unique Solutions to Interesting Problems

Paul Bandlow, PE  
Stafford Bandlow Engineering, Inc.

John Mann  
Port of Hood River

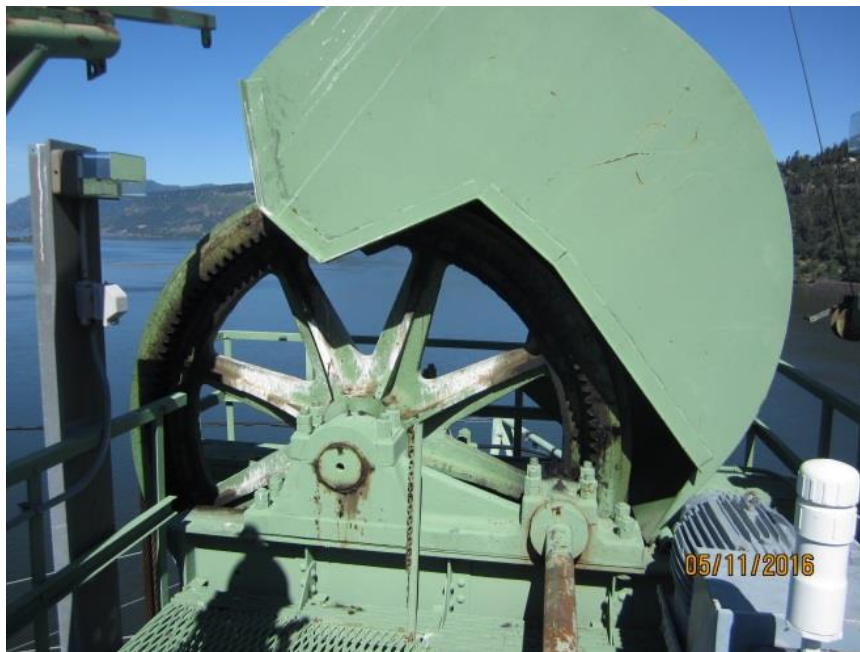
The racks and rack pinions are the only open gearsets. Visual inspection as well as cleaning of representative gear teeth indicated that the gear tooth wear pattern was consistent with the pattern in the gear lube indicating that there was no change to the alignment of the racks and rack pinions.

Figure 2: General view of rack and rack pinion.

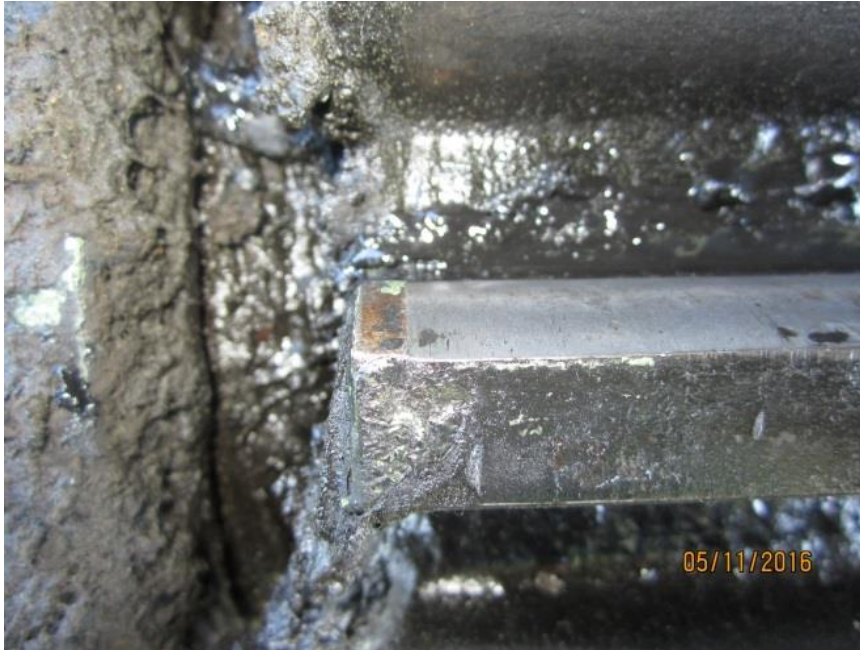
Figure 3: Rack pinion tooth cleaned for inspection.

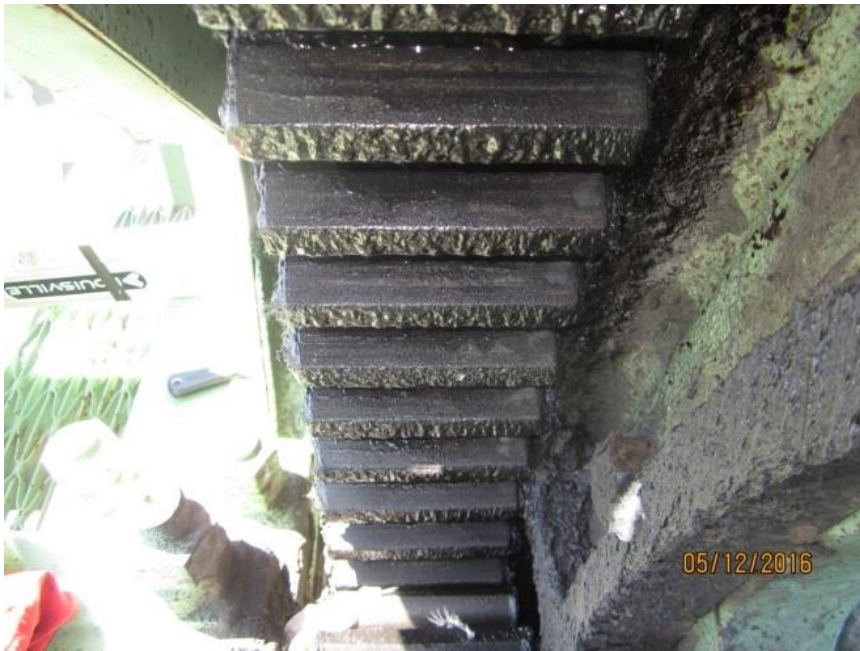
Figure 4: Rack teeth lube pattern

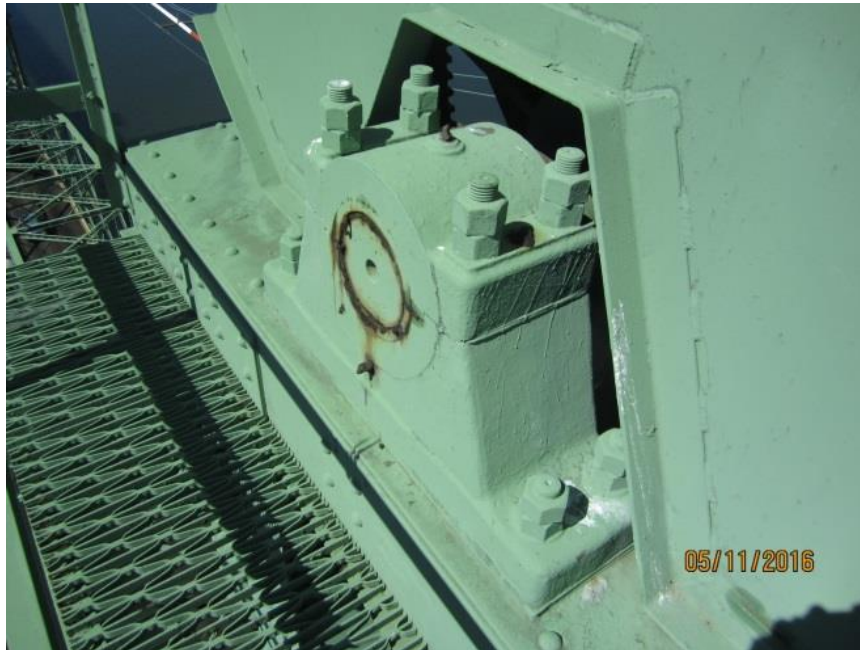
Clearance measurements and bushing to journal alignment at all trunnion bearings were found to be within acceptable limits. The maximum clearance was 0.027" and is within the limits of an ANSI RC9 fit which is commonly cited as a limit for rehabilitation. Maximum taper over 10" was 0.005" and is considered acceptable. All clearances were found at the top of the bearings. Trunnion bearing measurements are tabulated in Table 1 below.

Figure 5 shows a picture of a typical trunnion bearing. No movement was noted between any of the trunnion bearings and the supporting structure.

Figure 5: Typical trunnion bearing. There was no evidence of movement between the bearing and the supporting steel or between the bearing cap and base.

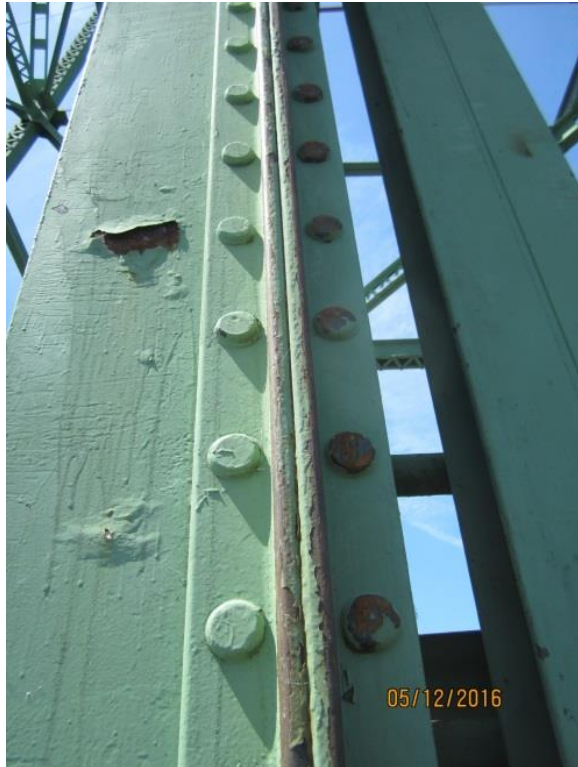
Damage was noted at all upper span guides in the longitudinal direction. This damage did not appear recent and was likely due to an excessive skew condition. Evidence of heavy contact was found at the southeast span guide location where the rivets that secure the guide rail to the structure are worn. The guide rail at this location was not worn indicating improper adjustment of the lower guide that allowed the guide to contact the rivets prior to contacting the guide rail. The lower span guide at this location was recently replaced and the original guide was not available for inspection.

Figure 6: Southeast span guide rail. Note damage to rivets that secure the guide rail to the structure at the right side of the guide rail but no damage to the guide rail.

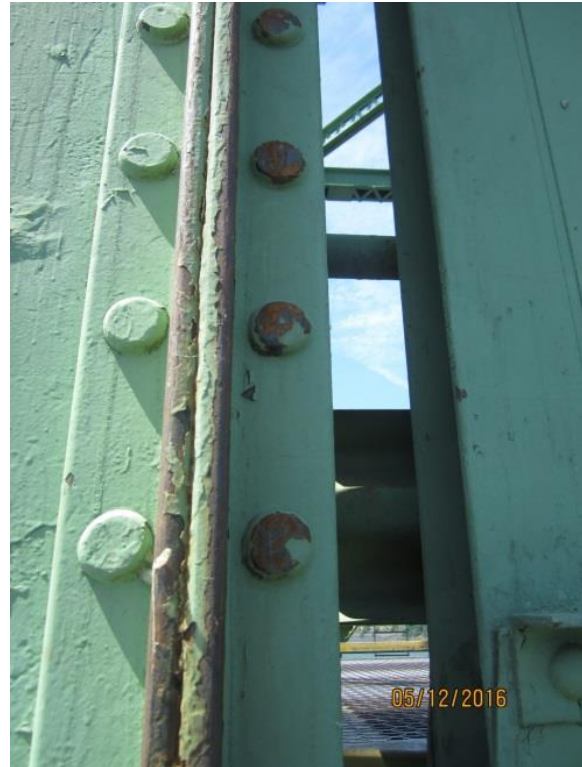
Figure 7: Close up of photo in Figure 6

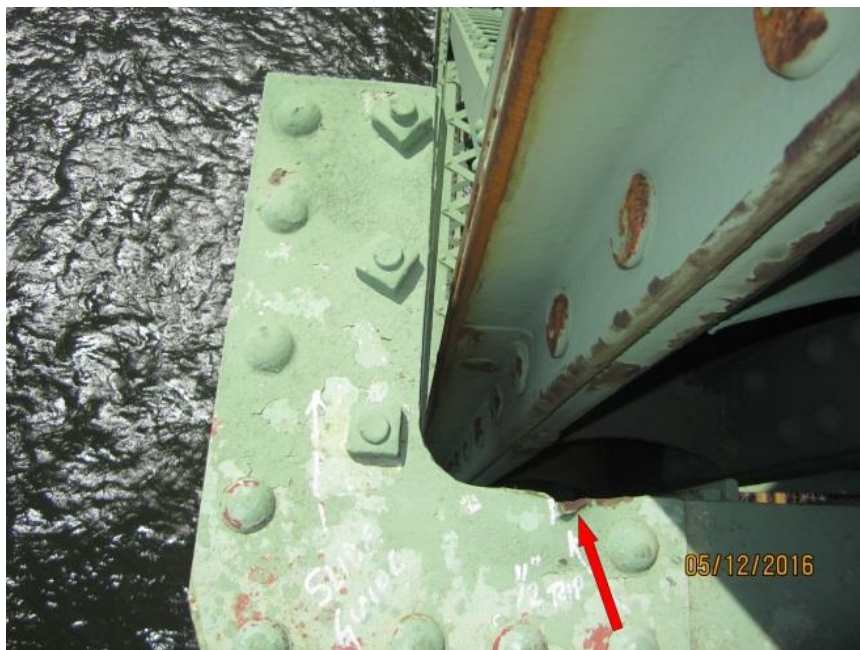
Figure 8: Southeast upper span guide. Note damage in longitudinal direction due to over-skew condition (arrow).

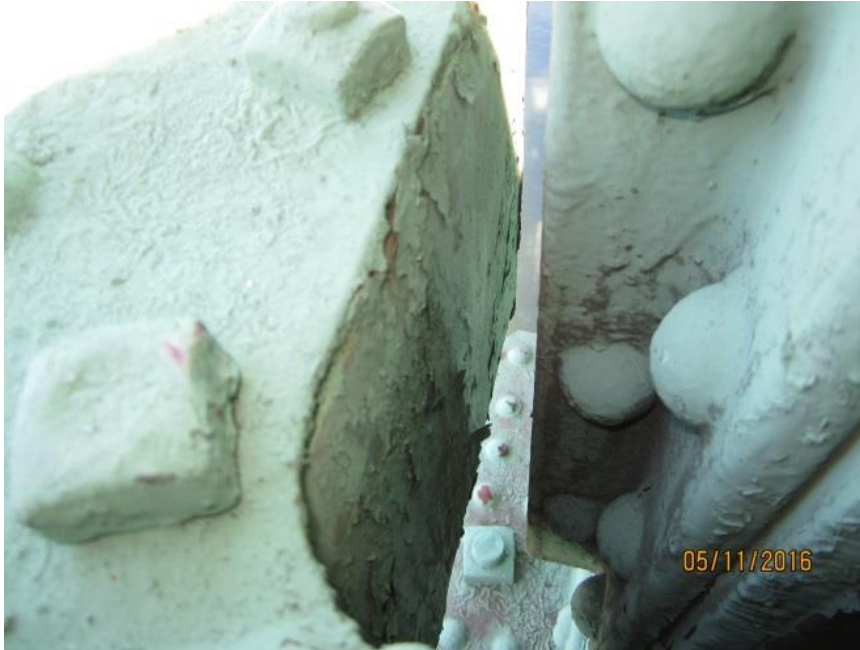
The north end of the movable span had shifted west relative to the north tower. Evidence of this included clearance at the northwest span guides, contact between the west side of the northwest live load rocker and the fixed support and contact between the northeast span guide and the northeast span guide rail.

Figure 9: Northwest lower span guide. The span guide is not in contact with the guide rail.

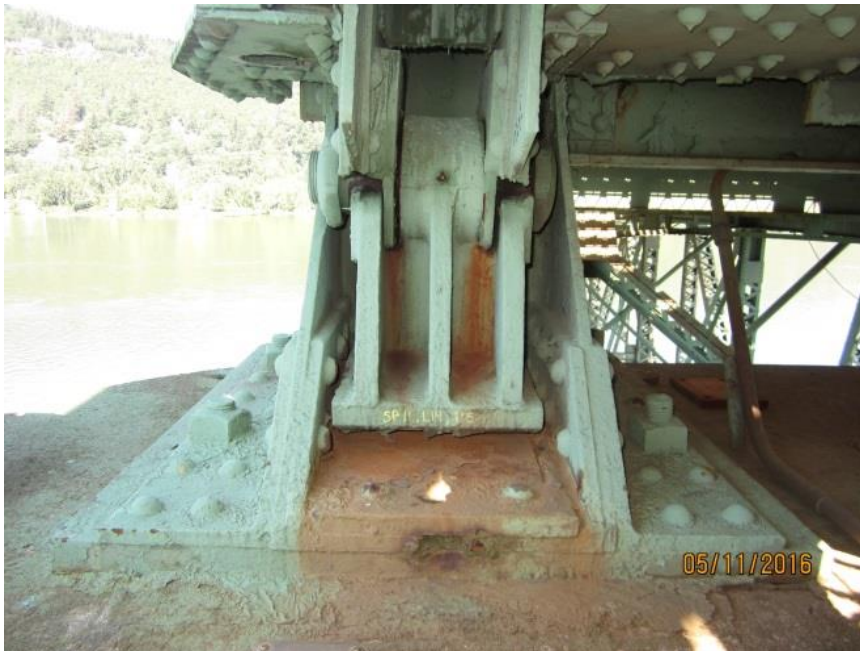
Figure 10: Northwest live load support. Note evidence of contact with the fixed structure at the left side of the rocker.

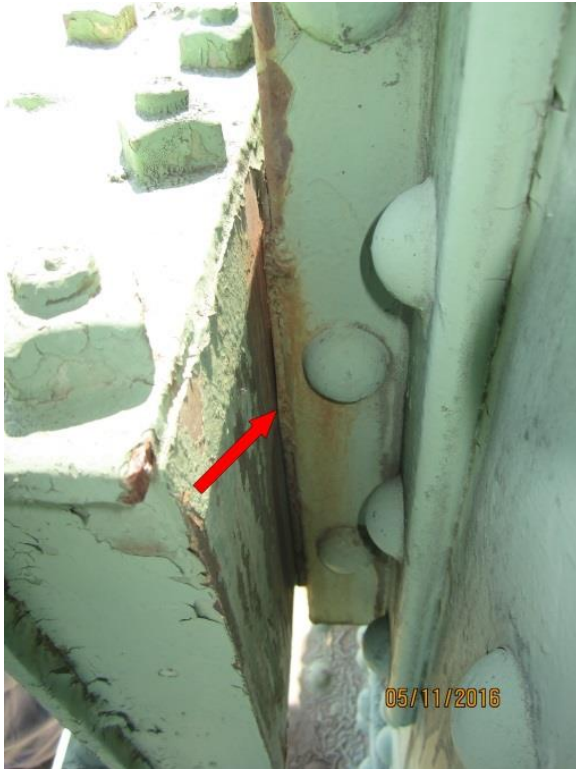
Figure 11: Northeast lower span guide. Note the addition of a wedge shaped shim

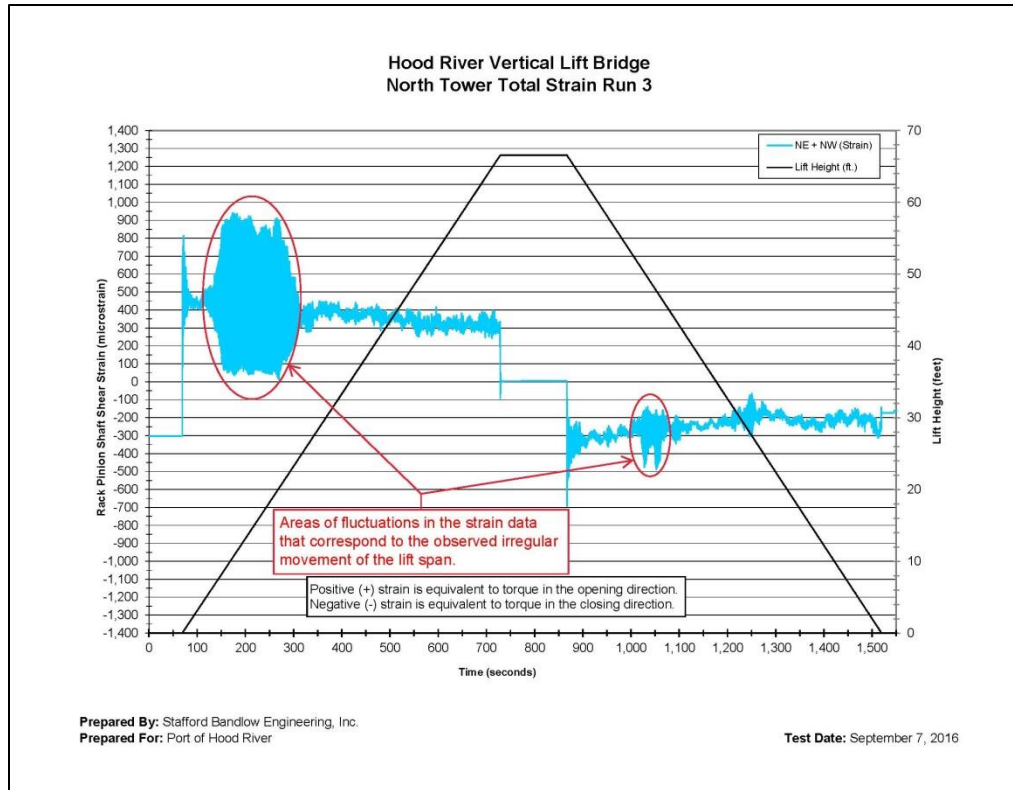
Figure 12: North Tower Strain Data

During the span operation it was observed that the movable span had a period during the opening cycle where the bridge had noticeable irregular movement. There is also a period during the closing cycle where similar behavior occurred but for a shorter duration and to a lesser magnitude than on the opening cycle. These periods of irregular movement did not occur at the same lift height. On the opening cycle the irregular movement occurred between 7 ft. and 23 ft. and on the closing cycle the behavior occurred between 51 ft. and 47 ft. The movement was characterized by short duration start-stop cycles observed at the counterweight sheave, the rack and rack pinion, and when standing on the movable span during an operation. The start-stop behavior was not noted at the high speed end of the drive. This behavior was noted at both ends of the bridge during the strain gage testing on both days of testing. Figure 12 and Figure 13 for the north and south towers respectively demonstrate the areas of irregular movement.

The observed behavior is somewhat consistent with stick-slip phenomena with the likely source being the trunnion bearings. Typically, some amount of noise is associated with stick-slip conditions however no unusual noises were noted during operation. The observed behavior is clearly seen in the strain gage recordings as a build-up and release of strain. It was noted in the strain gage report that the friction values for the bridge are very high. This friction is from the rack pinion bearing, the rack and pinion gear mesh, the trunnion bearings and the span and counterweight guides. No significant contact was noted at the span and counterweight guides, therefore friction from this source is considered negligible. Since the trunnion bearings are the most heavily loaded bearings, it is likely that the majority of the friction is from the trunnion bearings. It is not clear if the high friction is a factor in the observed behavior.

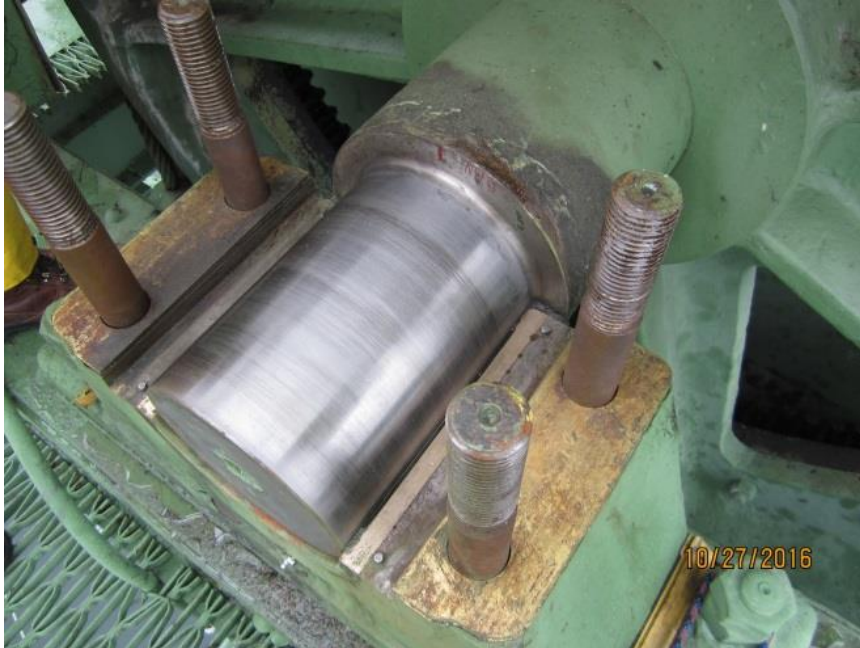
All eight trunnion bearings caps were removed and visually inspected with the bridge closed and then again after raising the bridge to observe the bottom half of the journal which is not visible with the bridge closed. The top half (bridge seated) of the trunnion journals was found to be well-polished and in good condition with only minor scoring and light bronze embedment on some journals. The bottom half (bridge seated) of the trunnion journals had light scoring and light bronze embedment. In addition, these areas had minor corrosion and dried lubricant. The corrosion was found to be limited and both the dried lubricant and corrosion were removed at the time of the inspection using emery cloth and Scotch-Brite™ pads.

Figure 14: Typical top half of trunnion bearing journal.

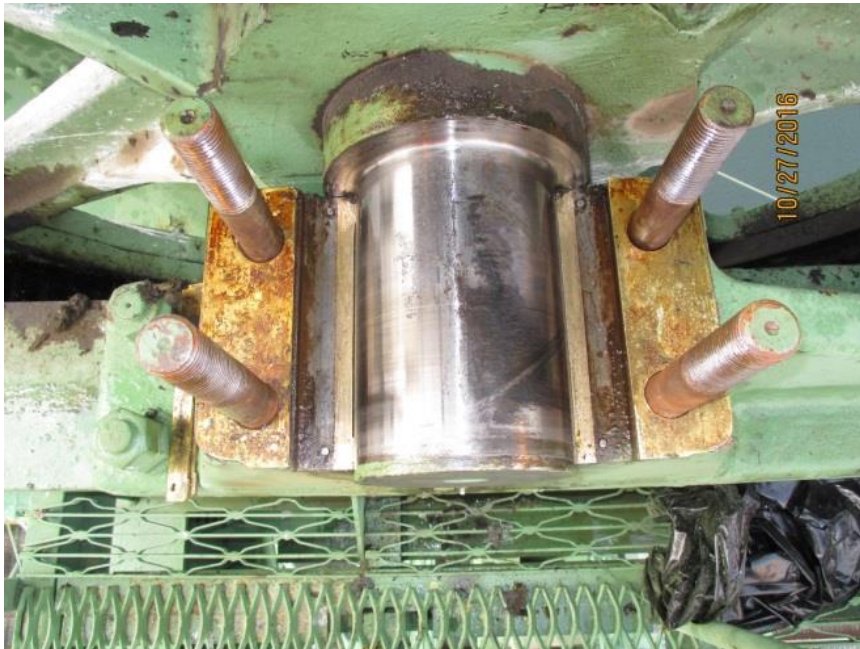
Figure 15: Typical bottom half of trunnion bearing journal.

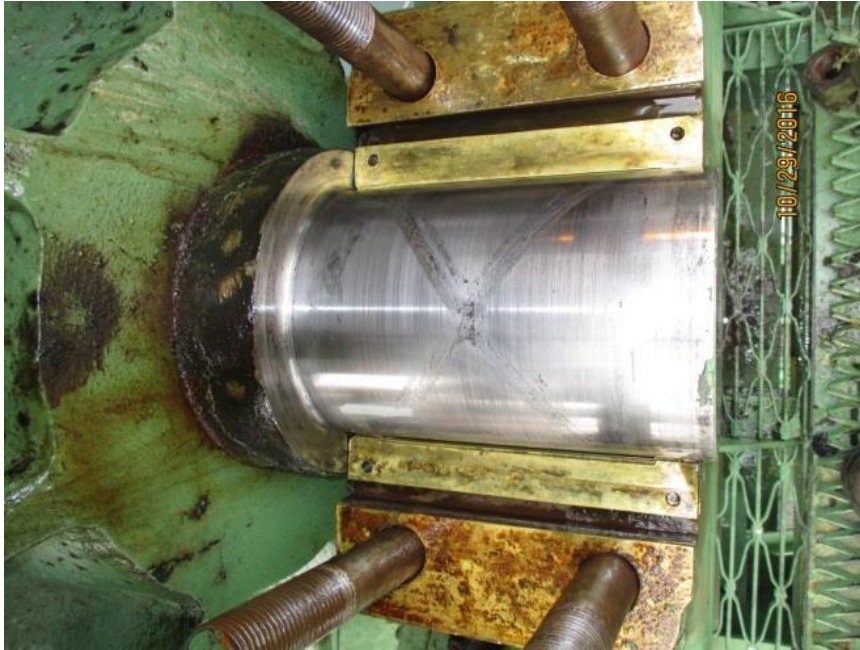
Figure 16: Typical bottom half of trunnion bearing journal after cleaning.

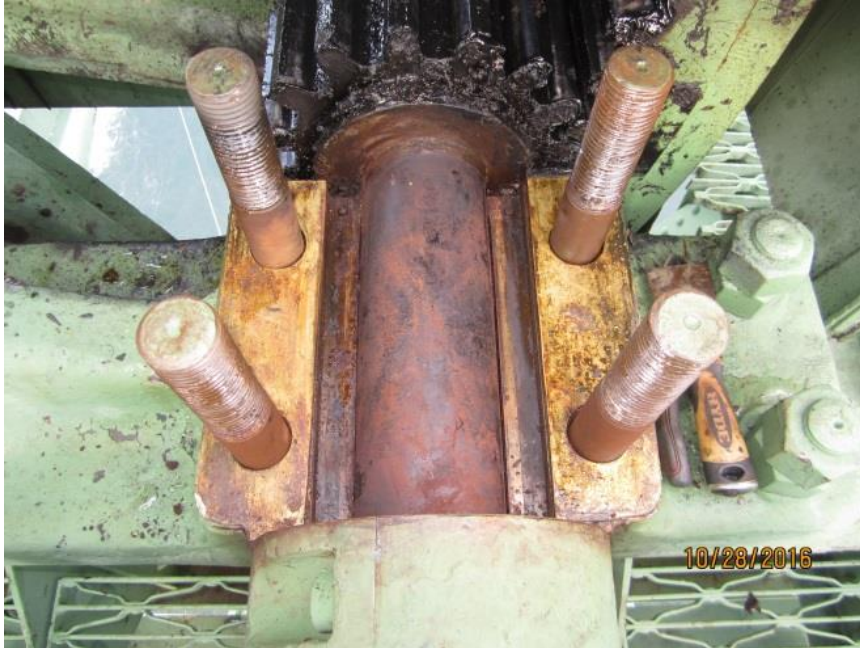
The condition of the inspected rack pinion bearings varied from fair to poor. The southeast bearing was found in fair condition with ample lubrication and only minor deficiencies. The northwest and southwest bearings were found in poor condition with moderate to heavy corrosion and dried lubrication deposits on the journal. The bearing caps at these locations had evidence of fretting corrosion (due to inadequate lubricant), dried lubrication deposits, and clogged lubrication ports. The northwest and southwest bearings were cleaned to the extent possible with the bridge in the closed position using penetrating lubricant and emery cloth to remove lubricant deposits and corrosion around the circumference of the journal. The depth of corrosive pitting at the journals was significant as the pits could not be removed by hand polishing. After cleaning, the journals were lubricated by hand and the bearing caps were installed prior to operating the bridge.

Figure 17: Northwest rack pinion bearing. There was no evidence of recent lubrication.

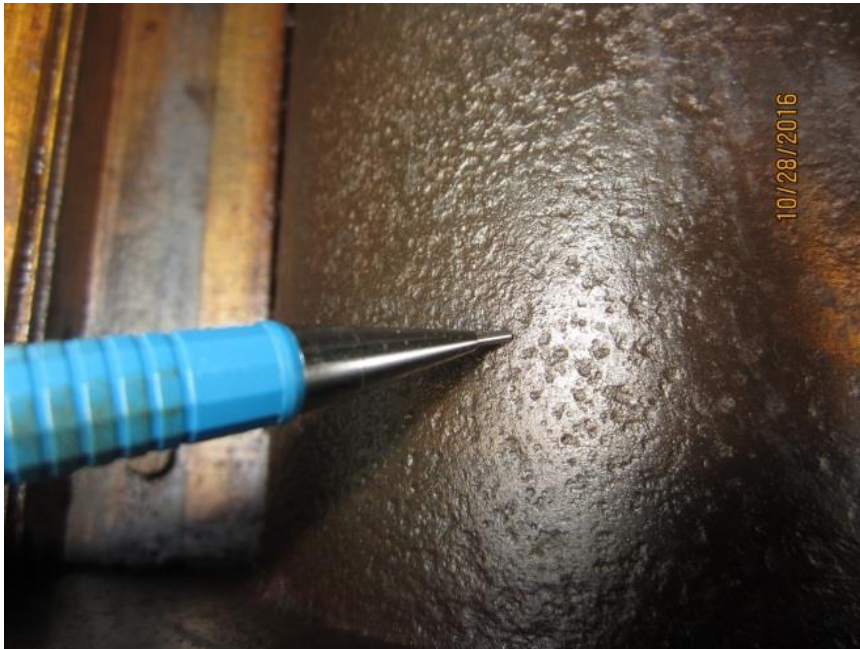
Figure 18: Southwest rack pinion bearing. Note the corrosion and heavy pitting on the journal.

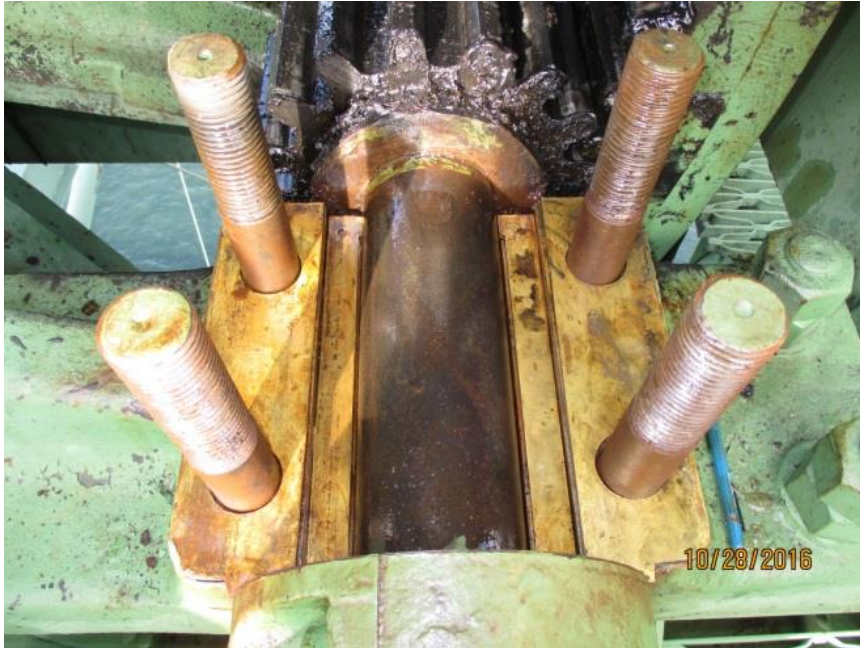
Figure 19: Northwest rack pinion bearing after cleaning.

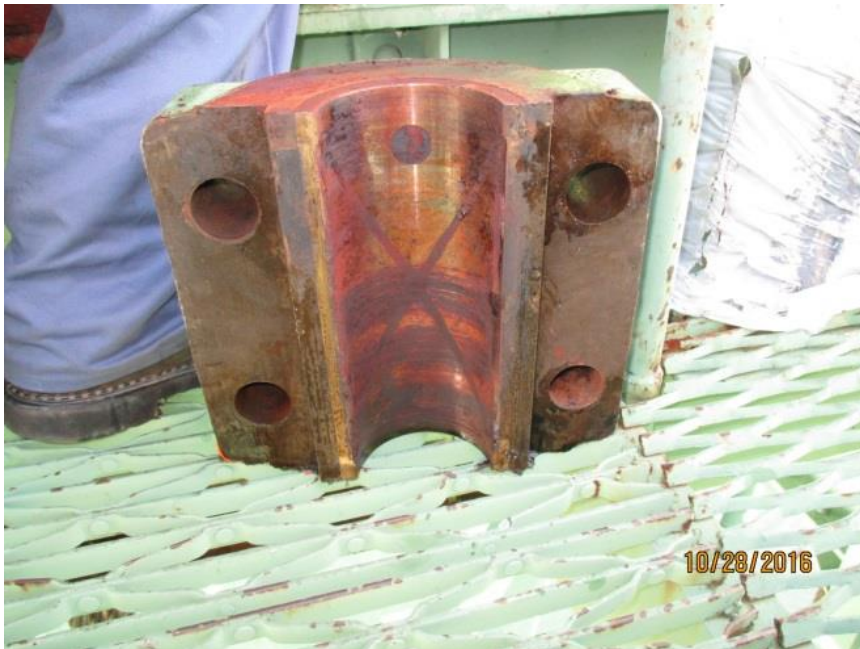
In addition to the trunnion bearings, the condition of the rack pinion bearings was a potential contributor to friction problems. A clogged lubrication fitting was previously noted at the northwest rack pinion bearing cap. There are four rack pinion shaft bearings with one bearing at the inboard side of each rack pinion. As part of the inspection, the northwest, southwest, and southeast bearing caps were removed by maintenance personnel to permit an in-depth inspection of the wearing surfaces of the bearings. Maintenance personnel were not able to remove the northeast bearing cap due to corroded fasteners.

Figure 20: Northwest rack pinion bearing cap. Note clogged lubrication port and lubrication grooves

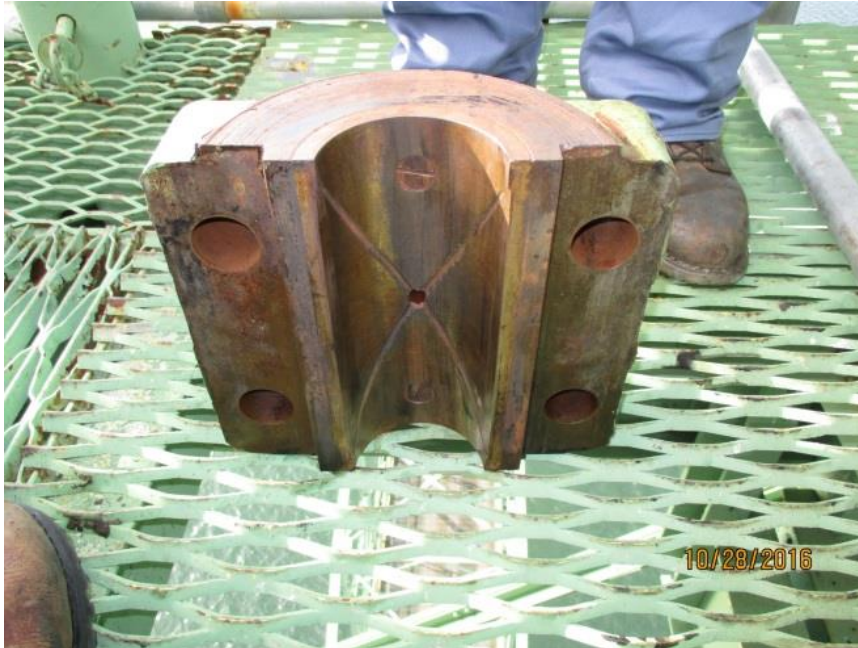
Figure 21: Northwest rack pinion bearing cap after cleaning.

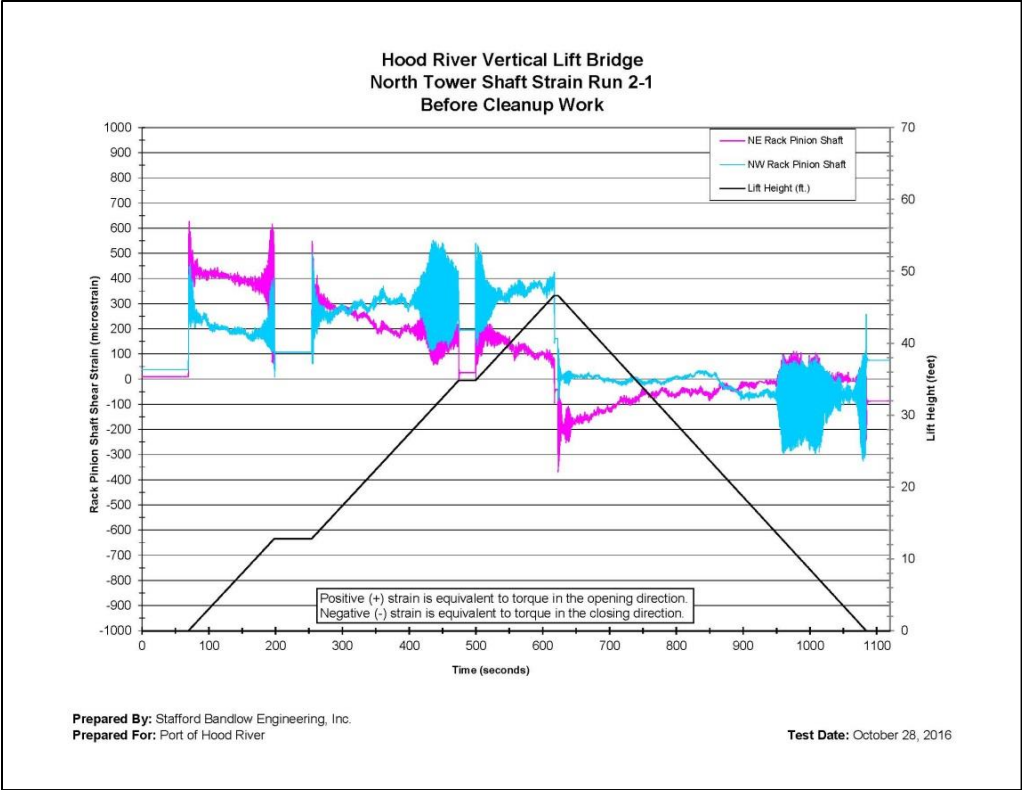
Figure 22: Strip Chart Recordings North Towner Shaft Strain Run 2-1 – Before Cleanup Work

Although not completely eliminated, the work at the trunnion bearings (corrosion removal, flushing, and lubrication) led to a significant reduction in the duration and magnitude of the strain fluctuations. The strain fluctuations were eliminated when the span was rising and the strain fluctuations were reduced when the span was lowering. The strip charts in Figure 22-Figure 25 show the effects of the work done at the trunnion bearings.

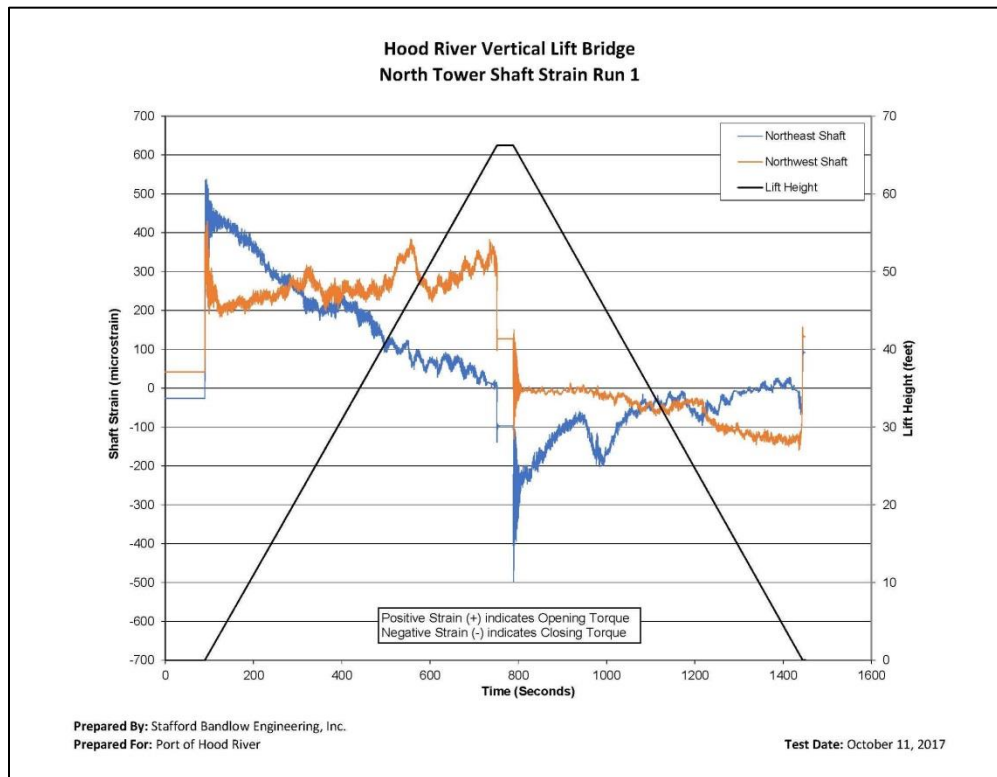
Figure 26: Strip Chart from October 2017 Balance Testing - North Tower Shaft Strain Run 1

Through continued flushing and lubrication as part of a regular maintenance program the strain fluctuations have been completely eliminated as seen in the strip charts in Figure 26 and Figure 27 from our October 2017 balance testing.
