**HEAVY MOVABLE STRUCTURES, INC.  
SEVENTEENTH BIENNIAL SYMPOSIUM**

**Retrofit of a Rolling Leaf Bascule Bridge –  
Laurel, Delaware**

By Gregory Black, P.E., Neil Shemo, P.E. and Dan Griffith,  
P.E.

Design by AECOM in support of the Delaware Department  
of Transportation

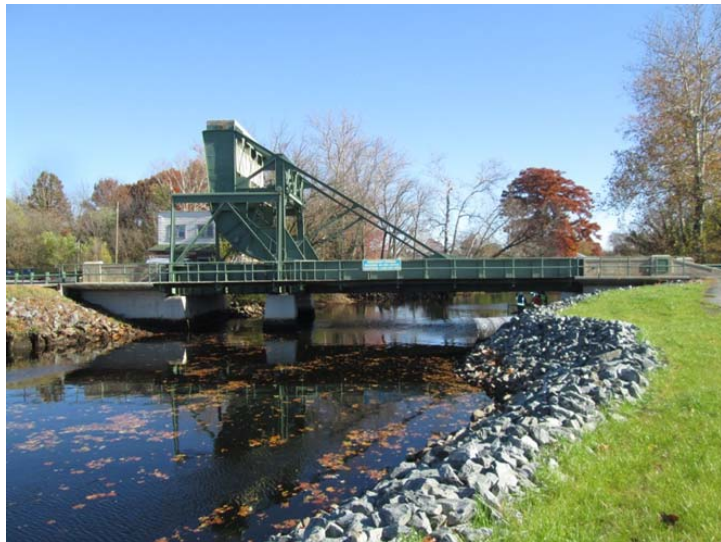
The bridge (BR 3-152) carrying Central Ave. over Broad Creek in Laurel, DE was originally built in 1923. It is a rolling lift bascule bridge, designed by the Scherzer Rolling Lift Bridge Company. See Figure 1 for photograph of the existing structure. The most recent inspection findings identified several areas of deterioration requiring repair and rating of the structure required a posting of 13 tons. The low posting requirement meant emergency vehicles could not make use of the bridge.

Figure 1: Bridge 3-152 Central Ave. over Broad Creek

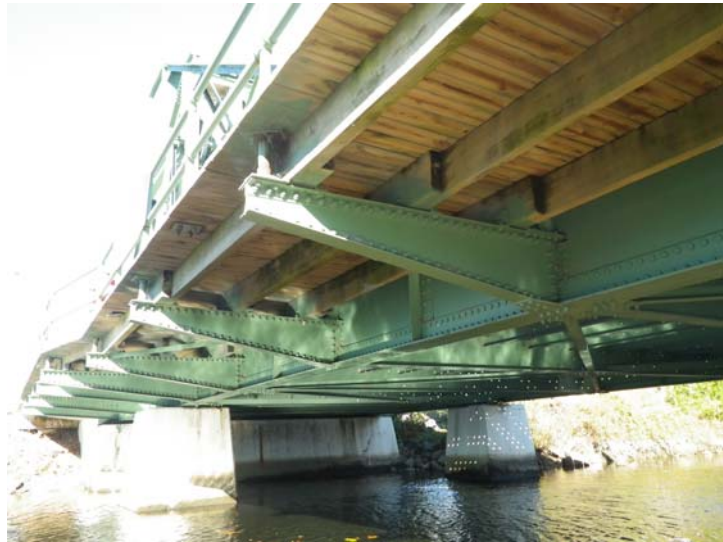
Figure 2: Underside of BR 3-152, looking northeast

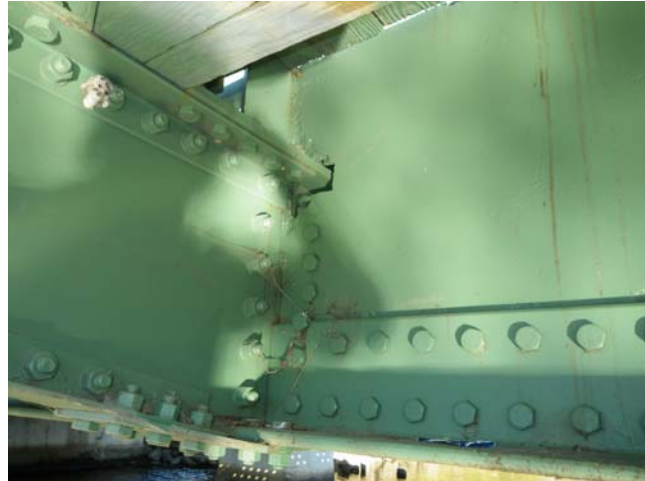
The bascule girders in Span 1 received several repairs during a previous rehabilitation, which included replacement of rivets with high strength bolts, complete replacement of the bottom flange angles and the complete replacement of the last few feet of the girders adjacent to the south abutment. Despite the previous rehabilitation, the Span 1 girders still exhibit minor section loss to the web above the bottom flange angles. Additionally, there is significant section loss to the web where the floor beam connections bolt on. During the original construction, holes were fabricated in the webs of the west through girders in order to allow for the passage of splice plates between the sidewalk brackets and floor beam top flanges (See Figure 5). These holes exhibit significant section loss, with knife edging.

Figure 5: Bracket Connection to Through Girder

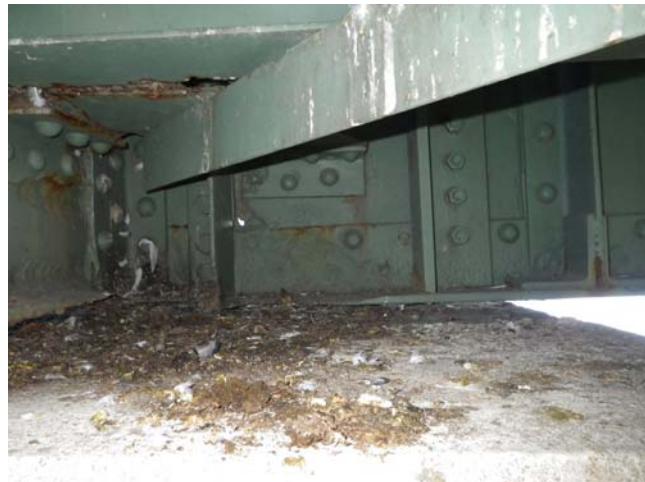
The track girders in Span 2 are original construction, with no previous repairs, with the exception of jacking stiffeners which were added when bearings at the abutment were replaced (See Figure 6). The webs of the track girders adjacent to the bearings exhibit areas of holed through section loss. The bottom flanges of both girders exhibit areas of 100% section loss at all floor beam connection locations and above the substructure.

Figure 6: Bottom of West Span 2 Girder at Pier

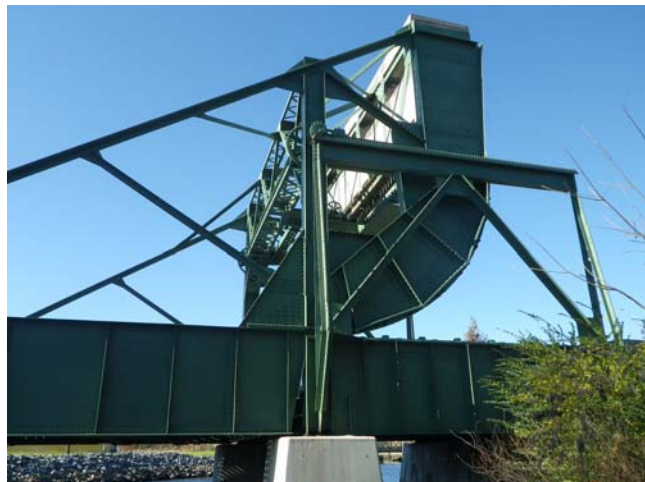
The overhead portion of the structure is also in fair condition overall. The segmental girder is in good condition, with no significant areas of deterioration or section loss. The main truss members connecting the counterweight to the bascule span girders are also in good condition. However, the bracing between the two trusses exhibits pitting, with areas of the 100% section loss in some of the machinery support frame members.

Figure 7: Counterweight, Rack Frame and Segmental Girder

After additional investigation, it was determined that the existing rack frame could support the counterweight with minor modifications. These included directly connecting them to the counterweight (See Figure 9), adding a tension tie and building new bearings at the base of the rack support columns. A second redundant system to resist the counterweight eccentricity is provided by new anchor bolts at the existing south abutment, which are designed to resist the full uplift force from the counterweight. A third redundant system is the new bridge superstructure itself. Although the lateral braces allow for differential movement, any large movement of the girders would be stopped by the connection to the new prestressed girder superstructure, which outweighs the old floor beam and stringer system.

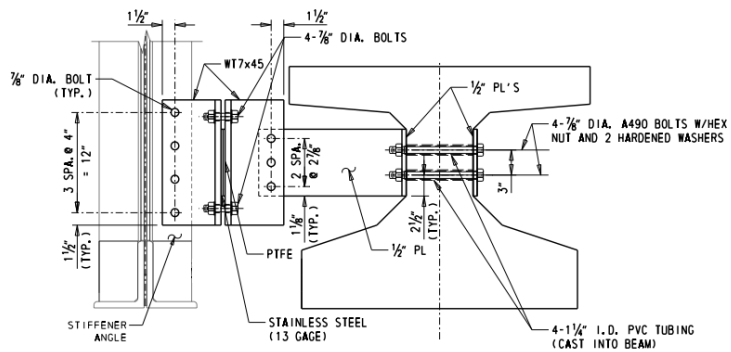
Figure 10: Lateral Bracing System

superstructure. This lateral bracing system is shown in Figure 10. By using short slotted holes in the connection, the superstructure is allowed to deflect without shedding load to the through girders. In order to minimize the size of the new girders, it is necessary to reduce the span length by installing a new wall pier between the two existing pier columns. Due to the unequal span arrangement, it is not possible to take advantage of continuous construction, as this would result in an uplift force on the north end of the girders. Instead, a link slab would be used in order to avoid putting a joint that will need to be maintained and could leak into the new superstructure.

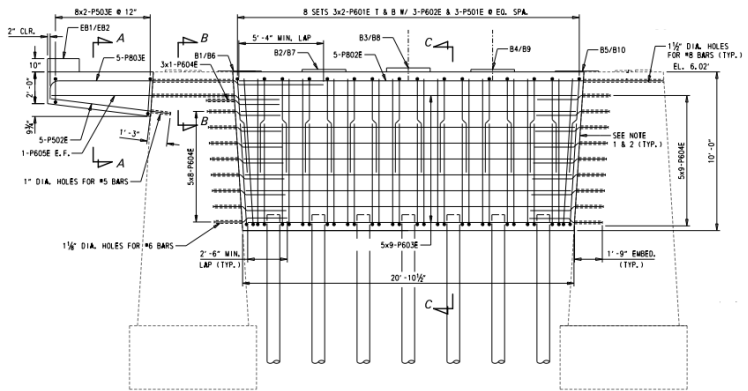
Figure 12: Pier Modifications

The sidewalk on the west side of the bridge will be composite timber deck to match the timber deck on the existing structure. Due to the isolation of the existing through girders from the new superstructure, the west girder could no longer support the sidewalk with cantilevered brackets. Instead, a stringer and tapered floor beam system designed to resemble the existing tapered brackets will support the new sidewalk. In turn, the floor beam will be supported by the existing west girders and a new edge beam. This edge beam will be supported on extended beam caps which will be added to the existing substructures (See Figure 12).

The modification to the rack frame spreads the counterweight load between the pier and north abutment. Both the existing pier and north abutment were designed for the entire weight of the bridge superstructure. The pier columns when the bridge is in the “closed” position and the north abutment when the bridge is in the open position. These two substructure units are in decent condition, and by spreading the load out between them, it is possible to add the additional load from the new superstructure and increased live load from removing the posting without actually increasing the design load to either unit. As the north abutment is already full width, it can be adapted to accommodate support for the new superstructure with minor beam seat modifications. As previously mentioned, a new infill wall between the existing pier columns will support the new superstructure at the pier. This infill wall will be supported by micropiles, which have been arranged so they can be installed through the existing bridge deck.

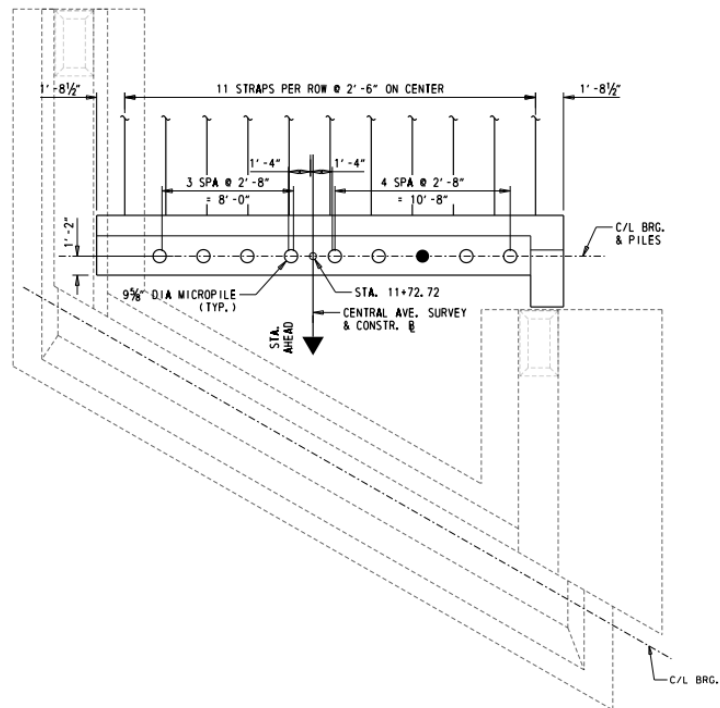
The existing south abutment was only designed to carry a tributary portion of the bascule span dead load, outdated lower live loads, and impact from the closing of the bascule span. Without accurate knowledge of reinforcement and pile placement, the capacity could not be evaluated or relied on to carry additional

Figure 13: New South Abutment

loads. Therefore, more extensive modifications were required. The easiest way to modify the existing south abutment was to build the new abutment behind the existing abutment, while using the existing abutment as shoring for any excavation. However, this extended the span length to 75ft, resulting in a deeper superstructure. In the end, this was still the preferred option because other options would have more extensive demolition and excavation around the existing structure, more challenging temporary supports and more work in the creek. By building a new abutment it was possible to remove the skew from the superstructure. The new abutment would also be supported on a single line of micropiles, which could be installed between the existing wing walls. Although the south abutment is

at the expansion end of the span, and therefore only sees minor longitudinal loads, with only a single line of micropiles, there is not much longitudinal stiffness to the pile system. Therefore, soil straps were added to the back of the abutment to resist the longitudinal loads.
