**HEAVY MOVABLE STRUCTURES, INC.  
SEVENTEENTH BIENNIAL SYMPOSIUM**

**Obtaining Acceptable Load Sharing & Gear  
Action without a Differential**

Geoffrey L. Forest

Modjeski and Masters, Inc.

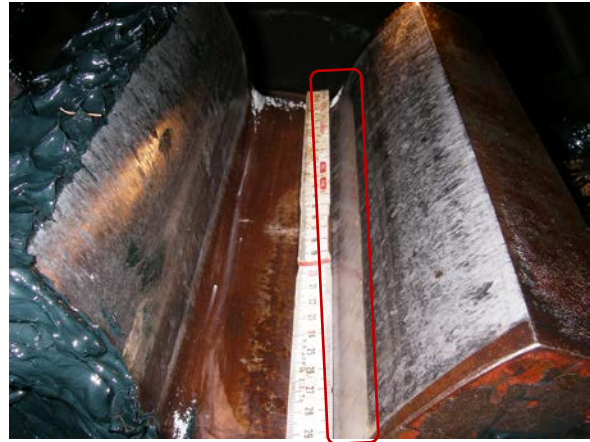
The machinery for the Spit Bridge was inspected in January 2011 to gather details for designing the upcoming upgrades. While taking measurements of the main pinions which engage the rack gears, an unusual wear pattern was observed on the east pinion. The wear was located in a band just below the pitch line of the pinion (see Photograph 2), and while corresponding wear was not immediately apparent on the rack teeth, heavier wear was noted in the addendum, especially at the tooth tip. This wear pattern was not found at the west pinion and rack gearset.

Photograph 2 – Band of increased wear just below the pitch line of the east pinion (box).

The east pinion has a wear pattern referred to in this paper as “undercutting” which is attributed to the over-engagement of the east rack and pinion. The undercutting is located nearest the root of the pinion teeth in the area of the pinion that is engaged with the rack at the nearly raised position. The wear at the undercut area is approximately 1.3% of the tooth thickness at the worn area (which is greater than the tooth thickness wear at the pitchline). The “undercutting wear” is a separate issue from the other “normal

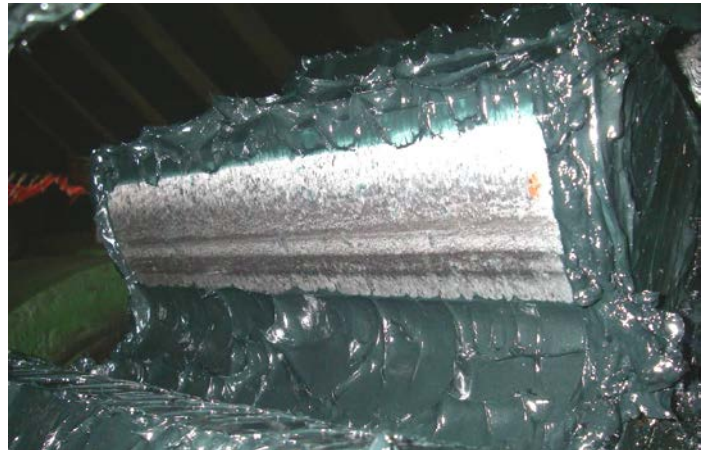
The gear teeth were numbered so that data could be tracked to specific locations on the racks and pinions. Tooth number 1 on both gears is engaged with the span seated. The rack and pinion gears have good face contact. Photographs 3 and 4 show the contact pattern prior to the grease being removed from the teeth for inspection.

Photograph 3 – East pinion contact pattern prior to grease removal.

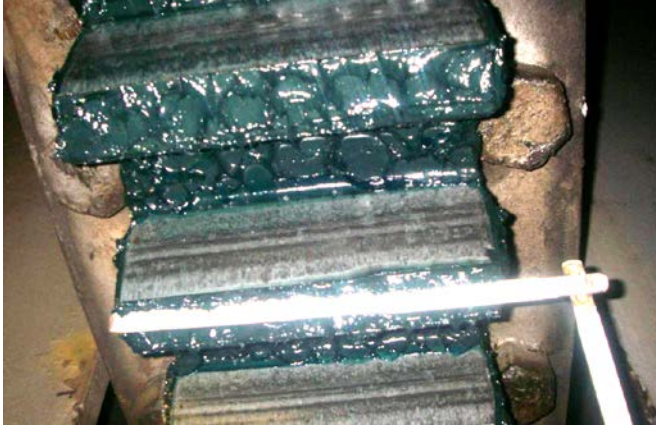
Photograph 4 – East rack contact pattern prior to grease removal

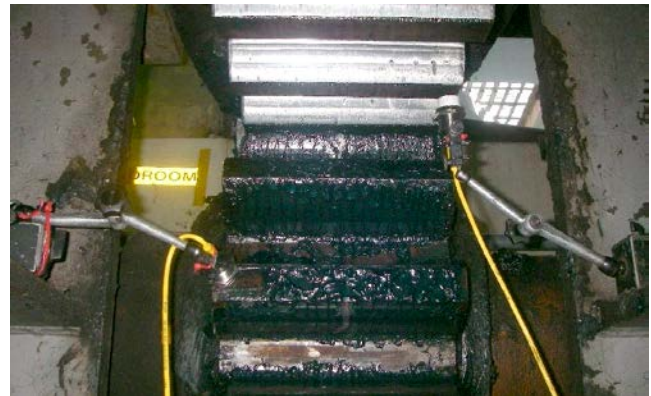
The runout (change in radius) of the rack and pinion gears was measured using non-contact inductive distance sensors. The sensors were focused on a pinion tooth and a rack tooth near the rack/pinion mesh (see Photograph 5). When the span was operated, the distance was recorded as each pinion and rack tooth passed by their respective sensor. This data for the east rack and pinion is presented in Figure 4, the west set is similar (note: the pinions have 15 teeth, since the first reading is on tooth 4, the reading for tooth 18 marks one revolution, and tooth 19 represents the 2nd reading of tooth 4).

Photograph 5 – Measuring gear runout during operation with inductive non-contact distance sensors

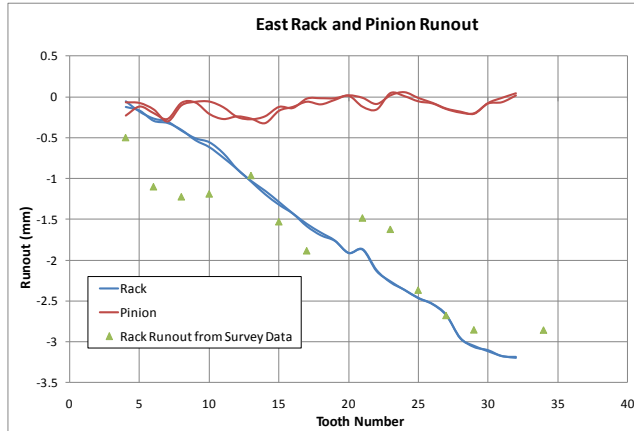
Figure 4 – Runout measurement data

as the span moves from the seated position to the raised position. This action causes the clearance between the rack and pinion teeth, also referred to as backlash, to decrease. The corresponding reduction in backlash, for a decreased center distance of 0.120" (3 mm), is 0.082" (2.05 mm).

The runout data shows both east and west pinions having very little change in radius, which is a desirable finding because it eliminates the possibility of a bent or bowed pinion shaft at the east pinion. However, the runout data shows that both east and west racks increase in radius from tooth 4 to tooth 32. This radius increase is approximately 0.120" (3mm) for both east and west racks. This radius increase effectively increases the engagement ("moves" the gears closer to each other) between the rack and pinion

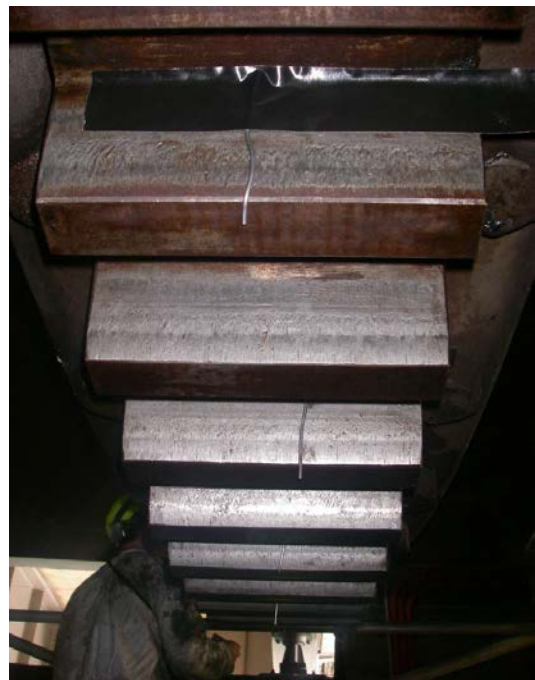
Because the east rack and pinion were the main interest of this investigation, the backlash was roughly determined for the whole length of the rack by placing lengths of soft lead solder on the lowering faces of every second rack tooth (see Photograph 6). When the span was raised, the solder passed through the gear mesh and was flattened by the lowering face of the pinion. The thickness of the flattened pieces of solder approximated the amount of backlash between the rack and pinion (Photograph 7).

Photograph 6 – Lead solder used to determine backlash during operation

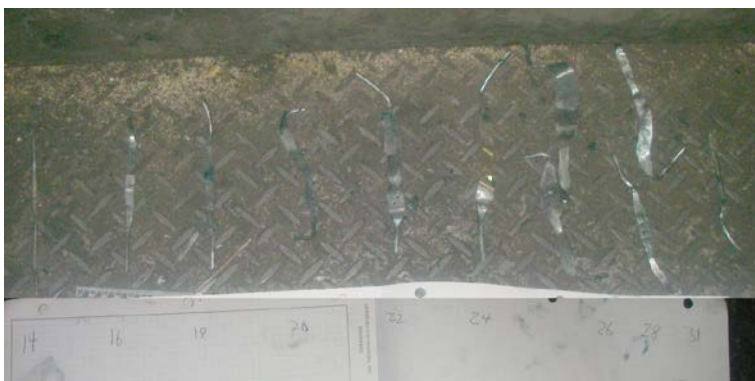
Photograph 7 – Flattened lead solder after operation

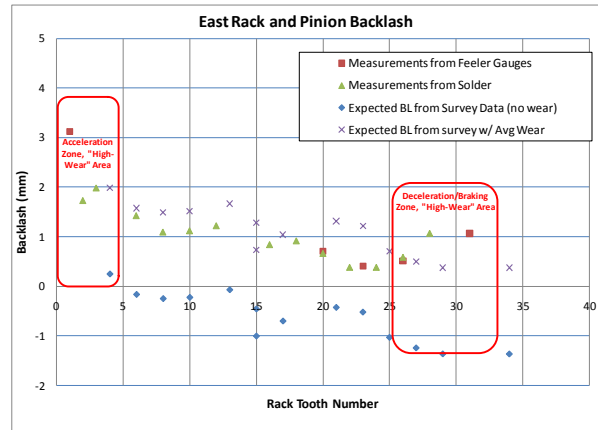
measurements are presented in Figure 5. The backlash measurements show that the backlash decreases to approximately 0.016" (0.4 mm) on the east rack/pinion, and to approximately 0.071" (1.8 mm) on the west rack/pinion.

The decrease in backlash coincides with the data recorded with the inductive distance sensors. When the minimum backlash is compared to the backlash at the seated position, the decrease is larger than that indicated by the distance sensors, which is likely because the wear is greater at the seated position due to repeated and high loads from starting, accelerating, and braking at the seated position. A similar, higher wear, condition exists at the fully raised position, where the braking repeatedly occurs, and can be seen in the backlash data.

Figure 5 – Measured backlash data

The survey data was plotted to determine the “Expected Backlash” at the various rack teeth for which data was collected. Figure 5 includes this data for the unworn east gear set. The survey data closely follows the actual backlash data collected, with the differences due primarily to gear wear (especially in the “high-wear” areas).

The measured minimum backlash for the east main pinion and rack mesh is unacceptably low (0.016”). A new installation should have a backlash range of 0.090” to 0.120”. The current backlash range for the east is 0.016” to 0.120” and for the west is 0.075” to 0.170”.

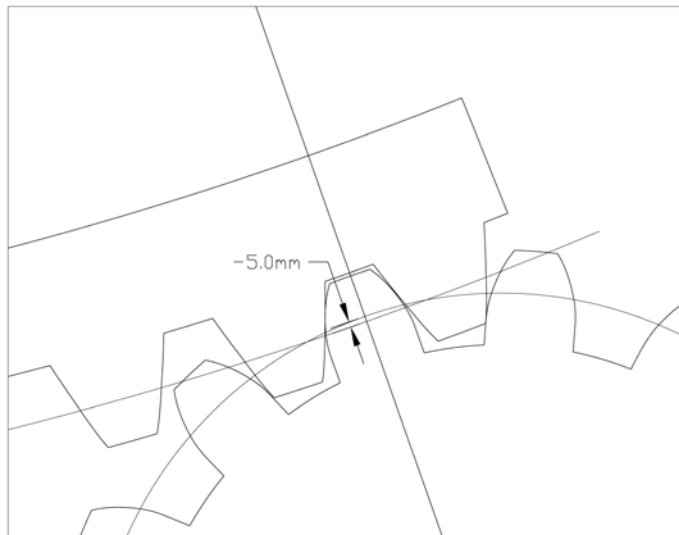
Figure 6 – Scale drawing of rack/pinion mesh over-engaged 0.200" (5mm)

Figure 6 shows over-engagement of the east rack pinion by 0.200" (5 mm) and includes the average wear of the rack and pinion. For comparison, Figure 7 shows a gear set with proper engagement and no wear.

The survey data was also used to calculate the distance between the tips and roots of the mating gears throughout operation. Measurements indicate the east rack and pinion are very close (less than 1/8" or 3 mm) to “bottoming out” at the raised position of the span. This correlates with the visual observations of undercutting near the roots of east pinion teeth 12 and 13.

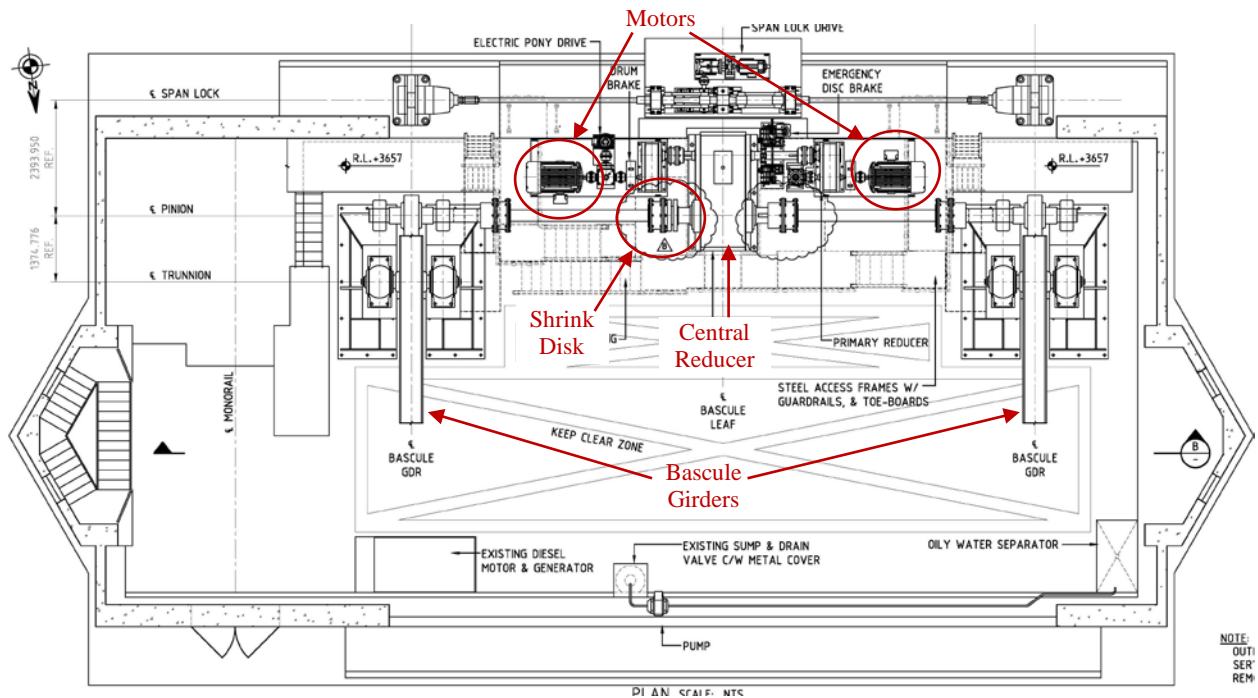
Figure 9 – New configuration of span drive machinery with shrink disk assembly on central reducer output shaft.

The span drive machinery was planned to be replaced up to (but not including) the final pinions in mid-2012 (see Figure 9). Having the existing machinery removed and the bridge inoperable for a defined period of time provided an opportunity to adjust the east pinion so that the backlash would match the west pinion, providing the best load sharing available in both directions. At the bridge owner's preference, the new machinery would not incorporate a central differential, so an ability to fine tune the pinion indexing was included in the new span drive arrangement. A shrink disk was planned to be added to one of the central reducer's output shafts, which would allow one pinion to rotate relative to the other before locking into position.

During the machinery installation, the marine channel was shut down for two weeks, and with the existing machinery removed, the east pinion bearings were available for adjustment. The over-engagement had been measured at about 0.080" (2 mm). However, due to the mounting arrangement of the pinion bearings, this small movement in the downward direction would have required drilling and reaming new mounting bolt holes. Alternatively, the bearings could be shimmed outward in more of a horizontal direction. This was not as efficient of a movement, but was much easier to accomplish. So the pinion was planned to be shimmed about 0.315" (8 mm) away from the mounting surface, which would place the pitch circles at the correct center distance. Since the machinery between the pinions was not yet installed,

During construction, the shims were adjusted until the backlash matched that of the west pinion and rack, which required about 0.395" (10mm) of pinion movement. Once the new span drive machinery was installed, the shrink disc coupling was left untightened while the pinions were manually indexed so that the raising and lowering faces of both pinions contacted their respective rack gears. To check the effectiveness of load sharing, strain gauge testing was performed with the new span drive system and compared to test results prior to the work (see Figure 10). As can be seen in the graphs, load sharing is much improved with the span near the lowered position, and the sharing diverges somewhat as the span approaches the raised position. Since the combined loading is higher with the span near the lowered position, it was decided to leave the indexing as is, rather than adjust the indexing to match elsewhere in the span operation.

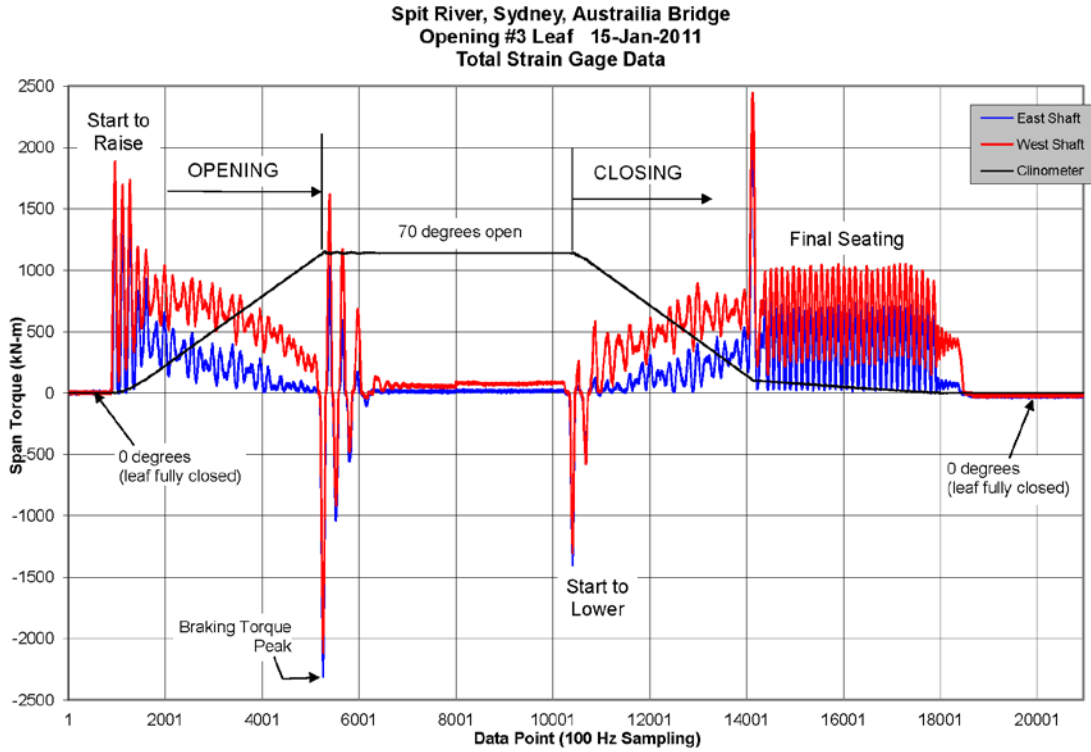
Torque in the two floating shafts was recorded during bridge operations using strain gauges. This data can be seen in Figure 8 (at end of this report). A lack of load sharing is evident in the data, with the west shaft taking about twice as much load as the east shaft. At the spikes in the closing direction (negative torque on the graph), the east shaft has slightly more load. Since these spikes are repeated at every operation, the gears have worn to share slightly better.

Figure 8 – Initial strain gauge test data (prior machinery replacemtn) showing east pinion with higher loads than west pinion

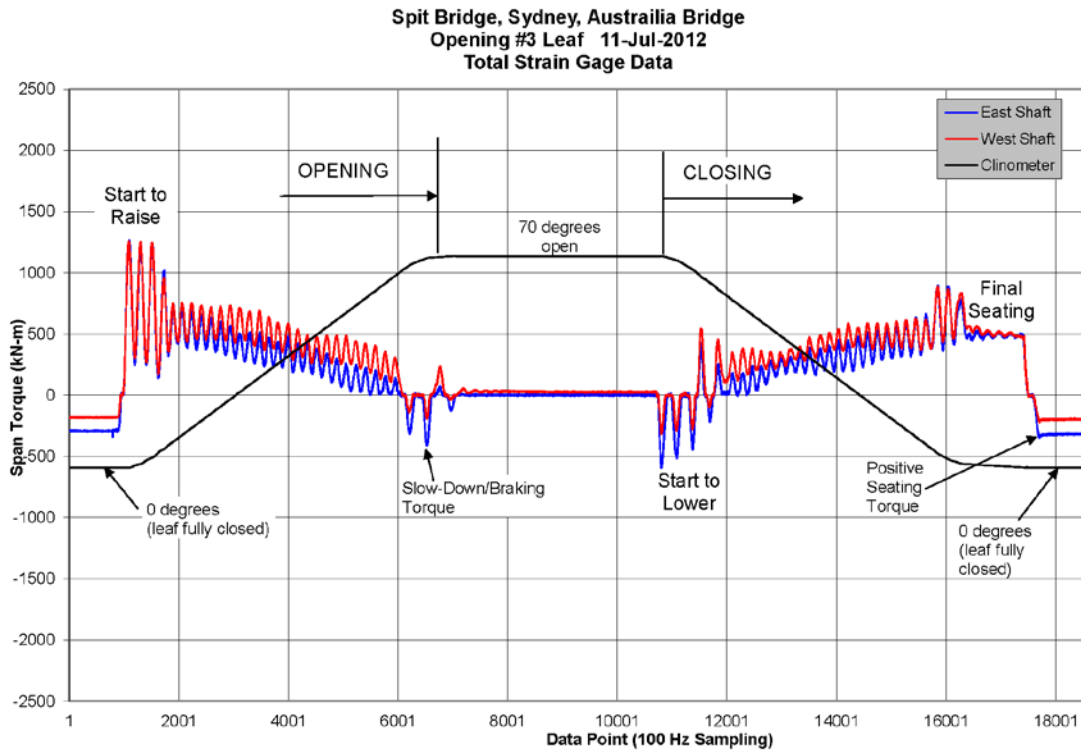
Figure 10 – Final strain gauge test data after installation of new span drive machinery, with improved load sharing between pinions
