**HEAVY MOVABLE STRUCTURES, INC.  
SEVENTEENTH BIENNIAL SYMPOSIUM**

**Mitigation of Cracks in  
Sheave Trunnions for the  
Burlington Bristol Bridge**

Robert D. Gessel; ASNT Level III  
Wiss, Janney, Elstner Associates, Inc.

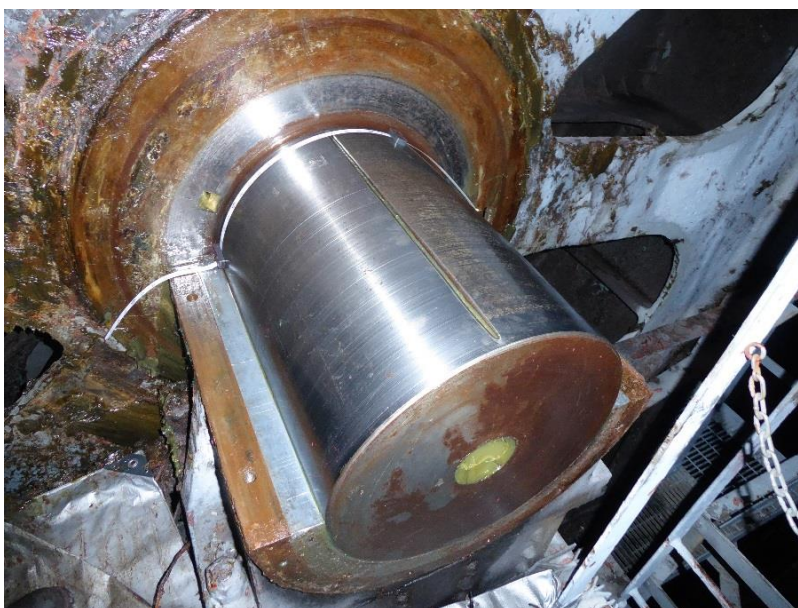
FIGURE 3: A trunnion journal seated in its half-bearing, is shown with the grease reservoir removed.

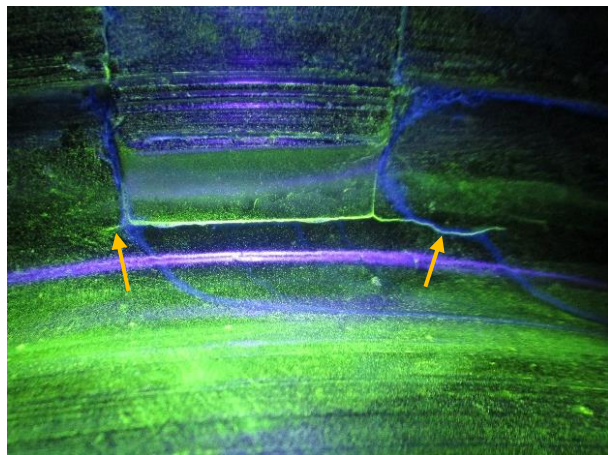
FIGURE 5: Keyway cracks located high in the transitional fillet extend from the keyway.

Cracks extending from the corners of keyways, referred to as “keyway-cracks,” appear to originate due to an impact or prying mechanism that is much different from the initiation and propagation of fillet-cracks. As shown in Figure 5, these cracks originate in the upper portion of the transitional region, and at the bottom surface of the keyway, where the key acts against the sides during rotations of the trunnions.

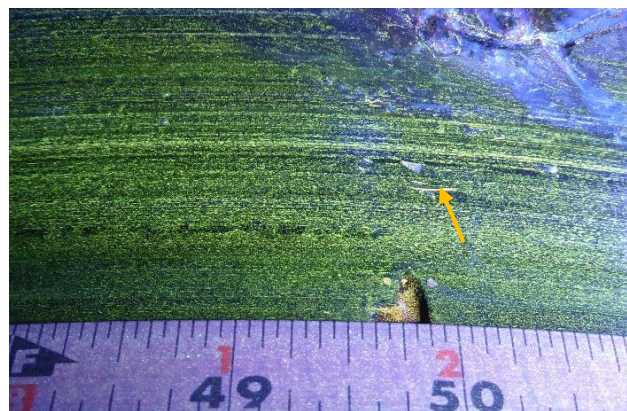
the journals during rotations of the sheave trunnions, with highest concentrations at regions of the transitional fillet. Cracks that originate from this mechanism, referred to as “fillet-cracks” are typically positioned low to mid-fillet, as shown in Figure 4, within the transitional region of the journal.

FIGURE 4: Crack initiation (arrow) positioned low in the transitional-fillet.

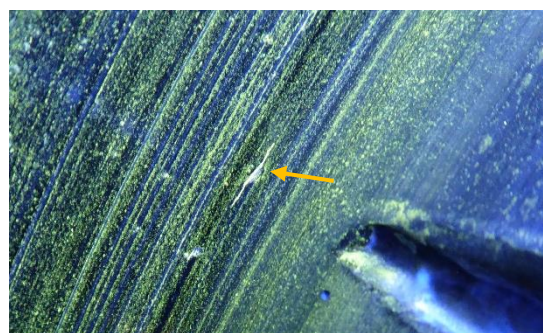
An apparent site of origination for some cracks in Burlington Bristol Bridge trunnions were nicks or gouges within the transitional region. Several blemishes of this type were in alignment with grease grooves in several trunnion journals, and might have been inscribed to mark the placement of groove locations during manufacture. These blemishes create stress risers with local concentrations when subject to tension that is associated with bending. Cracks extending circumferentially in both directions from one of these nicks, as shown in Figure 6, were revealed when subjected to wet fluorescent magnetic particle examination.

FIGURE 6: Crack initiations extend in two directions from a blemish (arrow) in the transitional region of a journal.

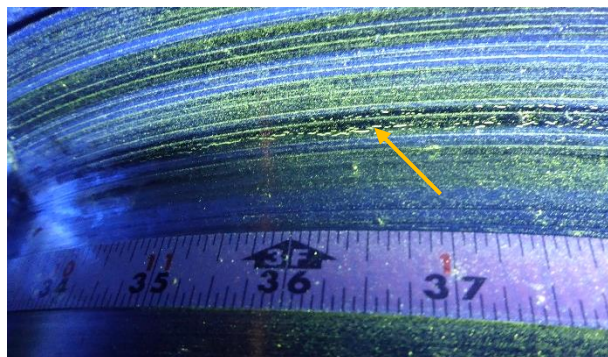
FIGURE 8: Multiple crack initiations, beginning to coalesce were detected in one journal.

over a circumferential area of about five inches. Fillet crack initiations detected at other locations were typically short and scattered, as shown in Figure 9. With crack initiations that originate within the regions of highest stress concentrations, and propagation that is transverse to the axis of the trunnion, all fillet cracks threaten the integrity of the trunnions, and should be mitigated if possible.

A concentration of fillet-cracks, shown in Figure 8, was detected in the 2017 examinations, distributed

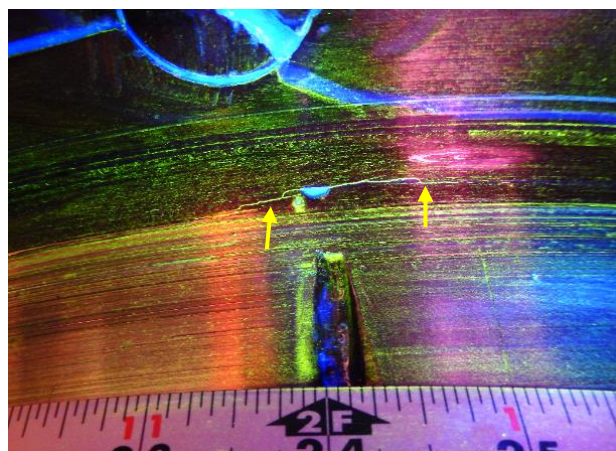
Fillet-cracks were detected in two journals during examinations of 2014 and 2015, but in additional journals as well, during the biennial examinations of 2017. Cracks have not, however, been detected in all of the trunnion journals. Coalescence of the fillet-cracks shown in Figure 7 had exceeded a length of 1-1/2 inches by 2015, however, the response from ultrasonic examinations indicated that the depth was relatively shallow, and that mitigation by excavation could be accomplished.

FIGURE 7: Multiple low to mid-fillet cracks (arrows) have coalesced and extended.

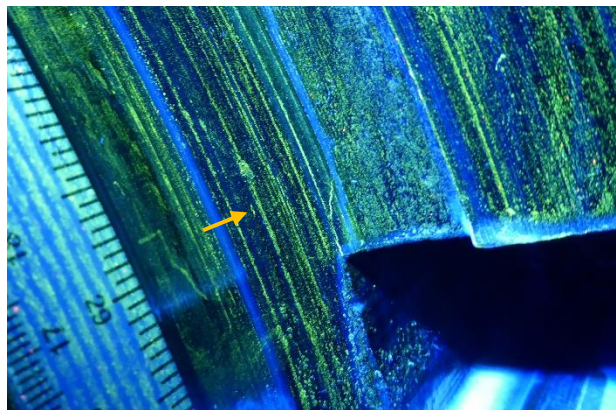
FIGURE 9: Most new crack initiations in 2017 (arrow) were short and isolated.

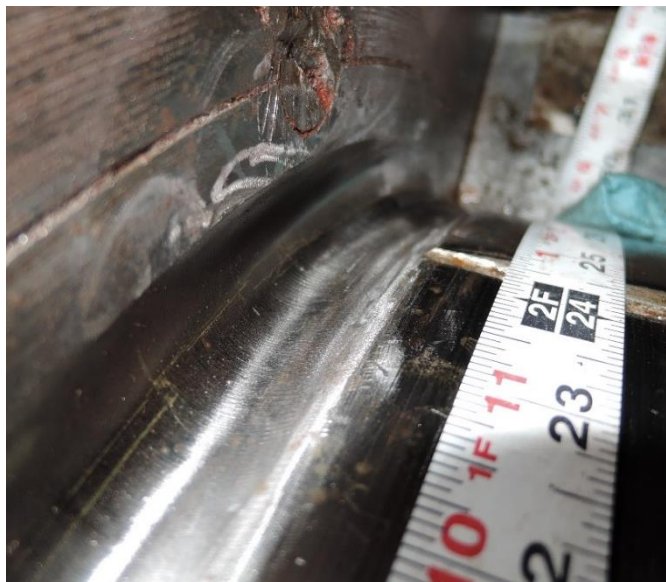
FIGURE 10: Excavations for mitigations of cracks sometimes undercut the plane of the journal.

The fillet-cracks identified in 2014 and early 2015 were excavated in November 2015, as shown in Figure 10, for mitigation of the affected regions. Feasibility for remediation was established prior to the start of mitigation efforts, where depths of about 0.15 inches were estimated for most cracks that were identified in nondestructive examinations.

The mitigation excavations were governed mainly by the fillet-crack depth, and generally followed the original contour to produce a gradual transition to the surrounding trunnion surface. Excavations required for the deeper cracks sometimes undercut the plane of the journal surface, as well as the trunnion thrust-face. The extent of material removed was kept to the minimum necessary for complete removal of the crack-tip, while maintaining the appropriate transition.

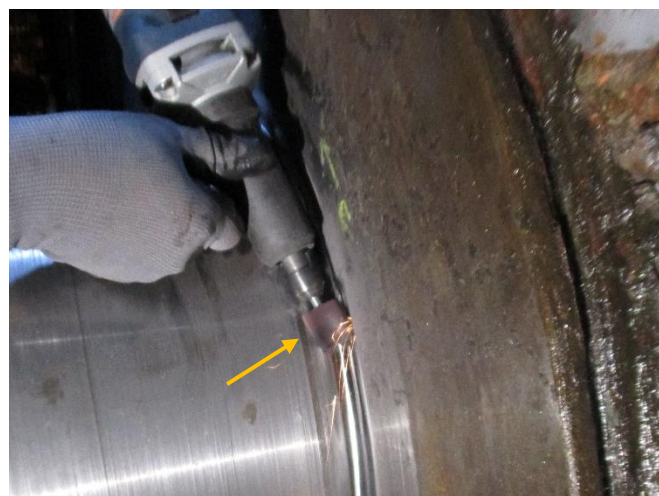
FIGURE 11: Excavations surfaces were completed by polishing with a sanding flap-wheel (arrow).

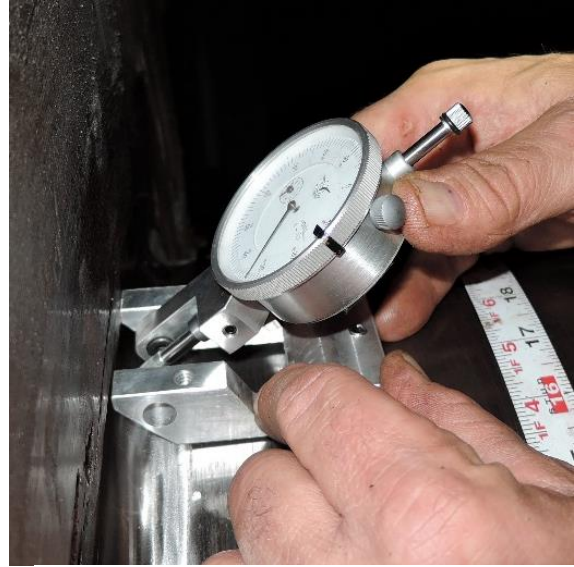
FIGURE 12: A dial gage was fitted to a fixture for post mitigation measurement of the fillet region profile.

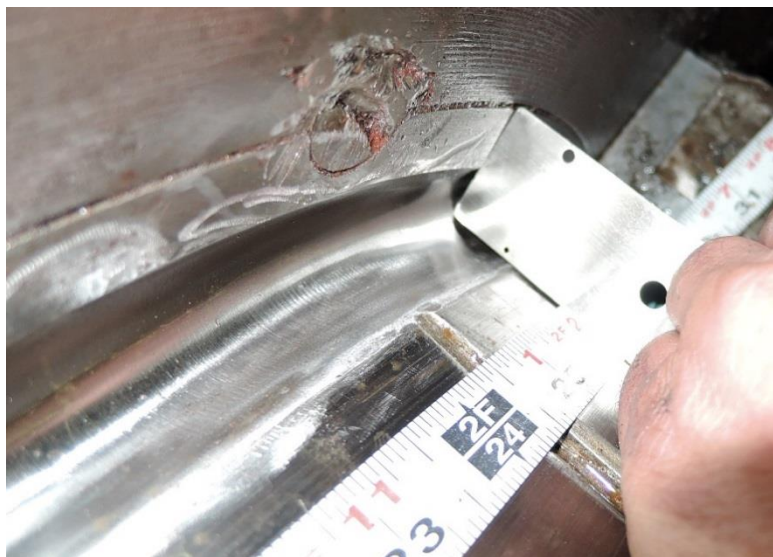
excavated rather than allowing crack-tips to remain within the highly stressed fillet region. The most extensive excavation, shown in Figure 13, undercuts the journal and the thrust face, but generally follows the contour of the original fillet. Detection and mitigation at an early stage may be expected to reduce the extent of material removal, and the potential for propagation or initiation of new cracks.

FIGURE 13: The deepest mitigation excavation undercut the plane of the journal surfaces, but followed the contour of the original fillet.
