**HEAVY MOVABLE STRUCTURES, INC.
SEVENTEENTH BIENNIAL SYMPOSIUM**

**CONSTRUCTION ENGINEERING FOR
THE ADAMS STREET BASCULE BRIDGE
AND VIADUCT REHABILITATION IN
CHICAGO**

Milhouse Engineering & Construction, Inc.

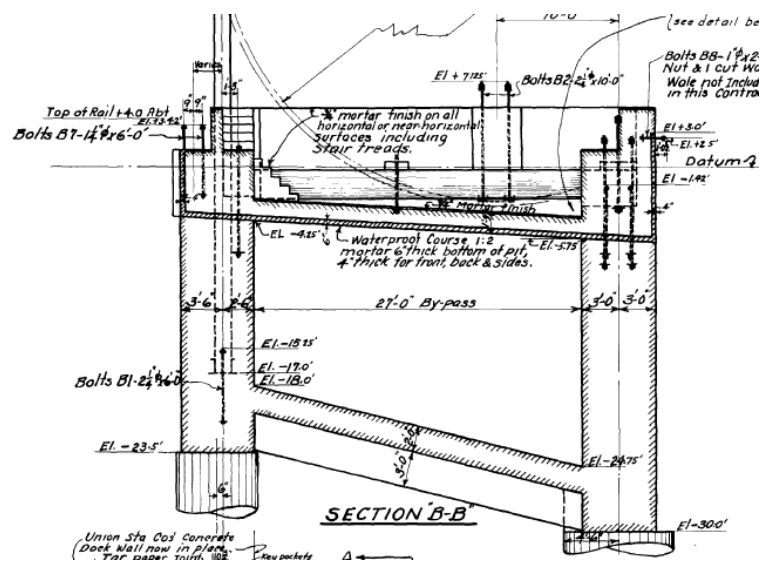
Figure 1: West Pit

caisson shafts founded on rock. Due to the proximity of the Chicago Union Station complex and the need to maximize the draw width, the west pit is smaller than the east pit and has a shallow floor two feet thick that spans between the river and back wall. It is believed that the west pit was designed this way to minimize impact to the Chicago Union Station tracks. See Figure 1.

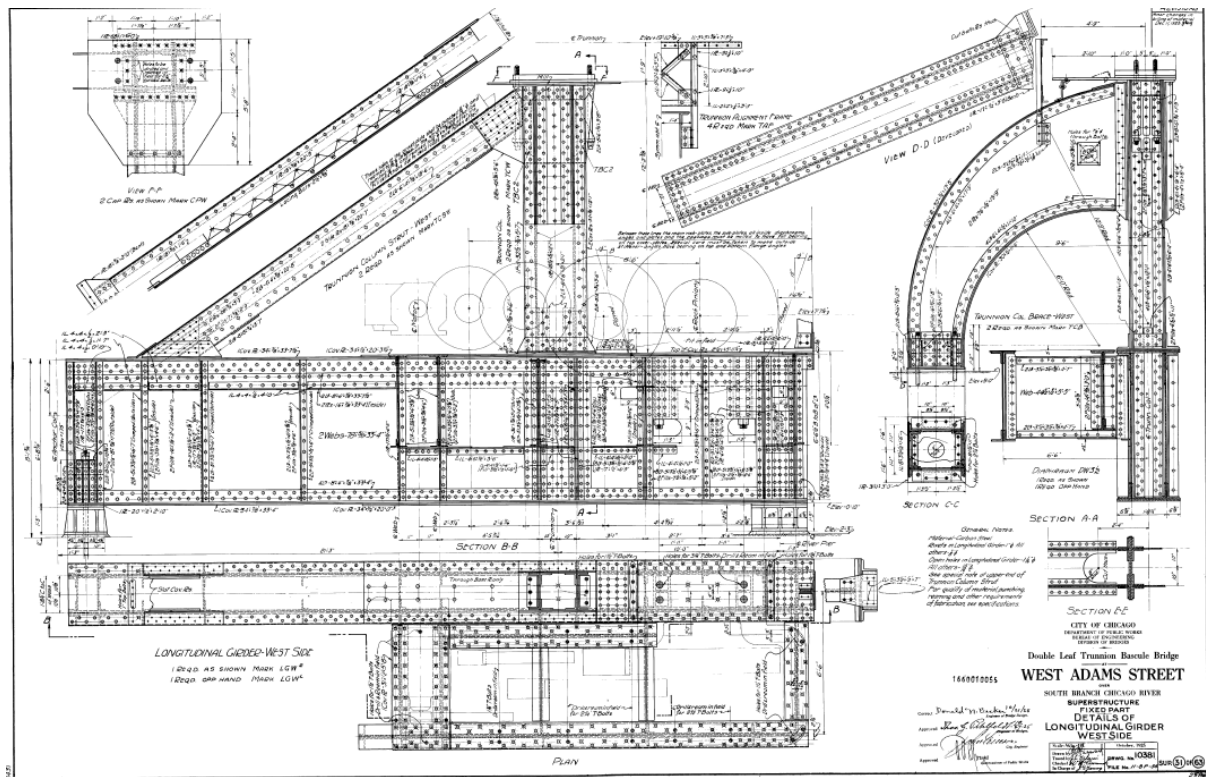
Figure 3: Longitudinal Girder with Trunnion Column and Brace

In the early 2000's, CDOT engaged the consulting firm CMT to design the replacement of the viaduct over Chicago Union Station and to address areas of deterioration on the bascule bridge. The bascule bridge rehabilitation design was entrusted to Collins Engineers of Chicago. The scope of the bascule bridge rehabilitation included replacement of the deteriorated floorbeams at the center break, replacing the west fixed span, new protective pile clusters, replacement of the live load bearings, repairs to the S-girders and trunnion girders, repair to the northwest longitudinal girder, electric motor rewiring, new control systems and rehabilitation of the historic bridge house. During inspections performed during the design, it was found that the northwest longitudinal girder of the west pit was severely deteriorated. Most of this deterioration was found on the north girder nearest to the pit wall. It is believed that road salt run off from the fixed approach through openings in the deck contributed to the heavy corrosion found on the

north portion of the longitudinal girder. The plans called for the replacement in kind of the flange angles, cover plates and stiffener angles in place.

CDOT's plans called for the rehabilitation of the northwest longitudinal girder in place. The longitudinal girders consist of two 78 inch deep built up plate girders with exterior pairs of 8 by 6 by 7/8 inch angles, web doubler plates, cover plates and stiffeners. The girders are spaced 20- inches apart to form a stiffened box that supports the trunnion column and a portion of the machinery girder. In the intervening 50 years since the last work on longitudinal girder, roadway salts and poor drainage conspired to cause severe corrosion of both girders with the interior girder more severely deteriorated. CDOT's design called for the rehabilitation of the interior girder in place with the replacement of the top and bottom flanges and the top plate. This was to be accomplished between the pit wall and girder with less than 24 inches of space and about equal space under the girder. See Figure 4.

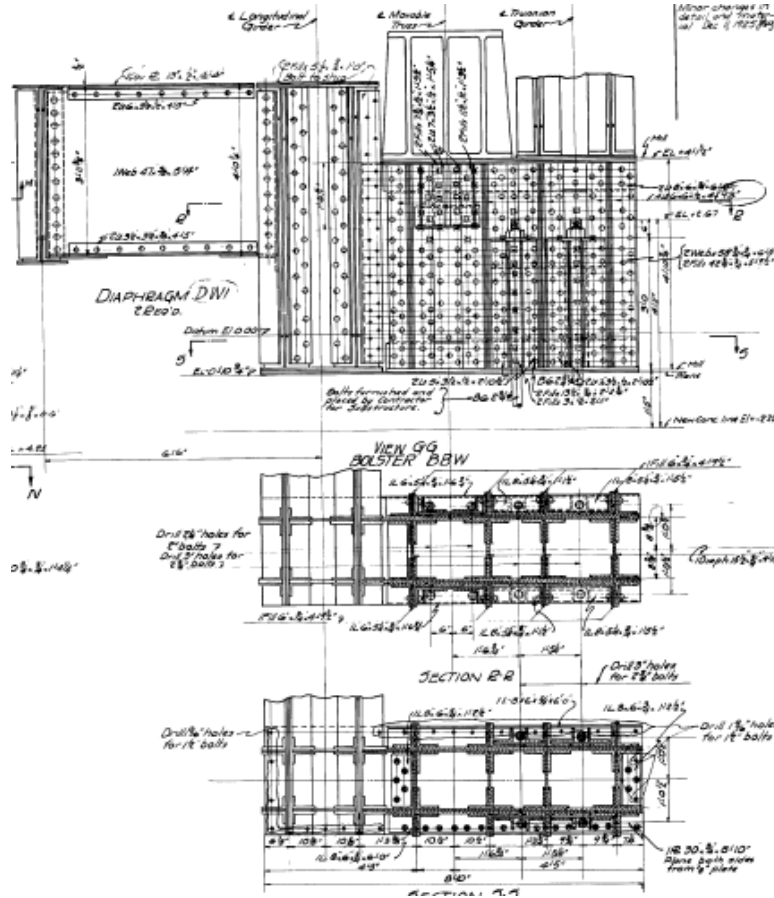
Figure 5: Live Load Grillage

The existing bridge plans indicated that there was a built up steel grillage embedded in the river wall of the pit that supported the S-Girder, live load bearing and longitudinal girder. See Figure 5. Based on a review of the plans, it was not known whether the grillage had been modified as part of the work performed in the 1960’s.

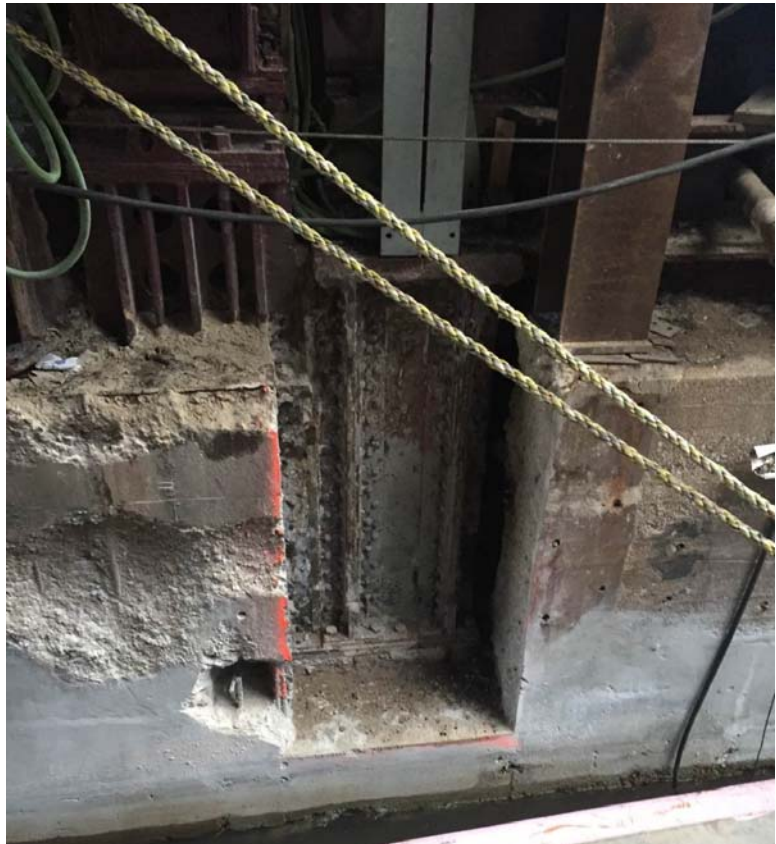
Figure 6: Mined out River Wall with Longitudinal Girder, Live Load Bearing and Bridge House Column

load bearings and shoring, Walsh was now able to rehabilitate the S-Girders as well as start mining out the concrete that encased the steel grillage below the live load bearings. The bottom of the longitudinal girder is located only about one foot above normal level of the Chicago River. See Figure 6.

As noted above, the machinery girder is partially supported by the longitudinal girder. Milhouse had to devise a means of supporting the machinery girder before the longitudinal girder could be removed. The simple solution was to erect a support girder over the gear train and the lash the gear train to the support girder so that the machinery girder could be cut free from the longitudinal girder. One of the main vertical support members of the bridge house also needed to be supported since it
