**HEAVY MOVABLE STRUCTURES, INC.  
SEVENTEENTH BIENNIAL SYMPOSIUM**

**Emergency Strauss Bascule Link Pin  
Repair - Seabrook Bascule Bridge**

Tyler J. Miller

Modjeski and Masters, Inc.

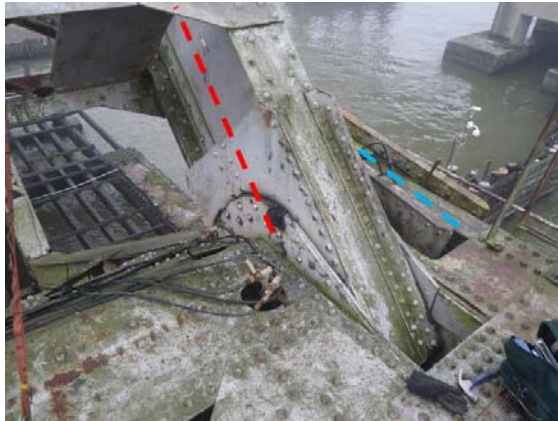
Photograph 1 - General view of the lakeside 2<sup>nd</sup> Link Joint. Note the counterweight link centerline (red dashed line) and operating strut centerline (blue dashed line).

The Seabrook lakeside 2<sup>nd</sup> Link Pin was found to emit loud grinding noises constantly through bridge operations (see Photograph 1). The joint exhibited advanced deterioration and a partial assembly failure. It was reported that it was no longer possible to apply fresh grease between the main sleeve and bushing. All six of the retainer bolts were sheared at both ends of the internal sleeve (see Photograph 2). The original bearing surface between the sleeve and the bronze bushing appeared to be frozen causing all relative bearing rotation during bridge operation to occur either

Upon completion of the field inspection, Modjeski and Masters recommended complete cessation of span operations until the lakeside 2<sup>nd</sup> Link joint was repaired. Rehabilitation of the riverside 2<sup>nd</sup> Link Pin and replacement of the 1<sup>st</sup> Link retainer bolts were included in the repair scope.

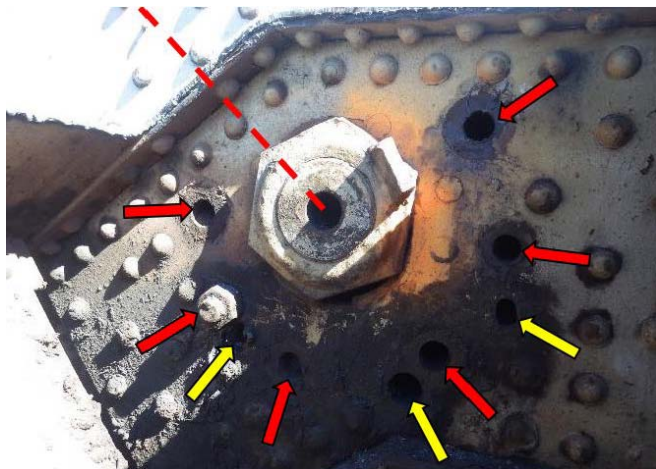
Photograph 2 - Broken retainers/bolts/holes (red arrows) and grease passages (yellow arrows) at the lakeside 2<sup>nd</sup> Link inboard gusset plate. Evidence of the 1" wear in the gusset plates can be observed by the gap at the 5 o'clock position. Note orientation of the counterweight link centerline in the seated position (red dashed line).

In addition, the sleeve retainer bolt holes and grease grooves no longer aligned with holes in the gusset plates. Therefore, it was impossible to add lubrication to and restore movement at the original bushing interface.

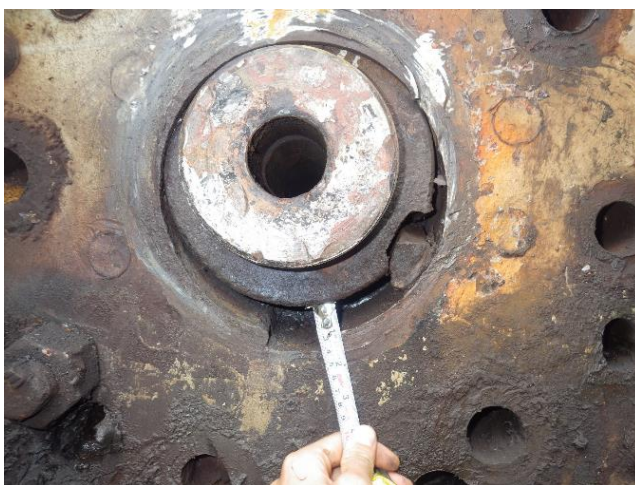
between the pin and the sleeve or the pin and the gusset plates (see Photograph 3). The original key at the interface of these surfaces had sheared in multiple places (refer to Photograph 3). Due to the reduced area, bearing stresses at these new locations of relative motion were over 6 times higher than the original sleeve to bronze bushing interface. Rapid wear was developing and pieces of the failed key were gouging into the adjacent components. The inboard gusset plate exhibited 1 inch of wear allowing the pin to shift radially from the original centerline (refer to Photograph 3). Internal damage between the pin and the sleeve could not be accurately assessed. Hard contact was present between the inboard lomas nut and the gusset plate and between the inboard face of the main sleeve and the gusset plate. Without the retaining bolts, the gusset plates lacked support to resist this side loading.

Photograph 3 - Lakeside 2<sup>nd</sup> Link Pin failure. Note the pin rotation, sheared key and approximately 1" wear between the pin and the gusset plate bore.

Significant gusset plate wear in combination with the need to support the operating strut at the 2<sup>nd</sup> Link Pin created several design challenges. An in-kind replacement of the pin was not possible due to the wear. Boring out the gusset plates and using a larger pin diameter was also not possible since the pin was to be inserted from the outboard side through the operating strut bearings. A solution was found in the use of gusset sleeves to fit between the pin and new clean bores in the gusset plates.

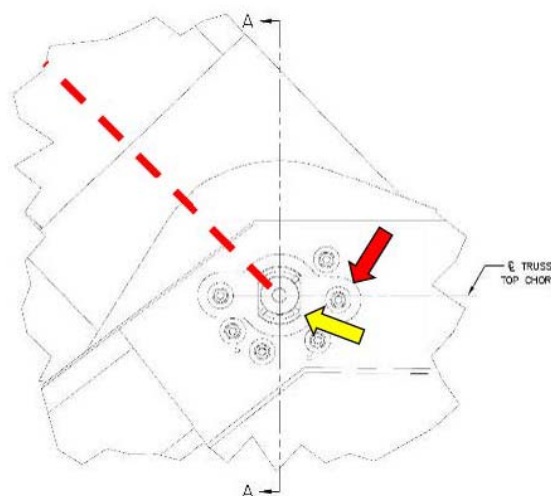
Figure 3 - Inboard 2<sup>nd</sup> Link gusset sleeve with pin flats to resist operating strut torque (yellow arrow) and sleeve ears extending to two of the shear insert plugs (red arrow).

The operating strut connection presented a second design challenge. Friction from the operating strut bearings causes rotational forces in the pin that must be resisted. Originally the pin was keyed to the span gusset plates for this purpose (refer to Figure 2); however, the new gusset sleeves were not thick enough for a keyway. Another method with similar anti-rotation capacity was required for the pin. The answer was found by adding flats at the interface between the end of the pin and the inboard gusset sleeve (see Figure 3). Ears were also added to the gusset sleeves, extending to two of the new shear insert plugs, to anchor the gusset sleeves from rotation.

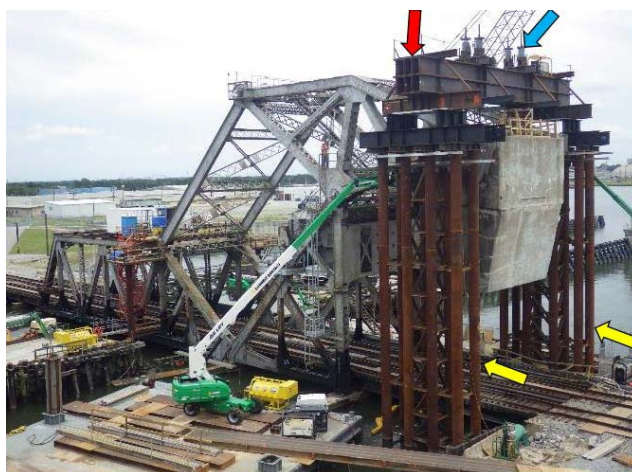
Photograph 4 - Temporary counterweight support structure. Note the pile structure on each side of the counterweight (yellow arrows), the four main double stacked W36x395 beams (red arrow), and the hydraulic jacks and Williams Rods (blue arrow)

four rods were put in place for safety. See Photograph 4 for the general layout of the temporary counterweight support pile structure. The threaded rods enabled the jacking mechanism to make the precise position adjustment needed during disassembly and reassembly of the 2<sup>nd</sup> Link Joints.

SBC's temporary counterweight support structure consisted of 16 x 24" diameter steel piles, lateral bracing angles, framing beams, and four double stacked W36x395 beams. SBC cored eight 5" diameter holes through the entire depth of the counterweight to allow for the passage of 3" diameter Williams Rods. These 150 ksi rods, in combination with washers and threaded nuts, were used to support the counterweight from below, where only a few inches existed before fouling the track clearance envelope. Atop the framing beams, SBC installed four 500-ton jacks to engage the rods and raise the counterweight from its natural resting position. Effectively, four of the rods acted as jacking rods, while

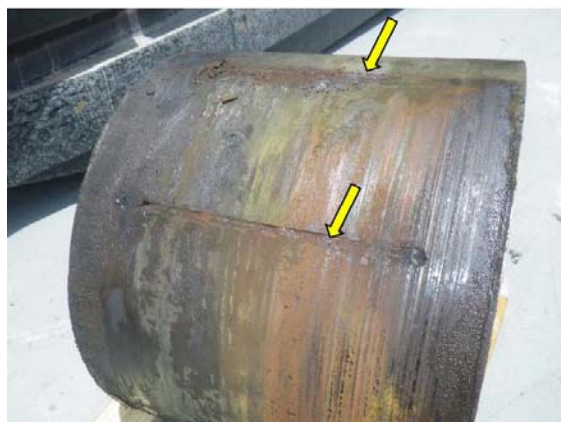
Photograph 5 - Lakeside 2<sup>nd</sup> Link main sleeve with grease grooves packed with solidified grease

Grease grooves in the lakeside 2<sup>nd</sup> Link main sleeve were discovered to be 100 percent filled with solidified grease (see Photograph 5). The lakeside 2<sup>nd</sup> link pin exhibited severe wear and abrasion with wear steps up to 1/2" deep (see Photograph 6). It was evident that most of the wear was occurring in the pin, thereby confirming the importance of ceasing bridge operations.

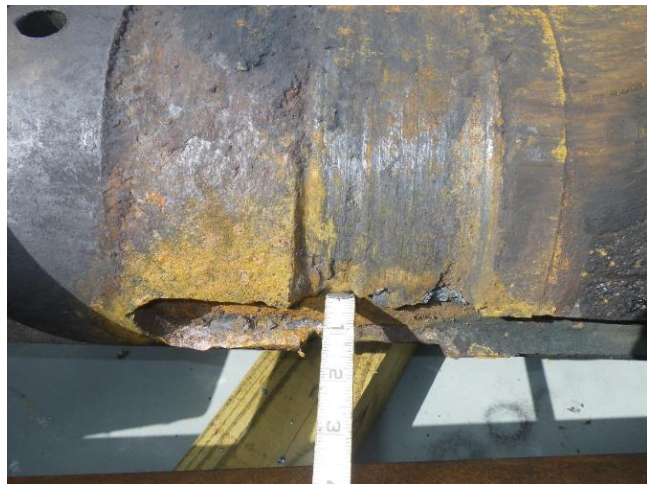
Photograph 6 - Lakeside 2<sup>nd</sup> Link Pin with wear steps up to 1/2" deep and severe abrasion

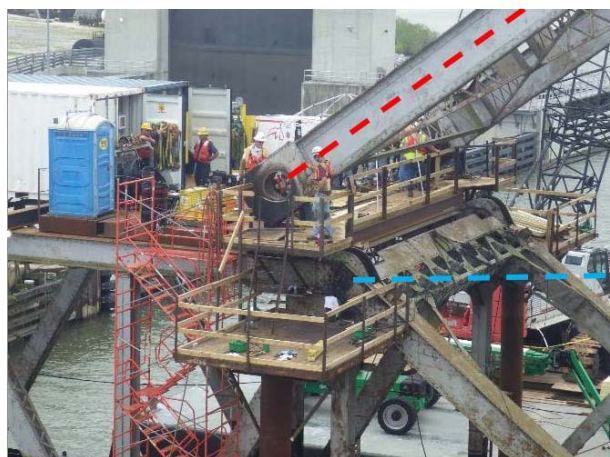
Photograph 7 - Disassembled 2<sup>nd</sup> Link joint with the counterweight link arms rotated out of the span gusset plates. Note counterweight link centerline (red dashed line) and original operating strut position (blue dashed line).

both counterweight link bearings and both span 2<sup>nd</sup> Link joints (see Photograph 7). New bushings and main sleeves were installed at the counterweight link bearings after a few clean up line boring passes (see Photograph 8). Initial rough machining efforts at the span gusset plates removed the existing wear and old keyways. The gusset plates were also faced in the areas of the new gusset sleeve flanges (see Photograph 9).

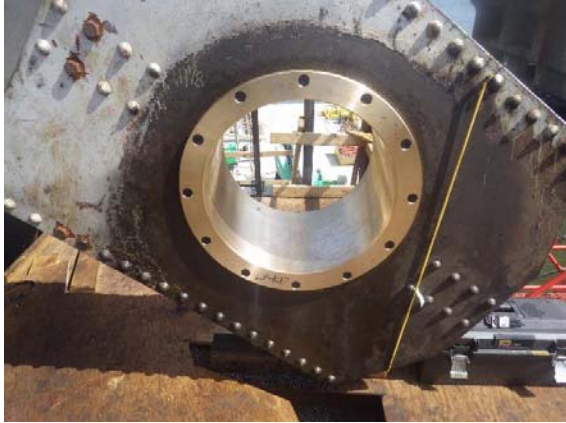
Photograph 8 - New bushing in the lakeside counterweight link bearing

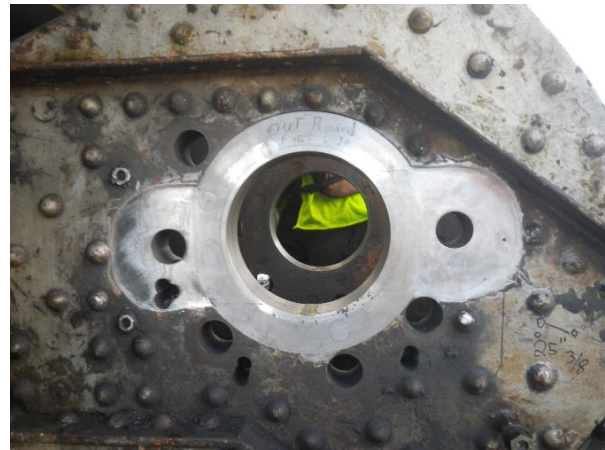
Photograph 9 - 2<sup>nd</sup> Link truss gusset plates after initial machining. Note the original keyway removed from the bores and facing in the area of the new gusset sleeve flanges

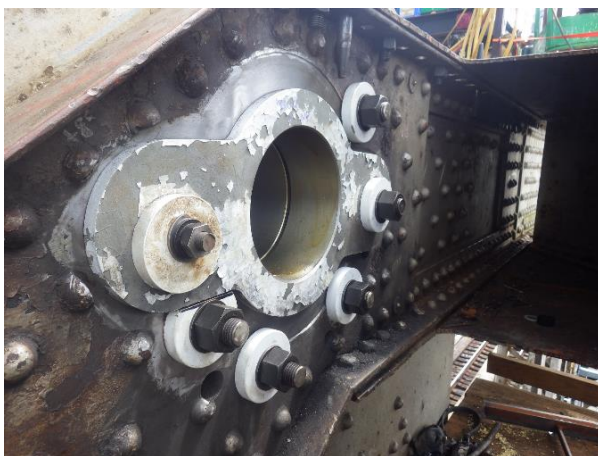
Photograph 10 - New gusset sleeves, shear insert plugs and thru bolts installed at the 2<sup>nd</sup> Link joint in preparation for installing the main pin.

achieved. The main sleeve position was temporarily held in place by tapered undersized shear plugs then secured once most of the final shear insert plugs were installed after drilling, reaming, and honing. Installation of the gusset sleeves, operating strut bearings, operating strut outrigger, and main pin required several more line boring and installation sequences (see Photograph 10).

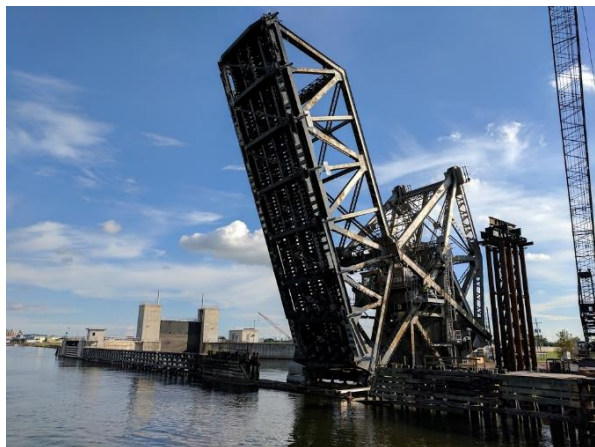
Photograph 11 - Bridge operation restored

Bridge operation was restored in July 2017 (see Photograph 11). Overall the emergency repair project was a great success. Long term reliability of the counterweight link joints was significantly improved. Post construction strain gage balance testing revealed that the total bridge friction was cut nearly in half with the new 2<sup>nd</sup> Link components.
